# Construction Observation Report 015 – October 17, 2024

Maplewood School

PROJECT NUMBER: 321169-01

OWNER:	MENASHA JOINT SCHOOL DISTRICT
From ARCHITECT/ENGINEER:	EUA
To CONTRACTOR	MIRON CONSTRUCTION CO, INC
SITE OBSERVATION TYPE	ARCHITECTURAL
DATE OF ISSUANCE:	October 21, 2024

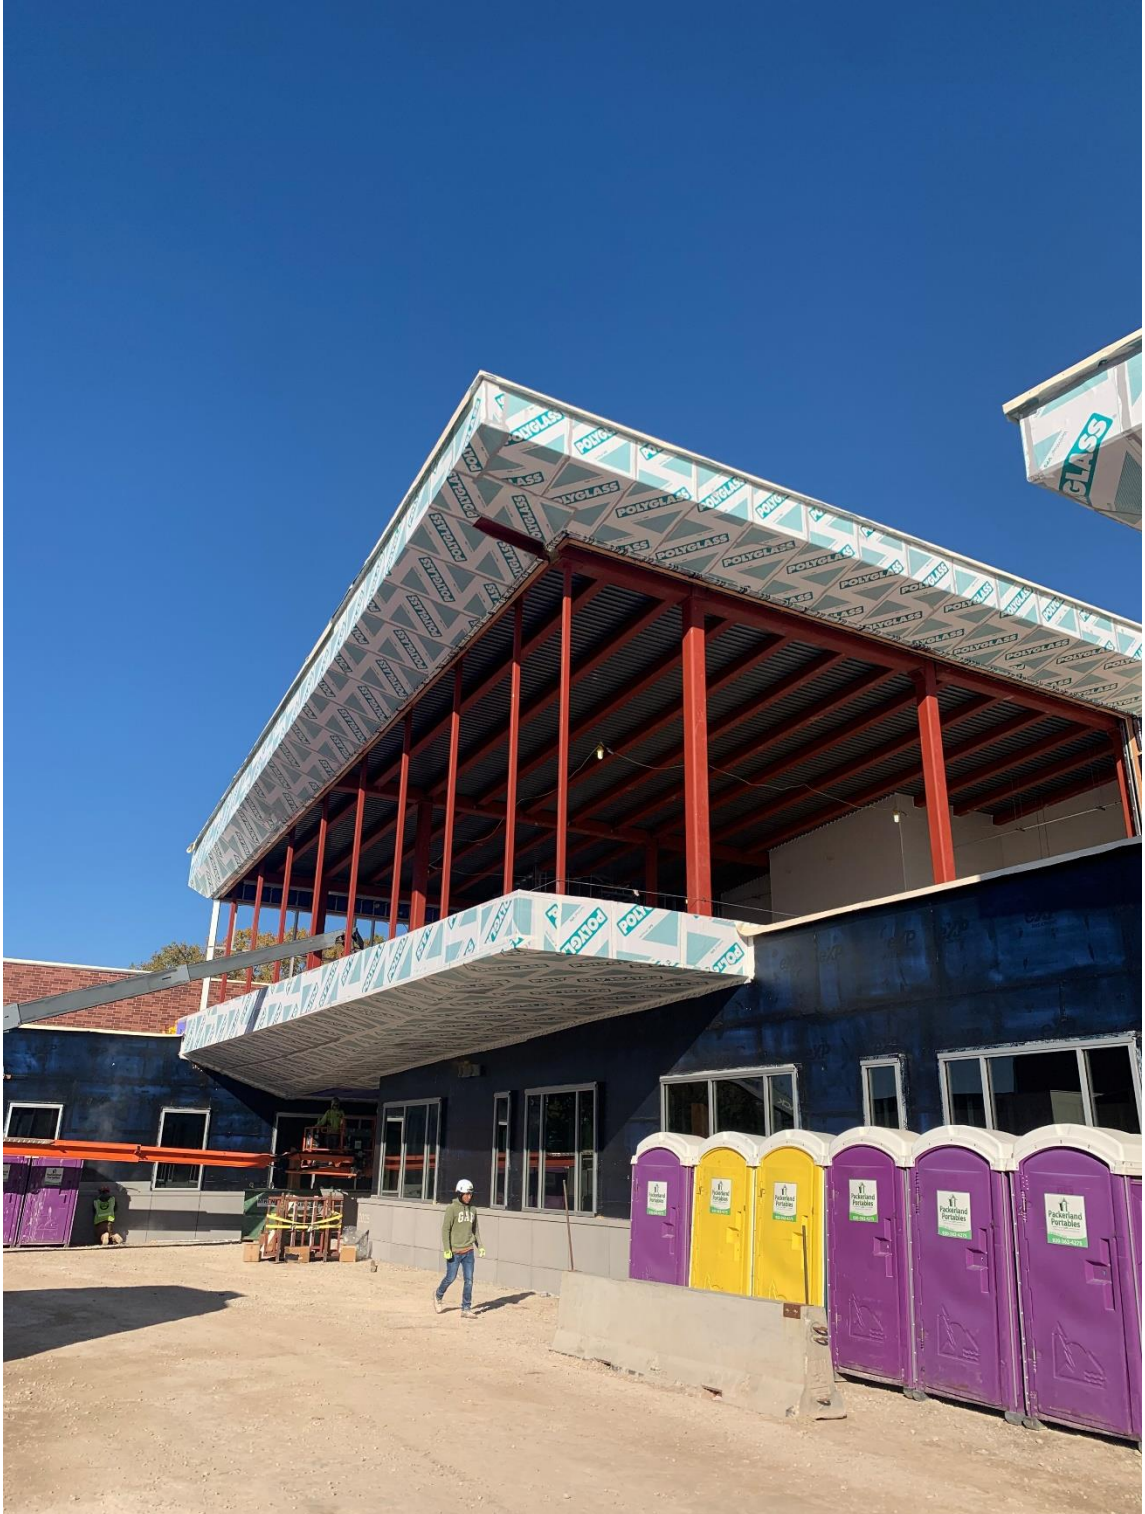
1. Area 1A South – Weather proofing membrane install in progress at openings. Storefront glazing installed.

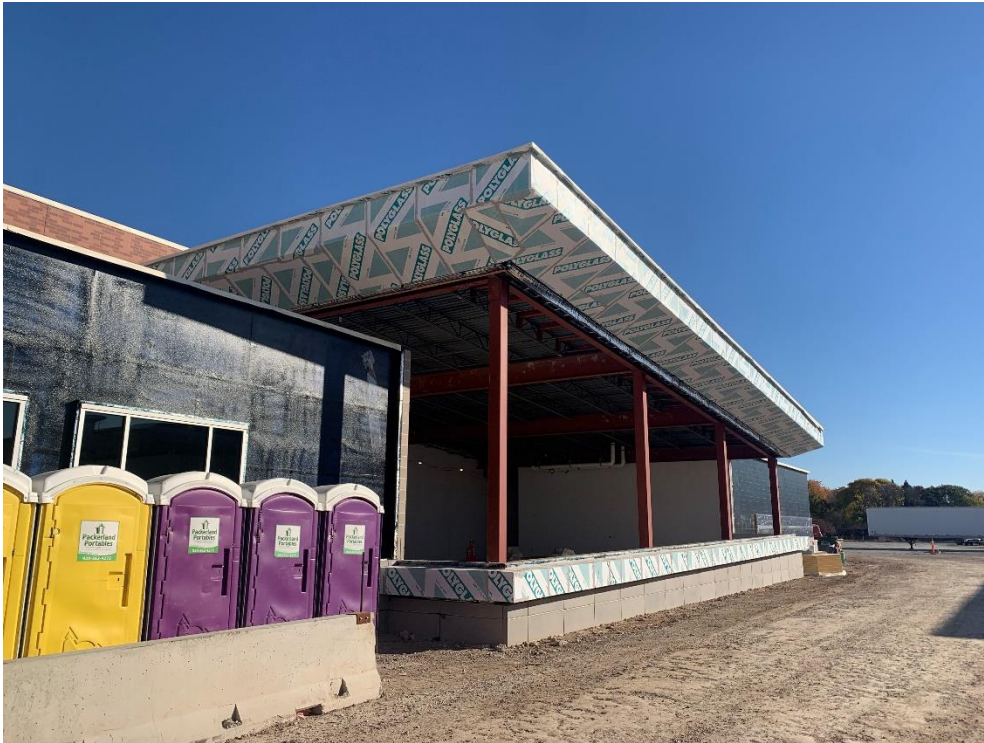
2. Area 2B South – Weather proofing membrane installed at openings and eye brows.

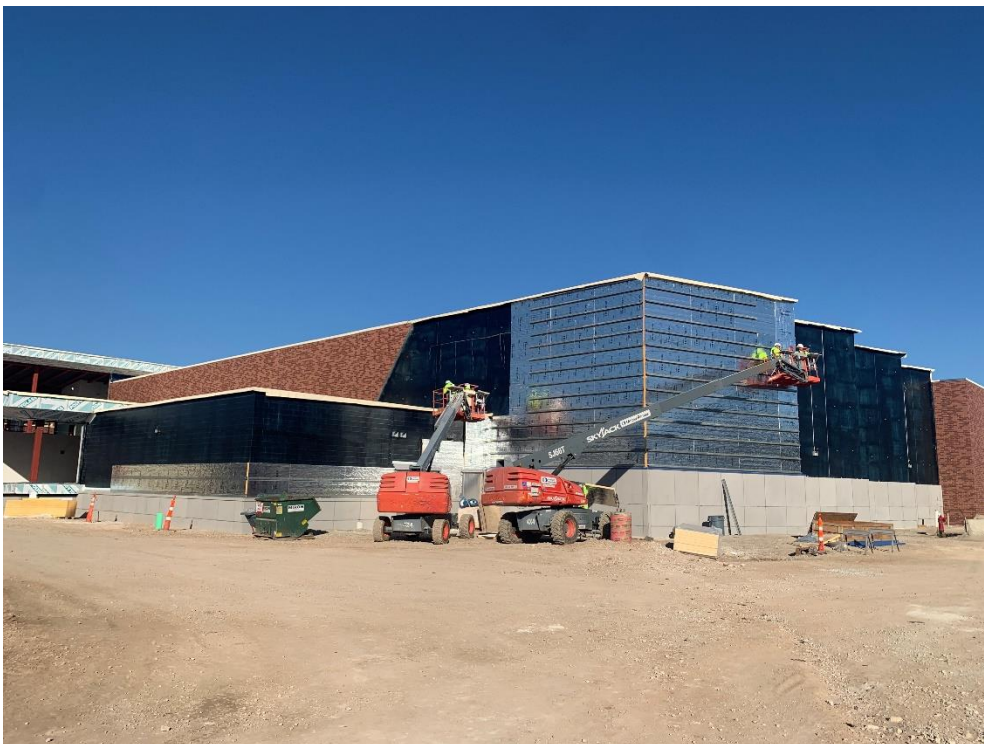
3. Area 2B & 6 Southeast – Board insulation and composite wall panel girt system install in progress.

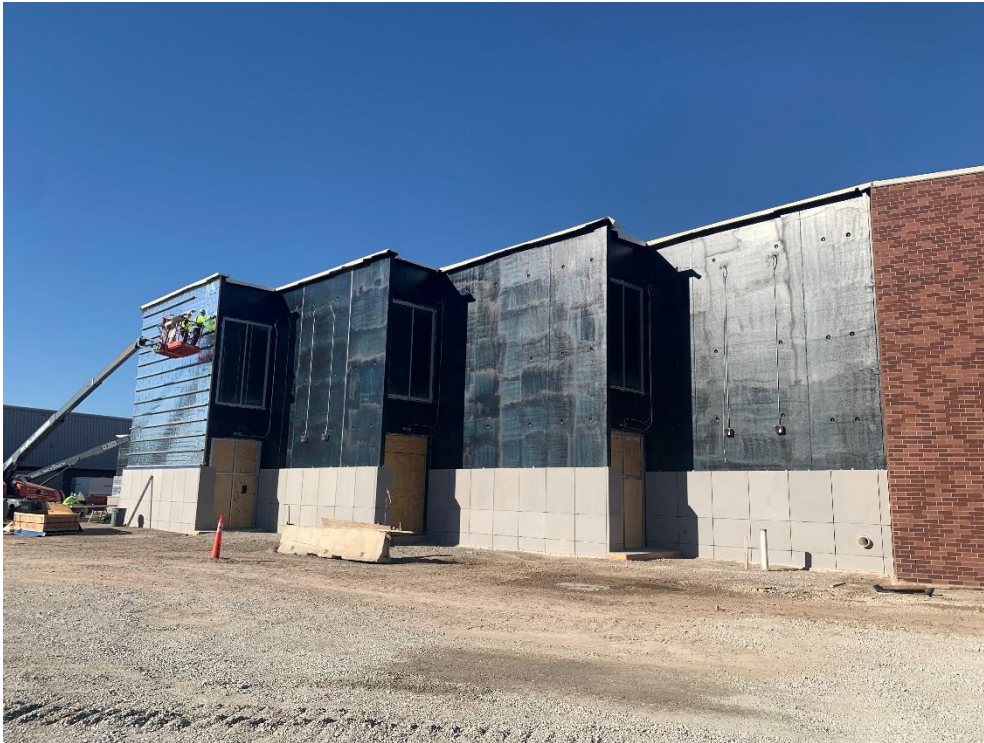
5. Area 6 East – Board insulation, composite wall panel girt system, and storefront framing/glazing install in progress.

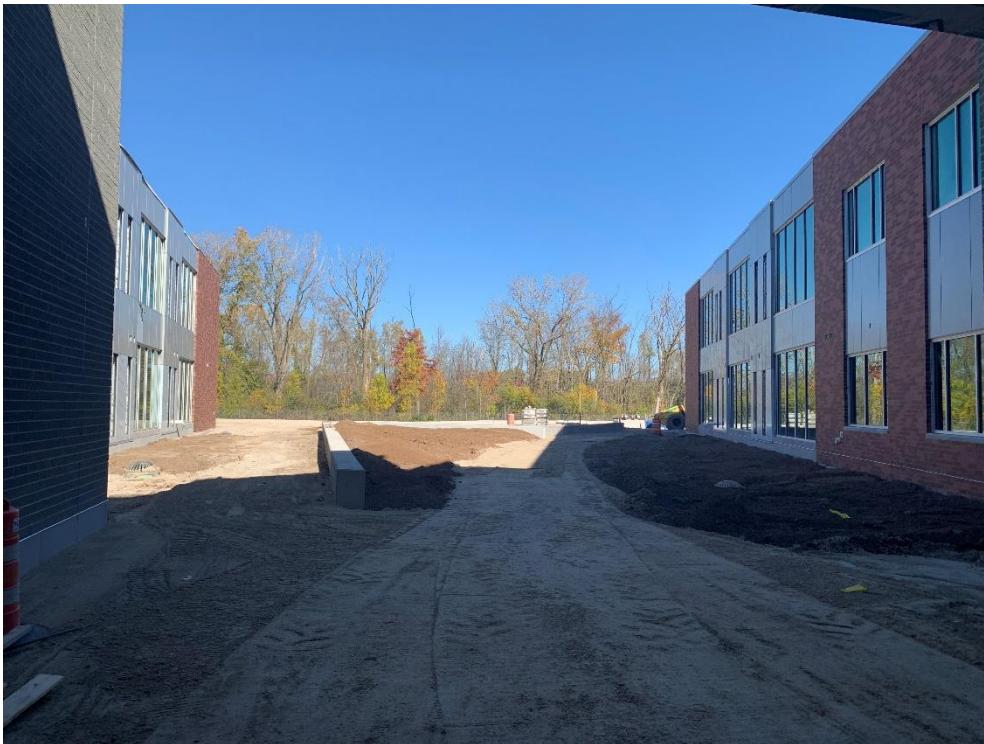
6. North Entry – Grading of outdoor entry plaza in progress.

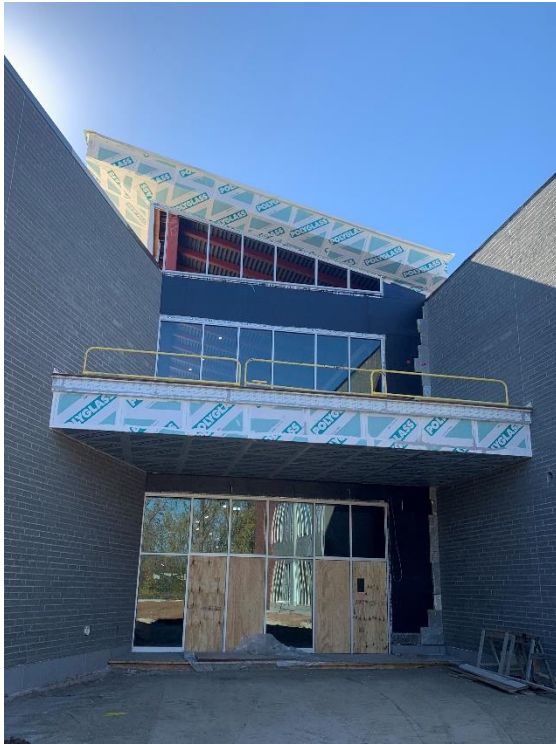
7. Area 1B North – Weatherproofing membrane, storefront framing and glazing install in progress. Temporary doors have been installed.

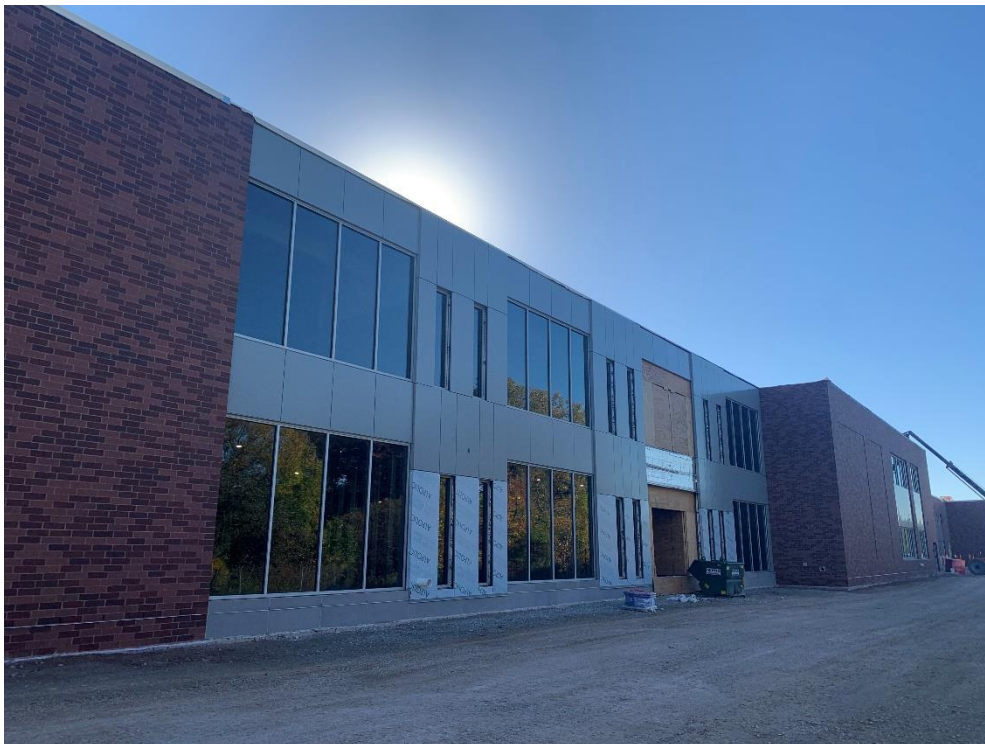
8. Area 4 West – Composite wall panels, storefront framing and glazing in progress.

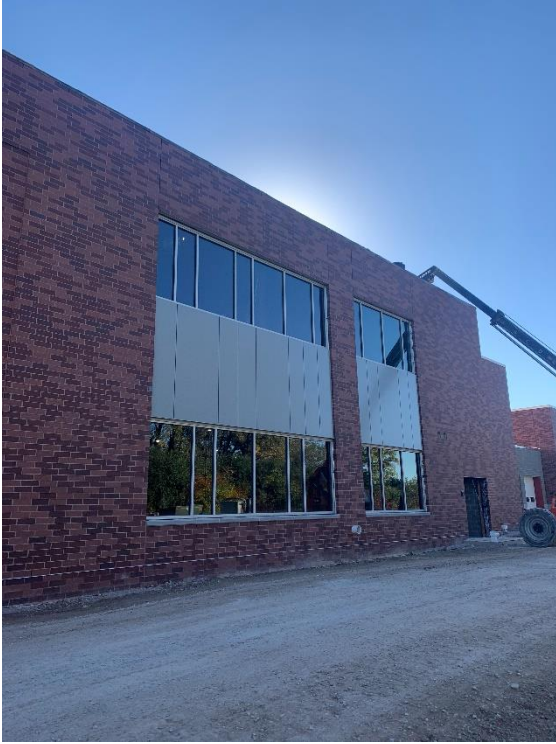
9. Area 3 – West Composite wall panels installed.

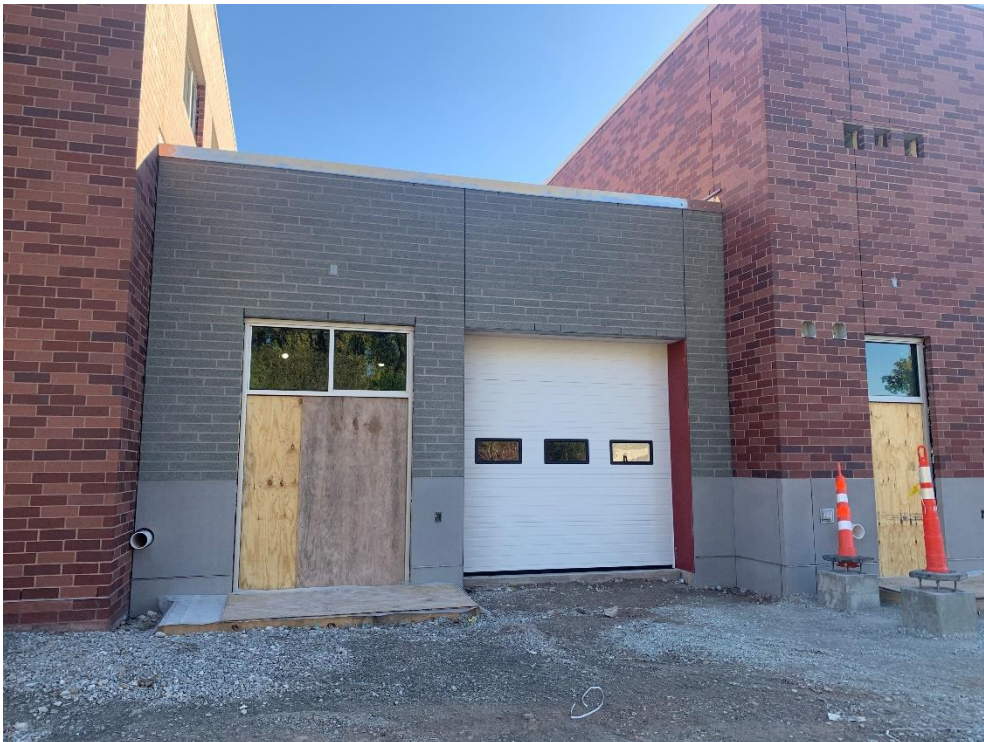
10. Area 3 West – Receiving overhead door installed. Storefront framing, glazing, and door install in progress.

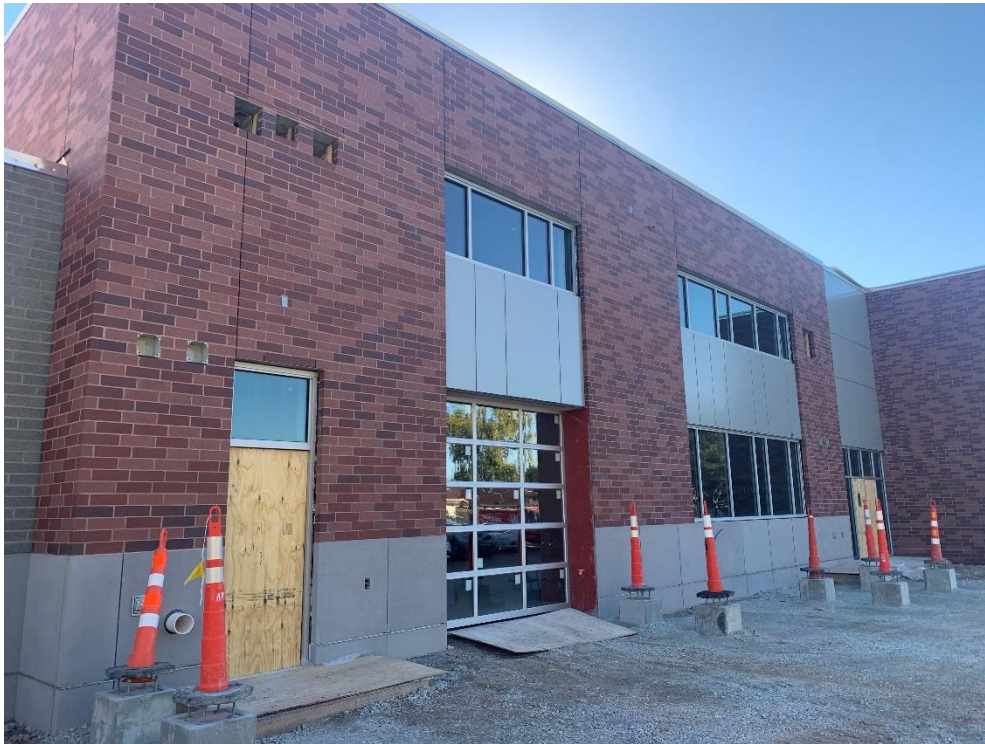
11. Area 3 West – Composite wall panels installed. Wood shop overhead door installed. Footings for dust collector poured.

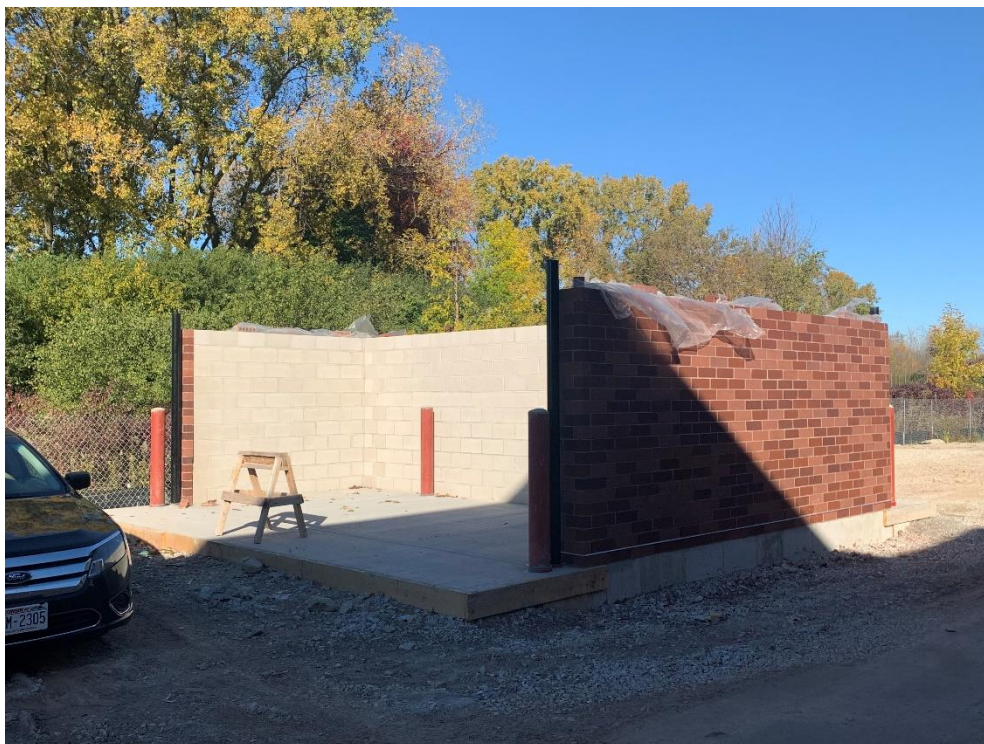
12. Dumpster Enclosure – Masonry walls installed and washed.

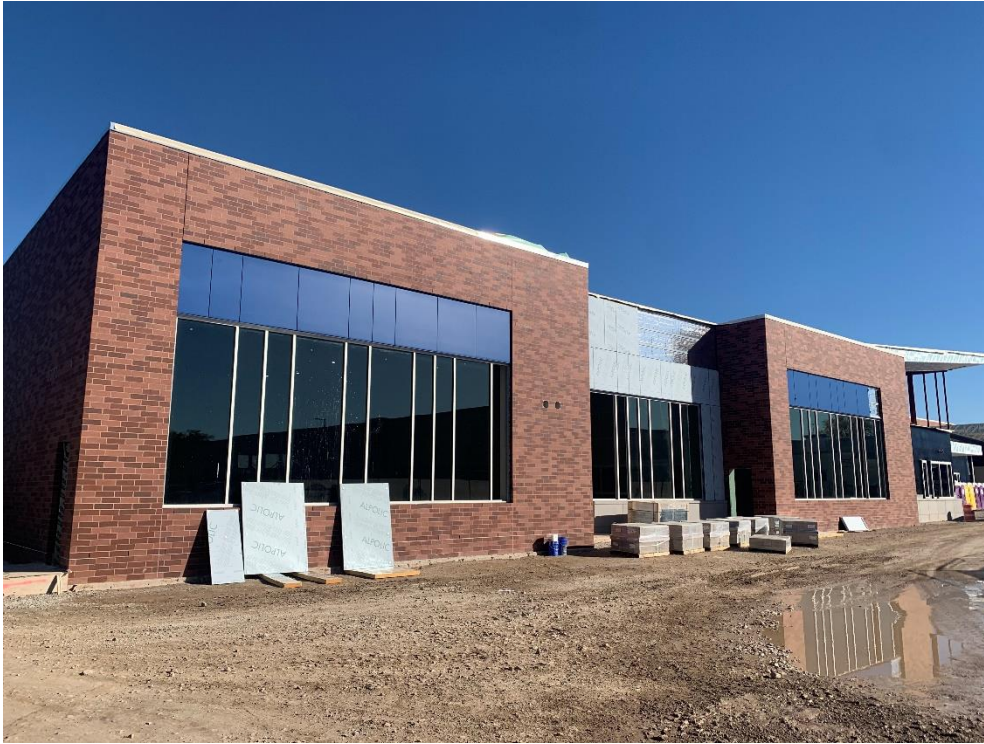
13. Area 2A South – Blue composite wall panel and storefront glazing install in progress.

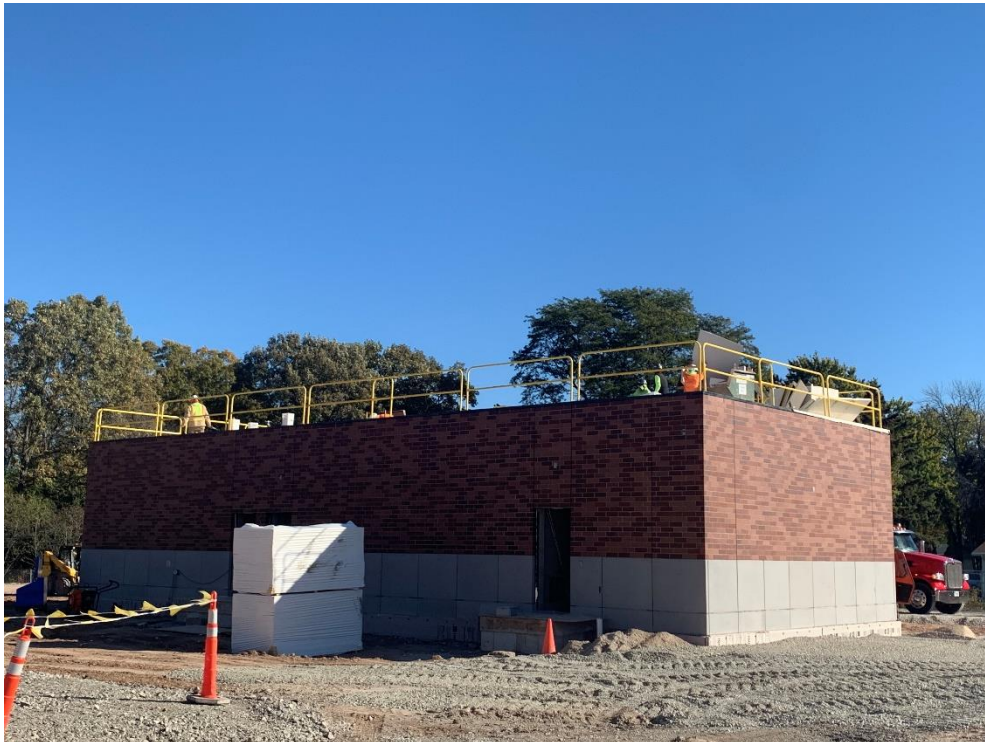
14. Locker Room Building Southwest – Roofing install in progress.

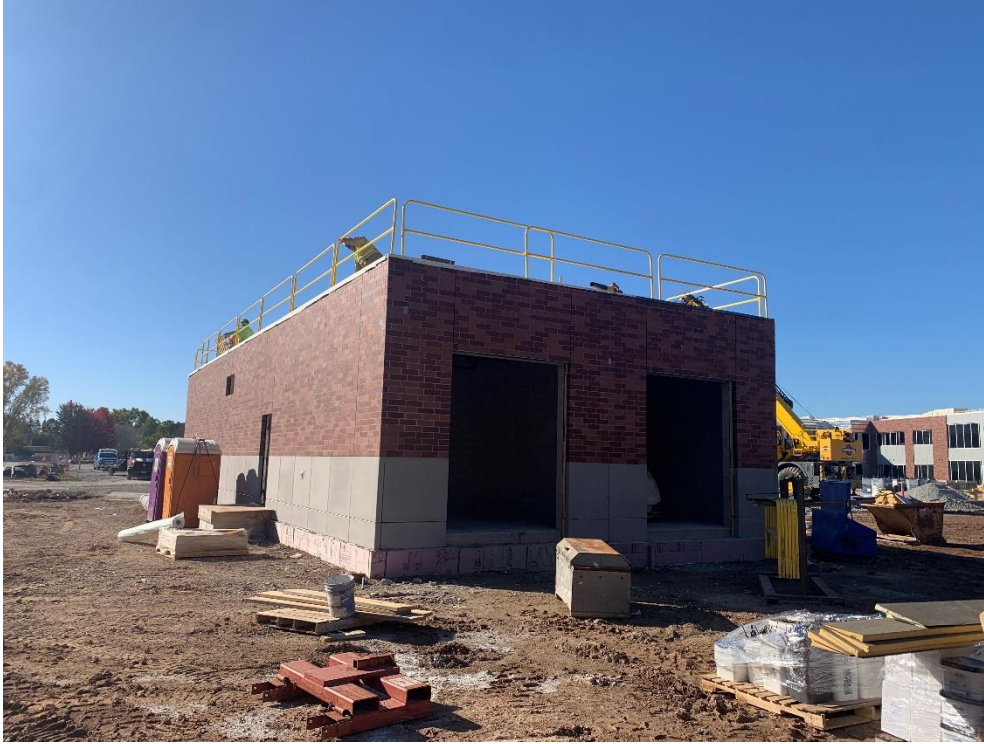
15. Locker Room Building Northeast – Roofing install in progress.

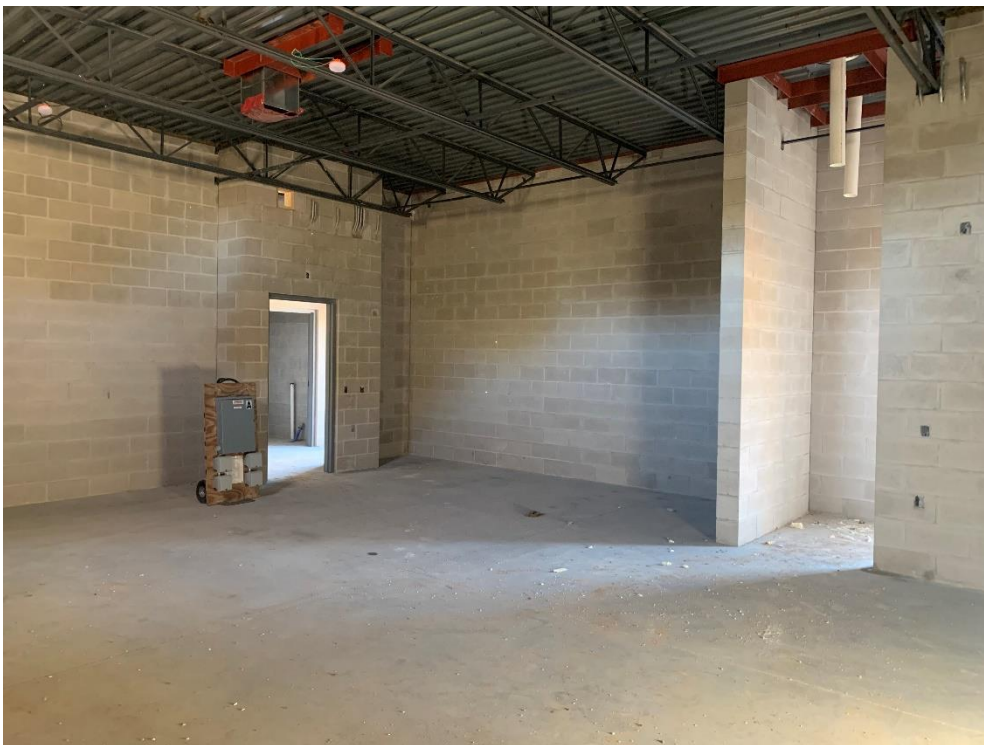
16. Locker Room Building – Interior CMU walls installed.

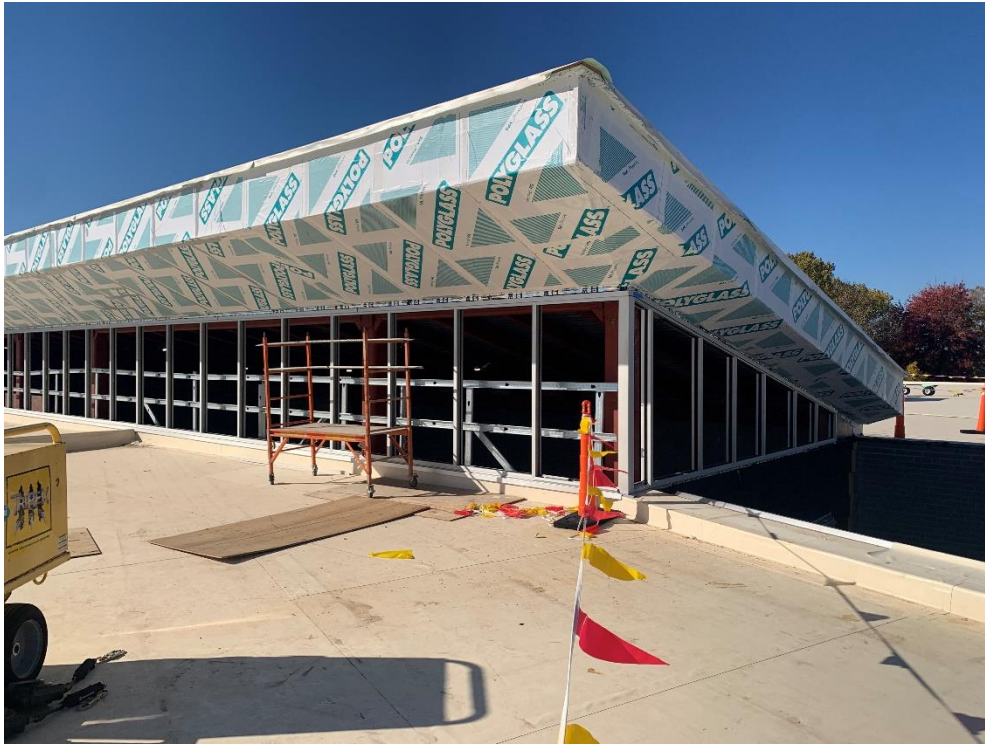
17. Area 1B Clerestory – Weatherproofing membrane installed. Curtain wall framing install in progress.

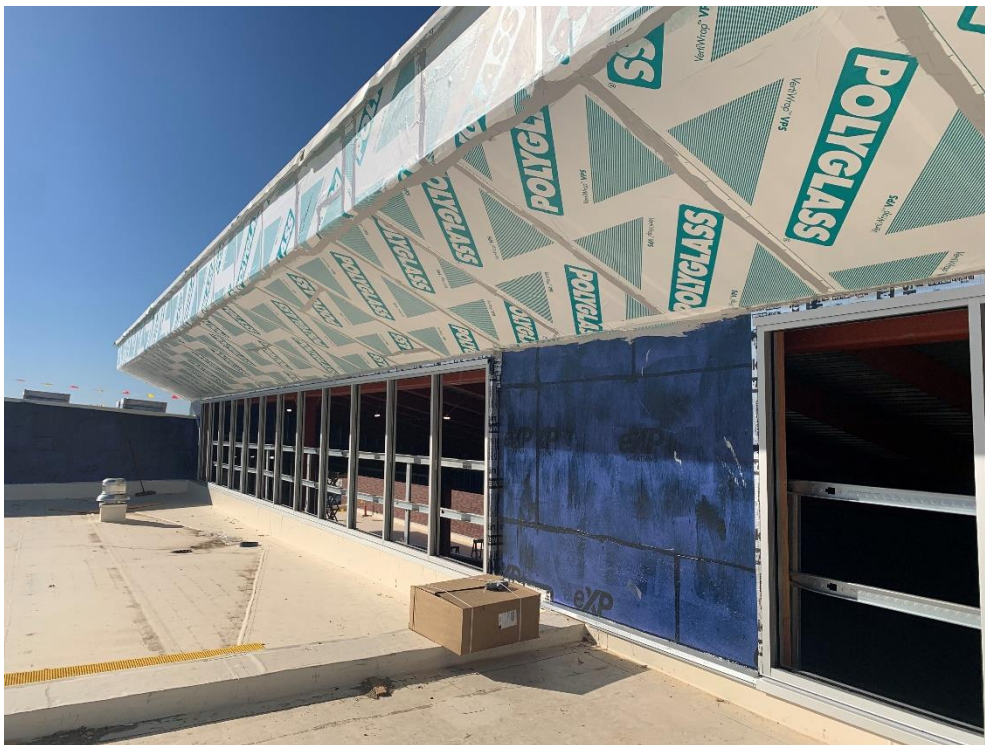
18. Area 1A Clerestory – Weatherproofing membrane installed. Curtain wall framing install in progress.

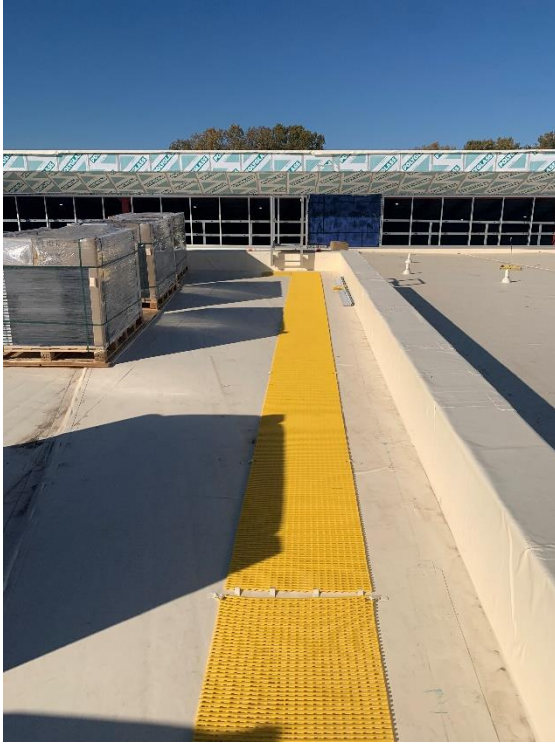
19. Area 6 – Roof walking pad install in progress.

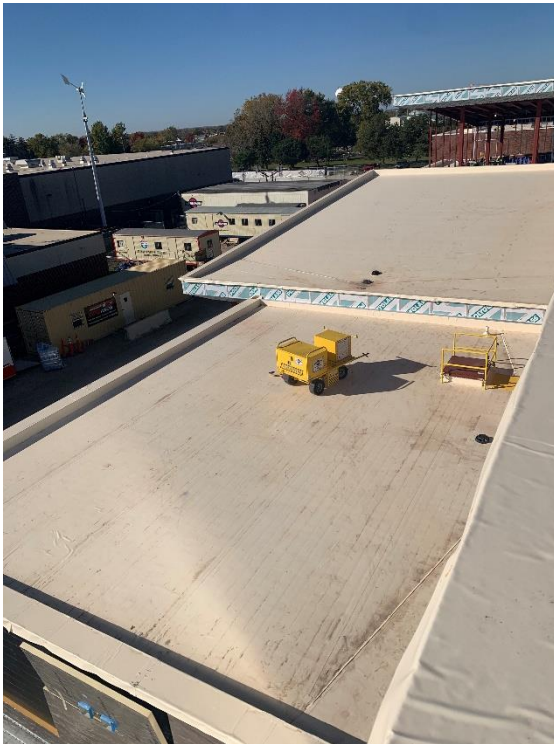
20. Area 2B – Roofing membrane installed.

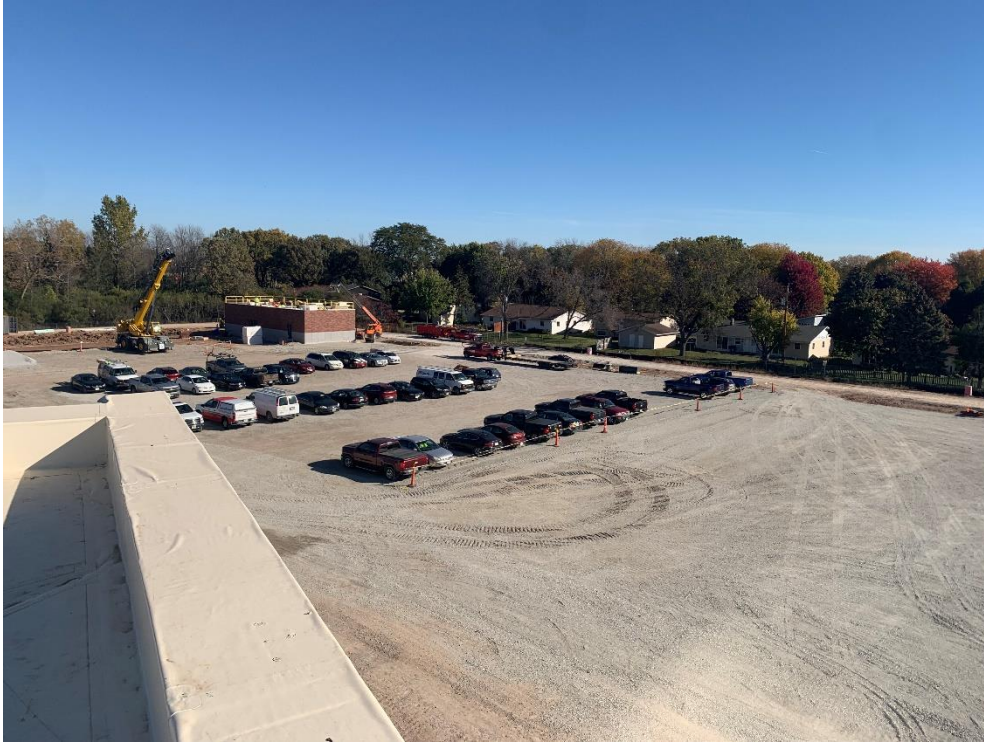
21. Geothermal field has been backfilled.

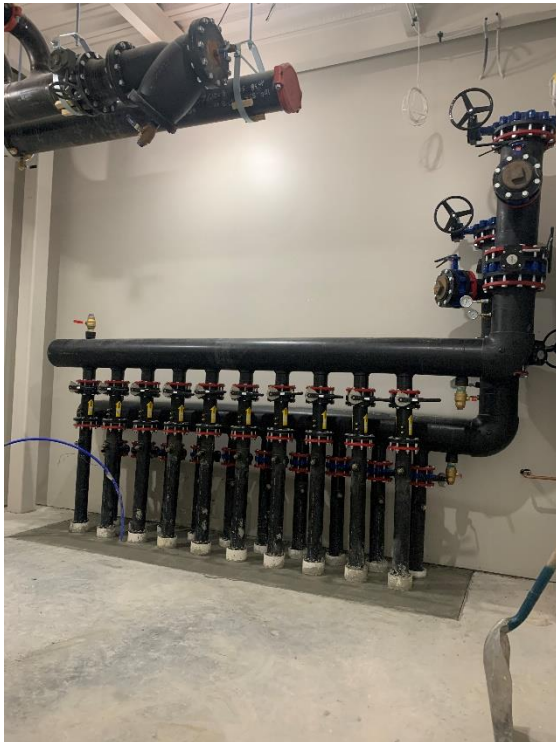
22. Area 6 North – Manifold room geothermal piping connections in progress.

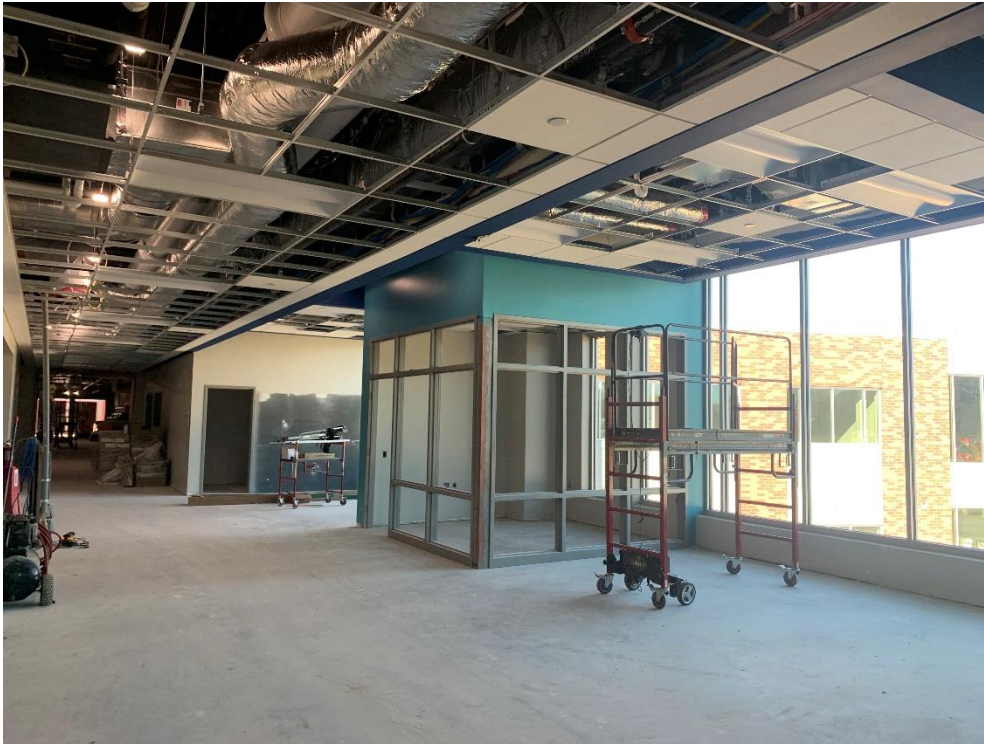
23. Area 6 North – Second floor collab area ceiling grid and electrical fixtures install in progress.

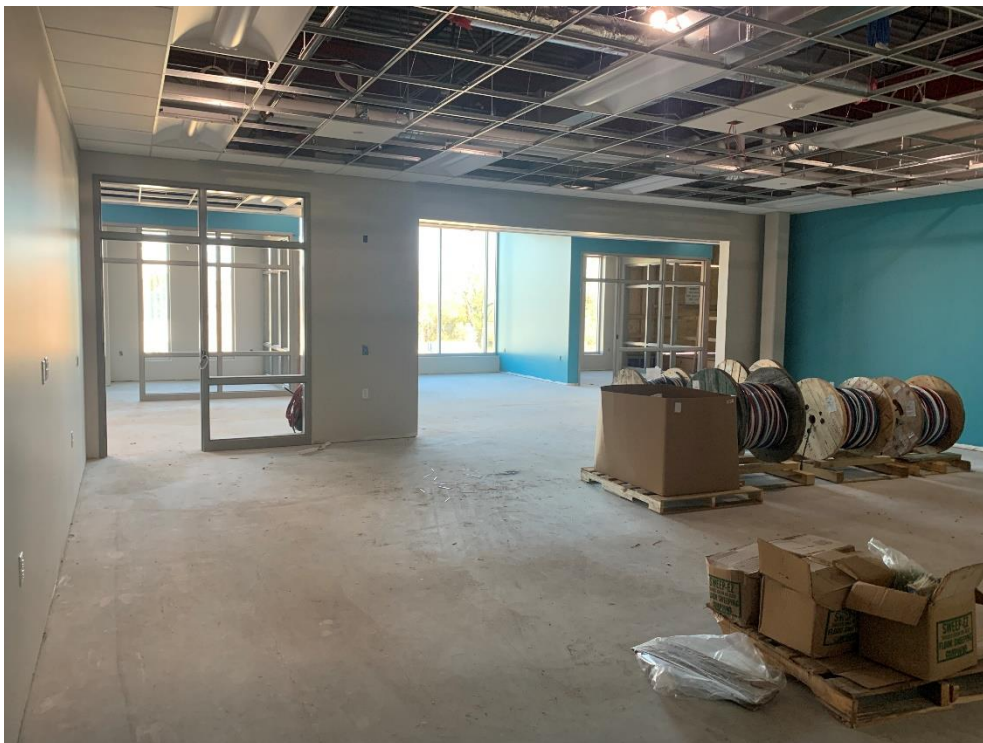
24. Area 6 North – Second floor classroom ceiling grid and electrical fixtures install in progress.

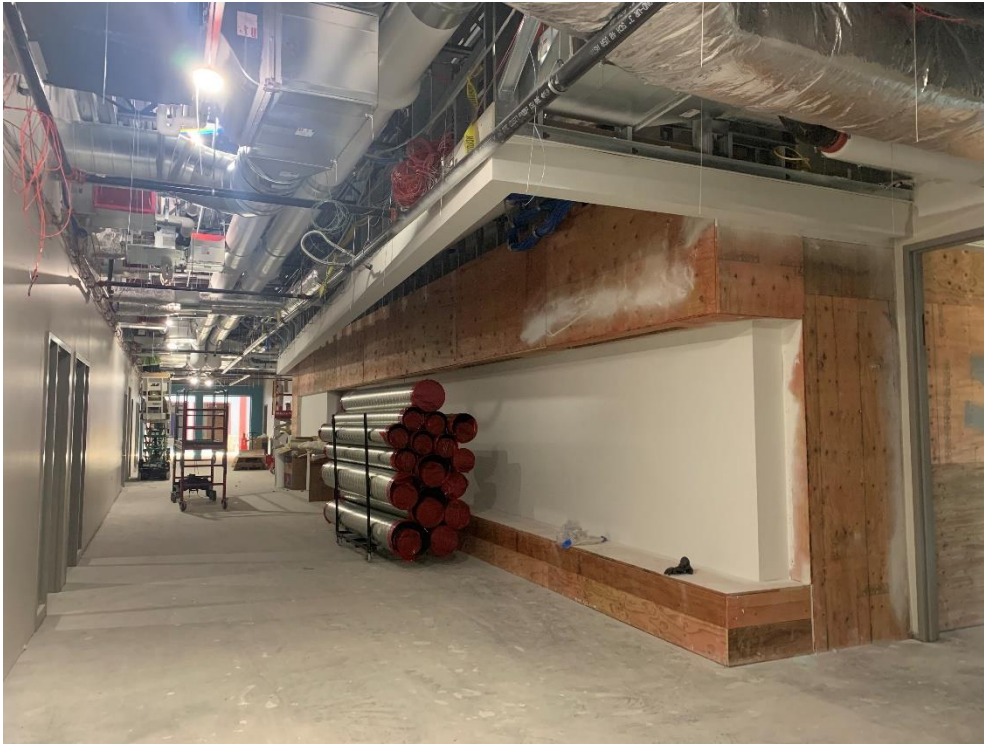
25. Area 6 – Second floor grade wing entrance feature painting in progress. Above ceiling MEP install in progress.

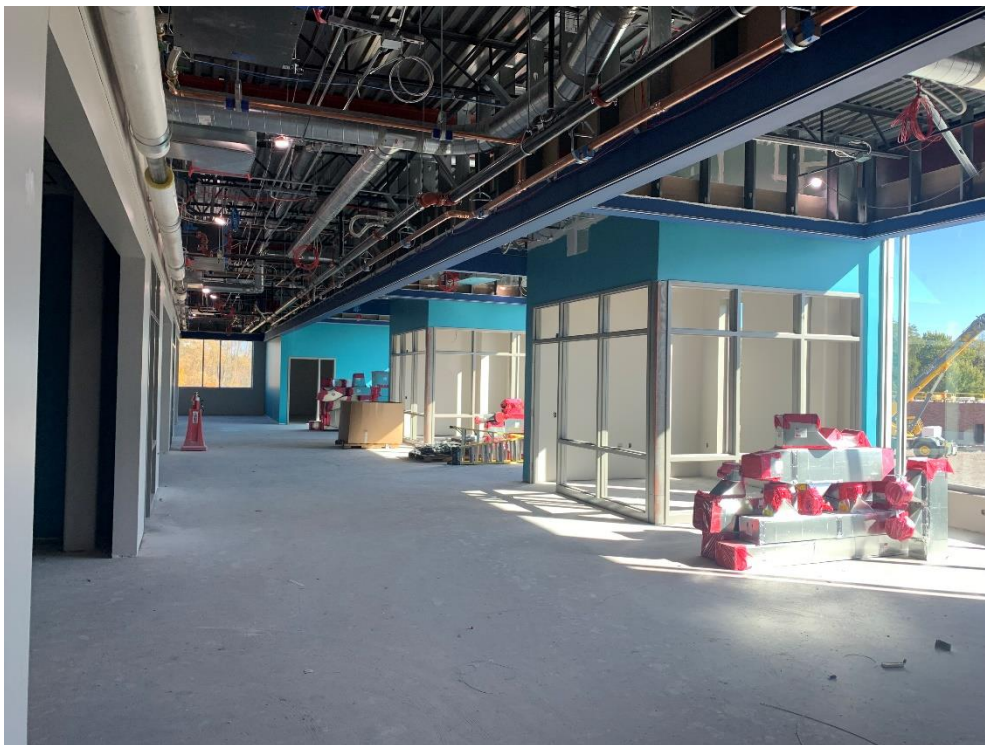
26. Area 5 East – Collab area above ceiling MEP install in progress.

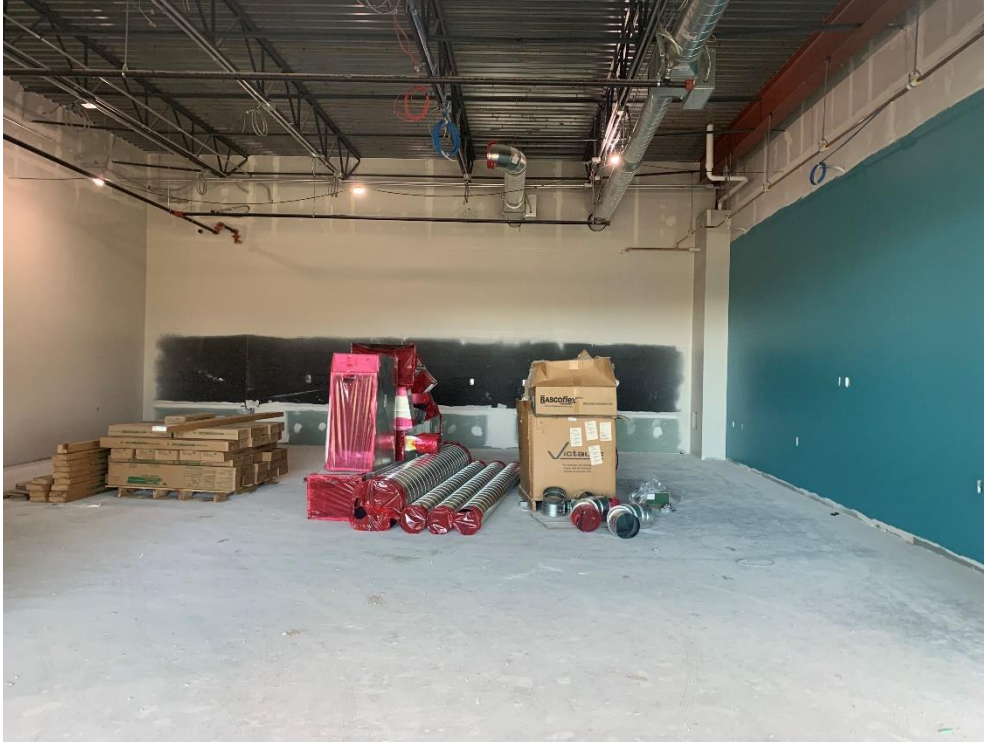
27. Area 5 East – Second floor classrooms above ceiling MEP install in progress.

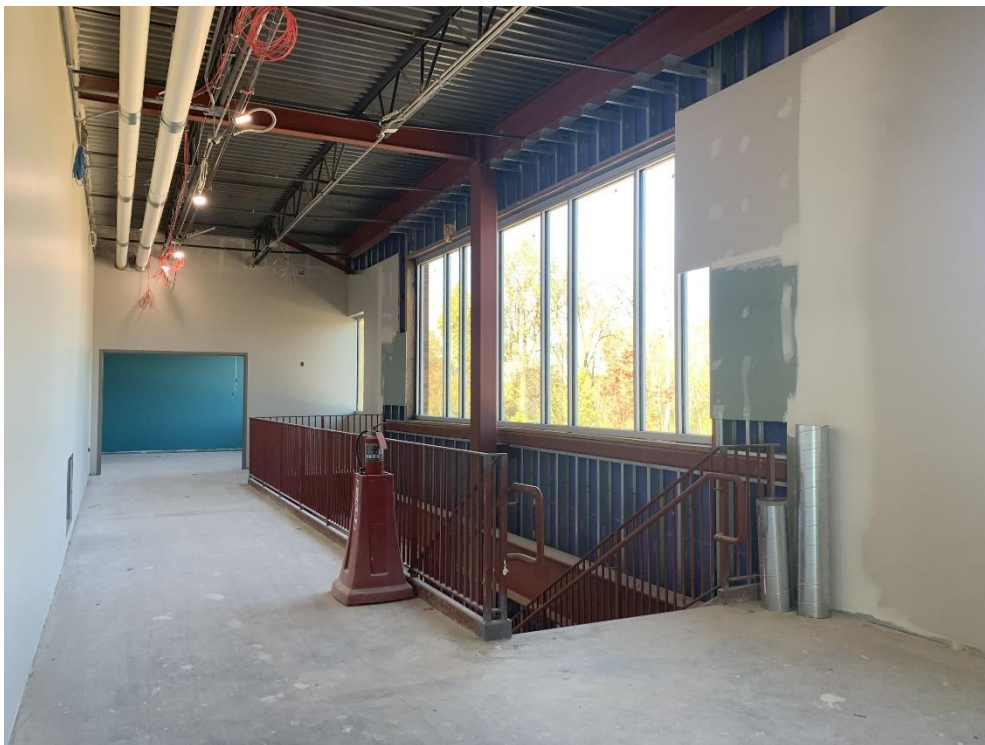
28. Area 5 – Second floor stair well gyp board, above ceiling MEP, and painting in progress.

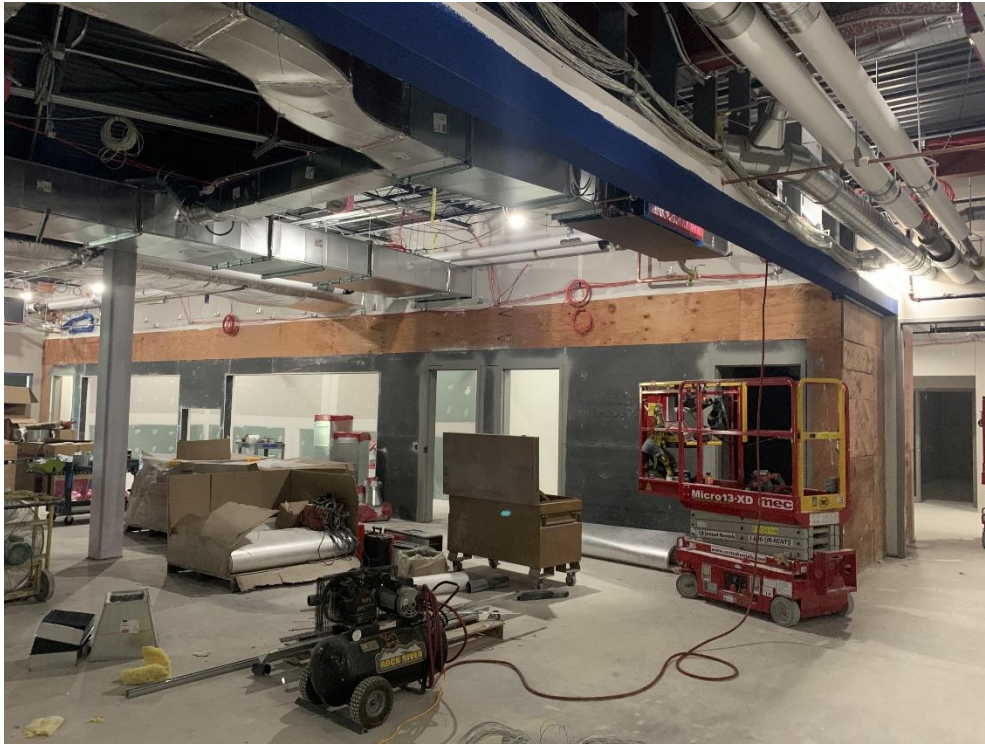
29. Area 5 – First floor servery taping , mudding, and painting in progress. Above ceiling MEP install in progress.

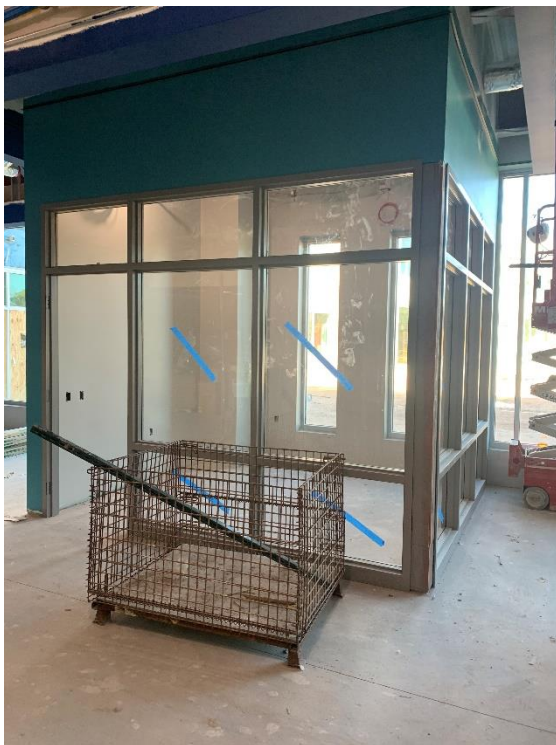
30. Area 6 North – First floor interior storefront glazing install in progress.

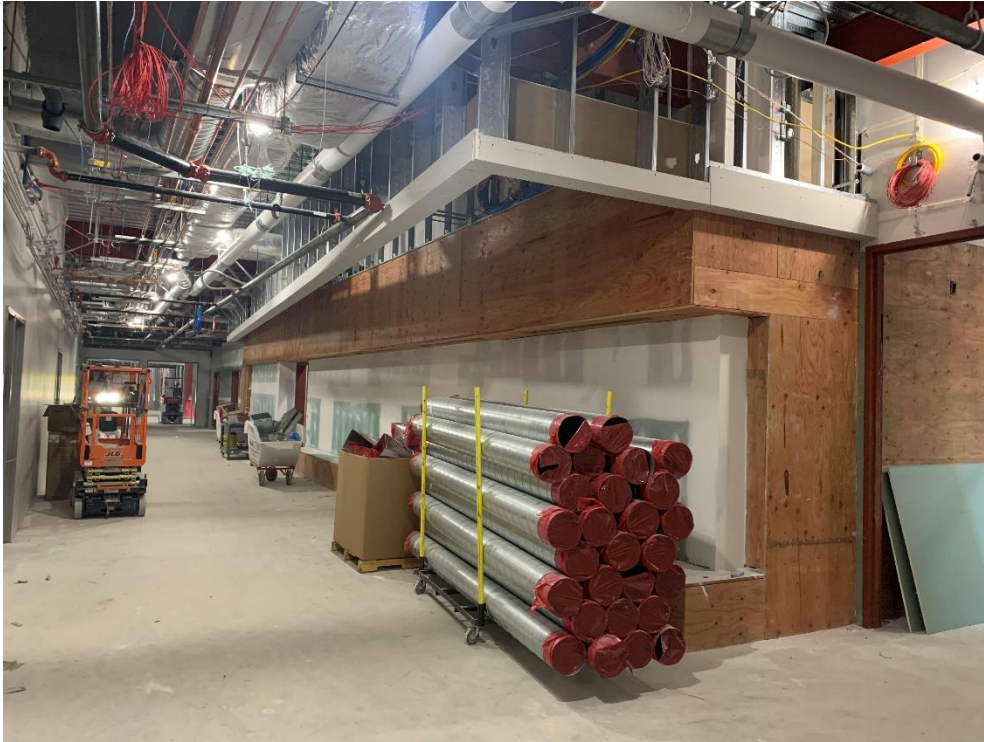
31. Area 6 – First floor grade wing entrance feature taping and mudding in progress. Above ceiling MEP install in progress.

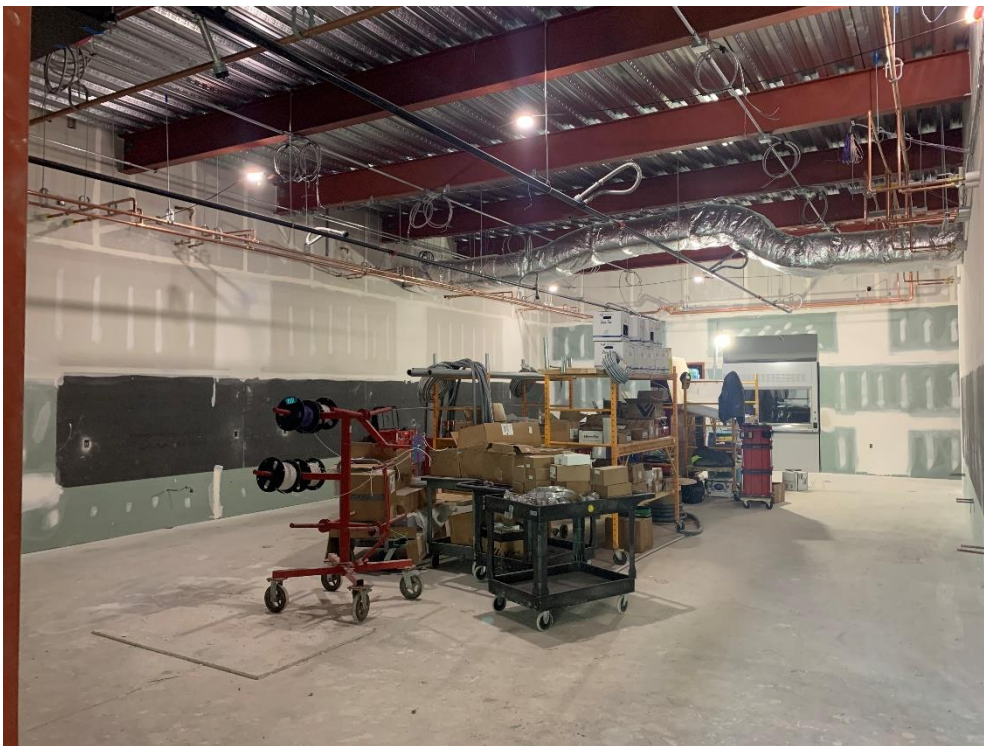
32. Area 5 – First floor science lab taping and mudding in progress. Above ceiling MEP install in progress.

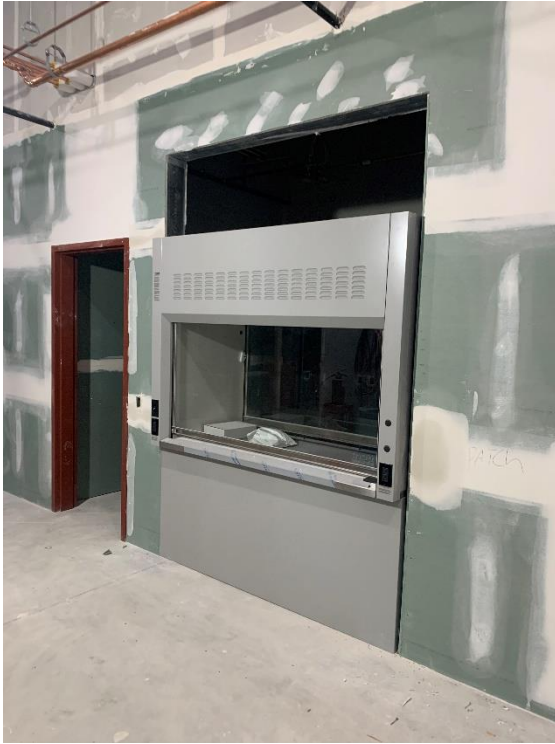
33. Area 5 – Science Lab fume hood(s) install in progress.
