# Construction Observation Report 015 – October 17, 2024

Maplewood School

PROJECT NUMBER: 321169-01

OWNER:	MENASHA JOINT SCHOOL DISTRICT
From ARCHITECT/ENGINEER:	EUA
To CONTRACTOR	MIRON CONSTRUCTION CO, INC
SITE OBSERVATION TYPE	ARCHITECTURAL
DATE OF ISSUANCE:	October 21, 2024

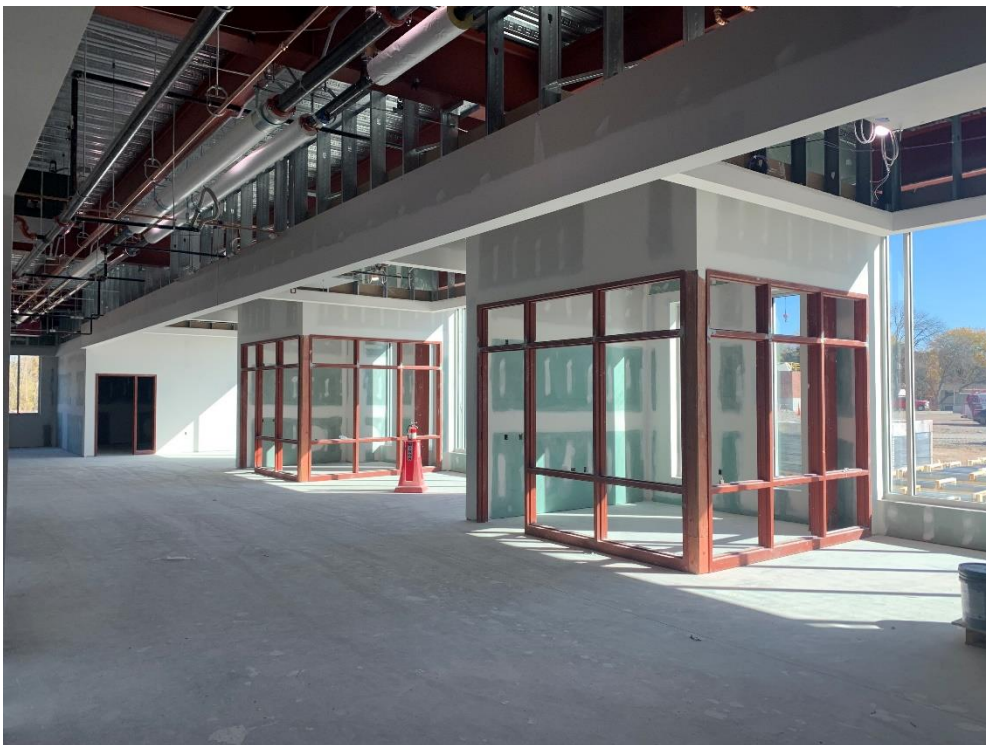
34. Area 5 – Taping, mudding, and above ceiling MEP in first floor collab areas in progress.

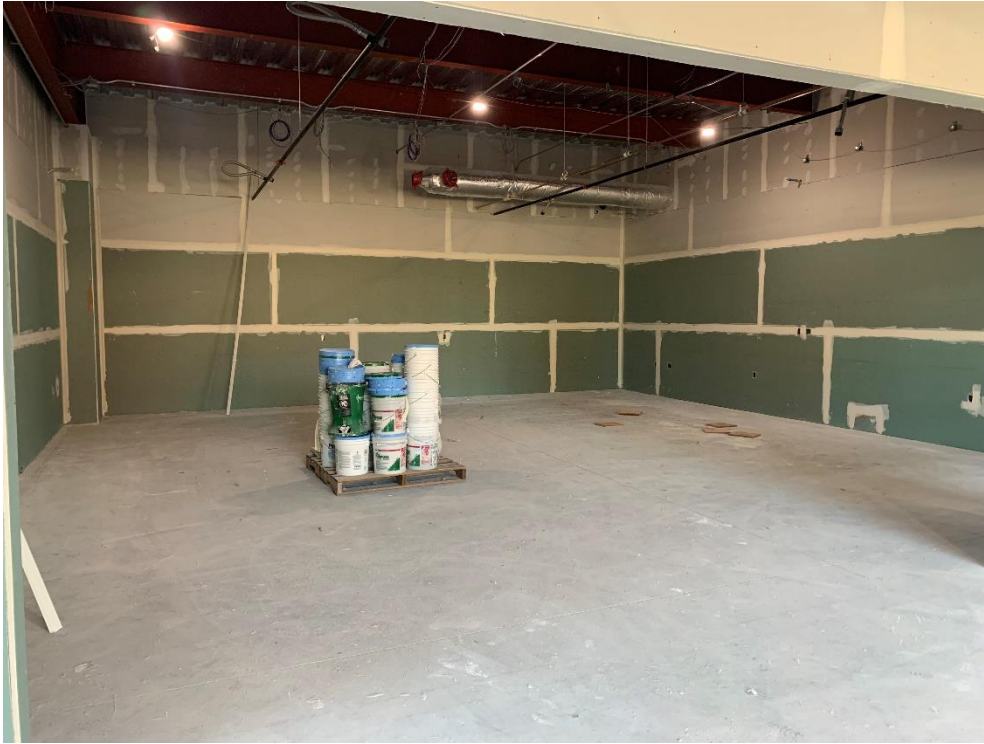
35. Area 5 – Taping, mudding, and above ceiling MEP in first floor classrooms in progress.

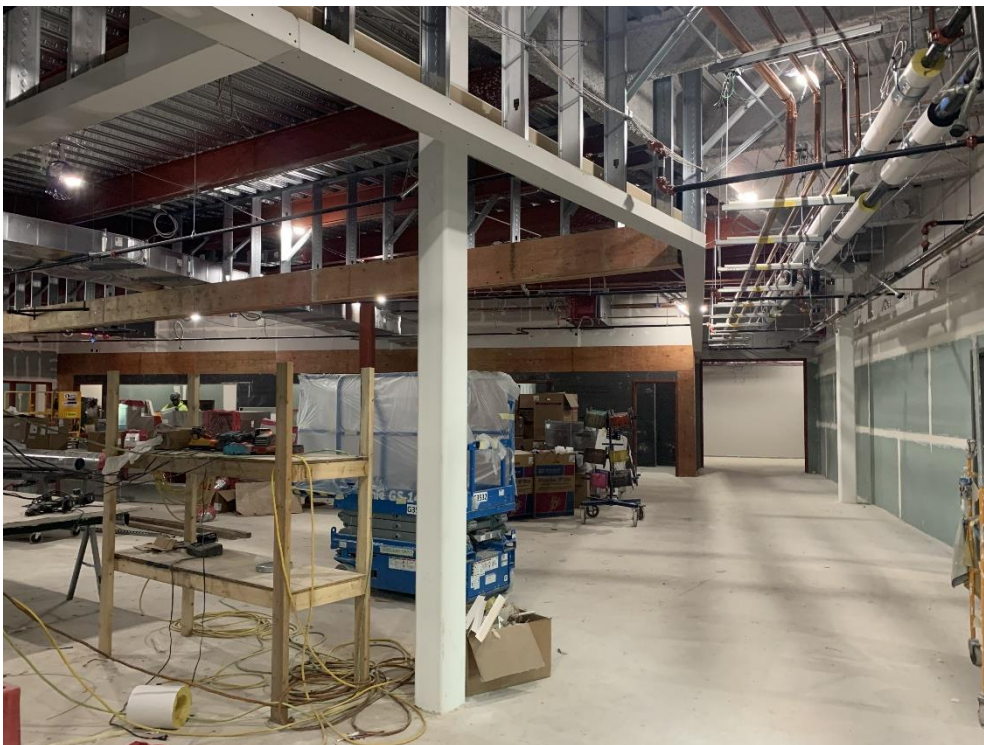
36. Area 5 – Gyp board, taping, mudding, and above ceiling MEP install first floor flex café in progress.

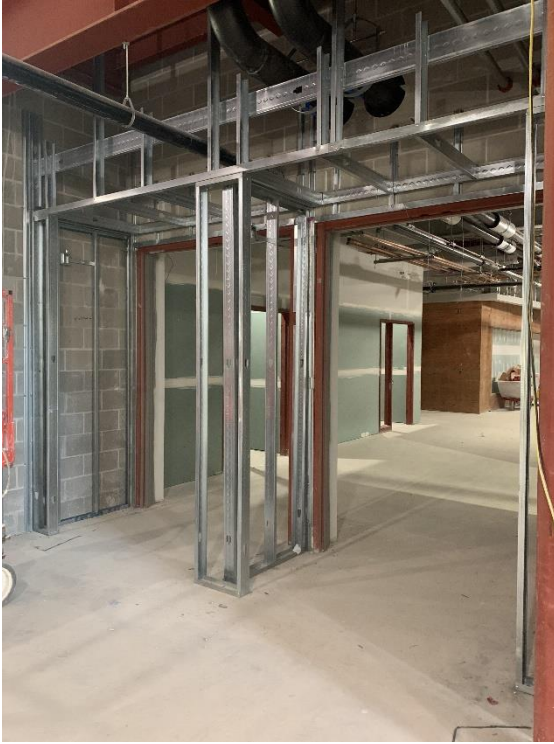
37. Area 5 – Metal stud framing for concealed doors in progress.

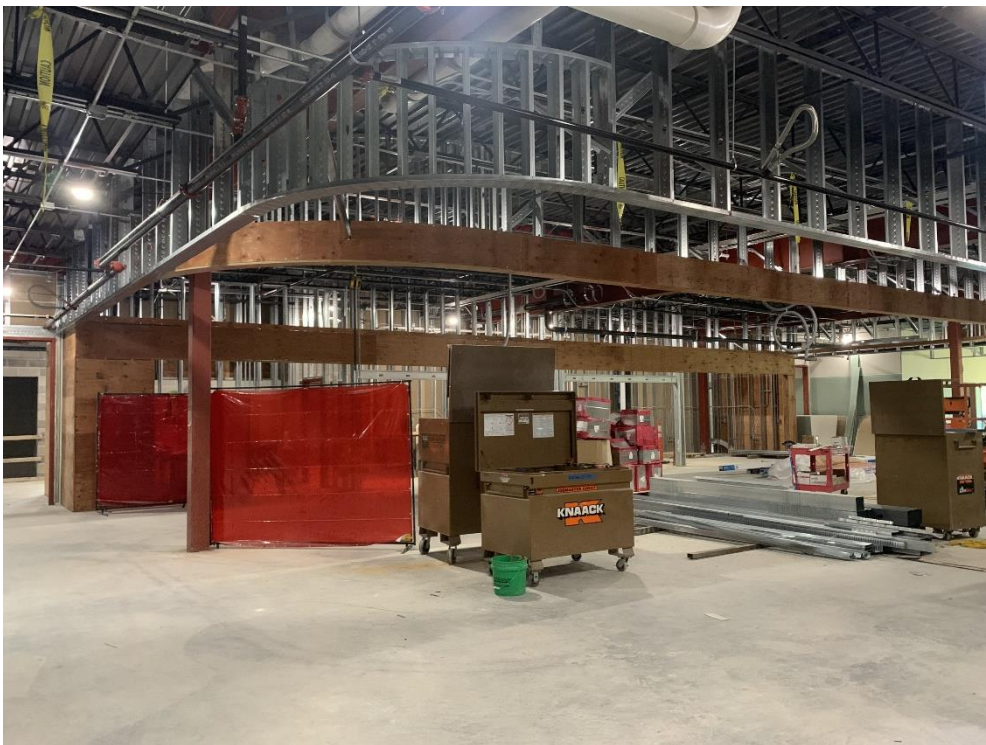
38. Area 3 – Metal stud framing and plywood backup install in first floor flex café in progress.

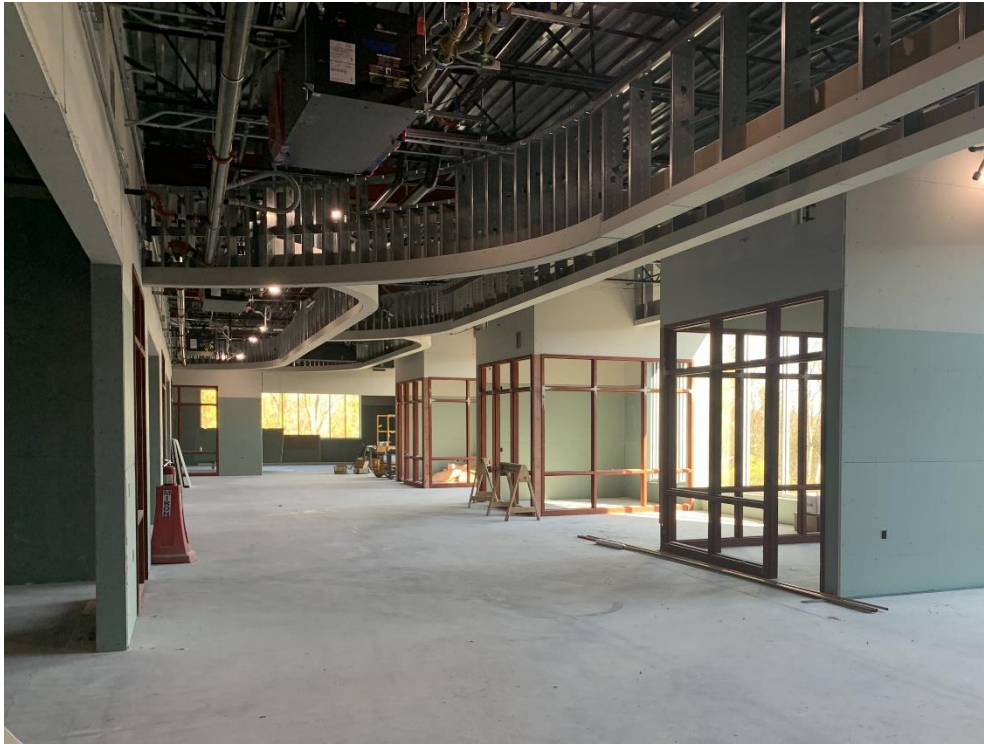
39. Area 4 East – Gyp board and above ceiling MEP install in first floor collab area and classrooms in progress

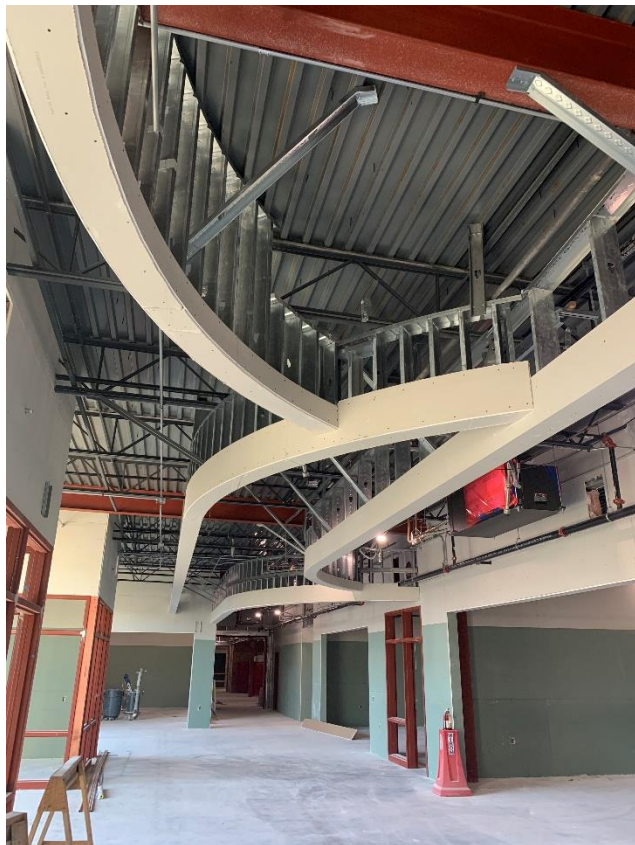
40. Area 4 East – Ceiling soffits in collab area in progress.

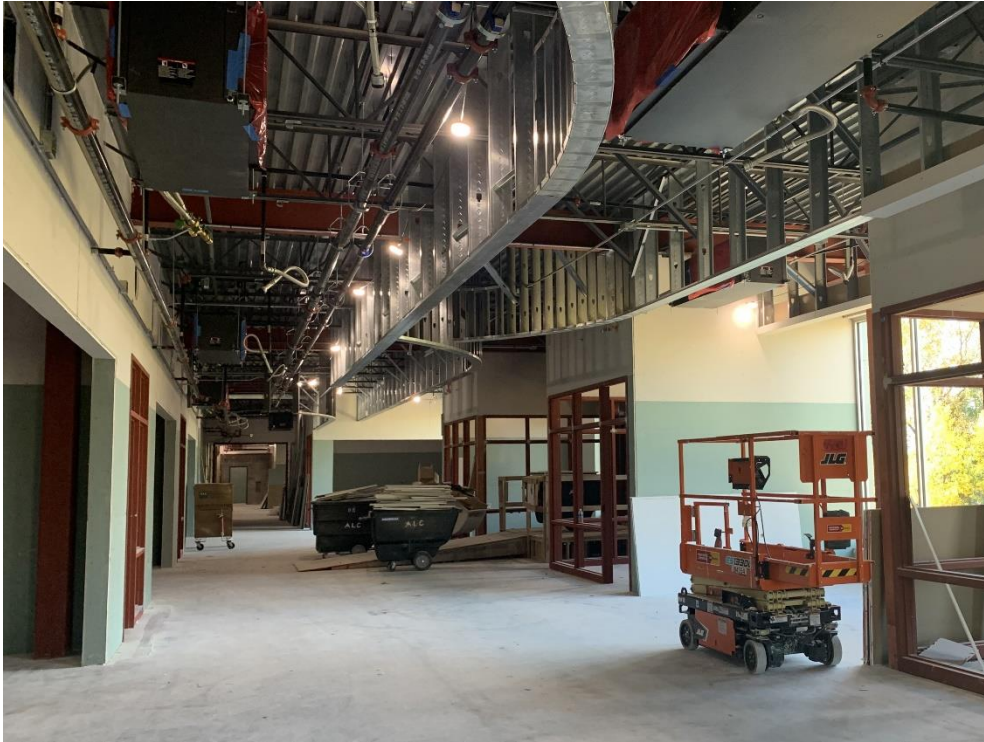
41. Area 4 West - Gyp board, metal stud framing, and above ceiling MEP install in first floor collab area and classrooms in progress

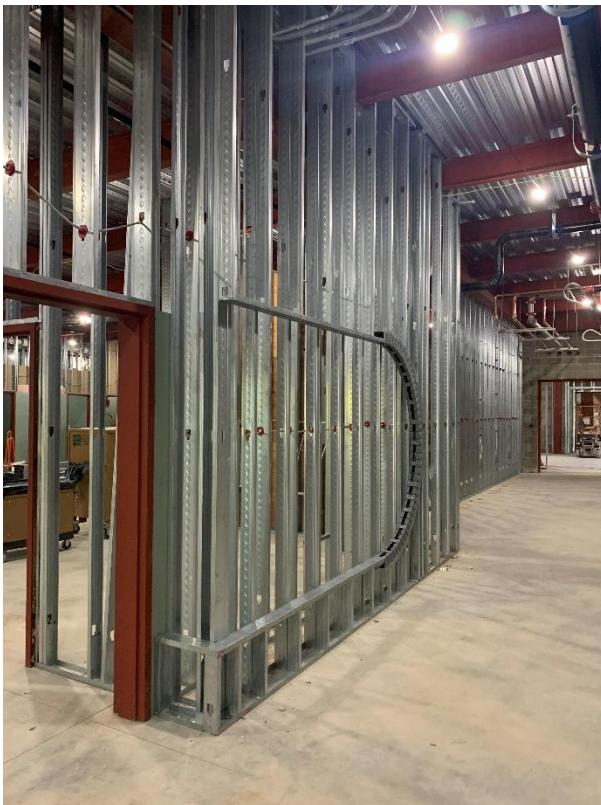
42. Area 3 – Metal stud framing of first floor grade wing entry in progress

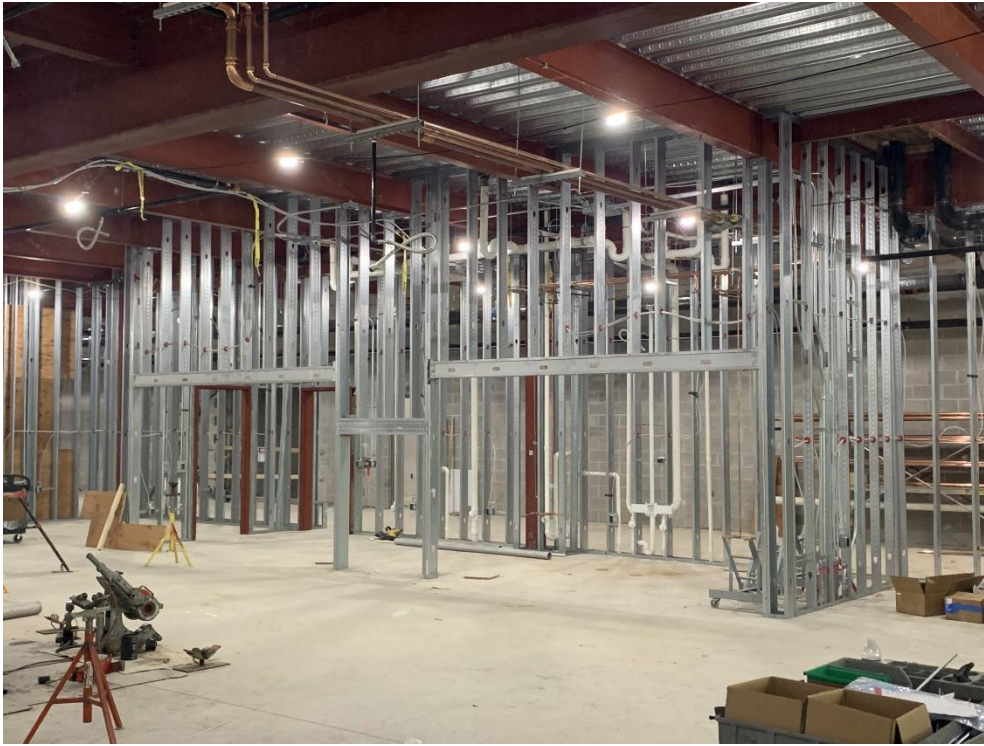
43. Area 3 – Metal stud framing and sprinkler piping install in first floor servery in progress.

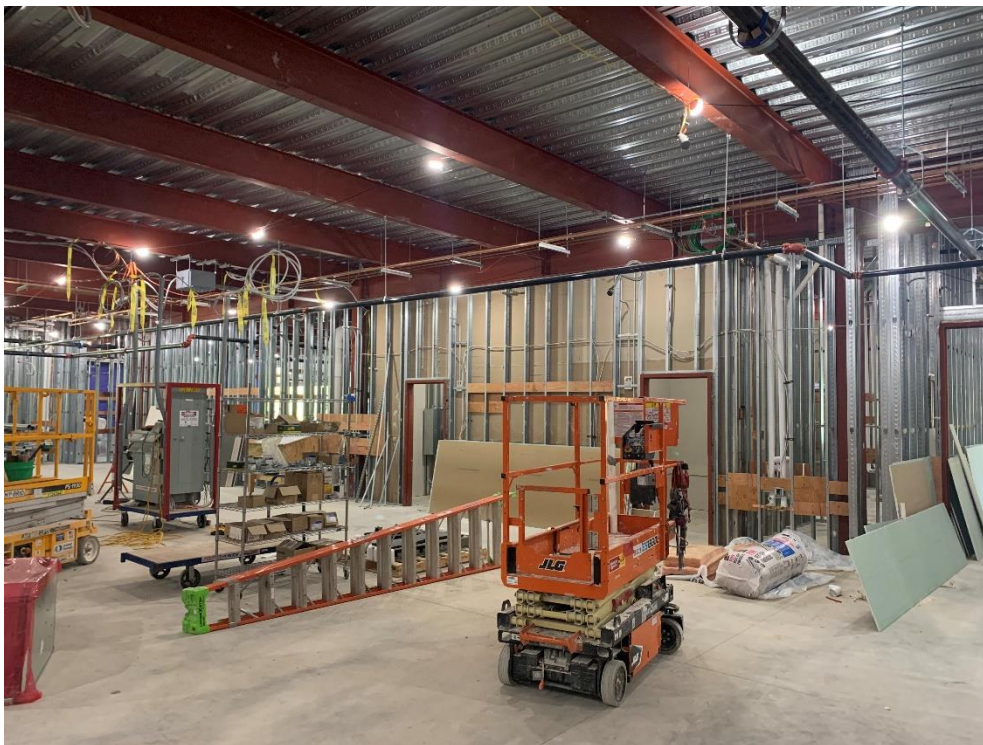
44. Area 3 – Wood blocking, gyp board, and sprinkler piping install in first floor flex cafe in progress.

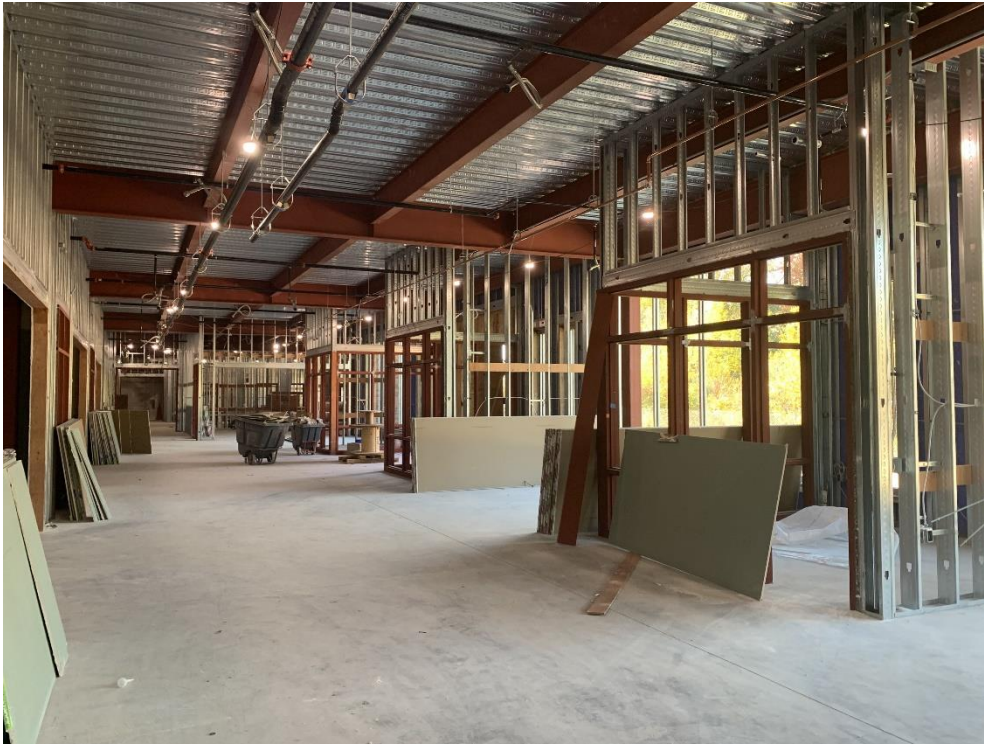
45. Area 4 West – Gyp board and sprinkler piping install in first floor collab areas in progress.

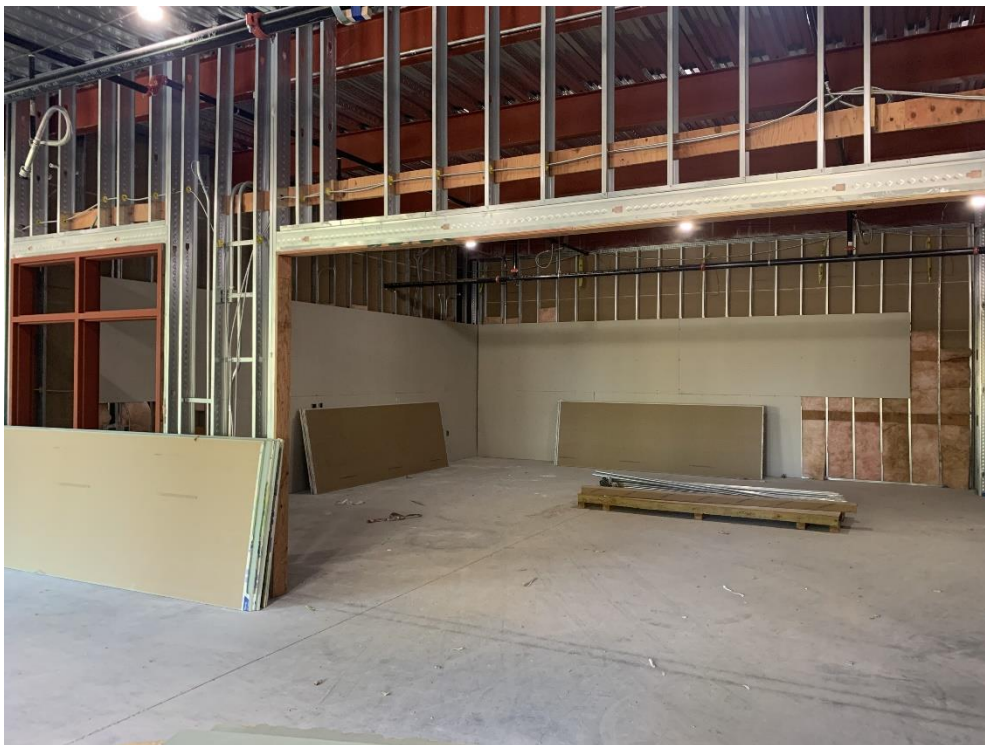
46. Area 4 West – Gyp board and sprinkler piping install in first floor classrooms in progress.

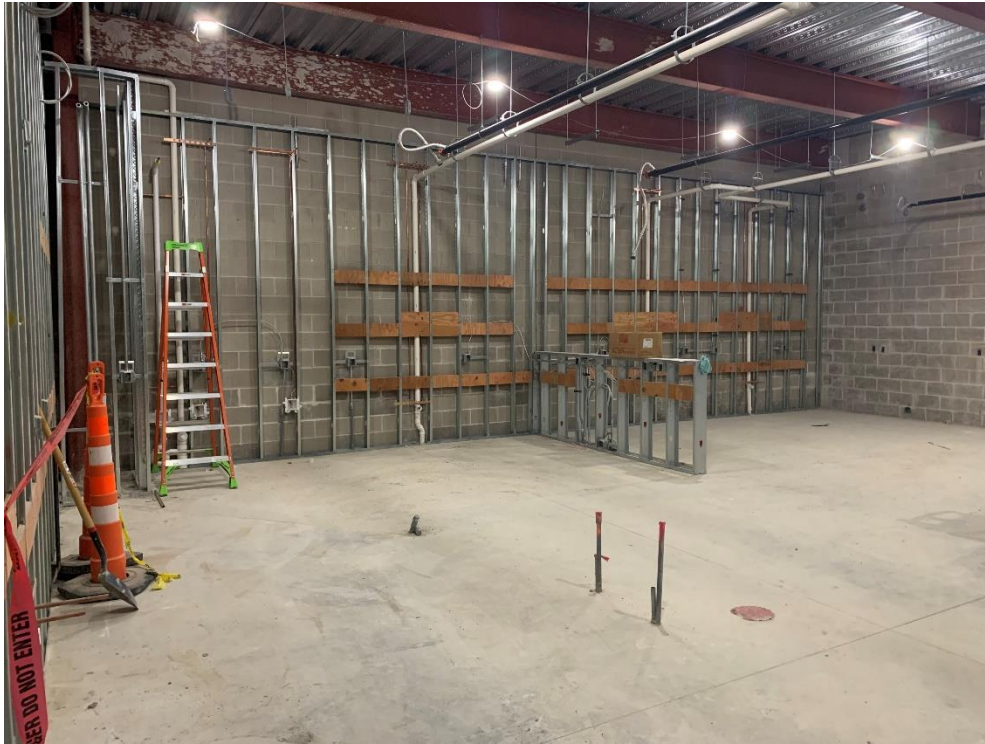
47. Area 3 – First floor Culinary Lab plumbing, electrical, and sprinkler piping install in progress.

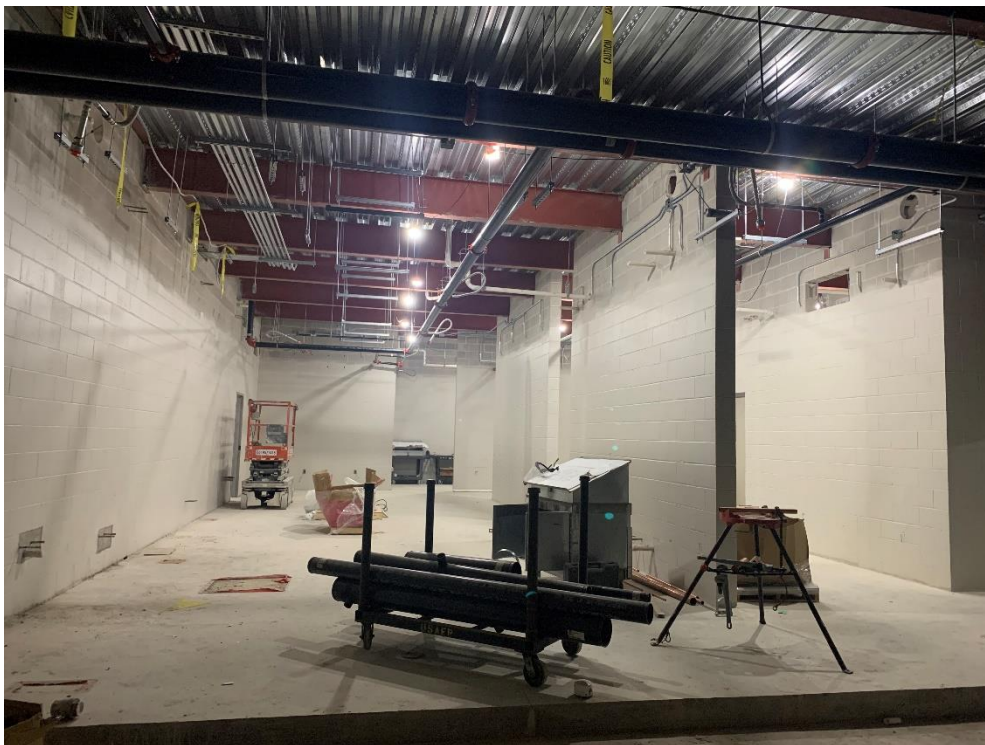
48. Area 3 – Kitchen sprinkler piping and above ceiling MEP install in progress.

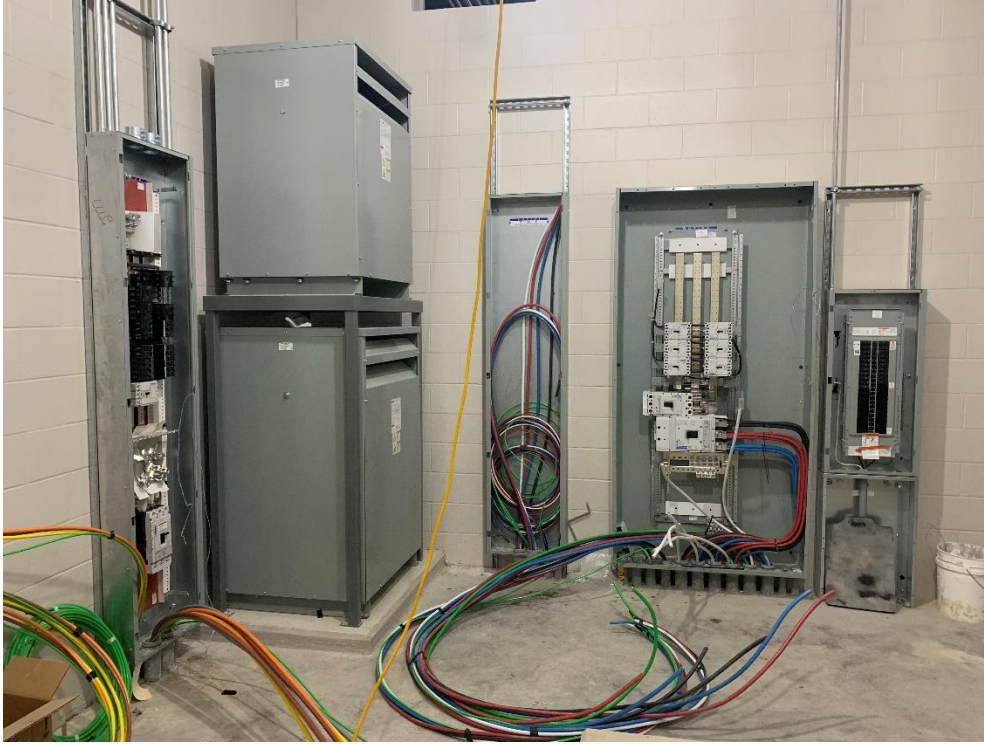
49. Area 3 – Work in electrical and water rooms continues.

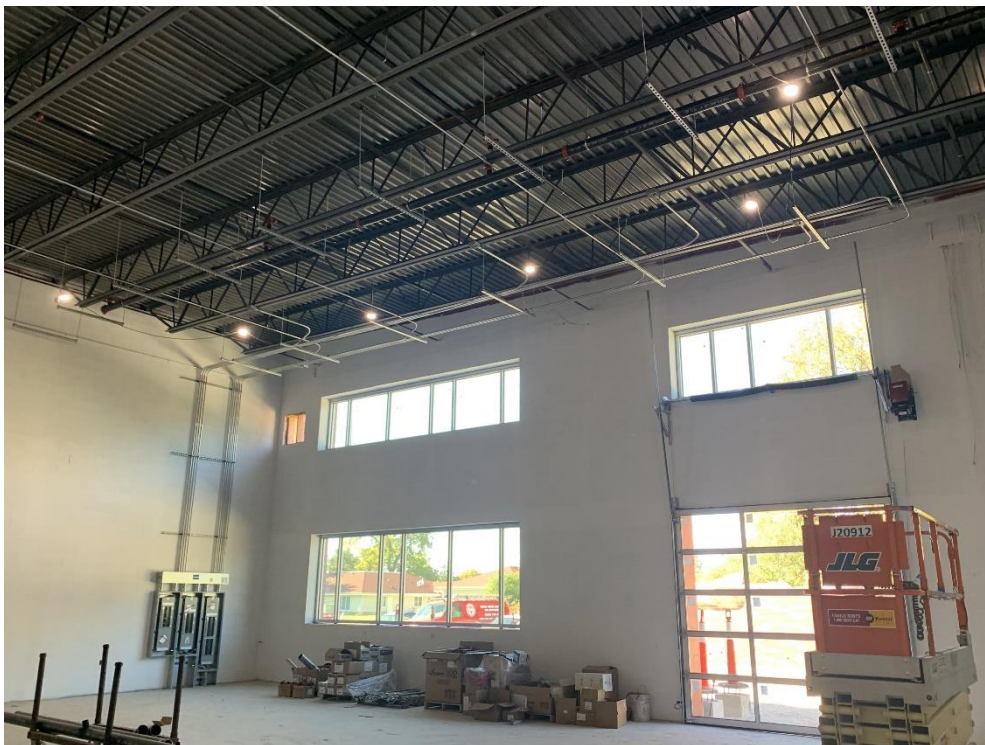
50. Area 3 South – MEP work continues in tech ed area.

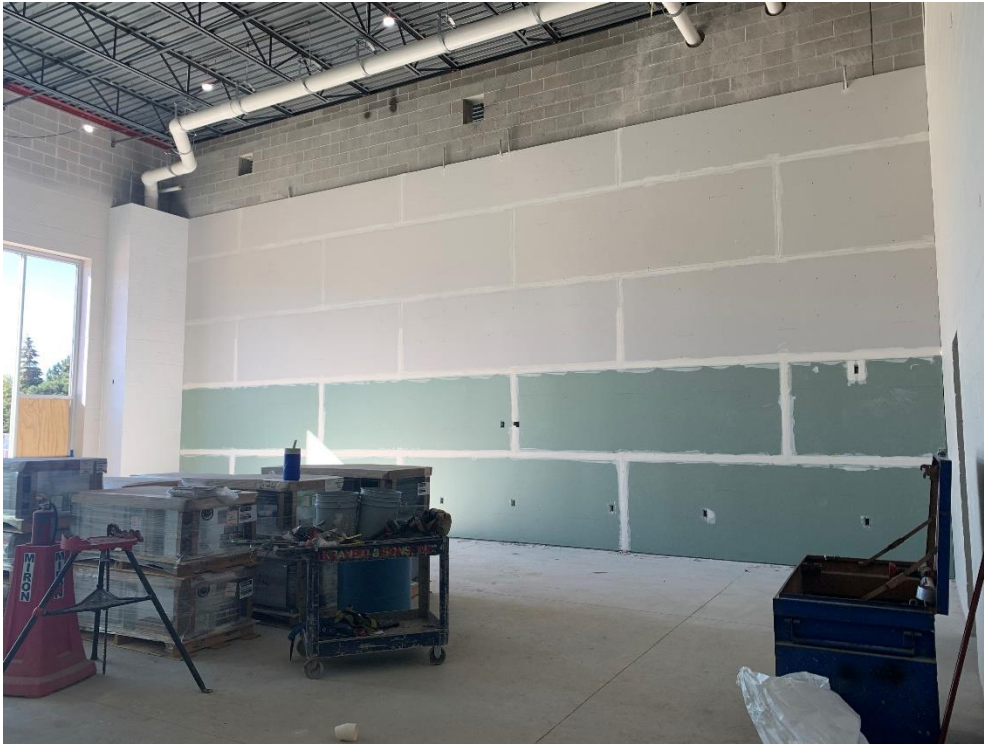
51. Area 2A – Taping and mudding in choir room in progress

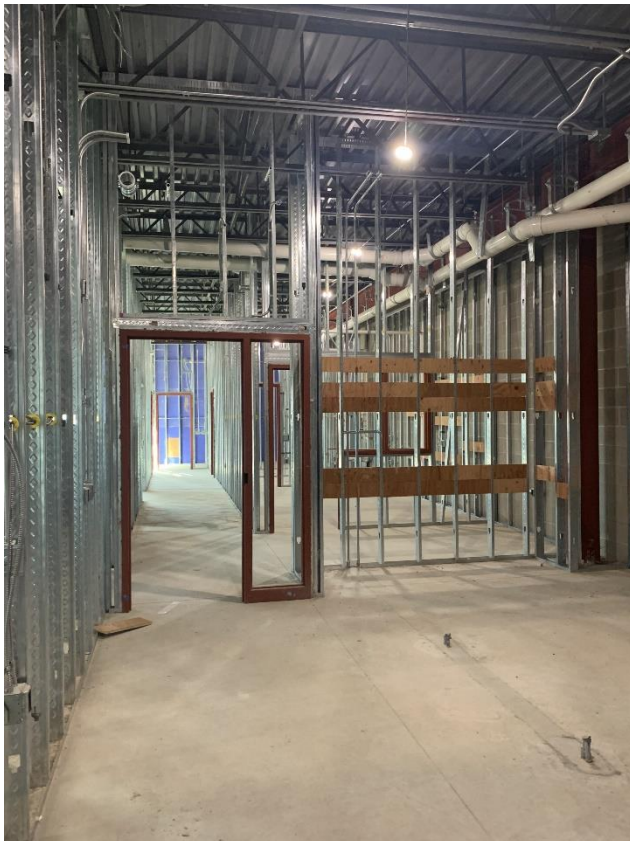
52. Area 2A – MEP work continues.

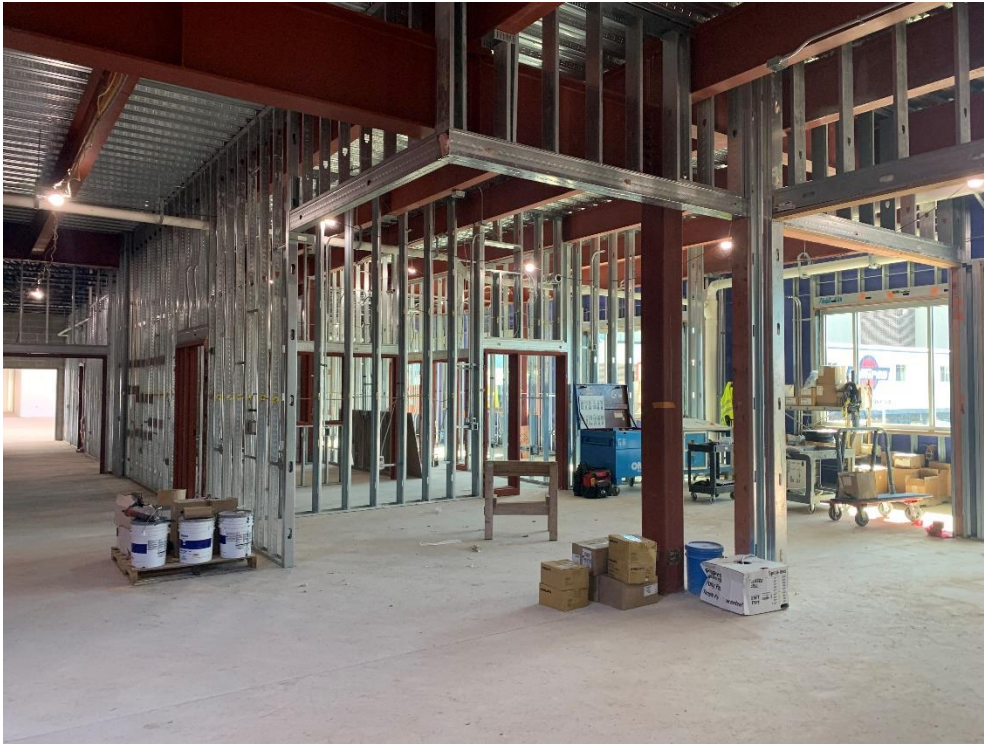
53. Area 1A – MEP work continues in 7/8 office area.

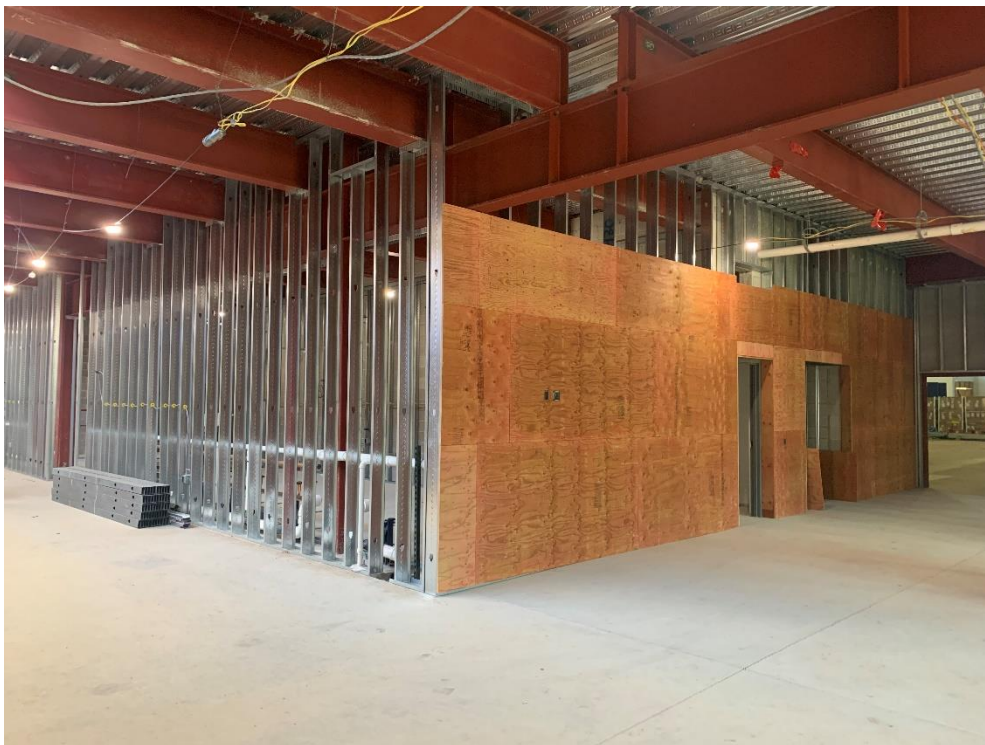
54. Area 1A – Metal stud framing and plywood backing install in progress center spine toilets.

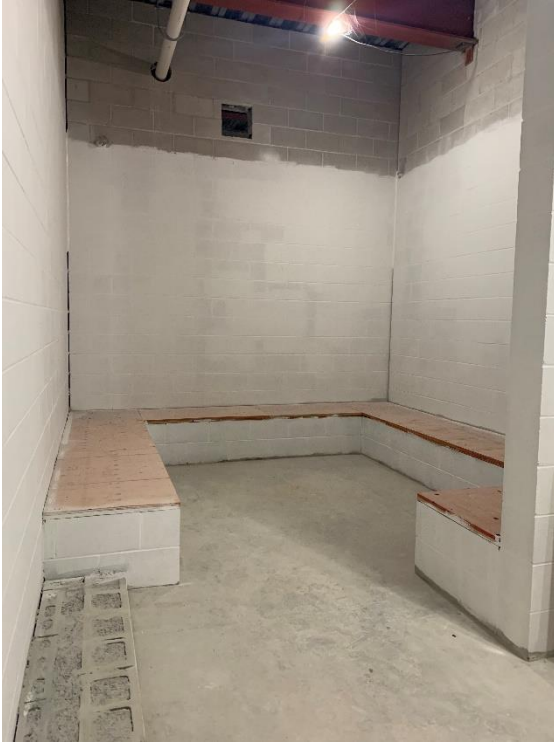
55. Area 1A – Painting in locker rooms in progress. Locker base installed.

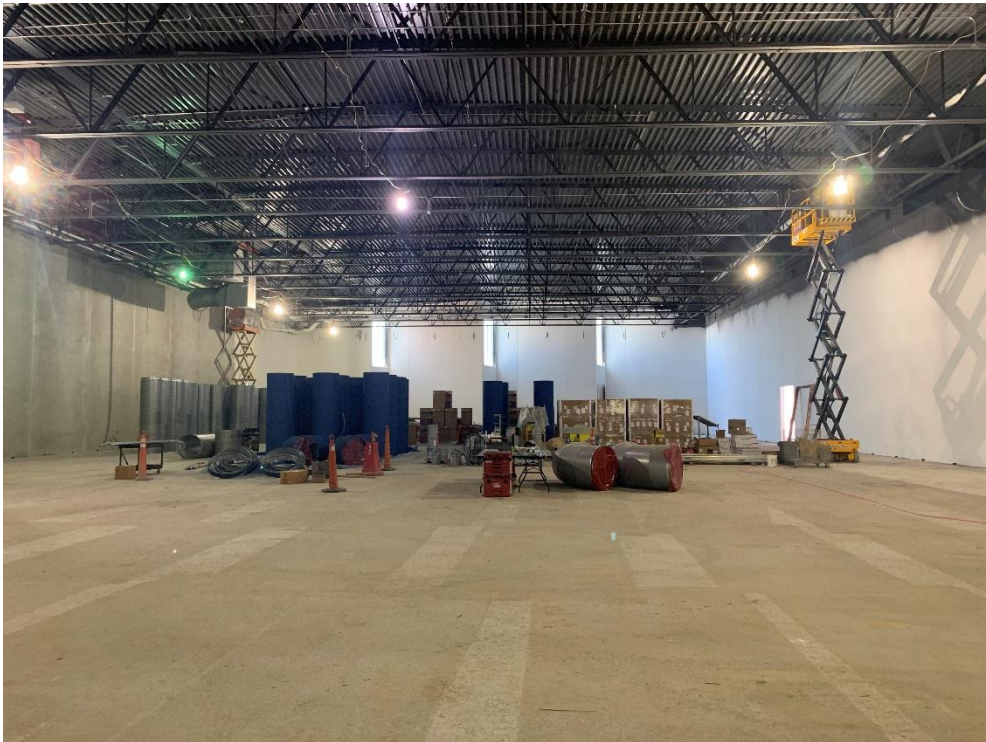
56. Area 6 – Painting and HVAC install in gym in progress

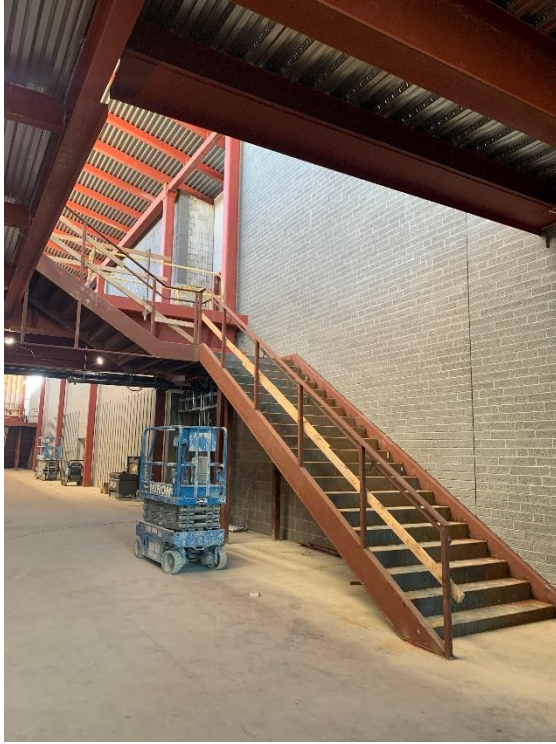
57. Area 1B & 1A – Center spine decorative stair install in progress.

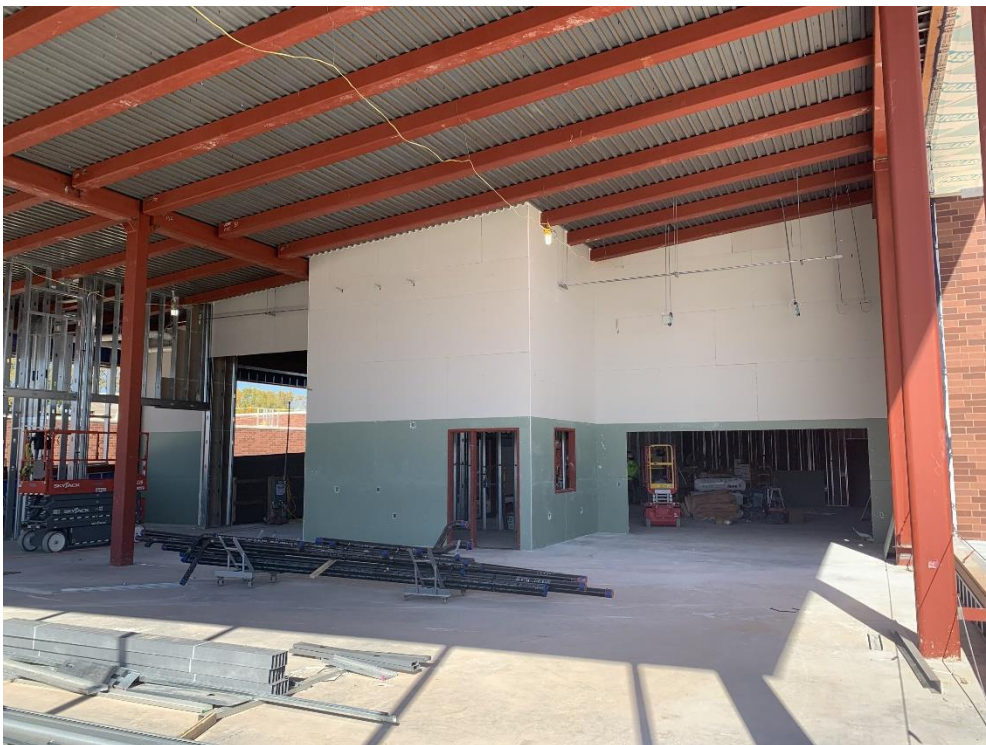
58. Area 1A – Second floor gyp board install in LMC in progress

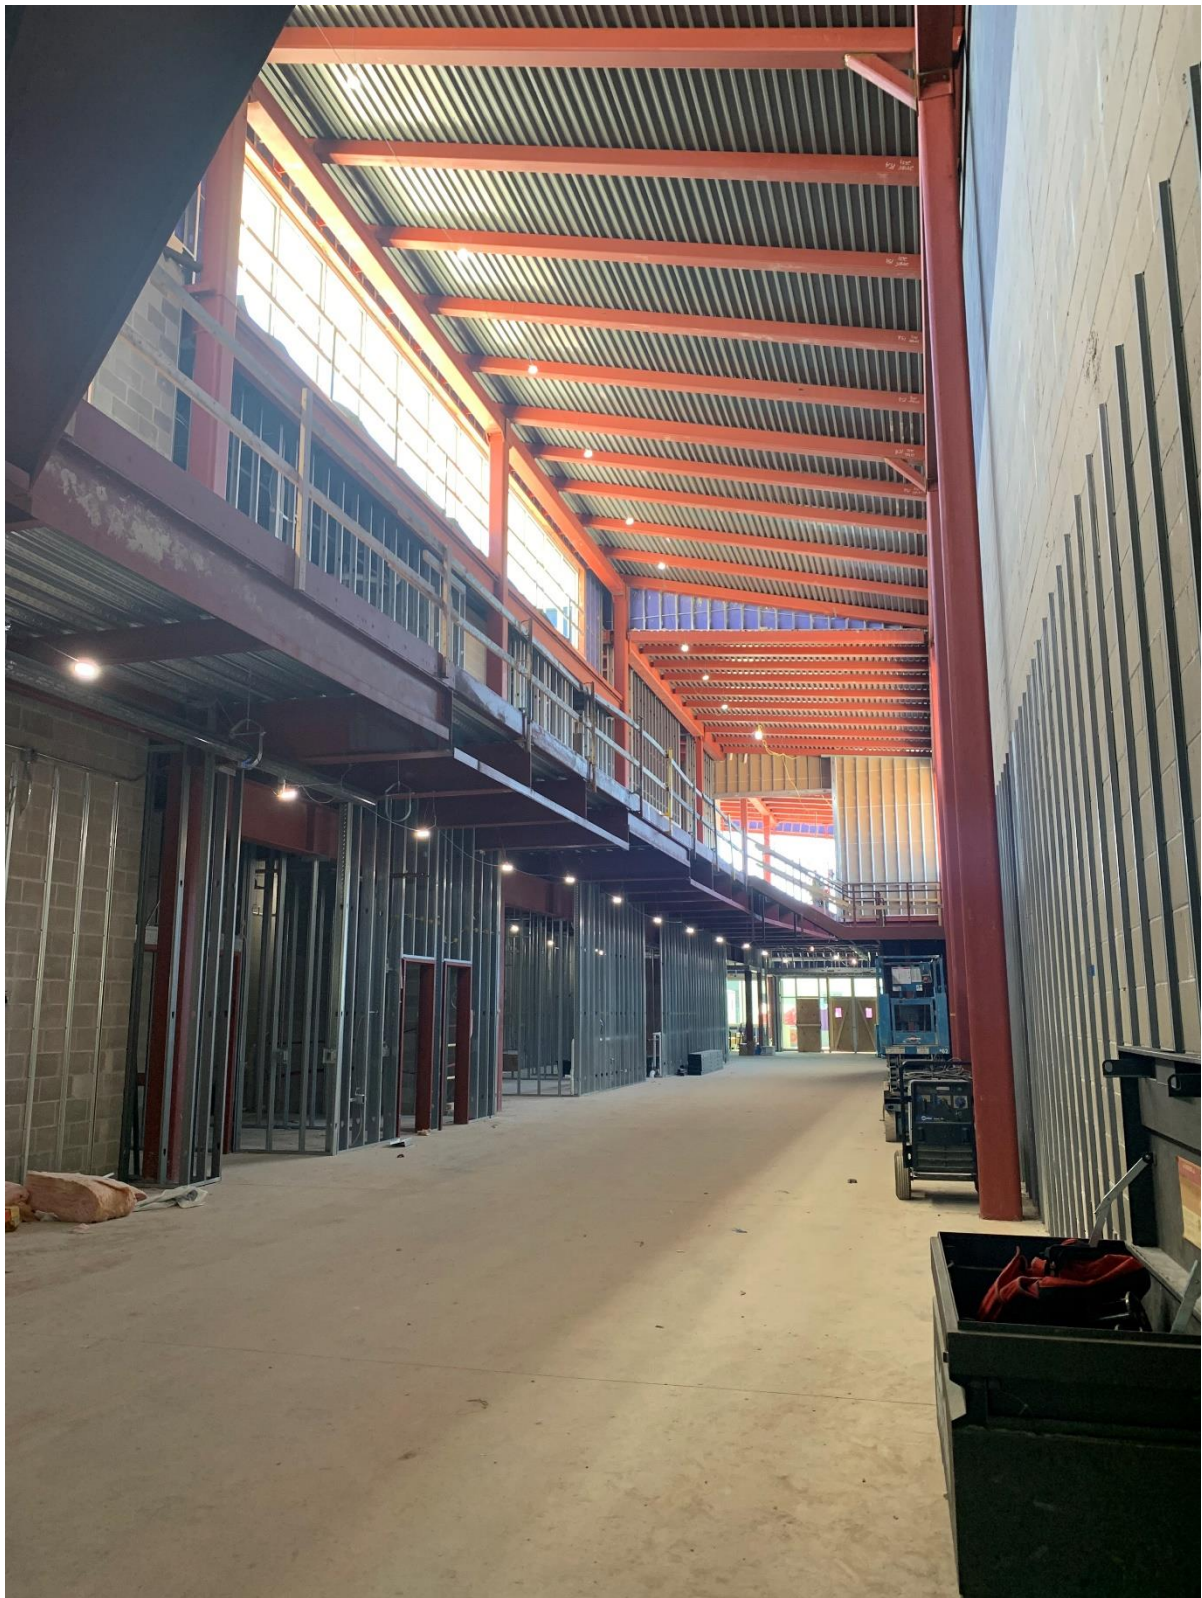
59. Area 1A&1B – Center spine metal stud framing, furring strips, and sprinkler piping install in progress.
