Construction Observation Report 011 – August 22, 2024

Maplewood School

PROJECT NUMBER: 321169-01

OWNER:	MENASHA JOINT SCHOOL DISTRICT
From ARCHITECT/ENGINEER:	EUA
To CONTRACTOR	MIRON CONSTRUCTION CO, INC
SITE OBSERVATION TYPE	ARCHITECTURAL
DATE OF ISSUANCE:	September 5, 2024

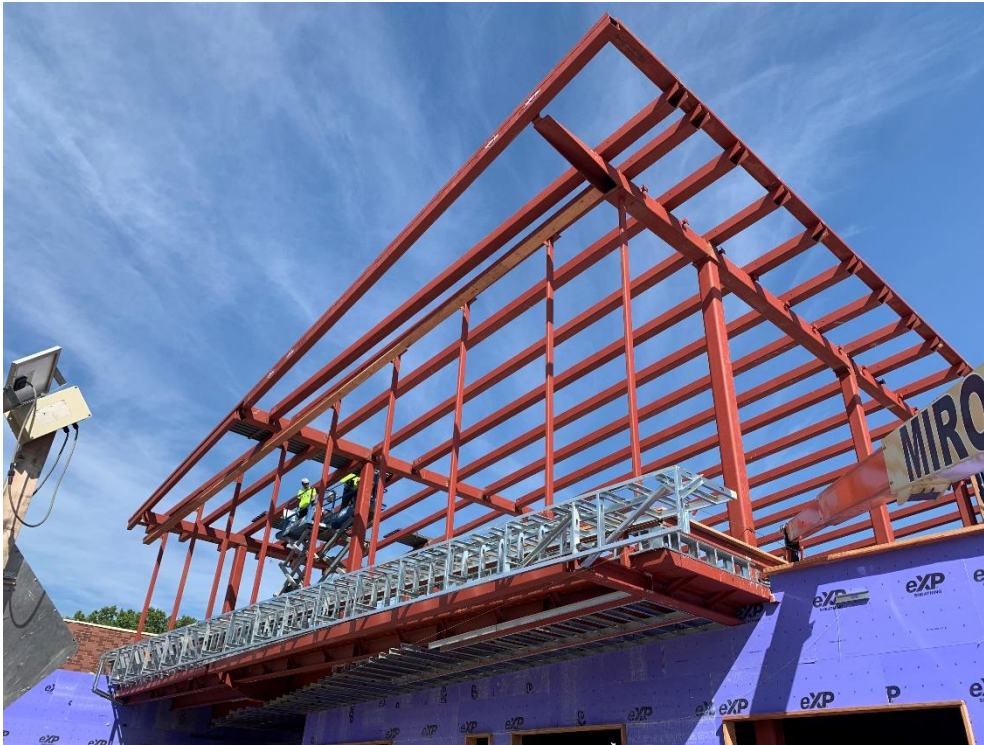
1. Area 1A South – Metal roof decking and cold form framing installation in progress.

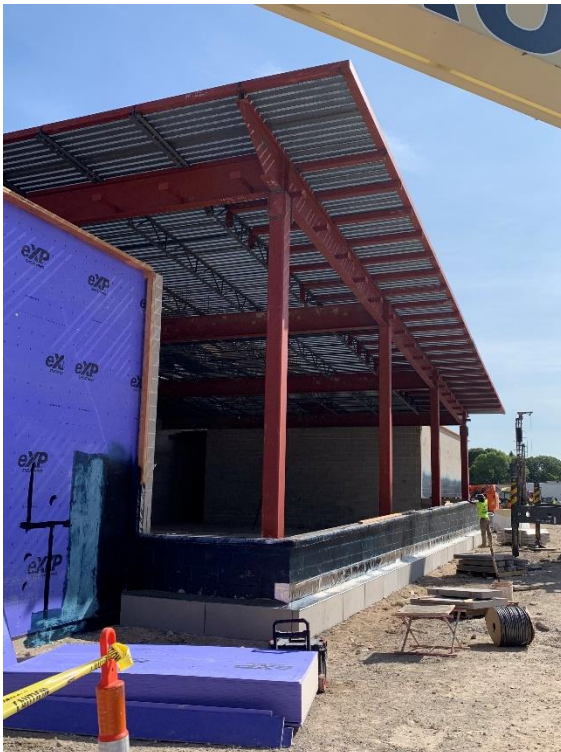
2. Area 2B South – Acoustic roof decking and cast stone panels are installed. Window blocking installation in progress.

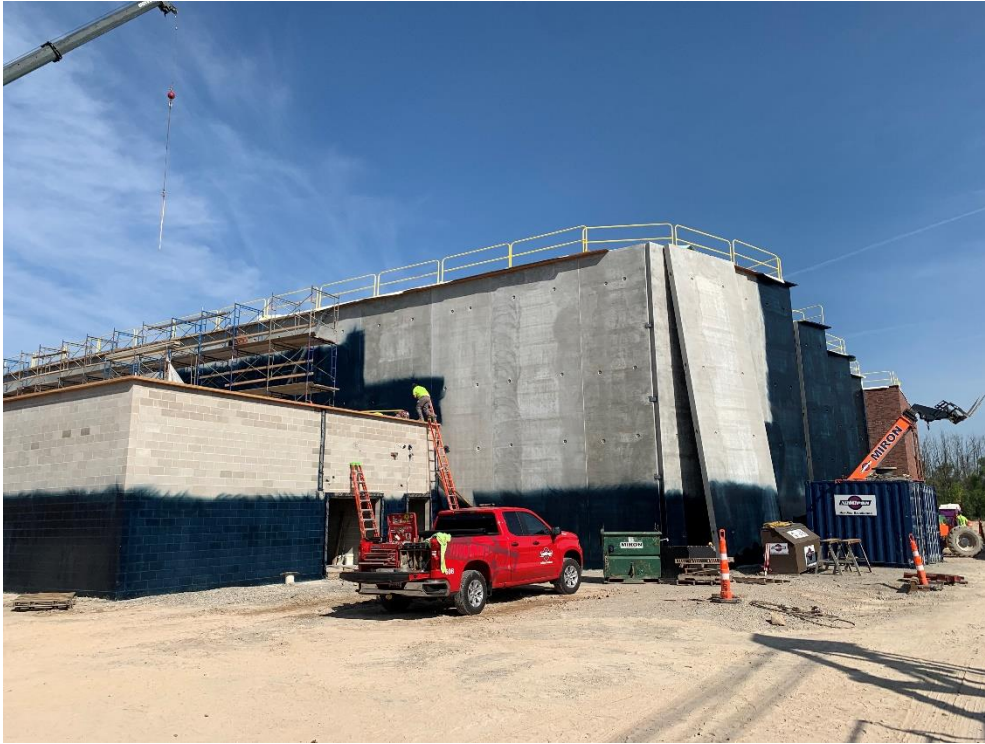
3. Area 2B & 6 South East – Spray applied AVB application in progress.

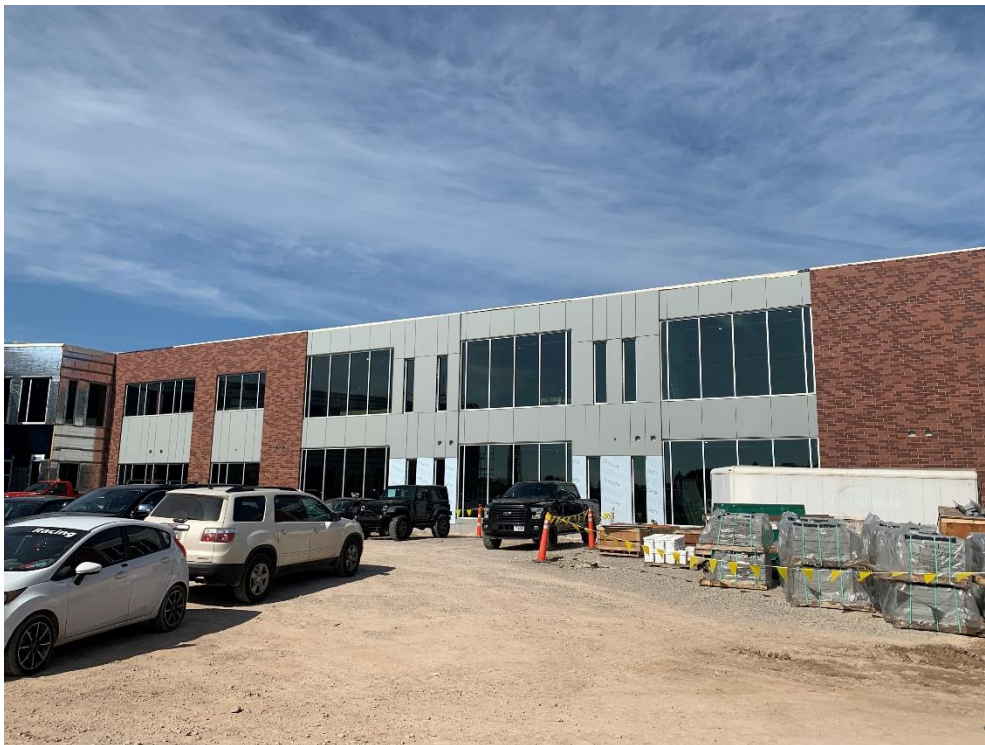
4. Area 5 East – Composite metal panels installed.

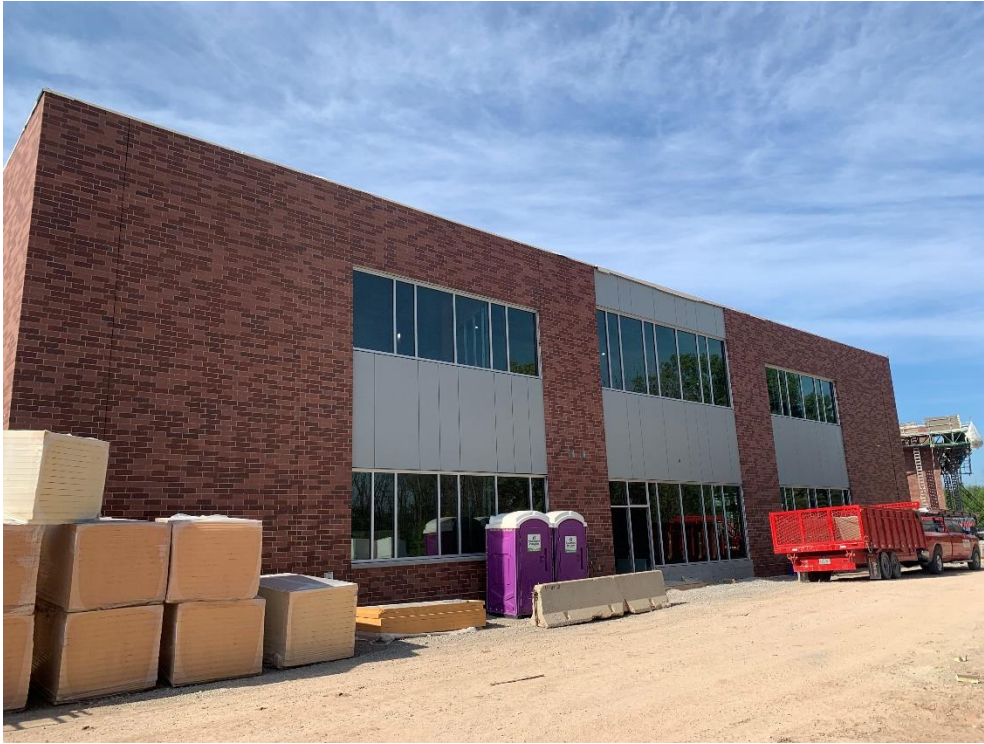
5. Area 5 North – Composite metal panels installed.

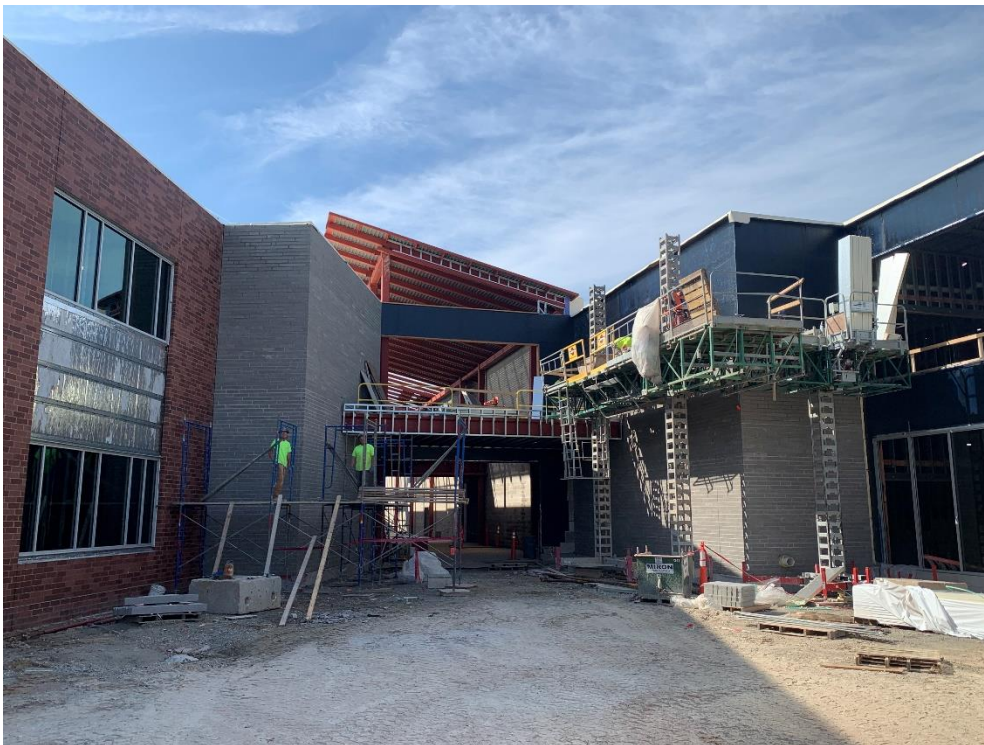
6. Area 1B North – Exterior brick veneer installation in progress.

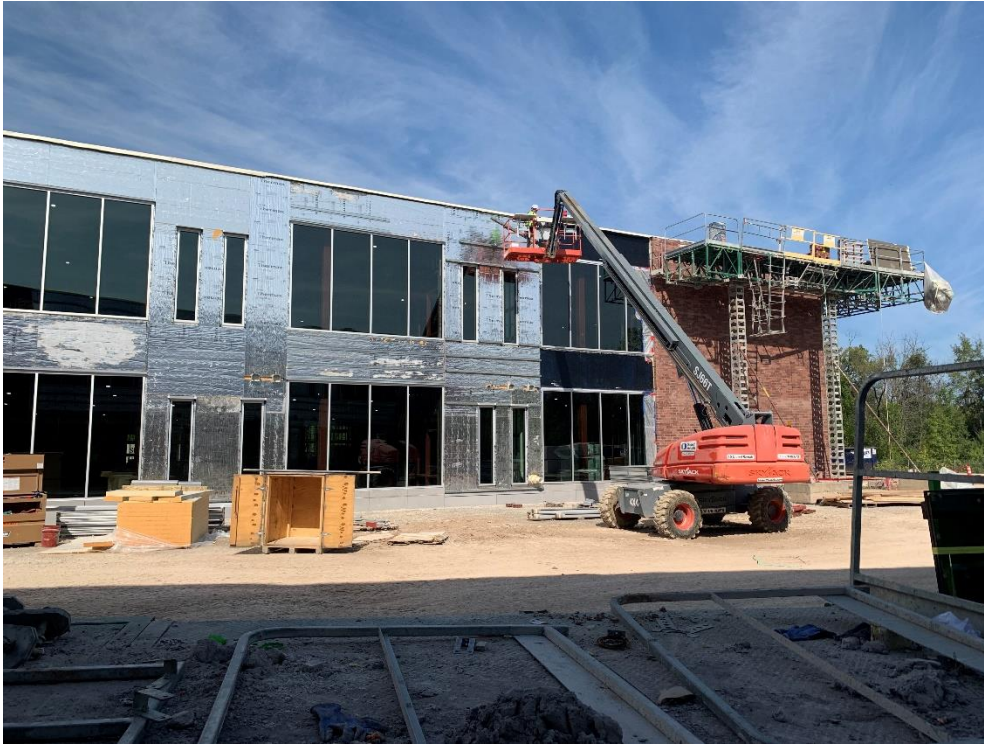
7. Area 4 East – Cast stone panels, brick veneer, and storefront glazing installed. Board insulation and sub girt installation in progress.

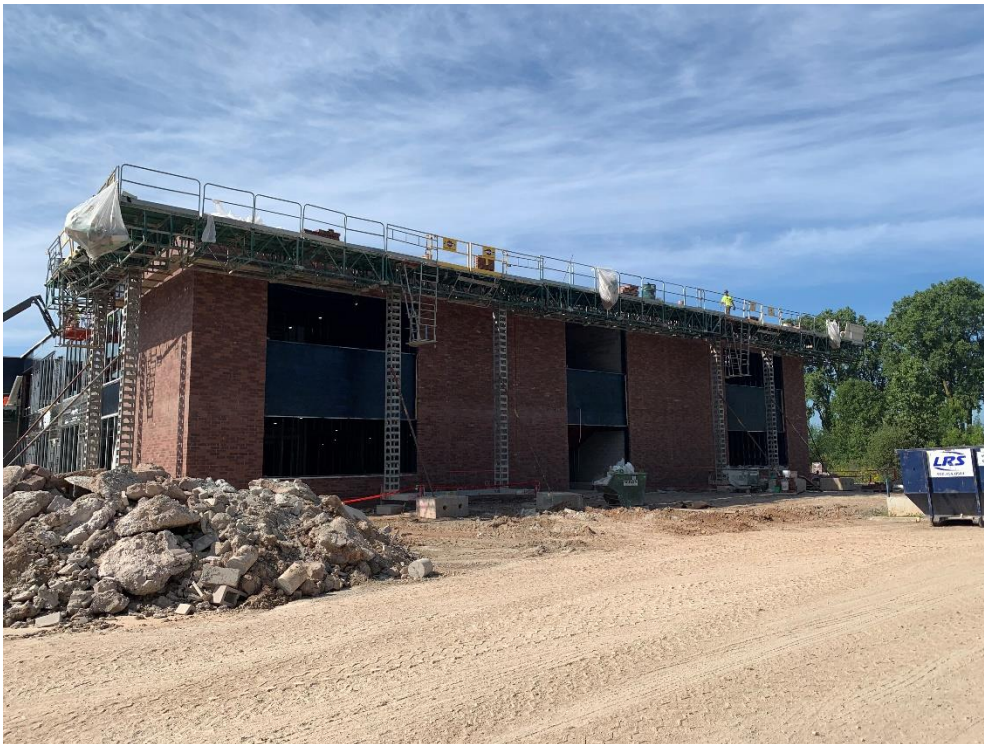
8. Area 4 North – Exterior brick veneer installation in progress.

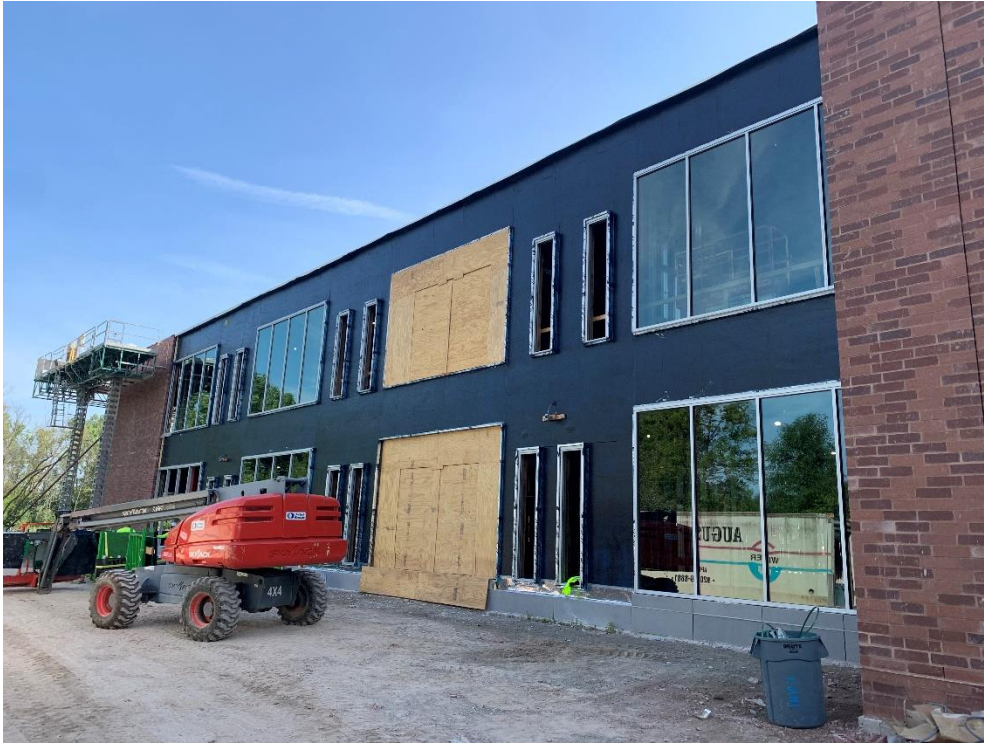
9. Area 4 West – Cast stone panel and storefront glazing installation in progress.

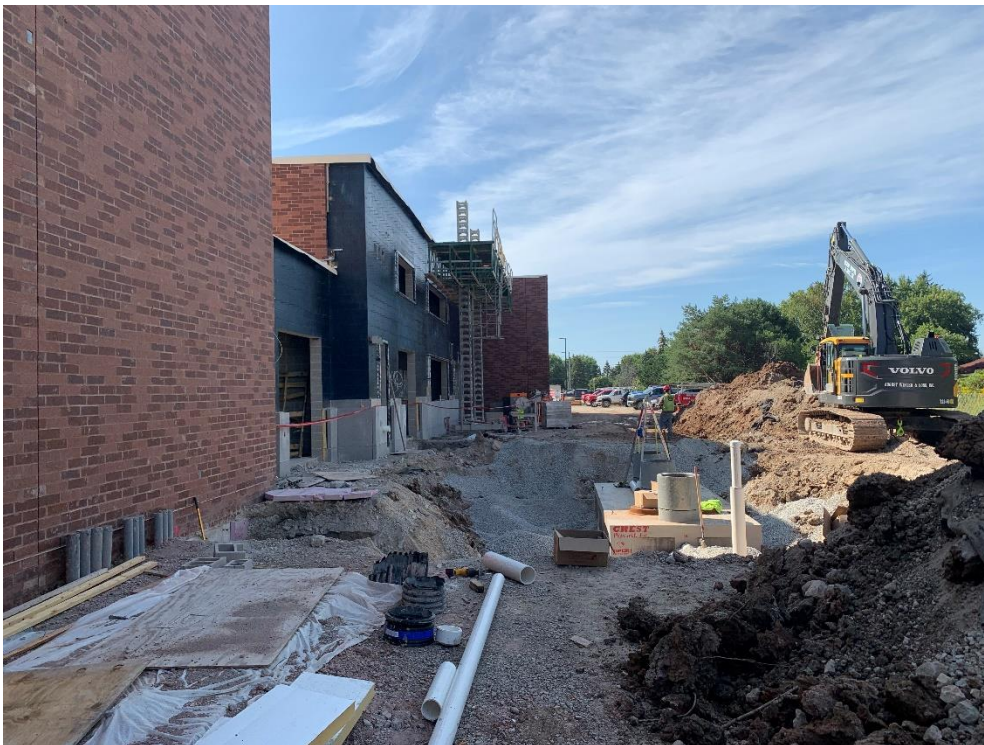
10. Area 3 West – Below grade work in progress. Exterior brick veneer and cast stone panels installed.

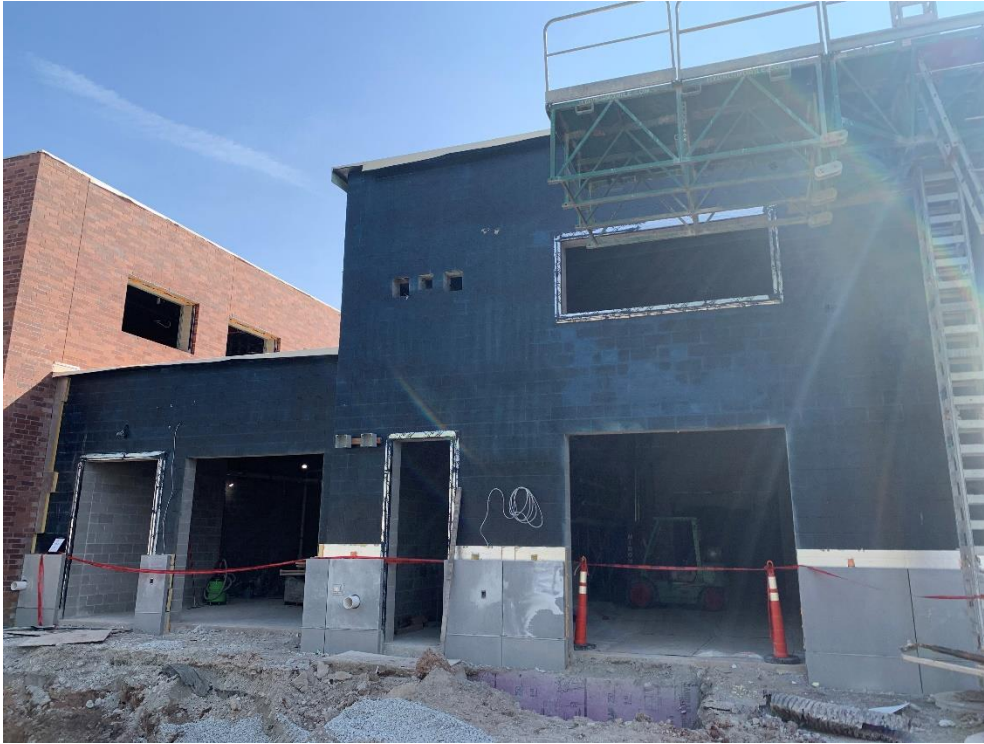
11. Area 3 West – Installation of weather proofing membrane at openings in progress.

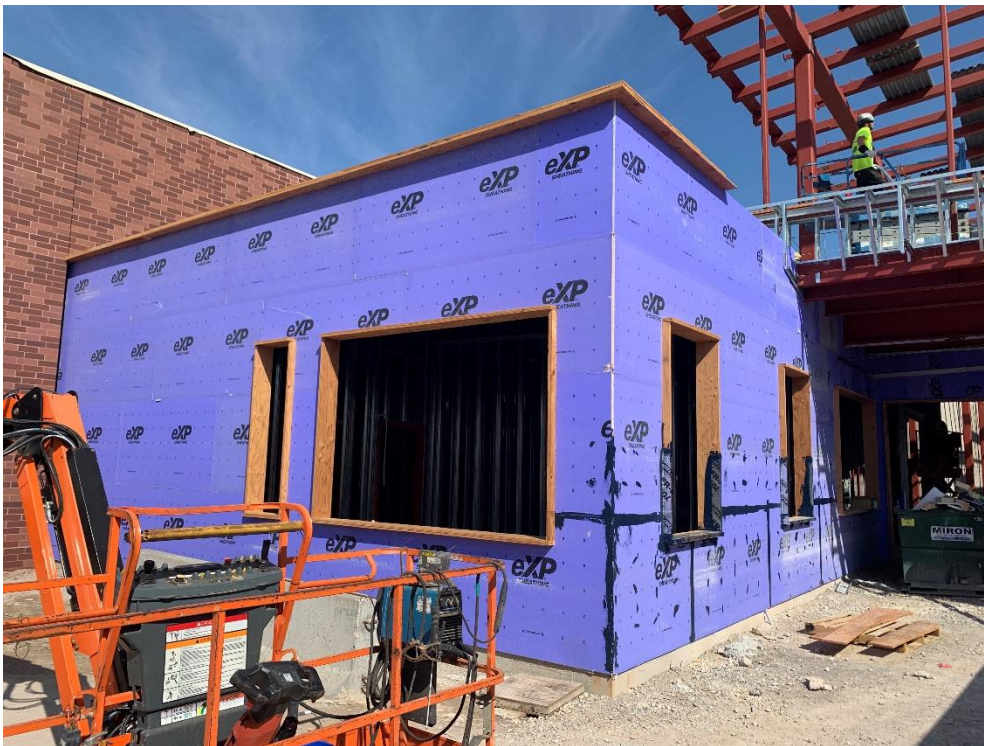
12. Area 1A South – Exterior sheathing, window blocking, and weather proofing membrane installation in progress.

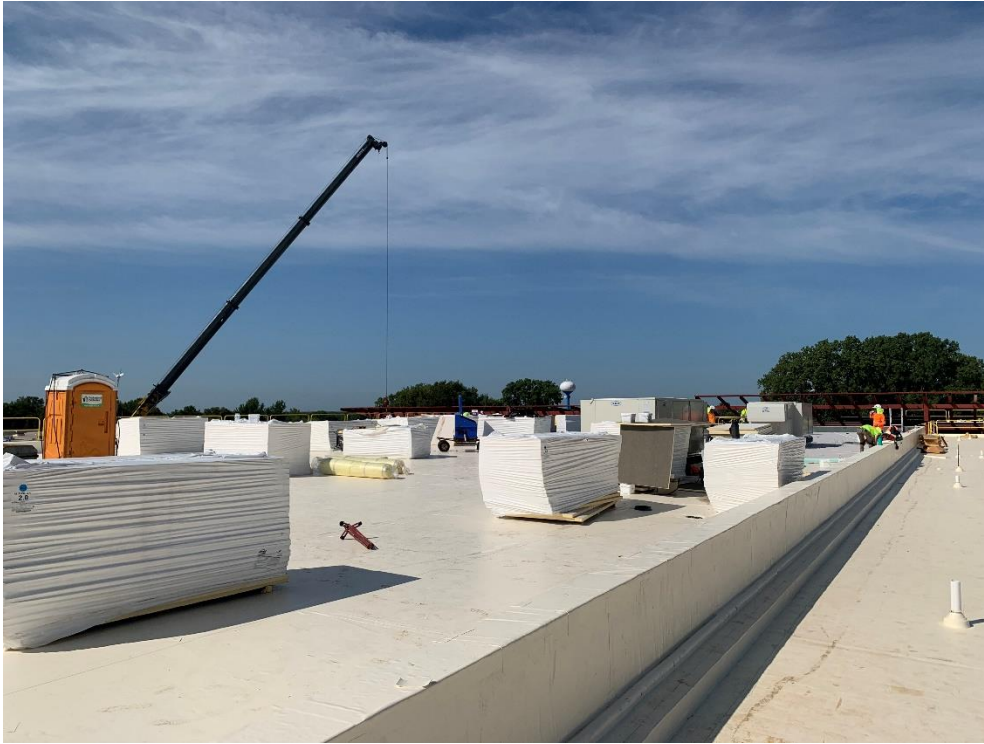
13. Area 6 – Roof installation in progress.

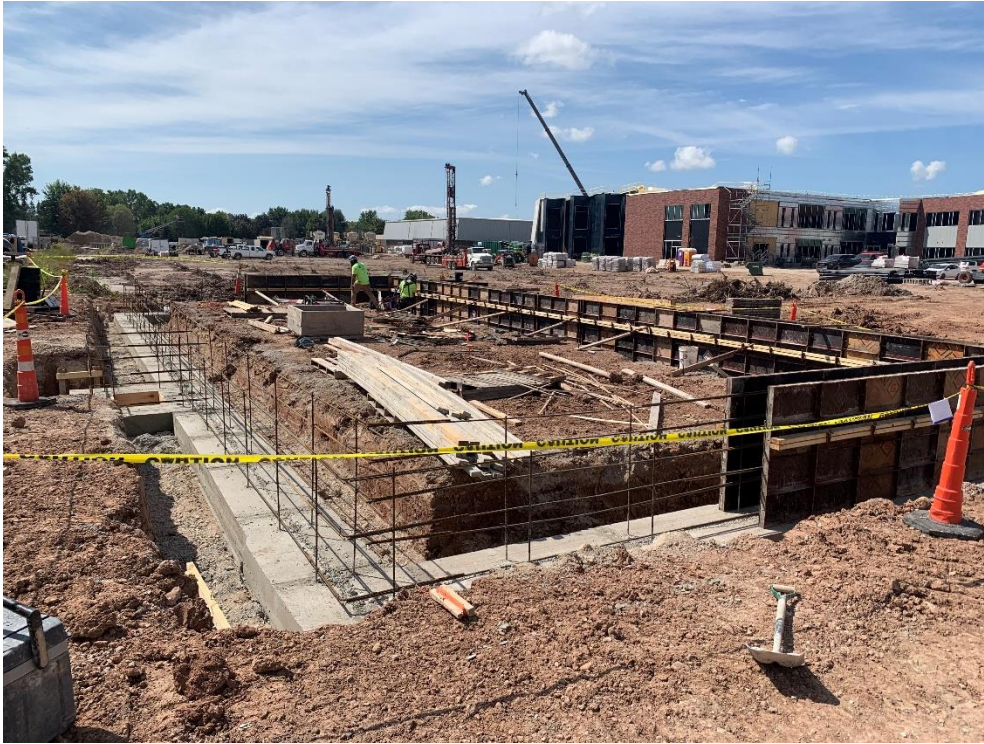
15. Locker Room Building – Concrete footings poured. Foundation wall construction in progress.

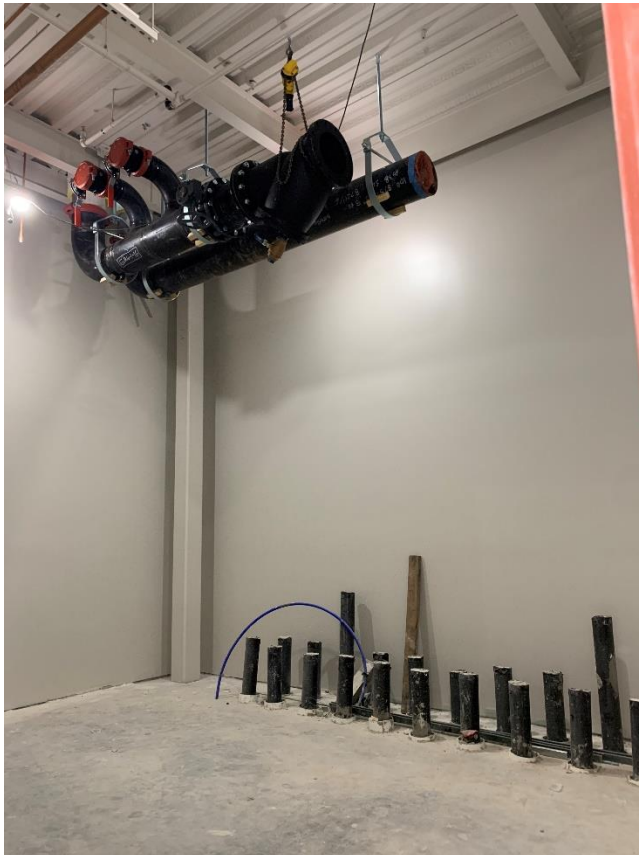
16. Area 6 First Floor – Manifold room geothermal equipment installation in progress.

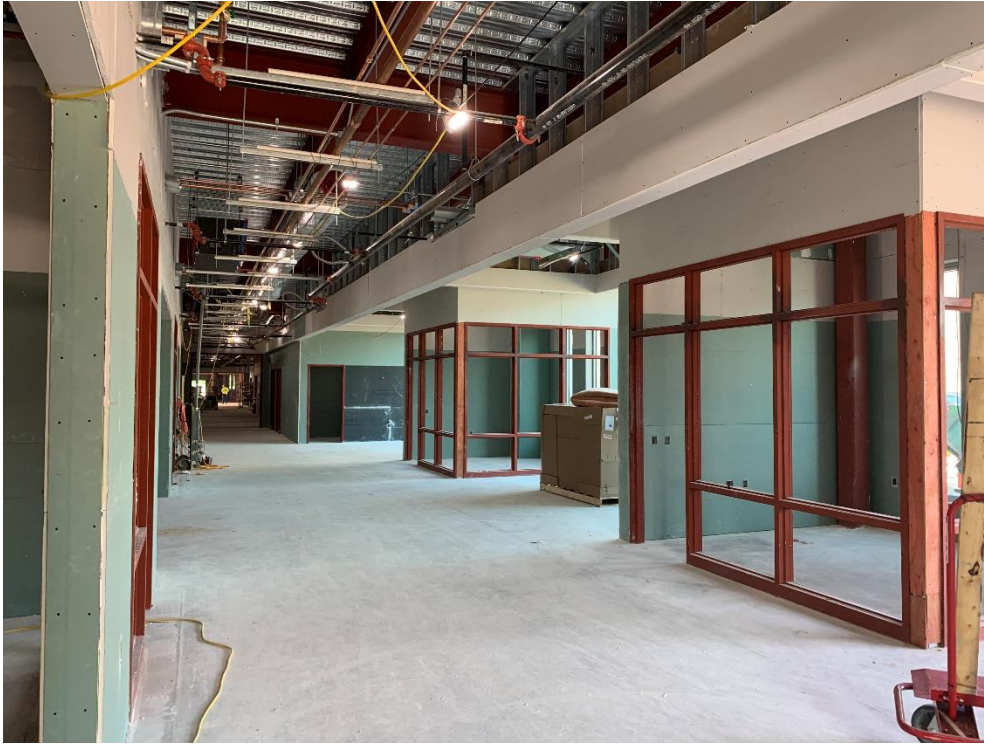
17. Area 6 First Floor – Interior gyb board installation in progress.

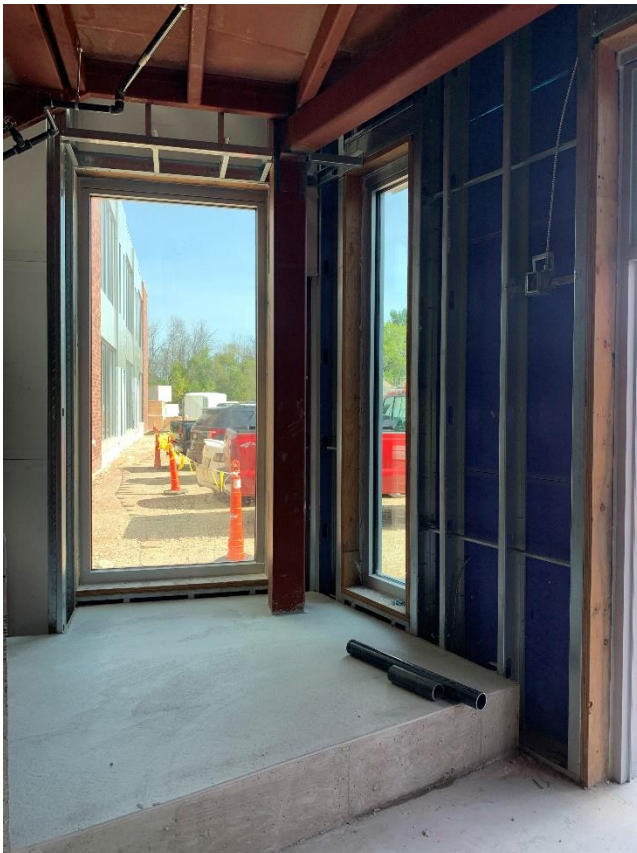
18. Area 5/6 First Floor - Under stair concrete base.

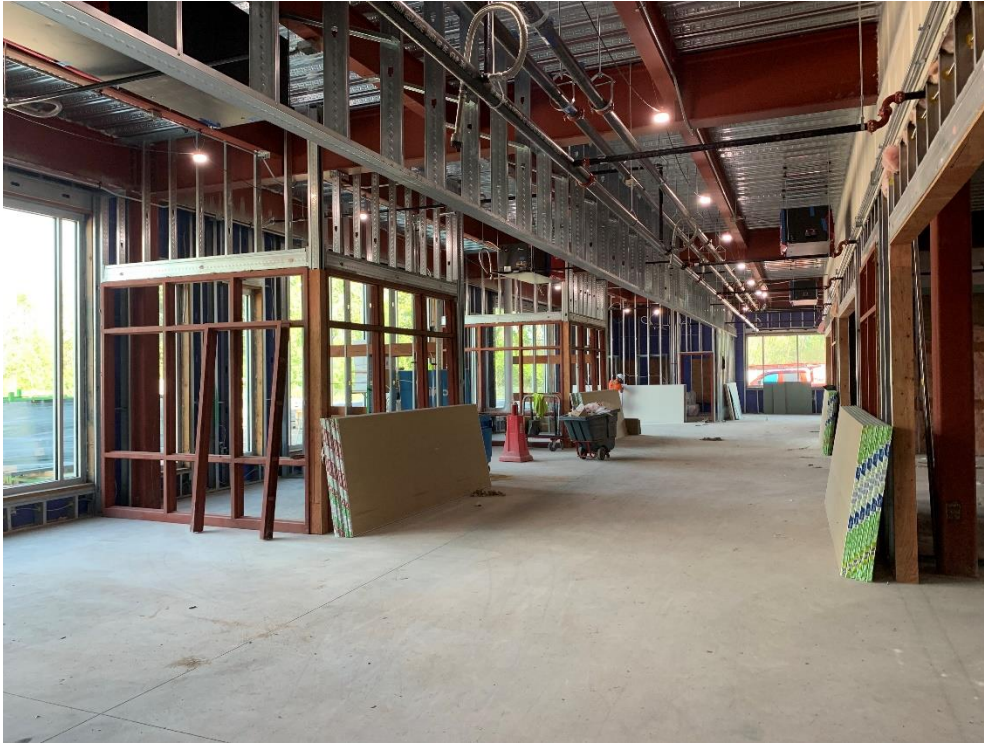
19. Area 5 First Floor – Installation of interior gyp board in progress.

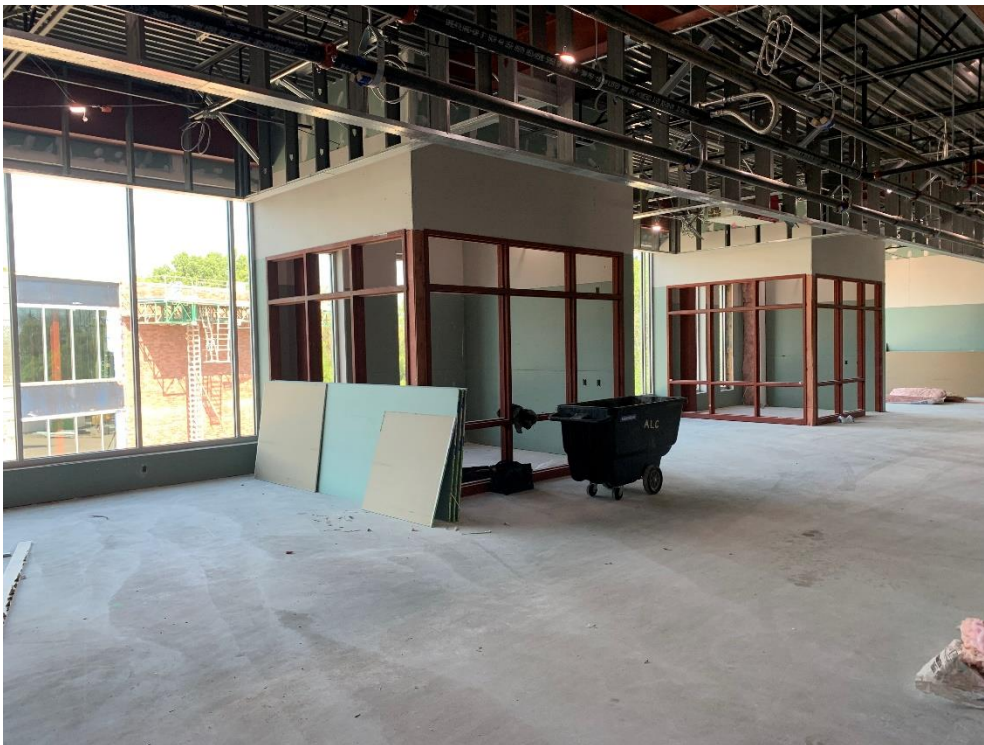
20. Area 5 Second Floor – Interior gyp board installation in progress.

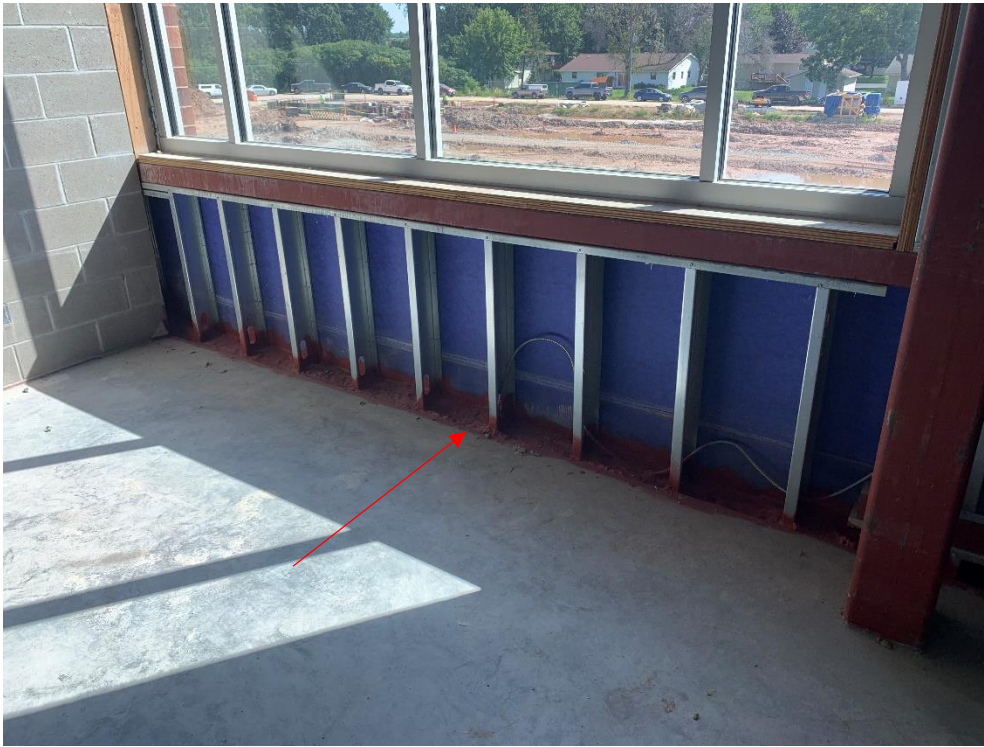
21. Area 6 Second Floor - Fire safing insulation.

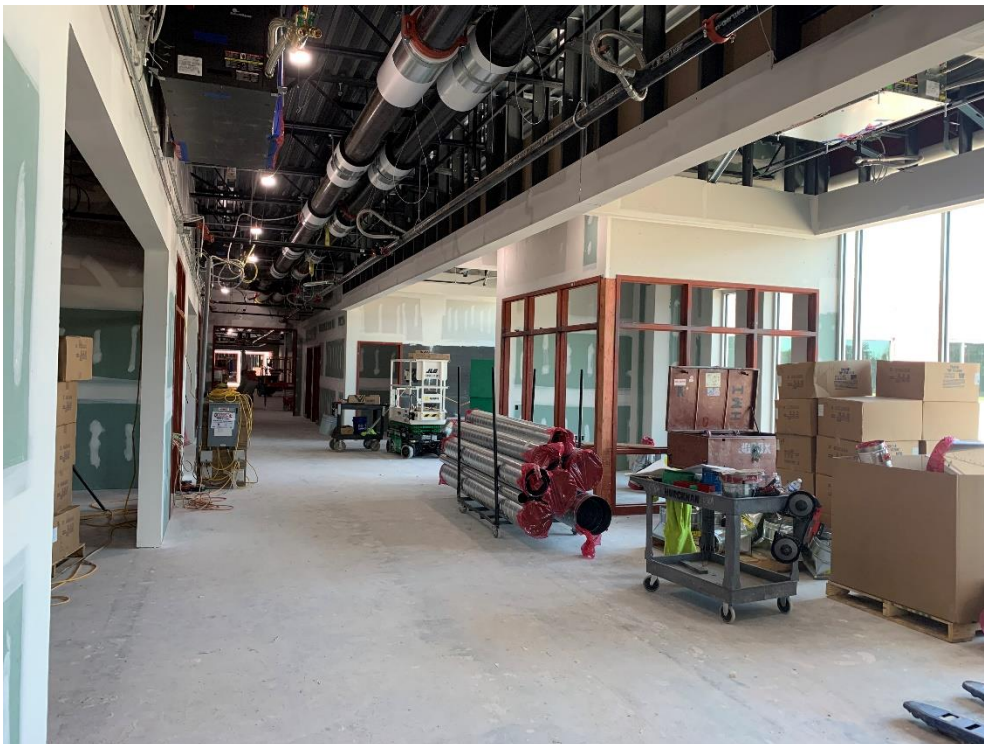
22. Area 6 Second Floor – Gyp board taping and mudding in progress.

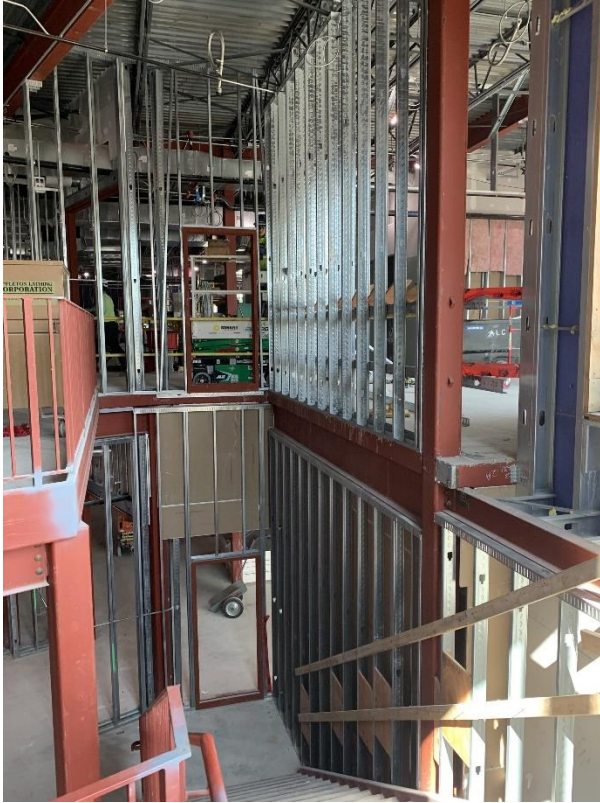
23. Area 5 – Interior metal stud framing in progress at knuckle stair.

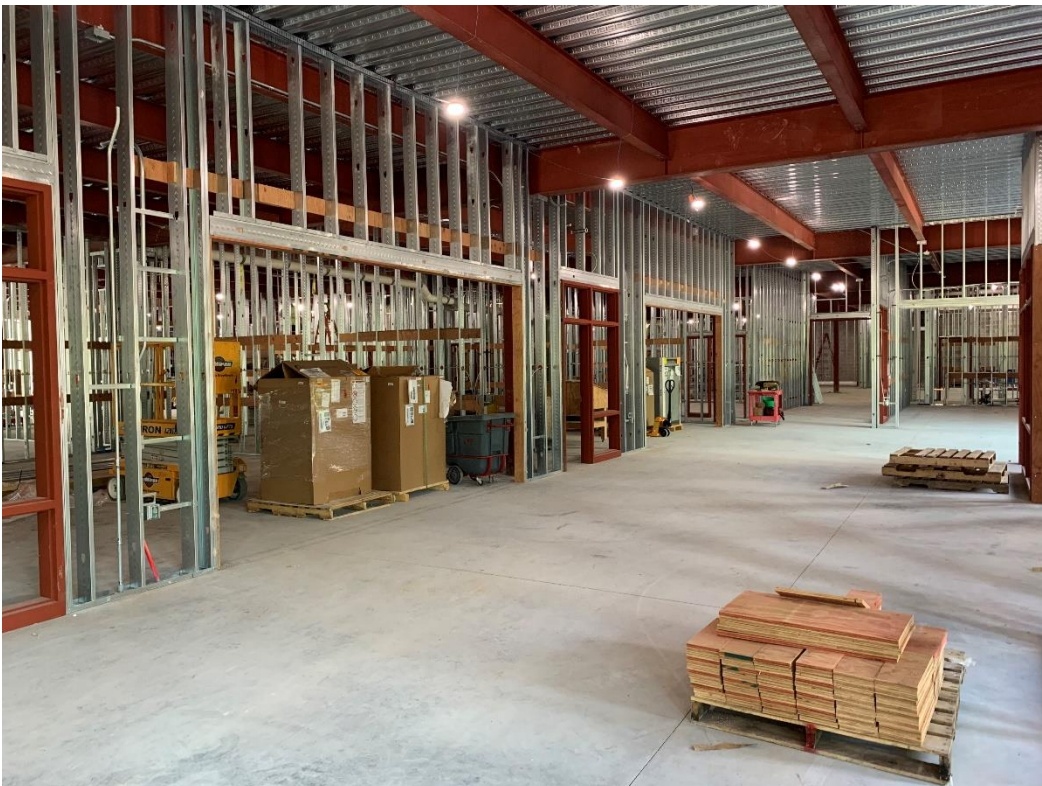
24. Area 4 First Floor – Metal stud framing and blocking installation in progress.

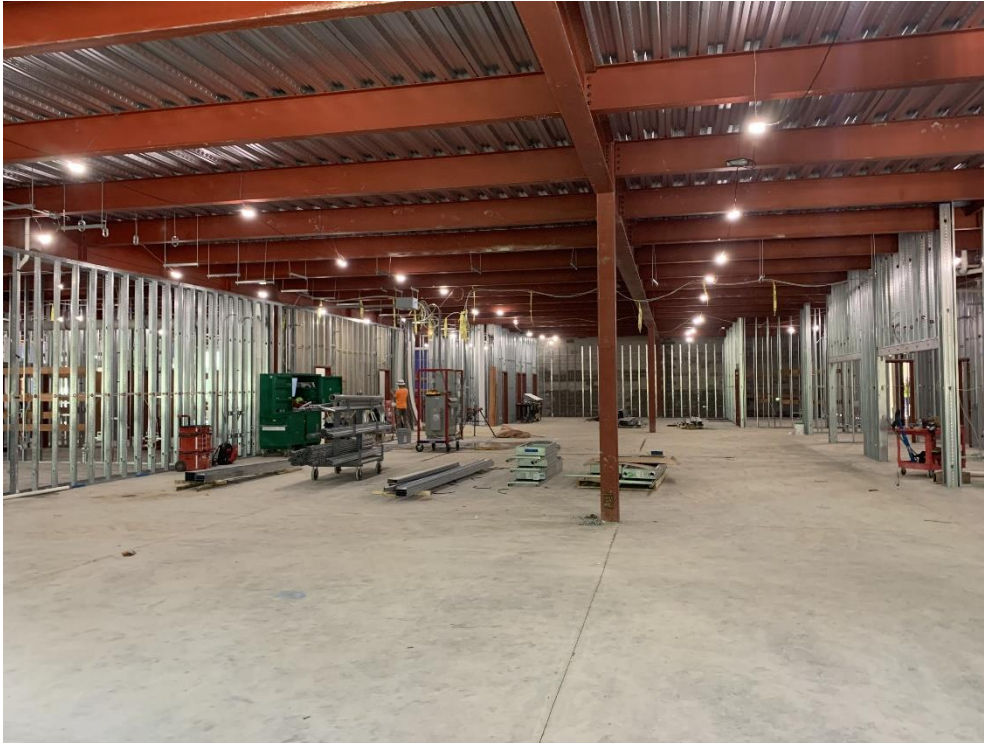
25. Area 4 First Floor – Servery interior metal stud framing installation in progress.

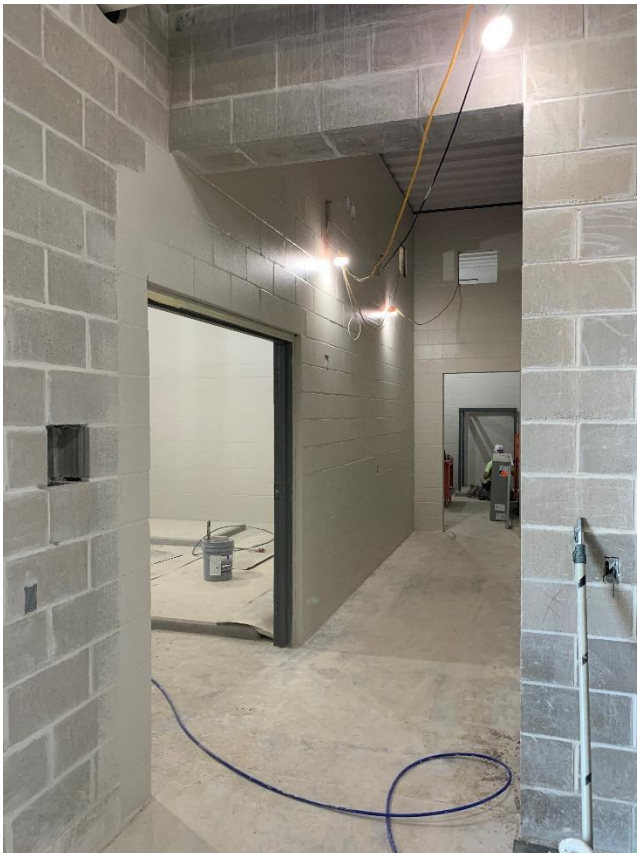
26. Area 3 First Floor – Paint and primer installation in water and electrical rooms in progress.

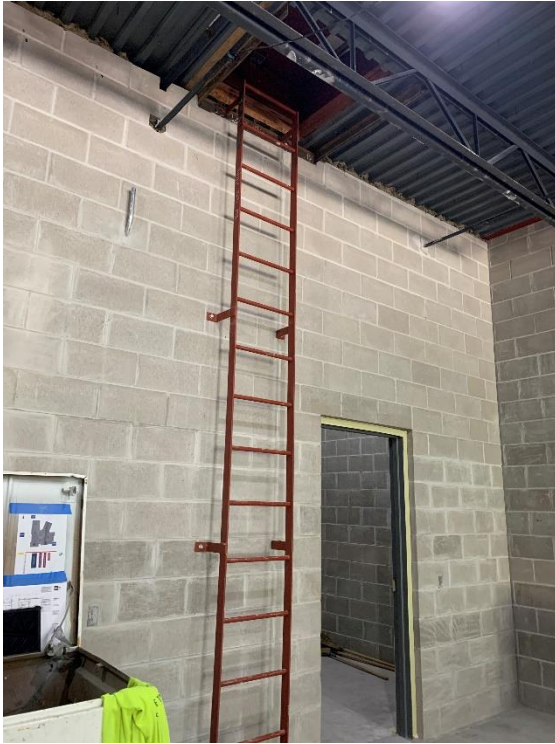
27. Area 3 First Floor – Roof ladder and hatch installed.

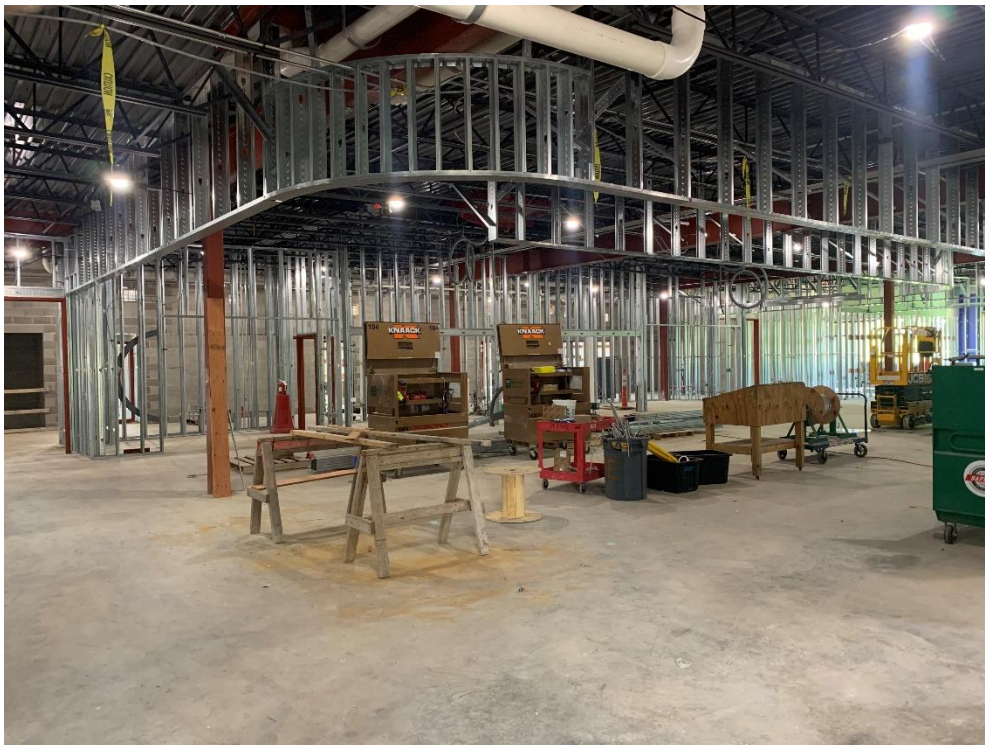
28. Area 3 Second Floor – Interior metal stud and soffit framing in flex café in progress.

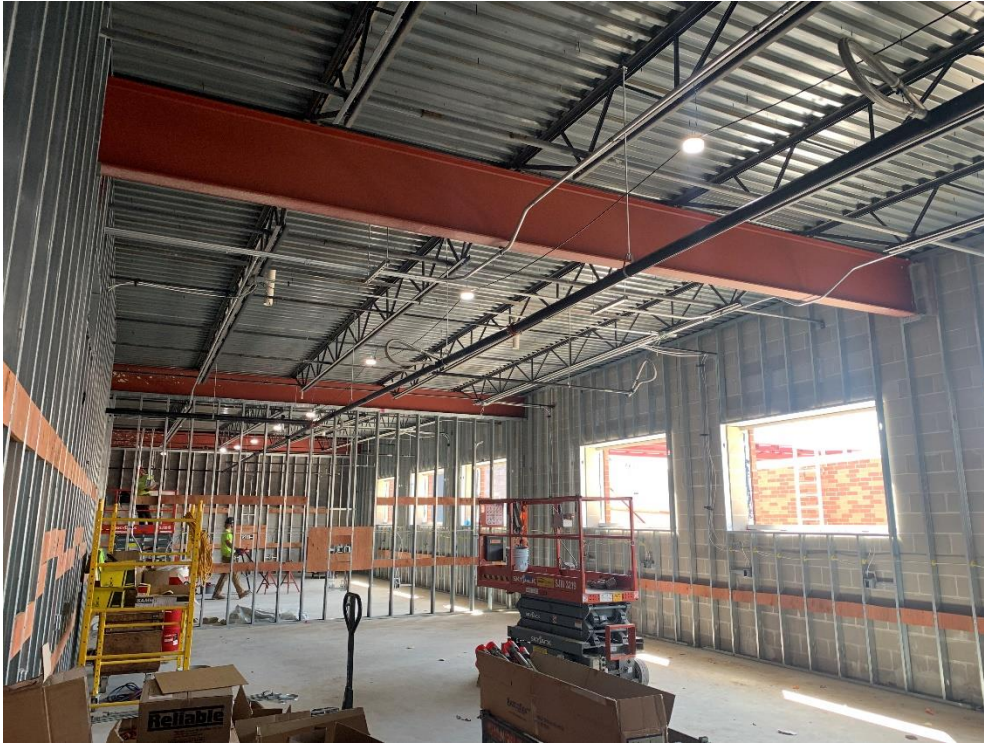
29. Area 3 Second Floor – Above ceiling piping installation in progress.

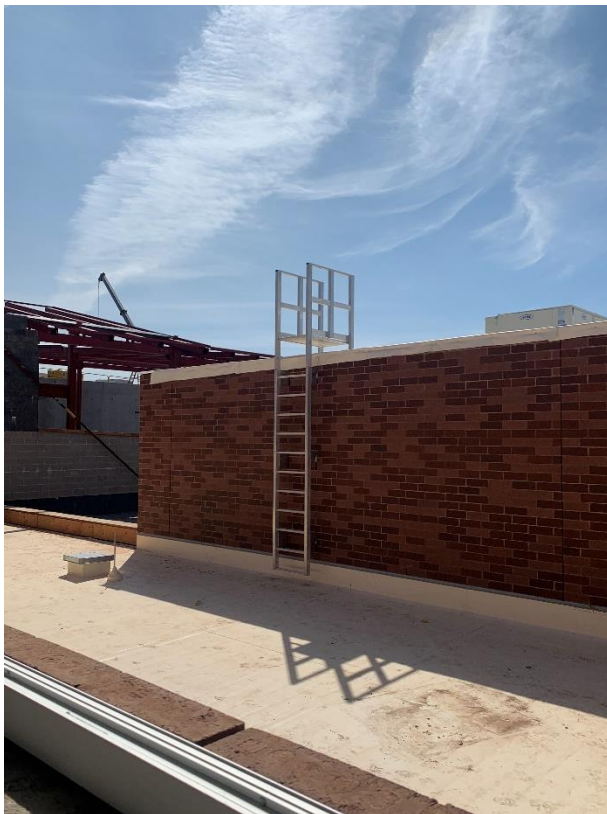
30. Area 2 - Roof Ladder and roofing installed.

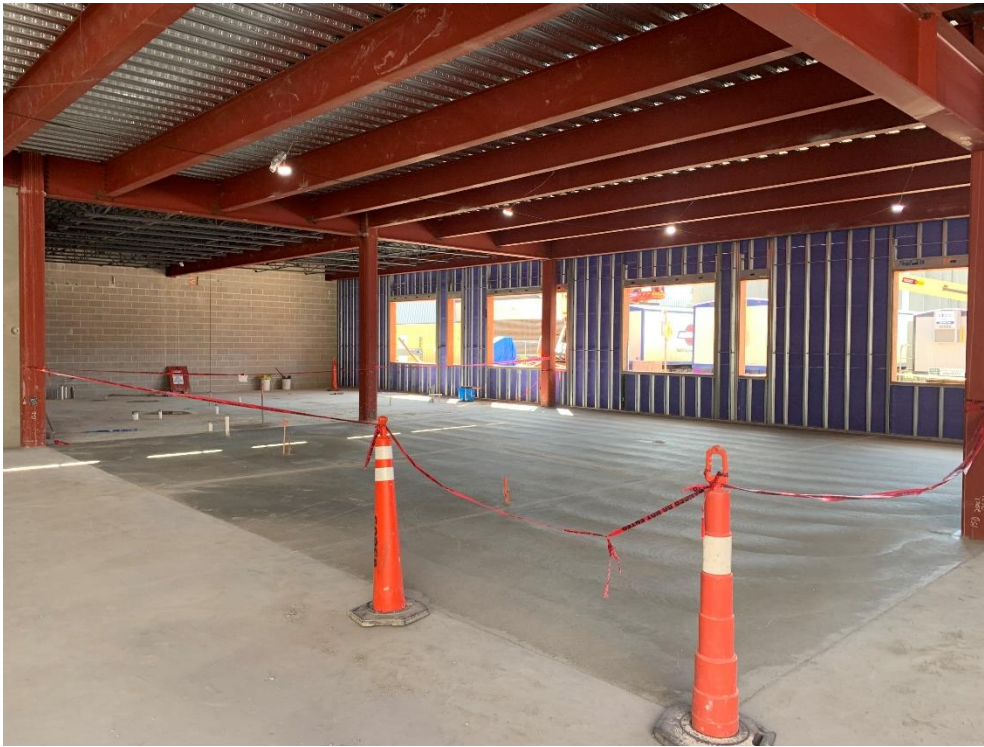
31. Area 1A First Floor – Floor slab pour in progress.

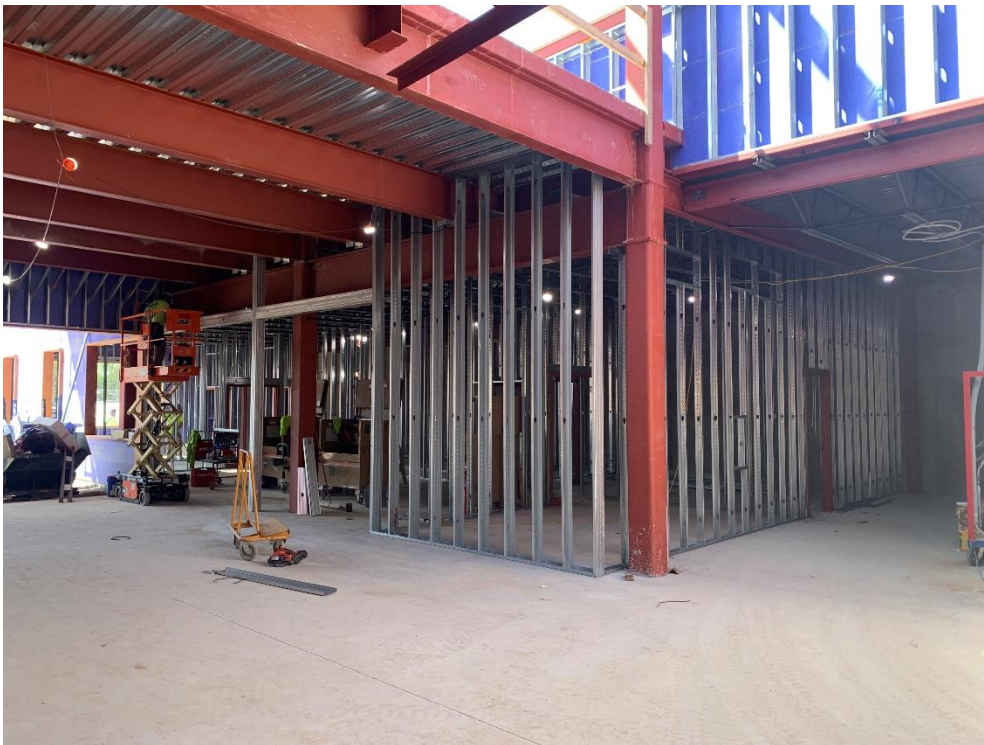
32. Area 1A/2B First Floor – Interior metal stud framing installation progress.

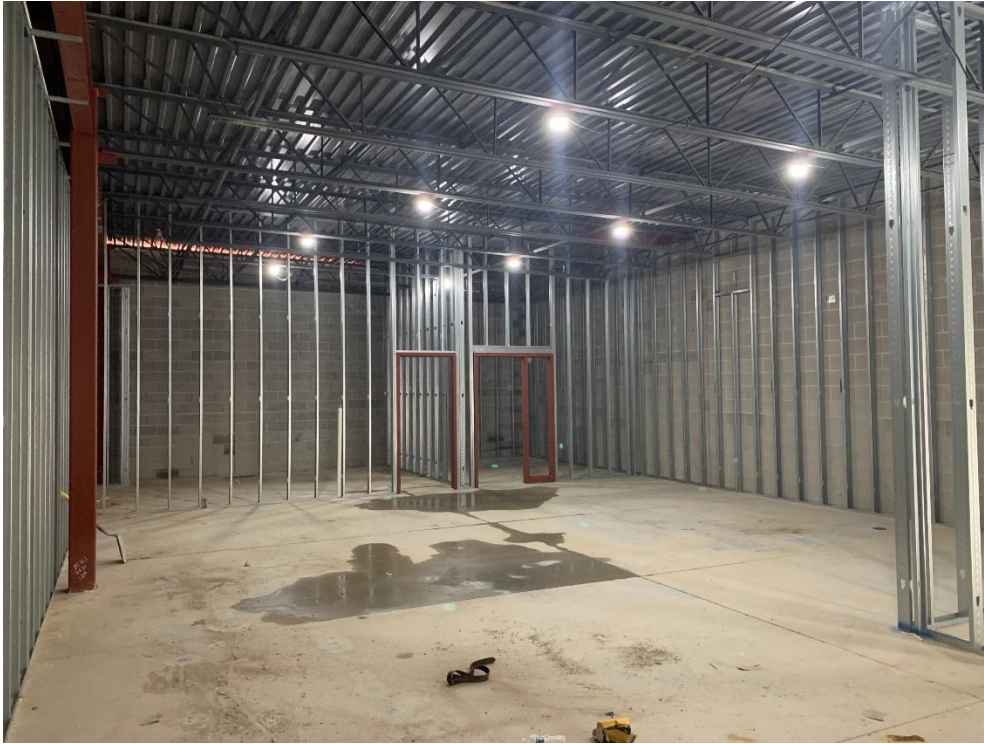
33. Area 1A First Floor – Interior metal stud framing installation in progress in OT/PT.

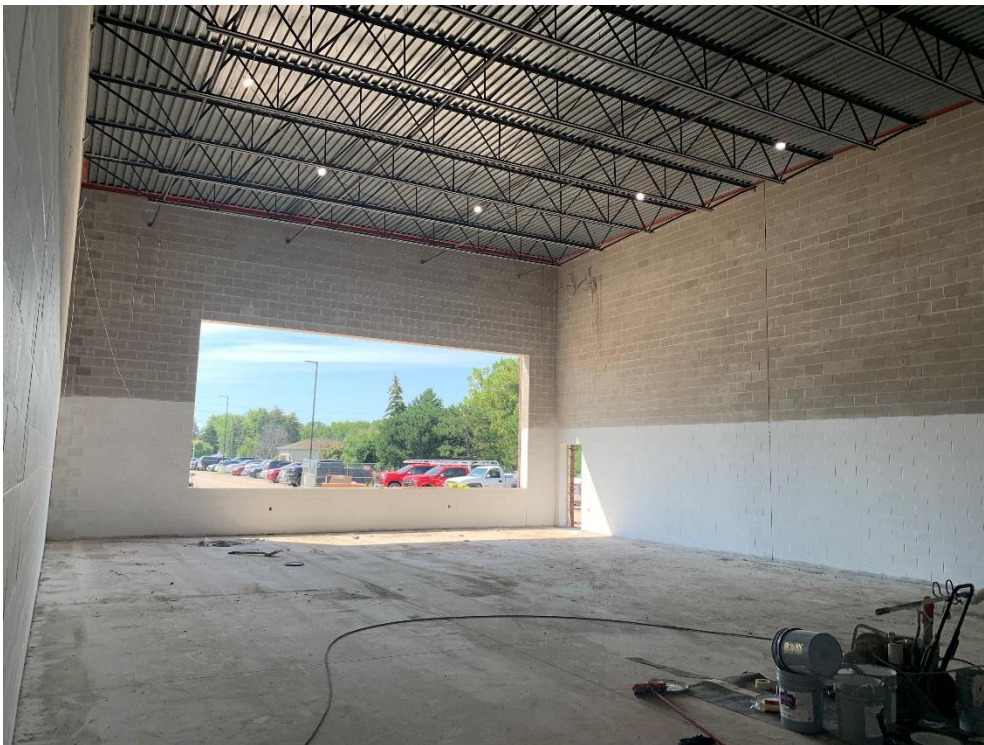
34. Area 2A First Floor – Paint and primer installation in progress in music rooms.
