Construction Observation Report 021 – January 10th, 2025

Maplewood School

PROJECT NUMBER: 321169-01

| SITE OBSERVATION TYPE | ARCHITECTURAL |

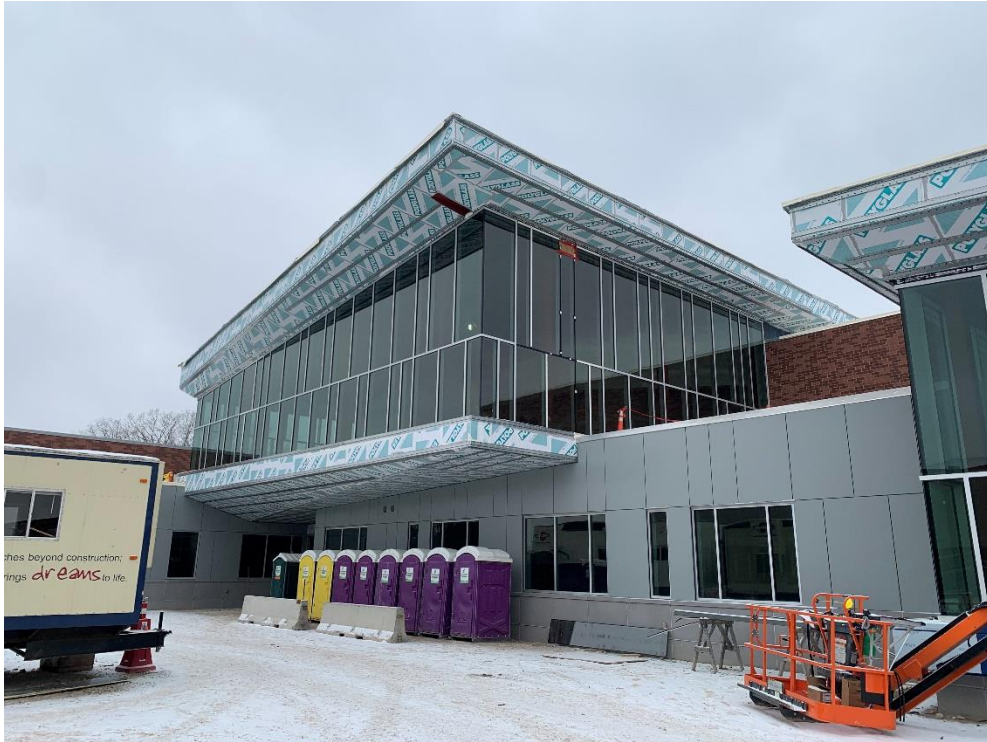
1. Area 1A South – Curtainwall mullion cap install in progress. Metal girt system install at upper and lower soffits in progress.

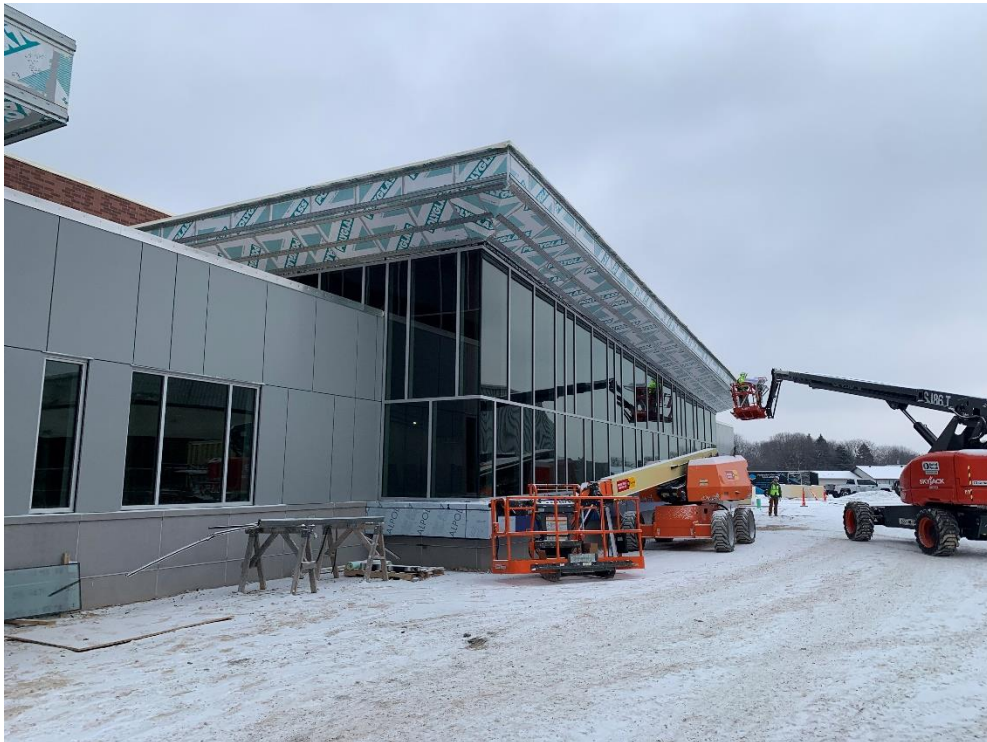
2. Area 2B South – Curtainwall mullion caps appear to be installed. Composite panel install at upper soffit in progress.

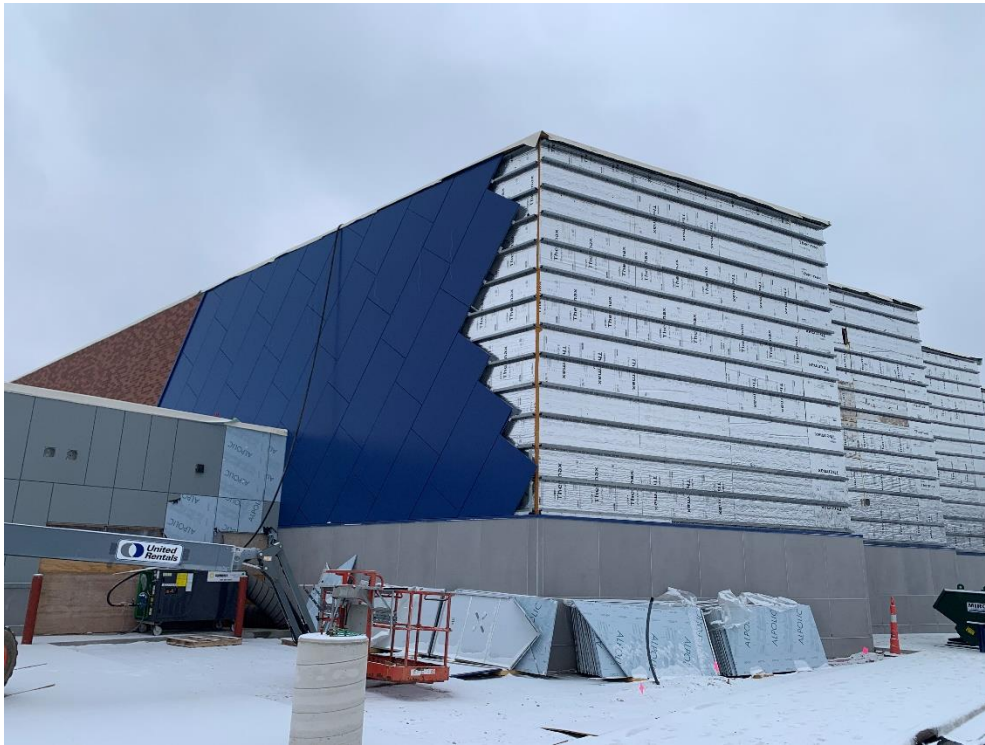
3. Area 2B East & Area 6 Southeast – Composite wall panel install in progress.

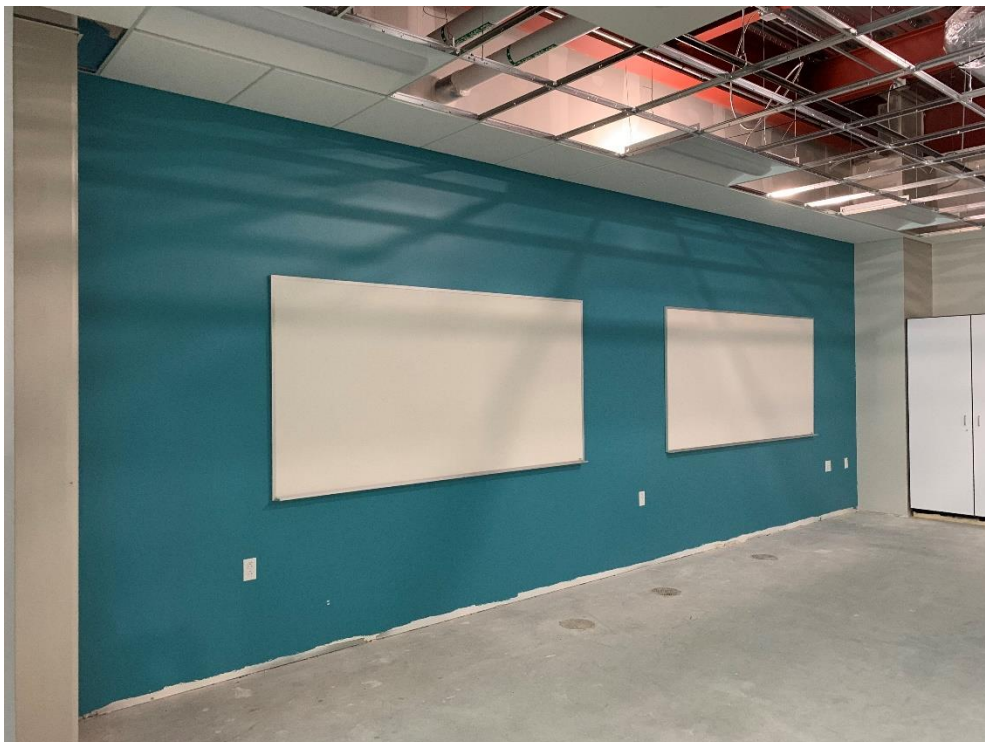
4. Area 6 North – Marker board and wall mounted equipment install in first floor classrooms in progress.

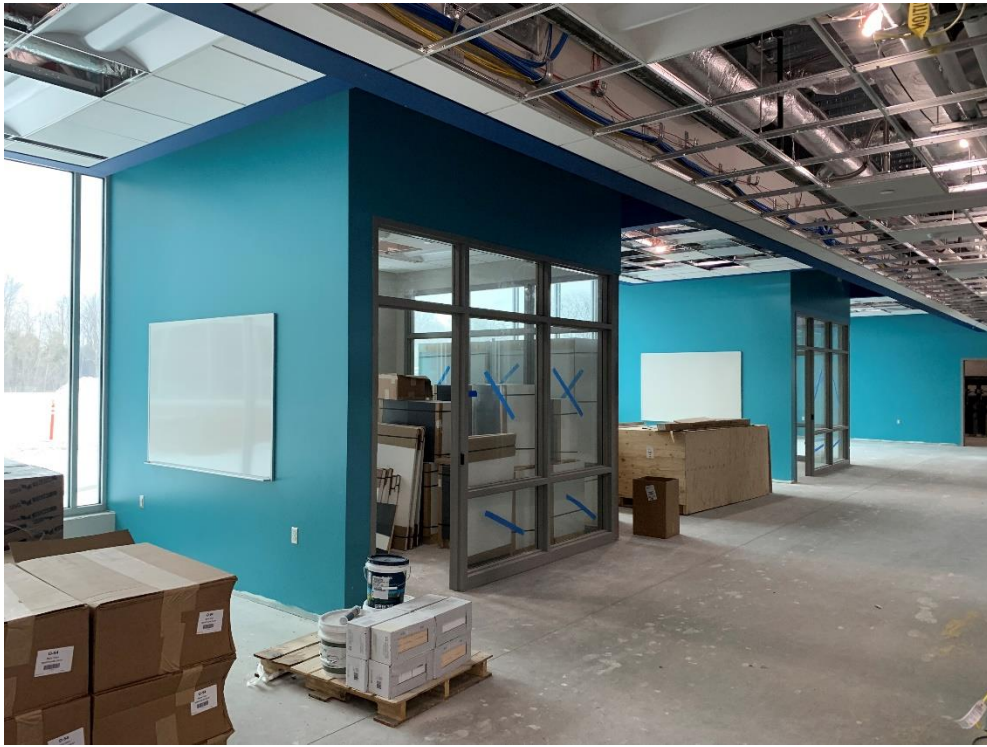
5. Area 6 North - Marker board and wall mounted equipment install in first floor collab areas in progress.

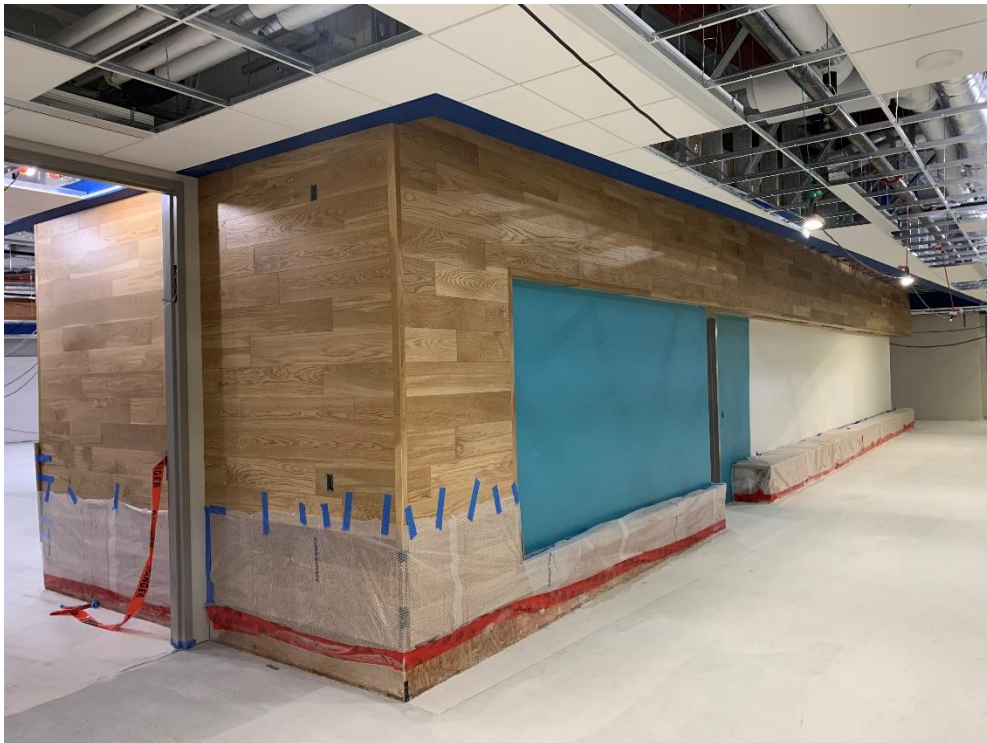
6. Area 6 North – Wood cladding of first floor grade wing entry feature appears to be installed.

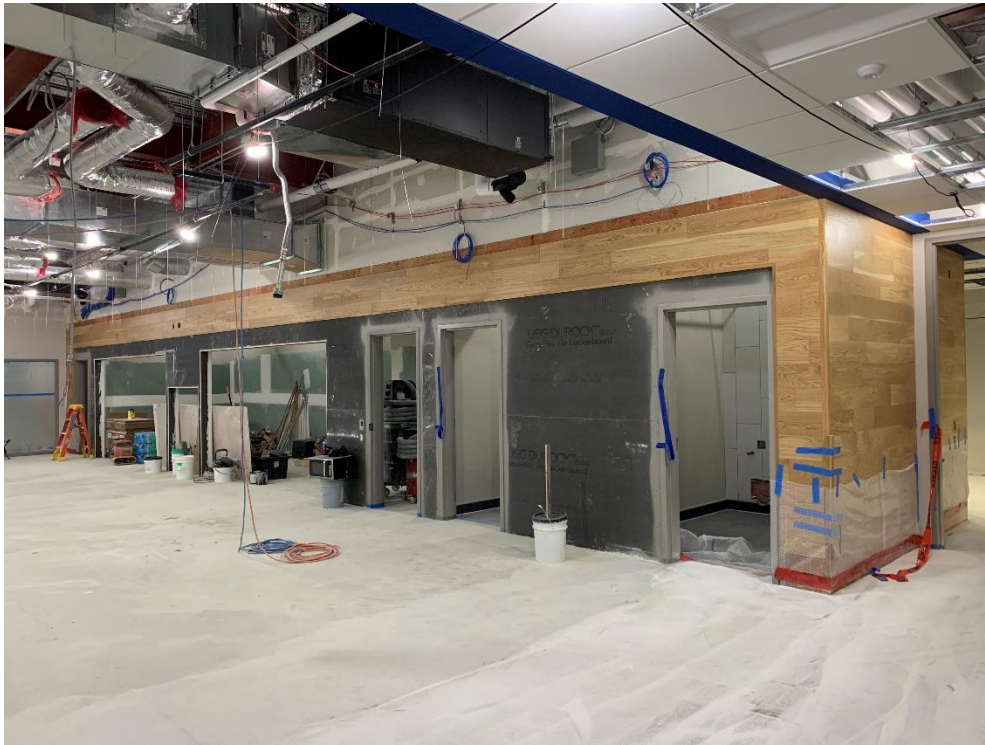
7. Area 5 – Wood cladding of first floor servery wall appears to be installed.

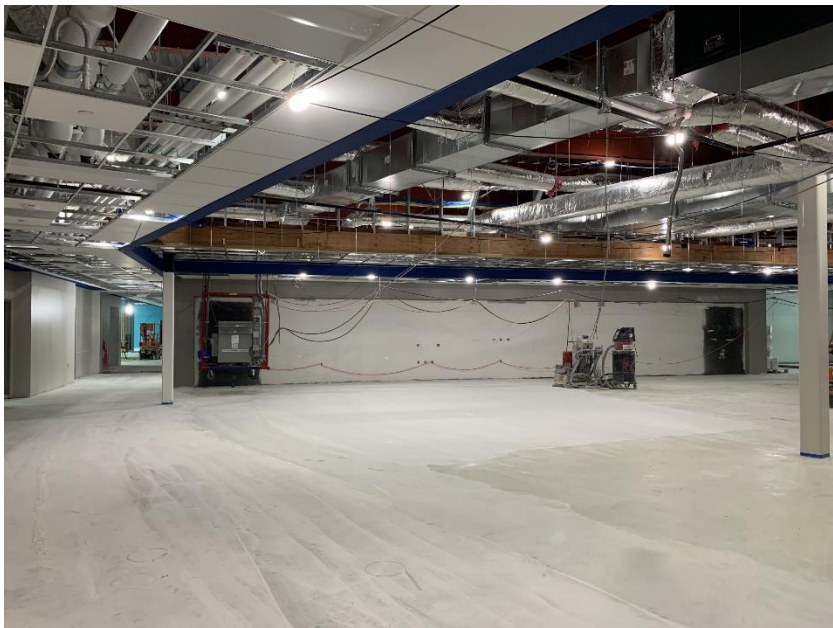
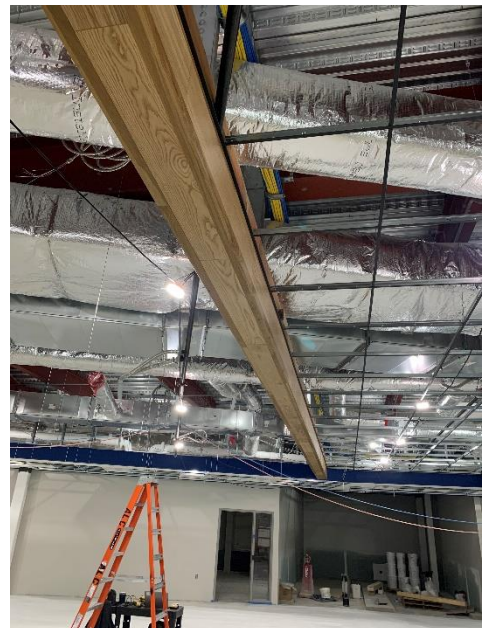
8. Area 5 – Grinding of terrazzo floor in first floor flex café in progress. Wood plank install at accent soffit appears to be installed.

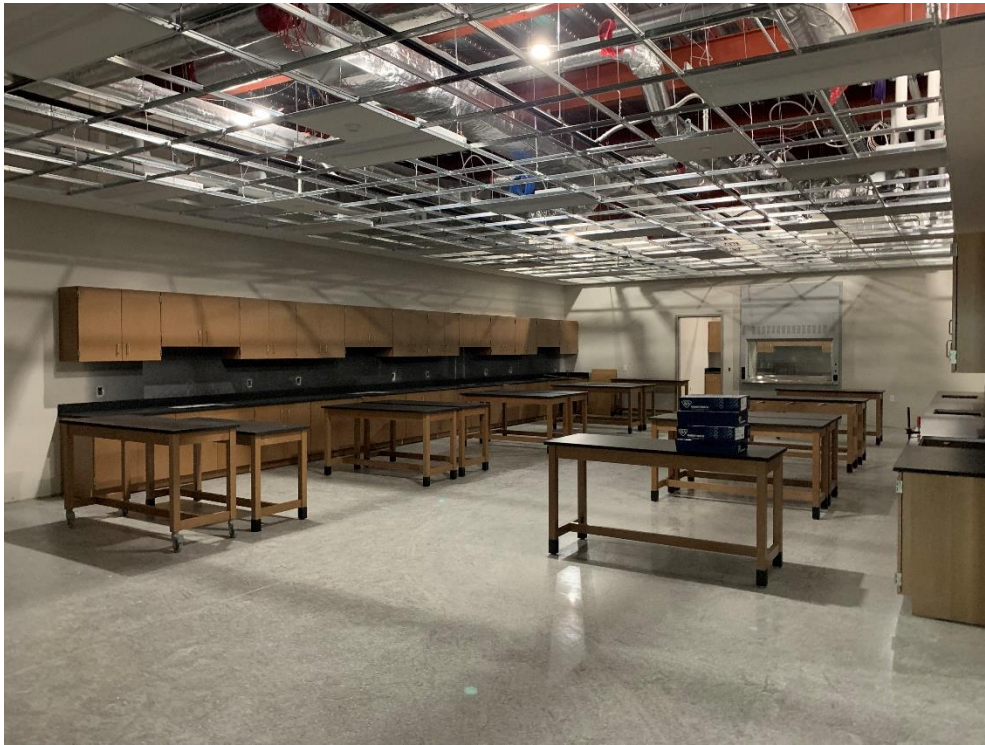
9. Area 5 – Lab countertops and table install in first floor science lab in progress.

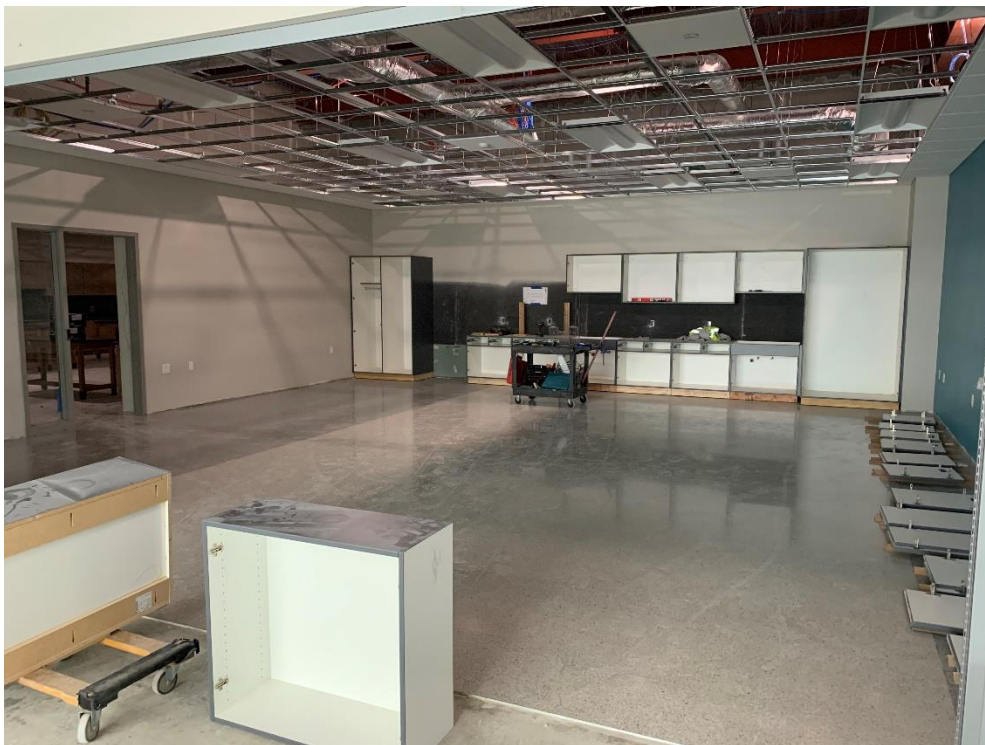
10. Area 5 – Casework install in first floor science classrooms in progress.

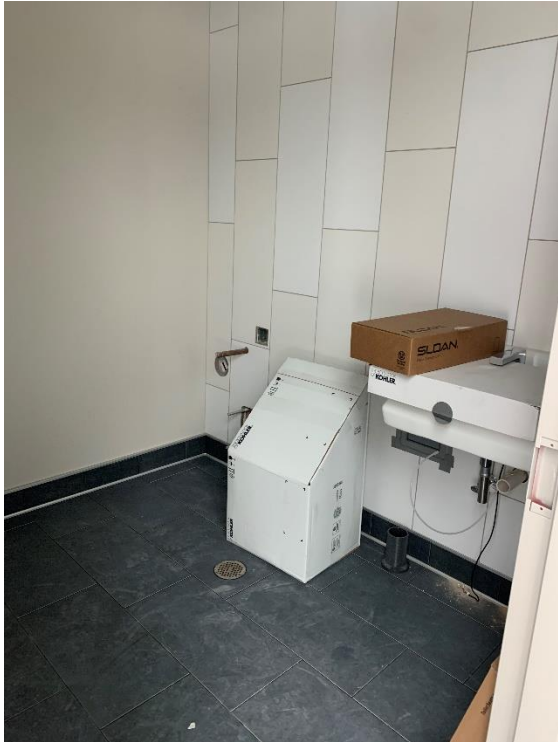
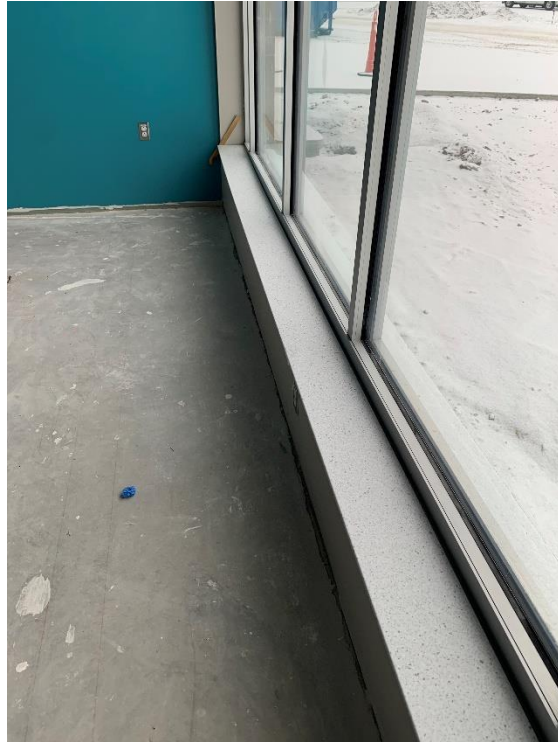
11. Area 5 – Plumbing fixture install continues throughout first floor. Solid surface sills at exterior windows in progress through first floor collab areas.

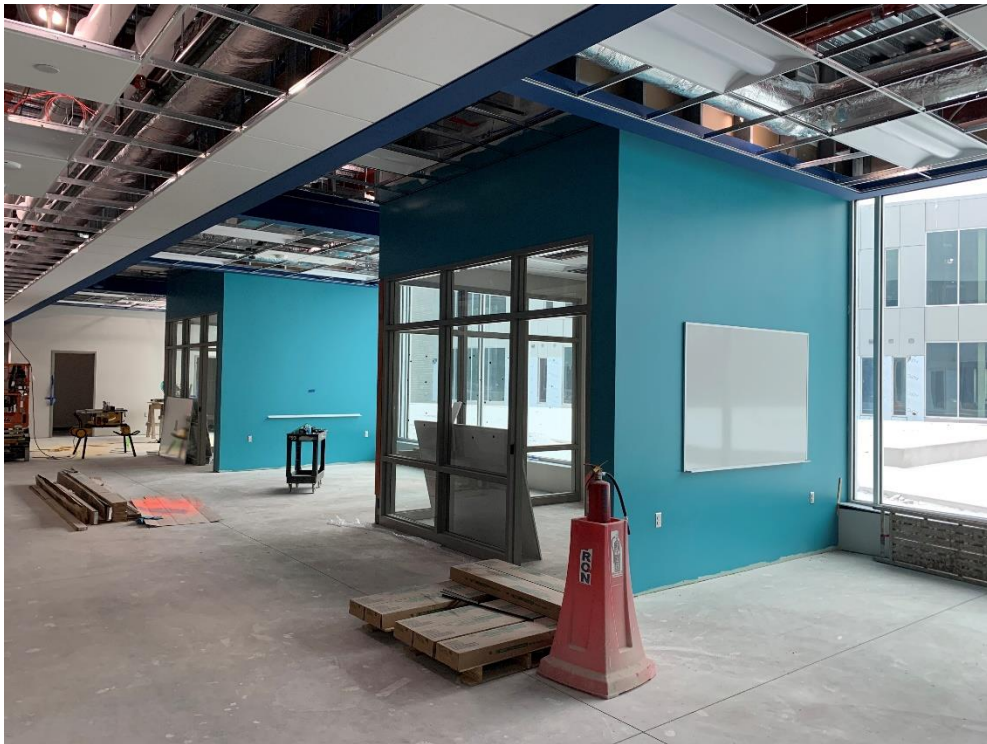
12. Area 5 – Marker boards and wall mounted equipment in first floor collab areas in progress.

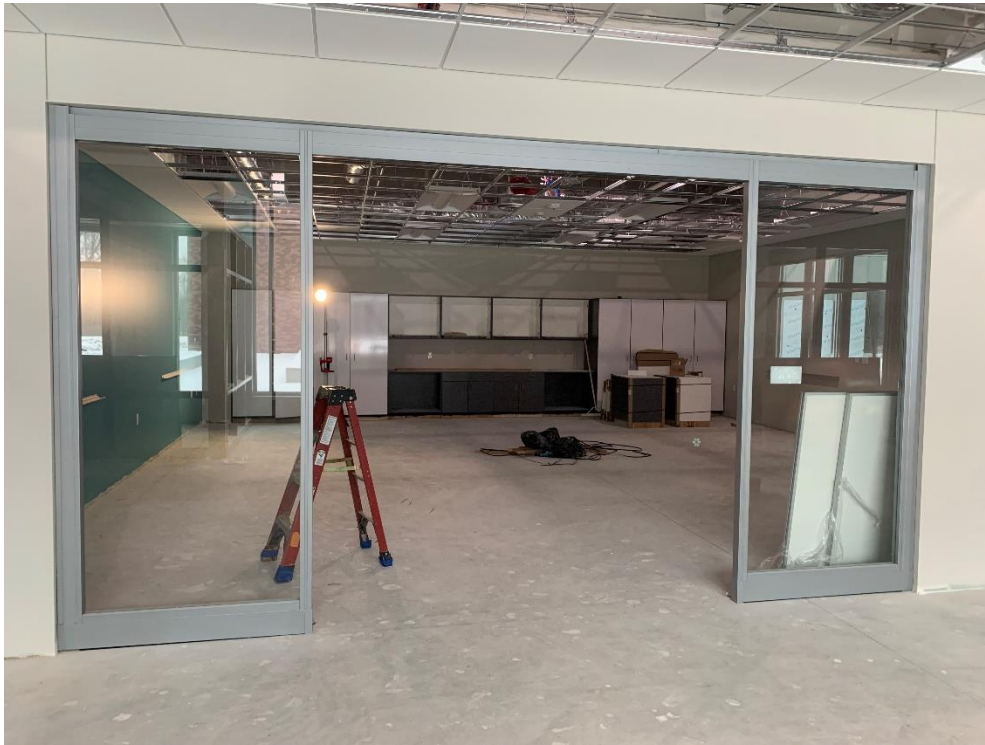
13. Area 5 – Casework, marker boards, and glass sliding door system install continues in first floor classrooms.

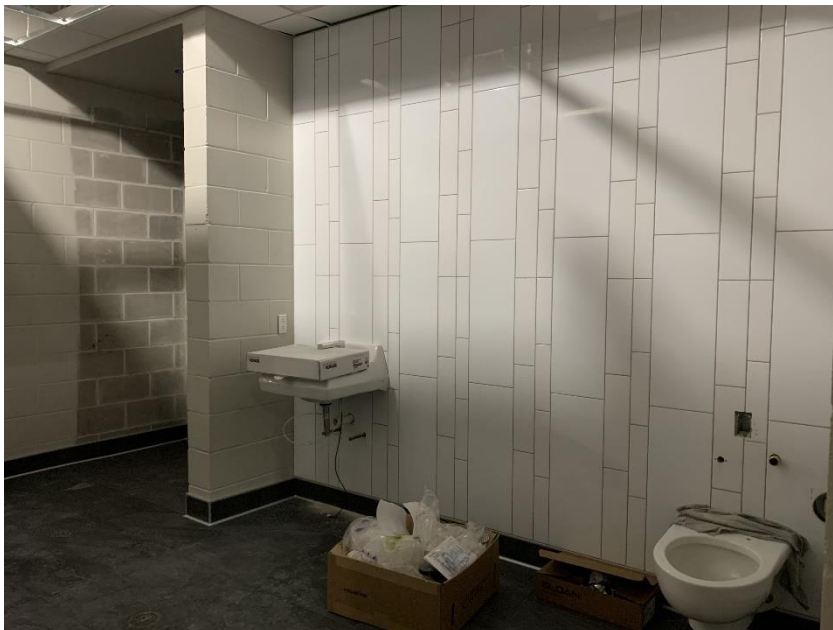
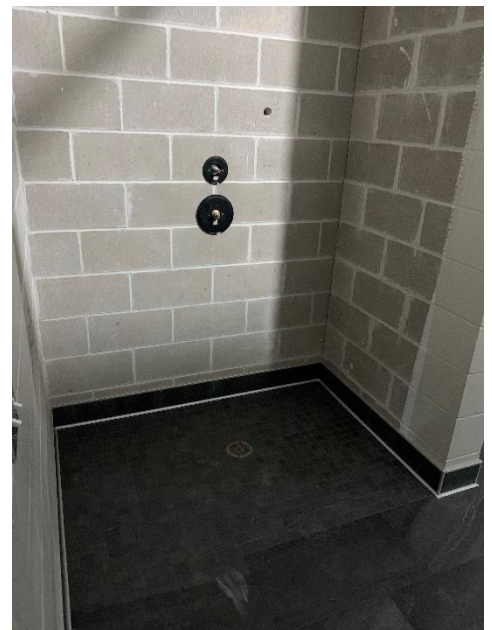
14. Area 6 – Floor and wall tile in IDS suite appear to be installed. Plumbing fixture install in progress.

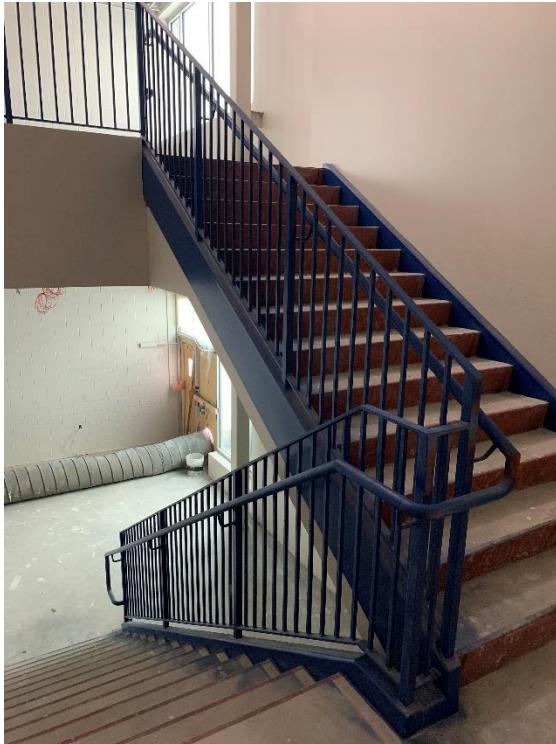
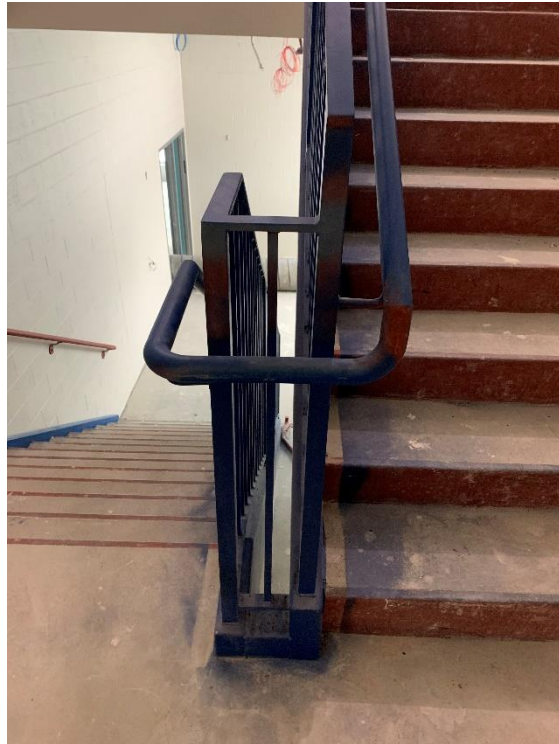
15. Area 6 East – Rail and stringer painting in progress.

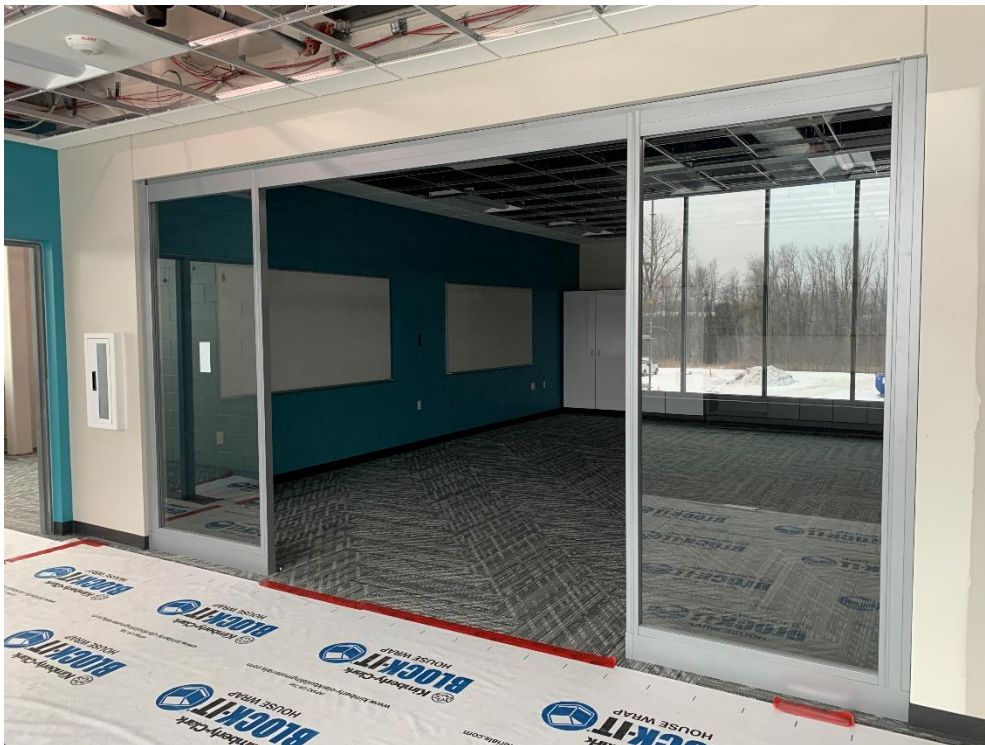
16. Area 6 North - Marker board and wall mounted equipment install in second floor classrooms in progress.

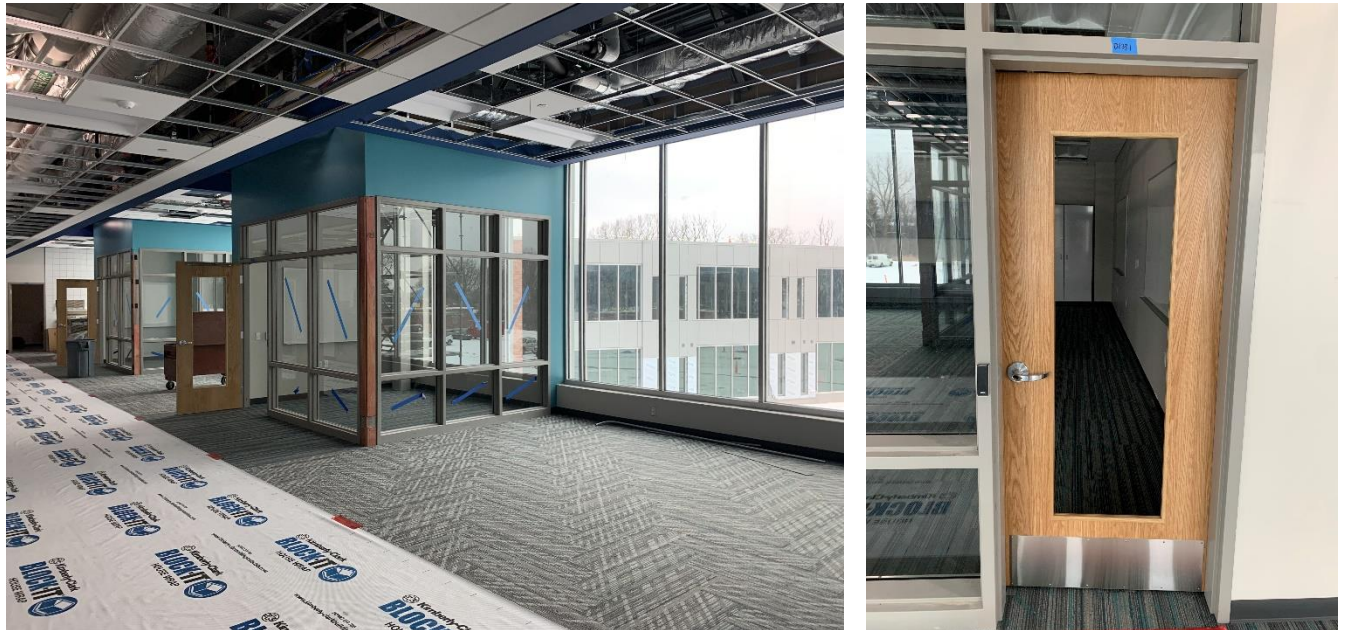
17. Area 6 North – Marker board and wall mounted equipment install in second floor SGI and collab area in progress. Door leaf, flooring protection, and wall base install in progress throughout area.

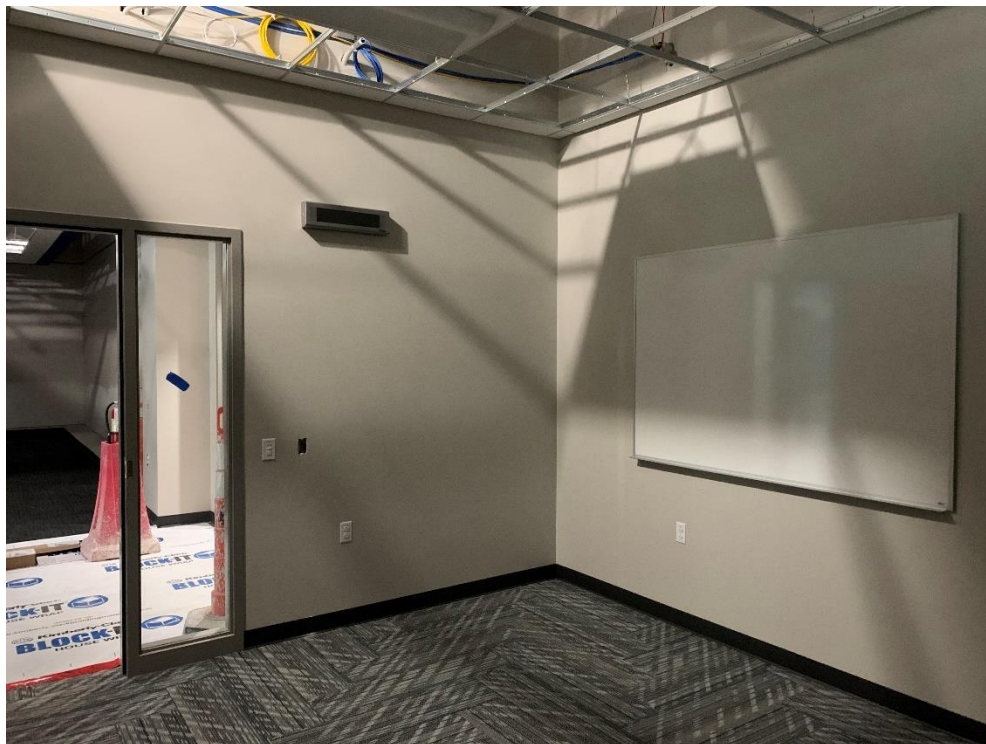
18. Area 6 North – Marker board, wall mounted equipment, carpet flooring, and wall base install in second floor offices in progress.

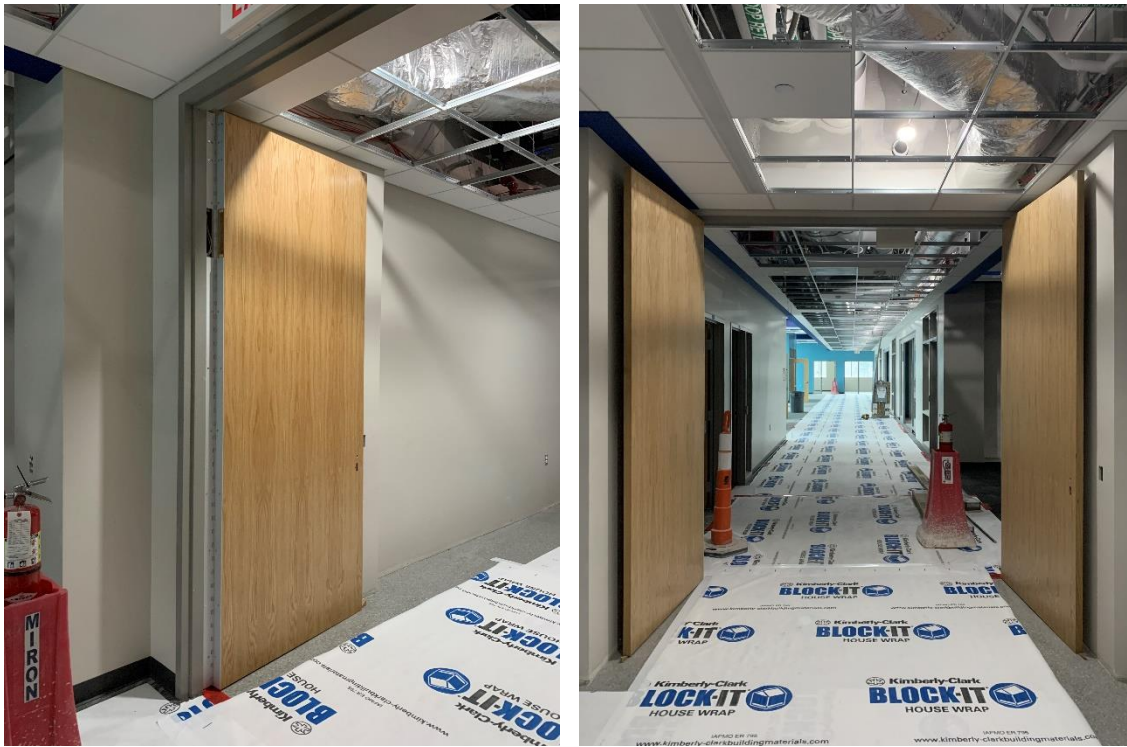
19. Area 6 North – Lock down door leaves in second floor corridor appear to be installed.

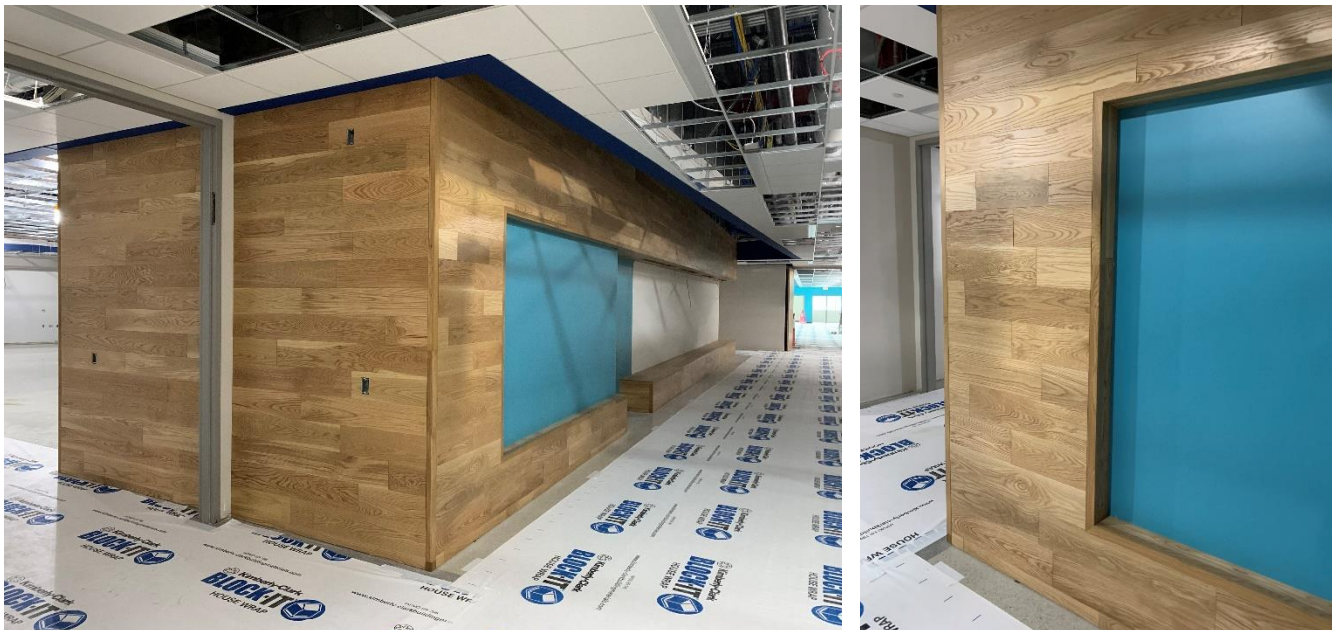
20. Area 6 North – Wood plank appears to be installed on second floor grade wing entry feature.

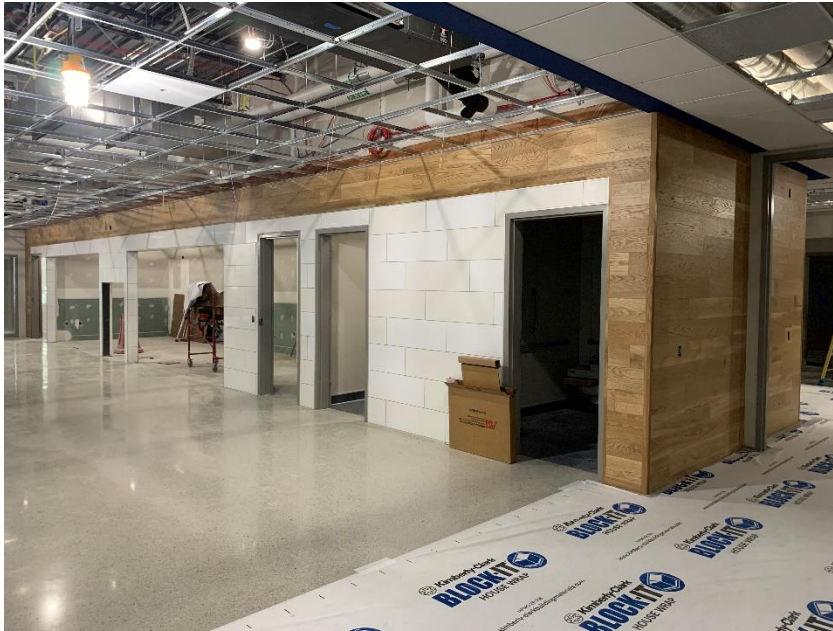
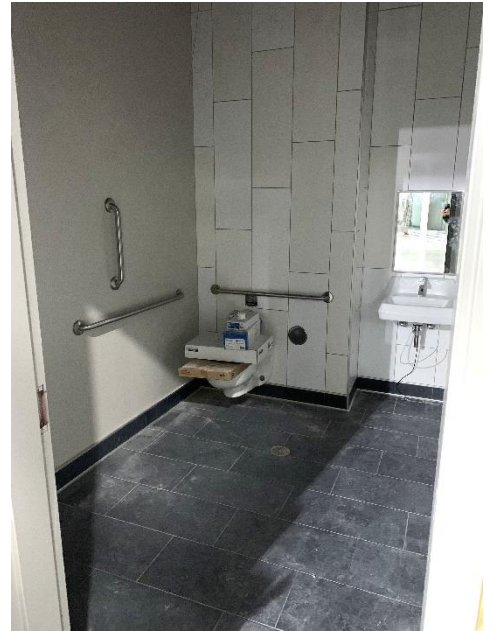
21. Area 5 – Second floor Served wood plank, wall tile, and associated trim appear to be installed. Wall tile, floor tile, plumbing fixtures and grab bars appear to be installed in second floor toilet rooms.

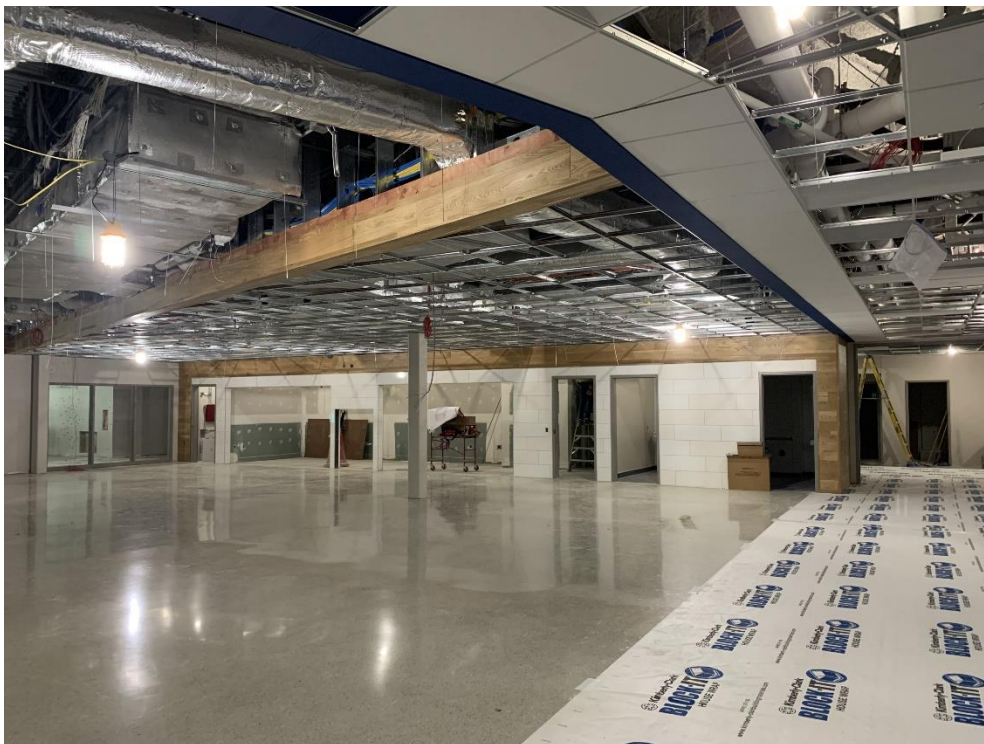
22. Area 5 – Terrazzo and wood plank soffit appear to be installed in second floor flex café. Floor protection install in progress throughout area.

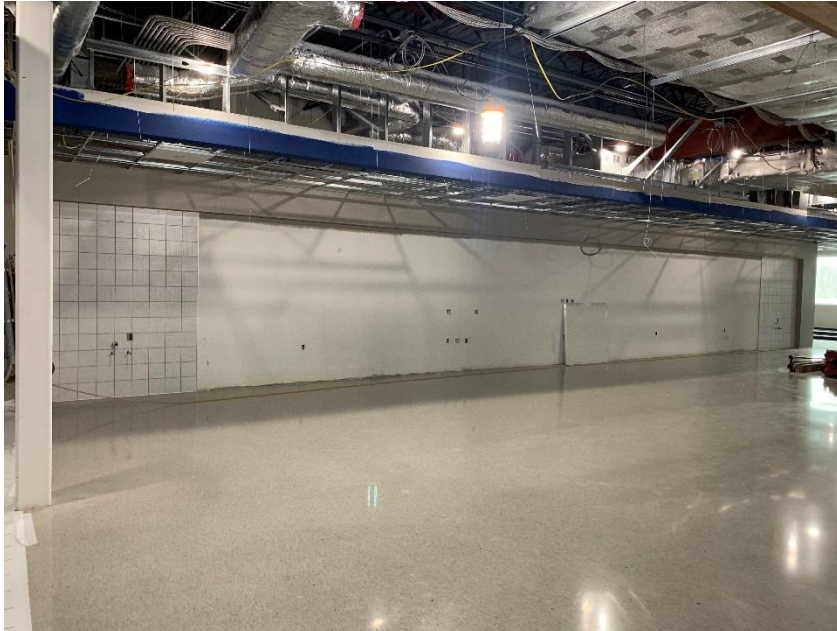
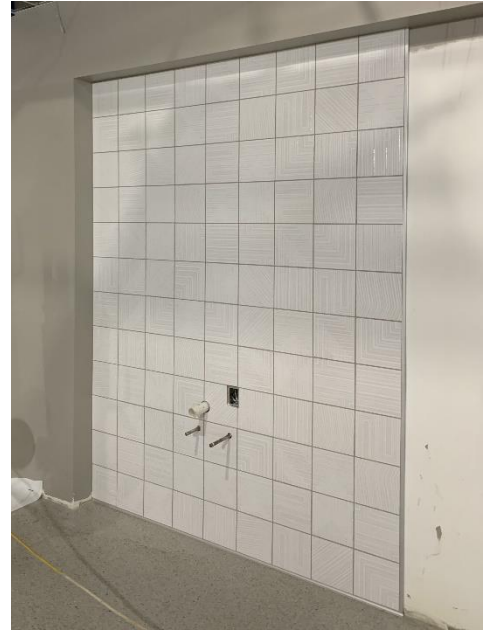
23. Area 5 – Wall tile on teaching wall in second floor flex café appears to be installed.

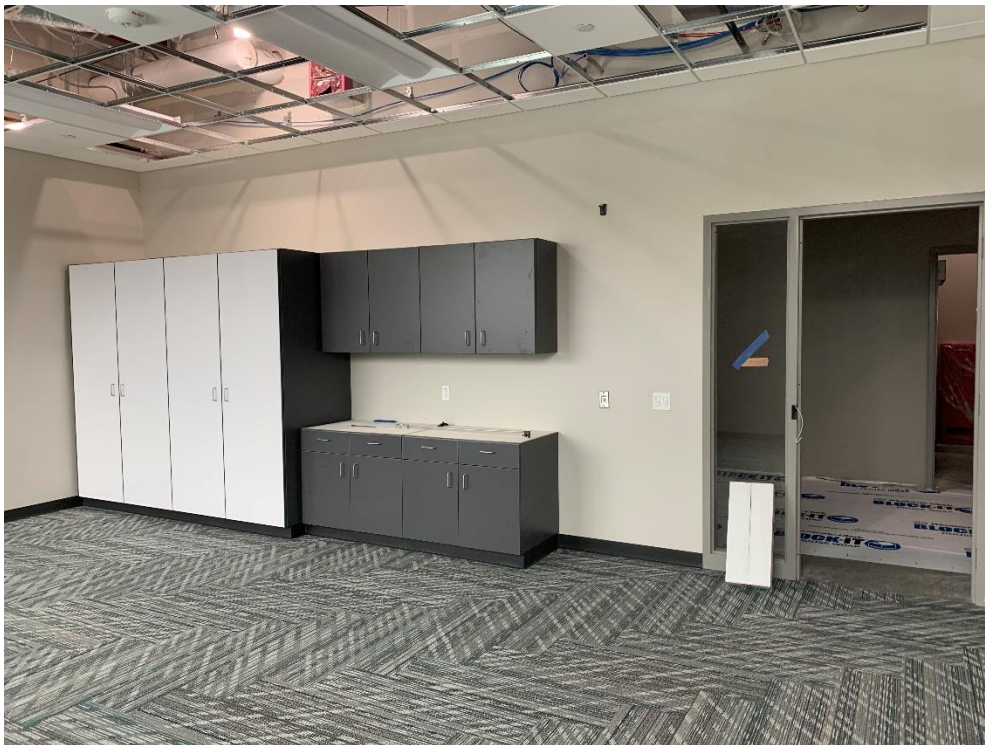
24. Area 5 – Carpet, casework, and wall mounted equipment install in second floor offices in progress.

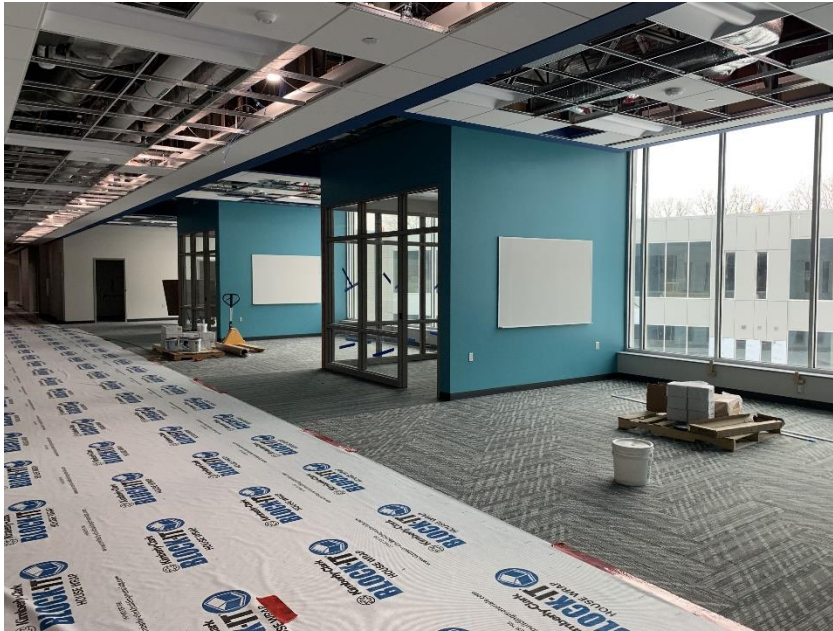
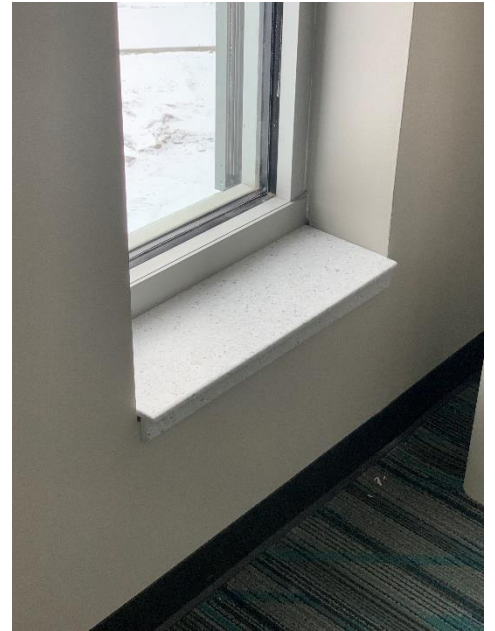
25. Area 5 – Carpet, marker boards, and wall mounted equipment appear to be installed in second floor collab areas. Solid surface sill and wall base install in progress.

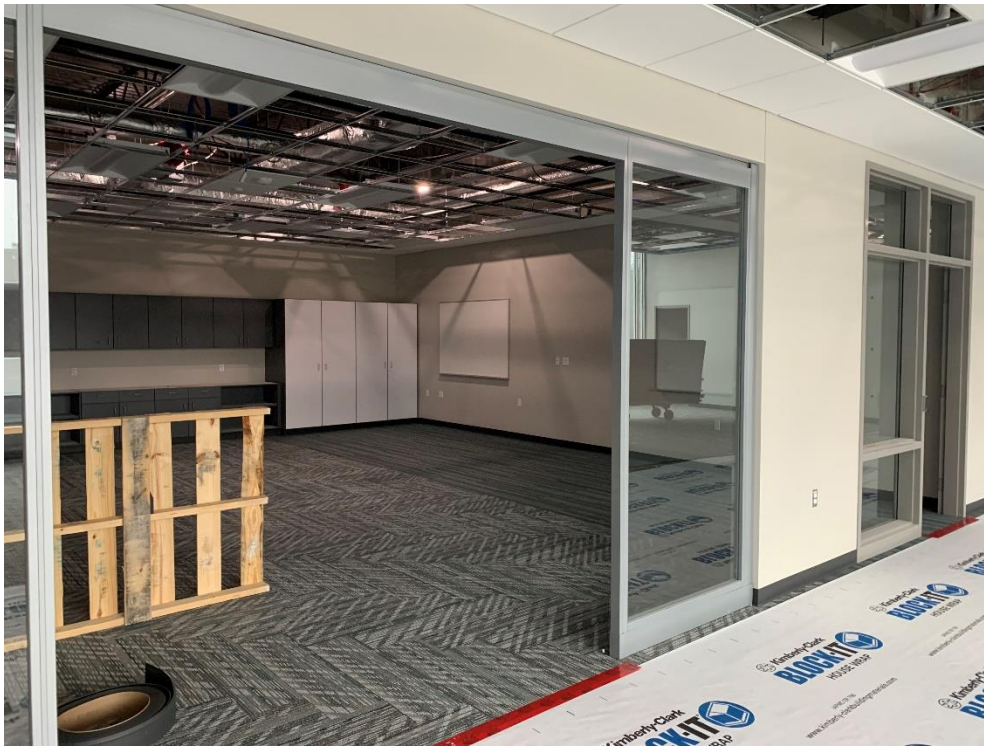
26. Area 5 – Carpet, marker boards, and wall mounted equipment appear to be installed in second floor classrooms. Sliding and swing door leaf install in progress.

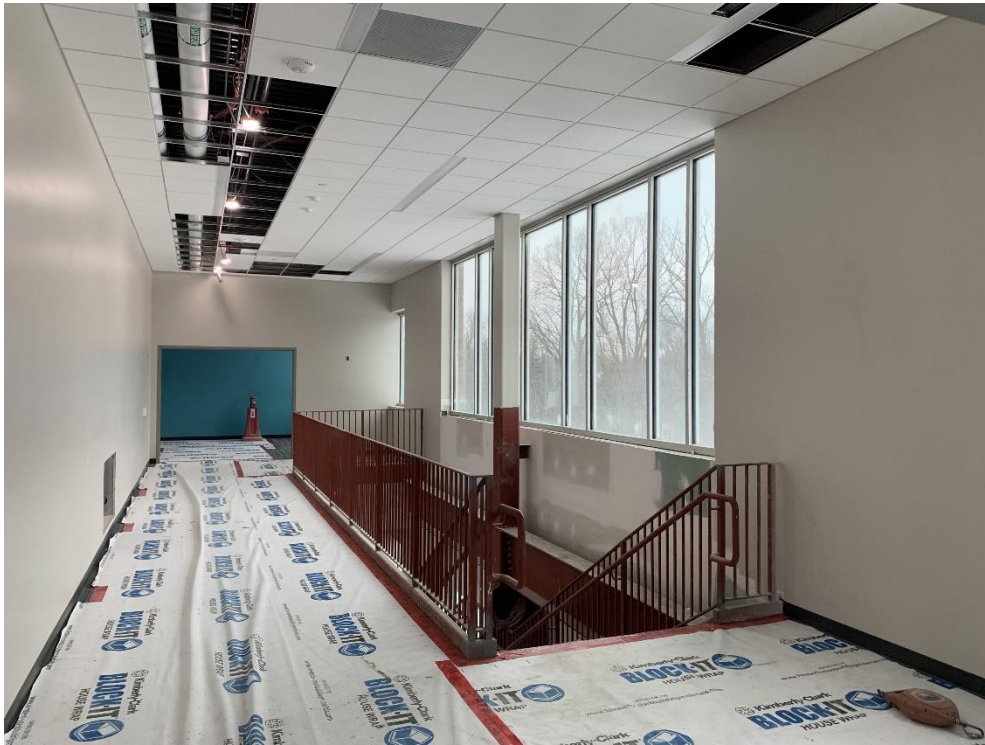
27. Area 5 – Painting and ACT ceiling tile install in north stair in progress.

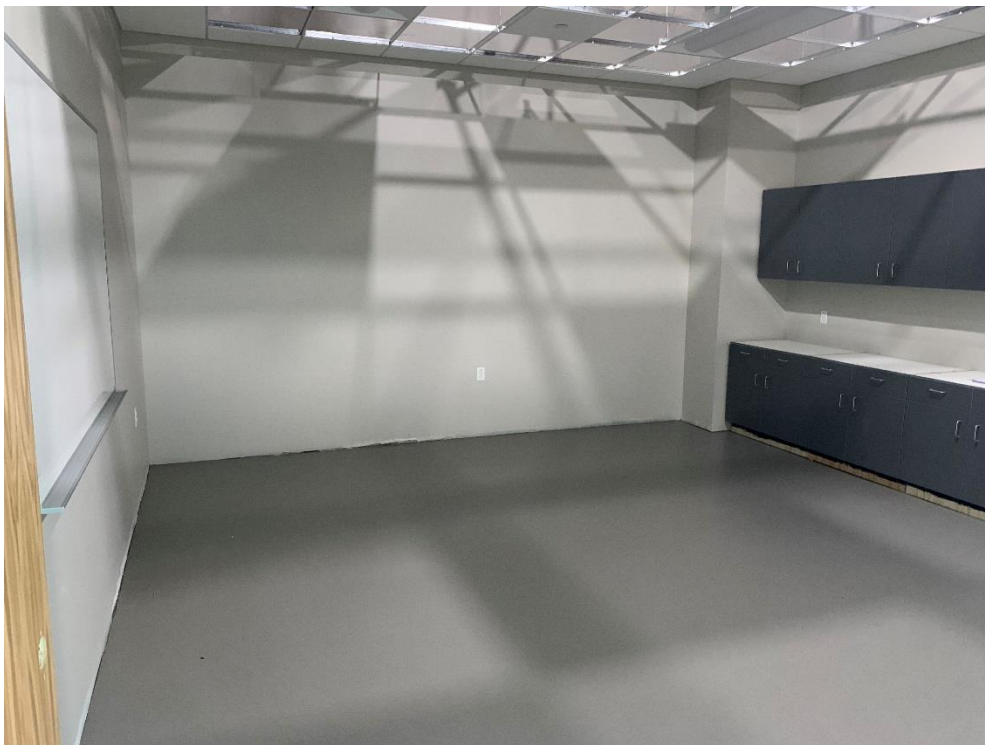
28. Area 5 – Casework, marker board, and resilient flooring appear to be installed in second floor staff work room.

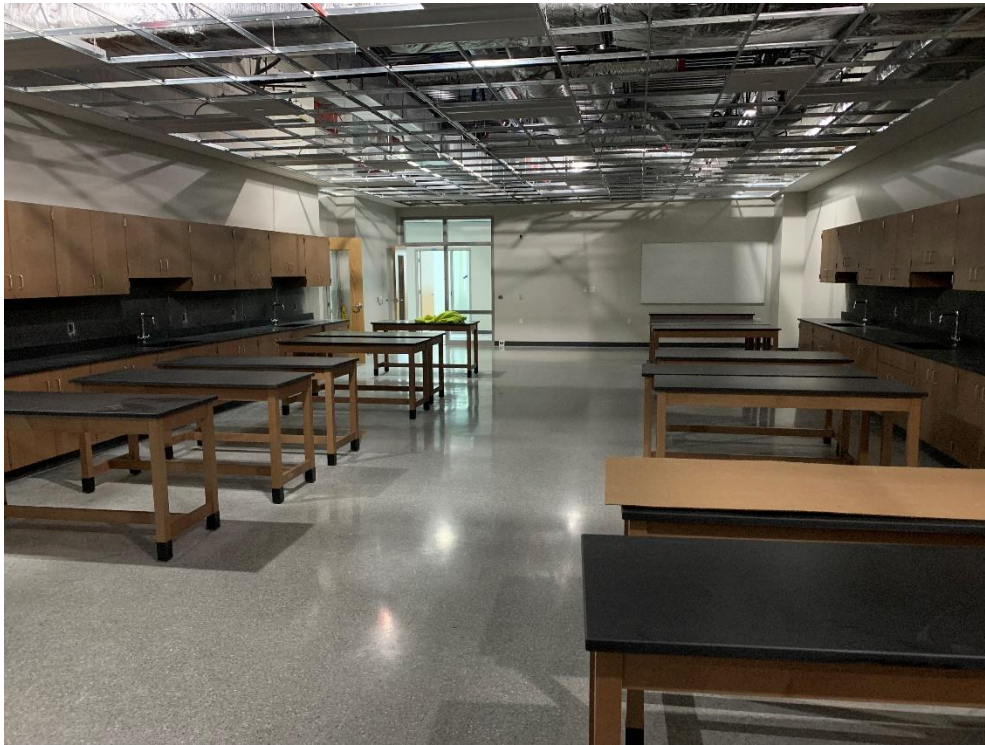
29. Area 5 – Plumbing fixtures, counter tops, and lab table install in second floor science lab appear to be installed.
