Construction Observation Report 021 – January 10th, 2025

Maplewood School

PROJECT NUMBER: 321169-01

| SITE OBSERVATION TYPE | ARCHITECTURAL |

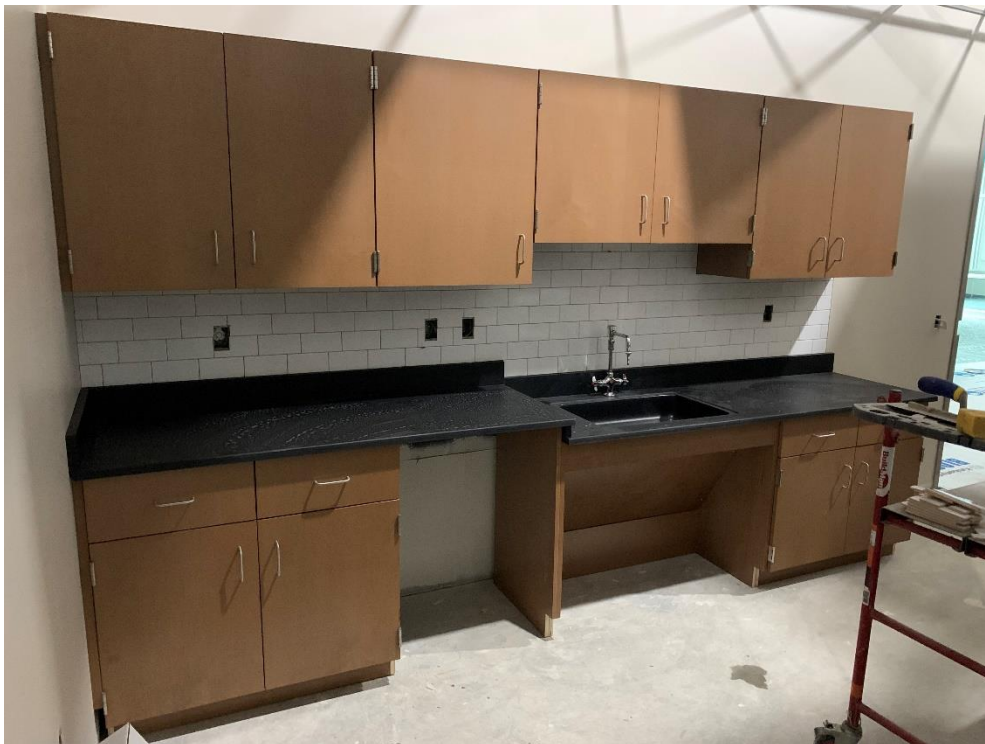
30. Area 5 – Plumbing fixture, counter top, and lab table install in second floor science lab prep room appear to be installed.

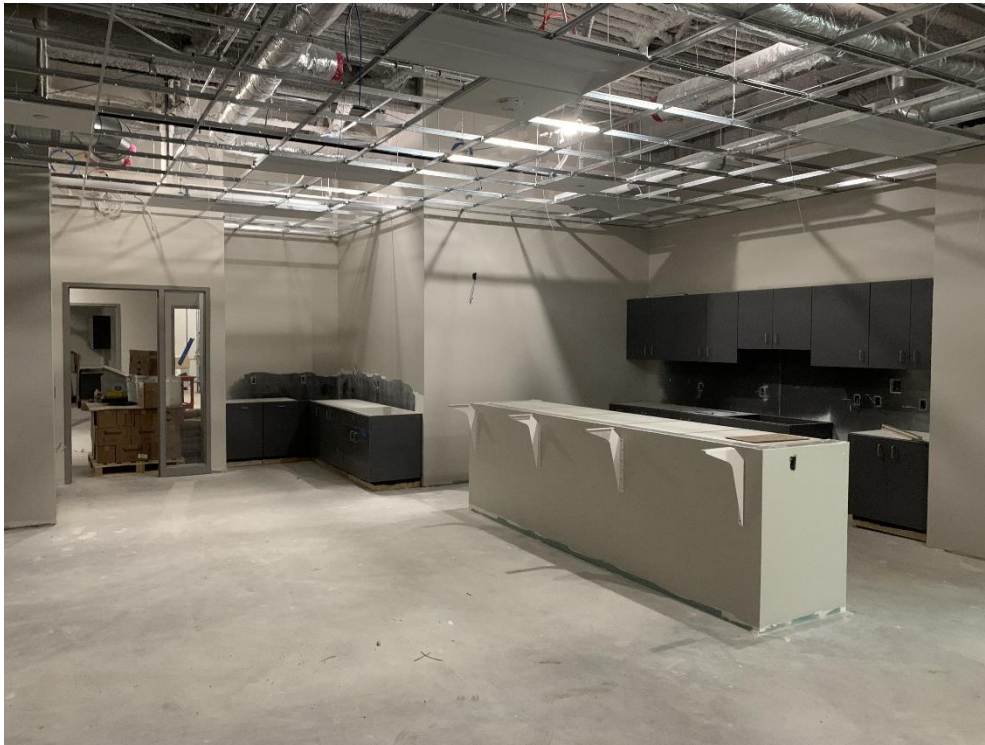
31. Area 5 – Casework install in second floor staff lounge in progress.

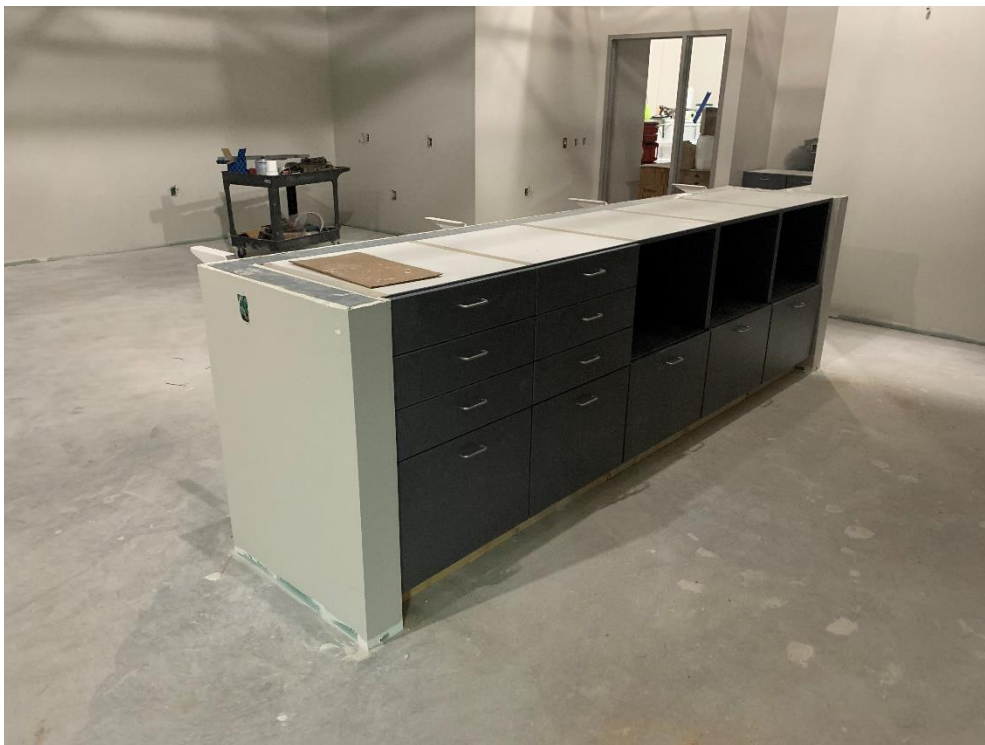
32. Area 5 – Casework install in second floor staff lounge in progress.

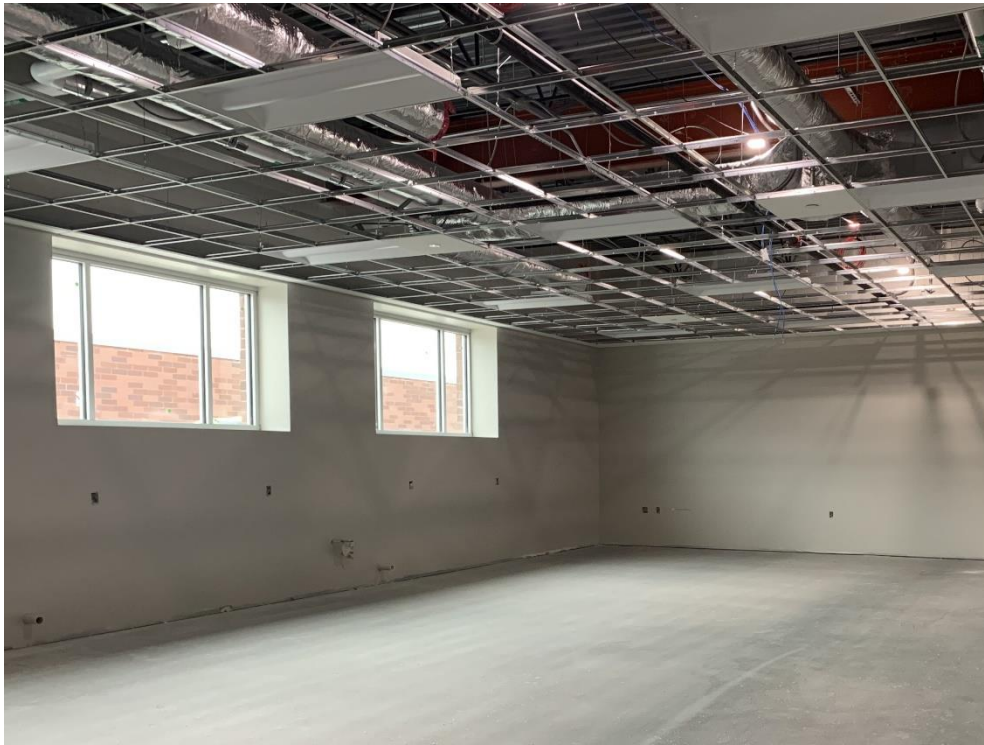
33. Area 3 – Ceiling grid appears to be installed in second floor art rooms.

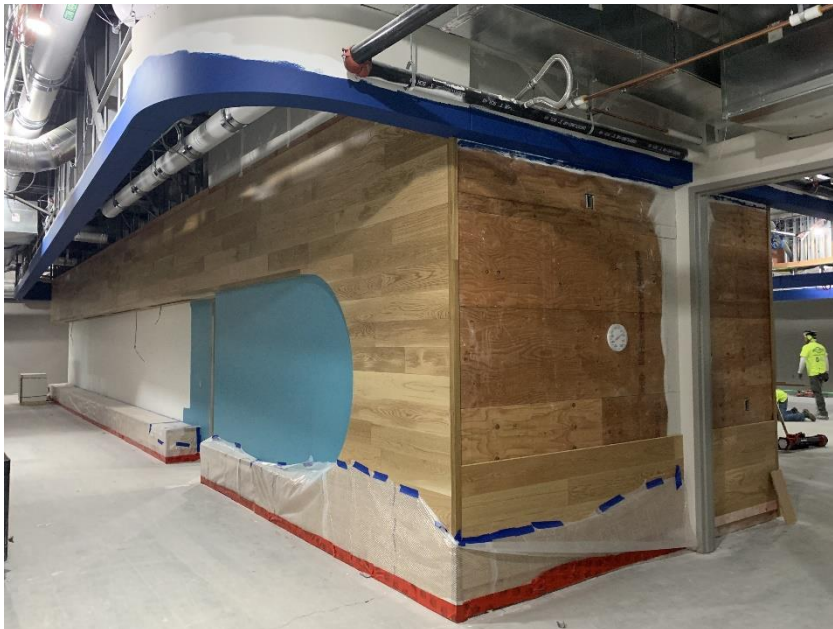
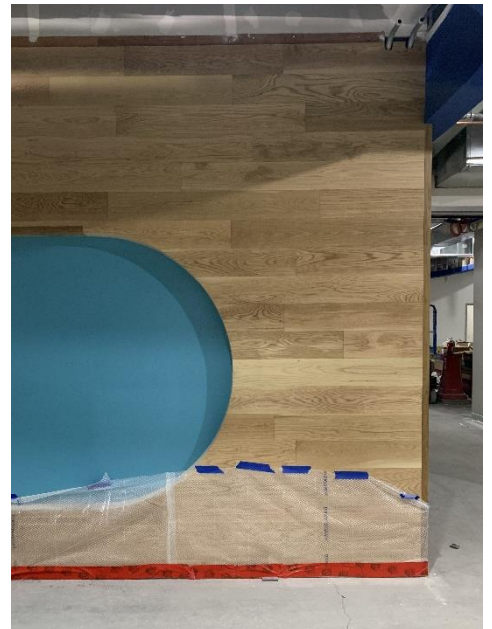
34. Area 3 – Wood plank install on second floor grade wing entry feature in progress.

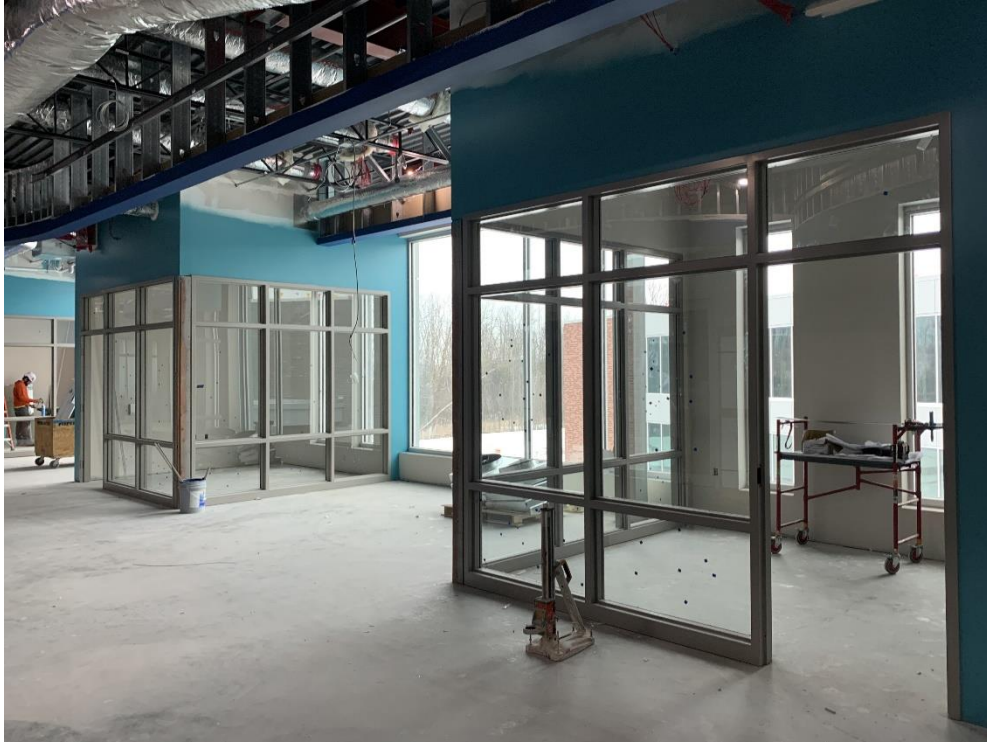
35. Area 4 – Interior storefront glazing install in second floor collab area in progress.

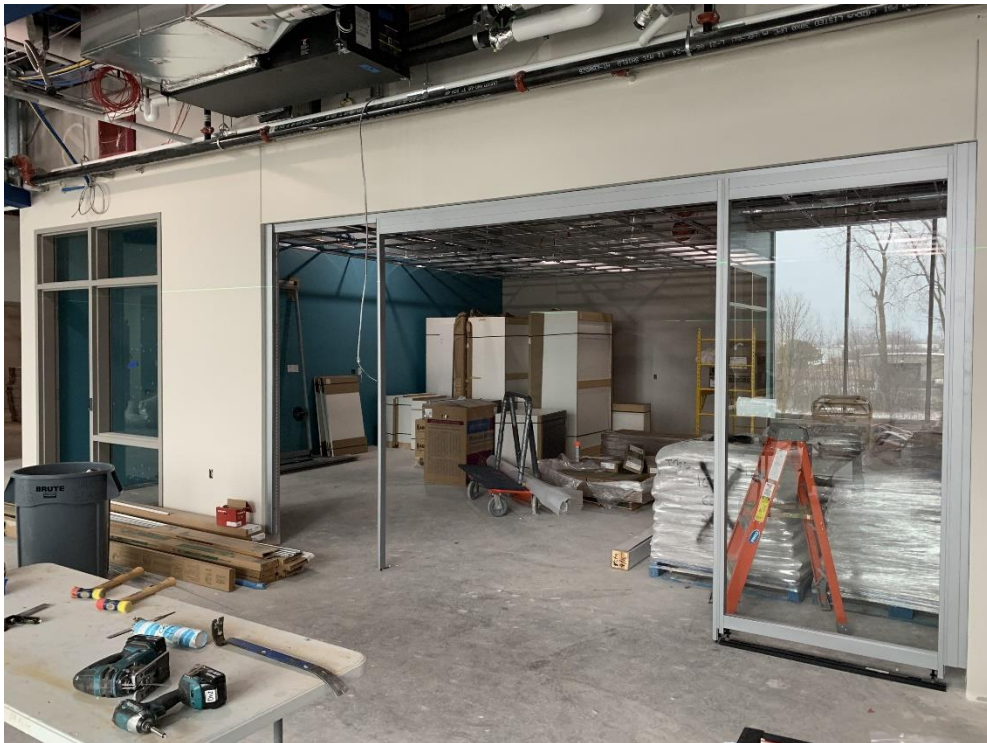
36. Area 4 – Casework and sliding door system install in second floor classrooms in progress.

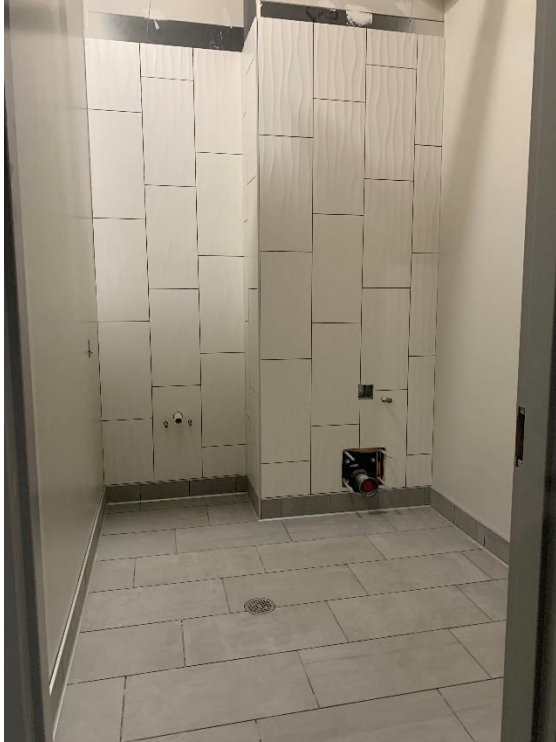
37. Area 3 – Wall and floor tile appears to be in installed in second floor grade area in progress.

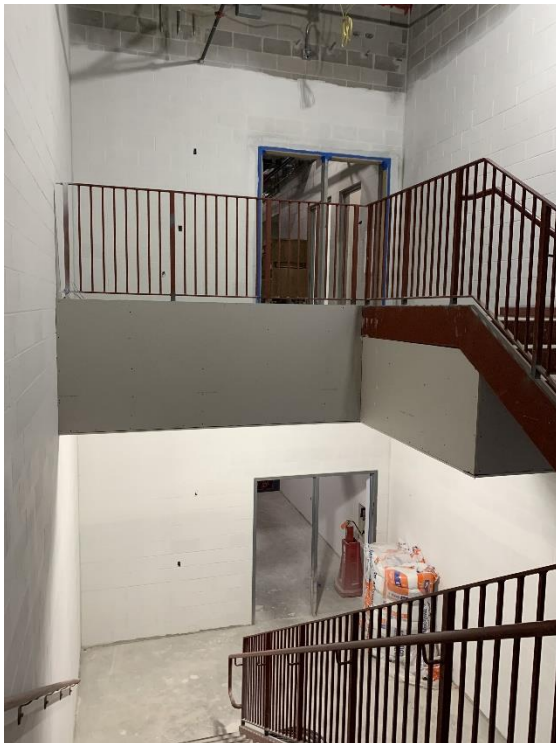
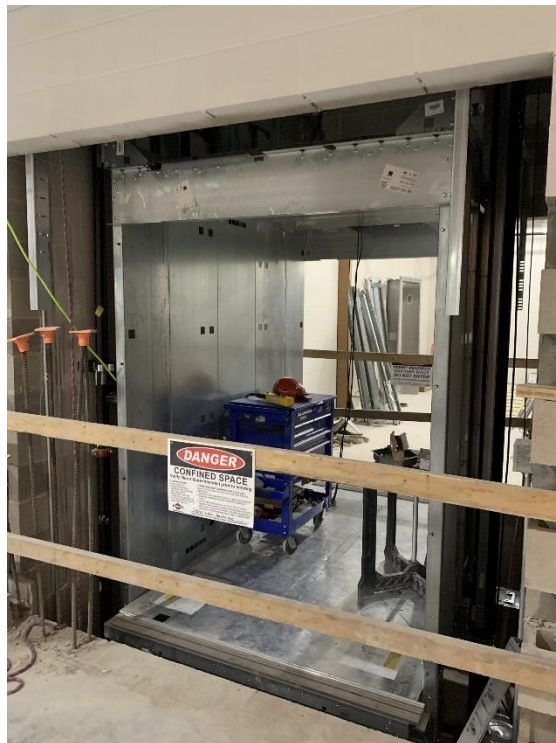
38. Area 3 – Gyp board in stairs and elevator install in progress.

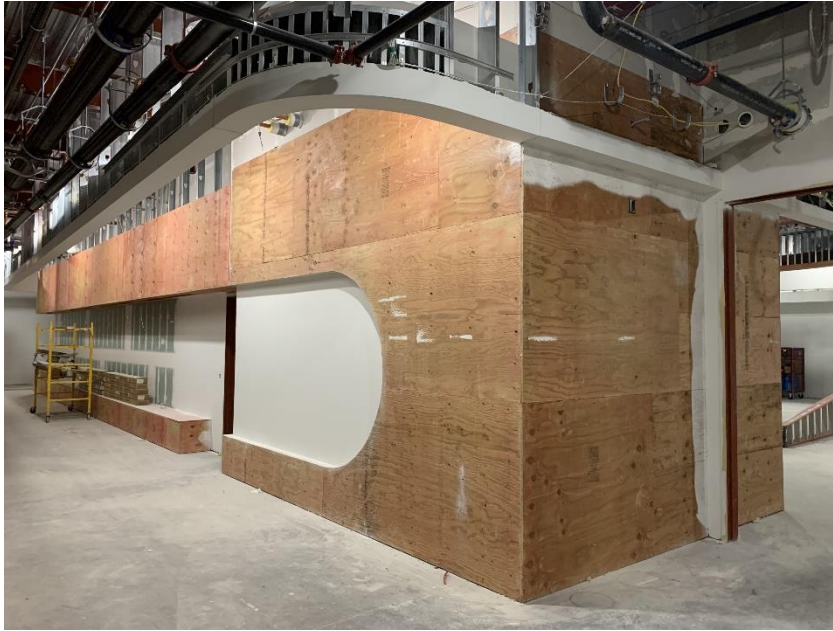
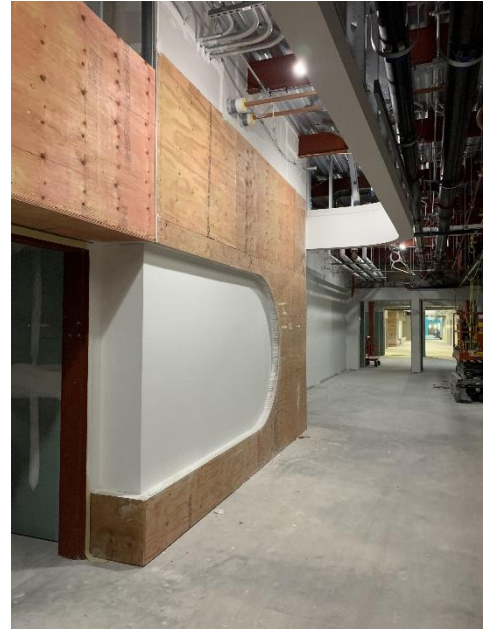
39. Area 3 – Plywood backing and painting of first floor grade wing entry feature in progress.

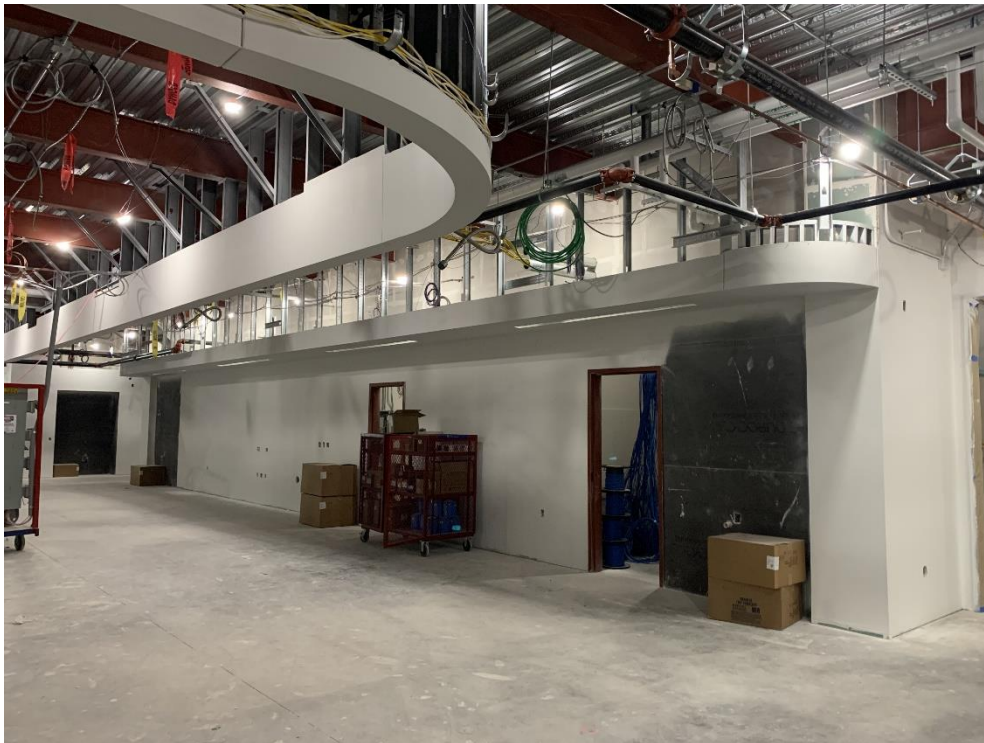
40. Area 3 – Painting in first floor flex café in progress.

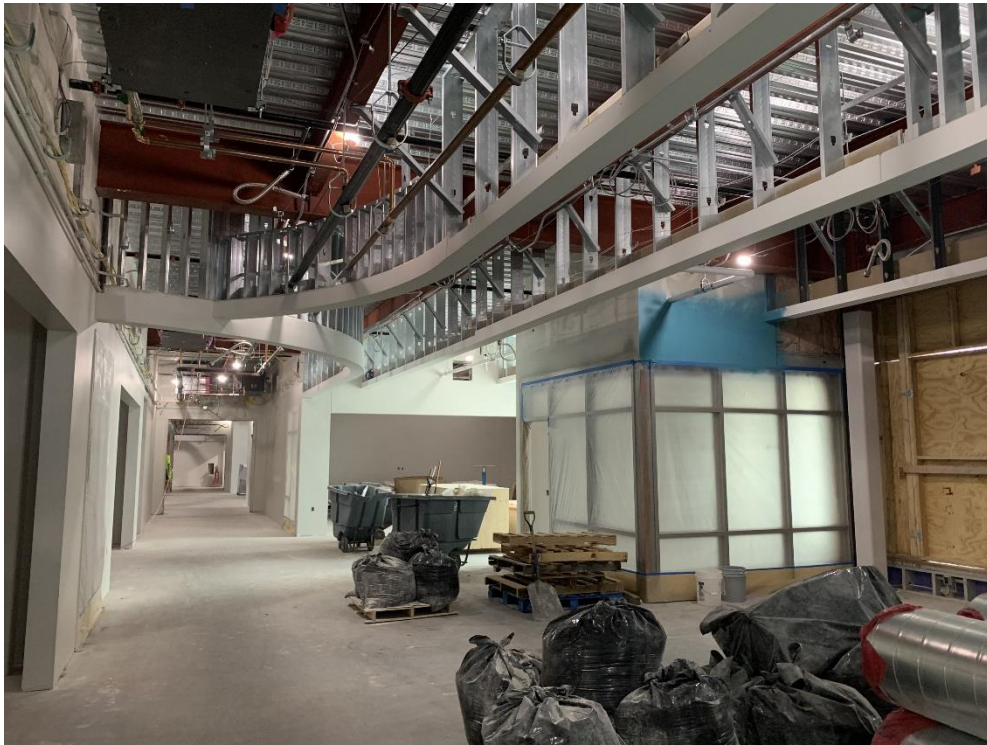
41. Area 4 – Painting in first floor classrooms and collab areas in progress.

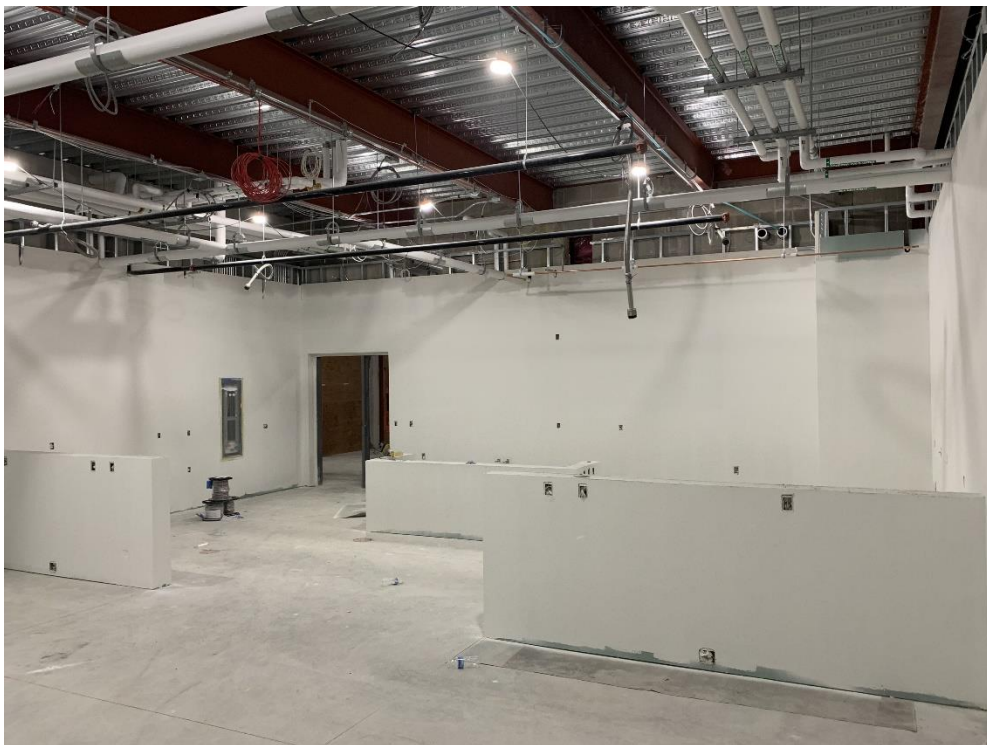
42. Area 3 – Painting in culinary lab in progress.

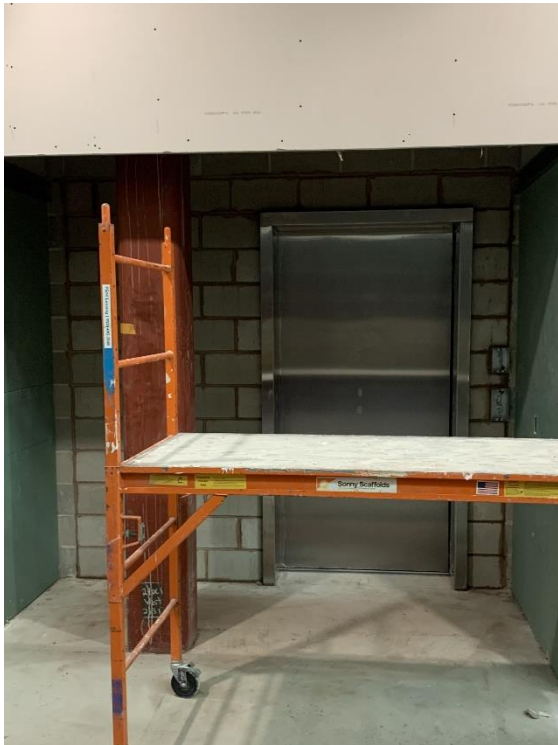
43. Area 1A&B – Elevator door install in progress on first and second floor stops.

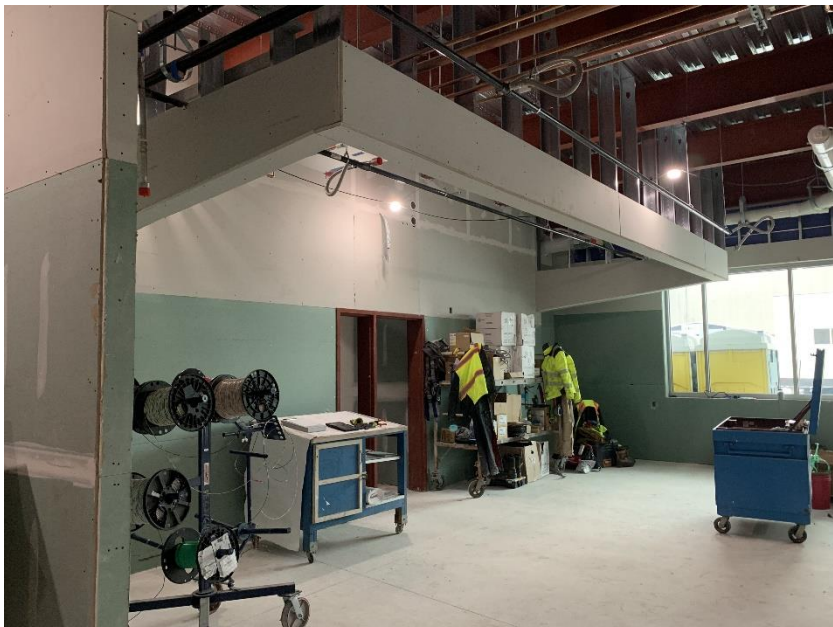
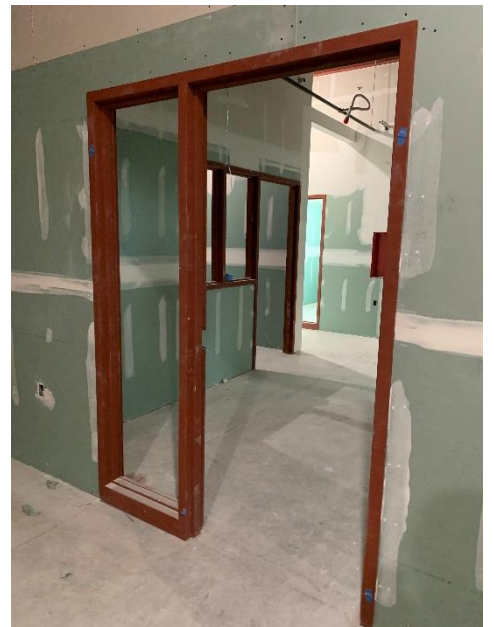
44. Area 1A – Gyp board taping and mudding in 7/8 office in progress.

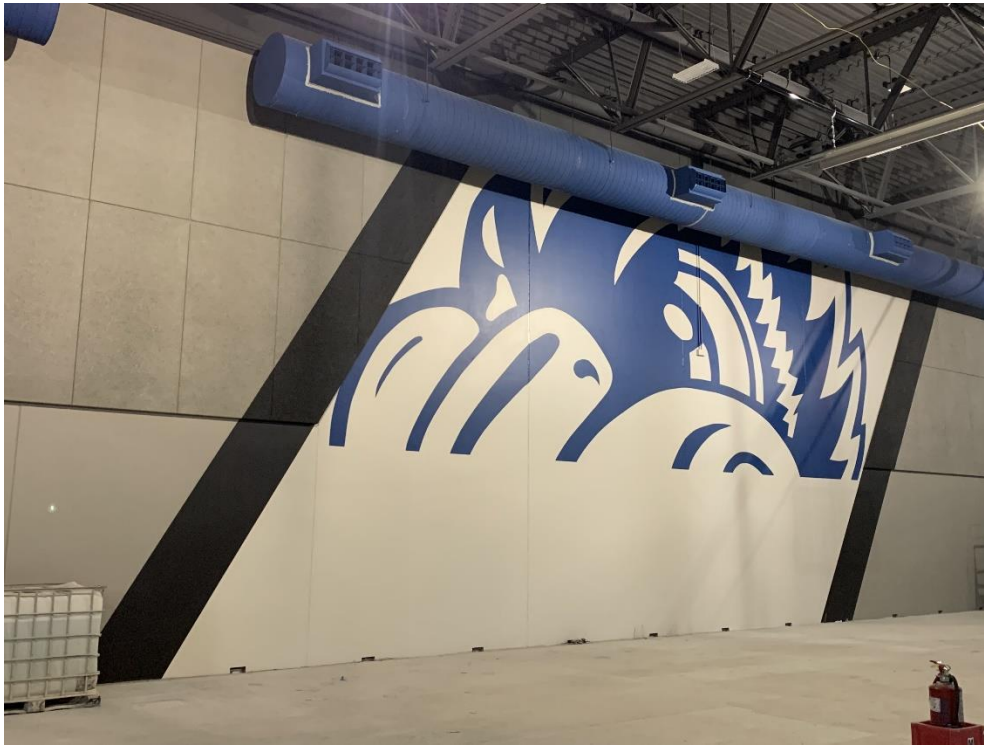
45. Area 6 – Painted wall graphics in gym in progress.

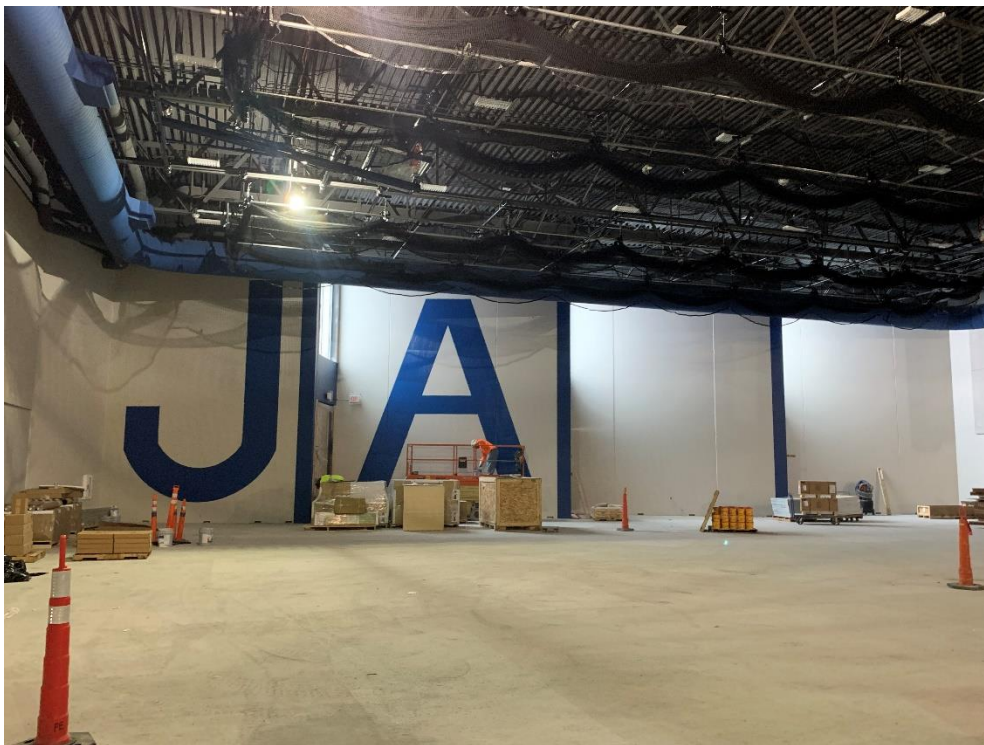
46. Area 6 – Painted wall letters in gym in progress.

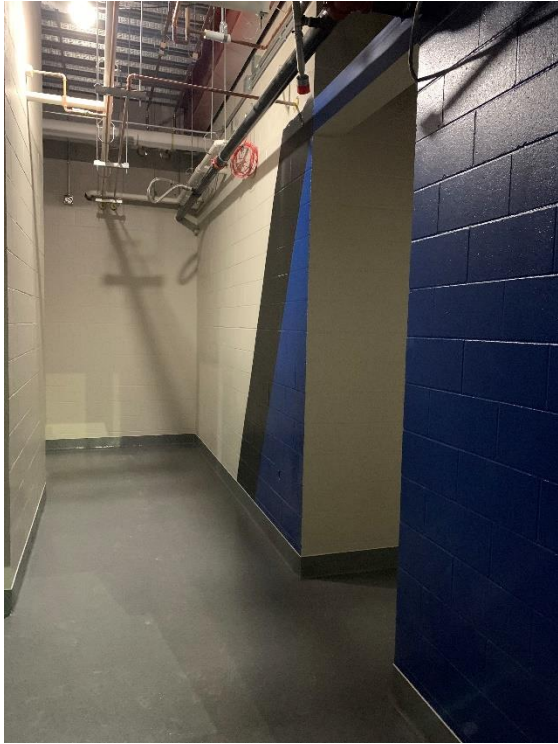
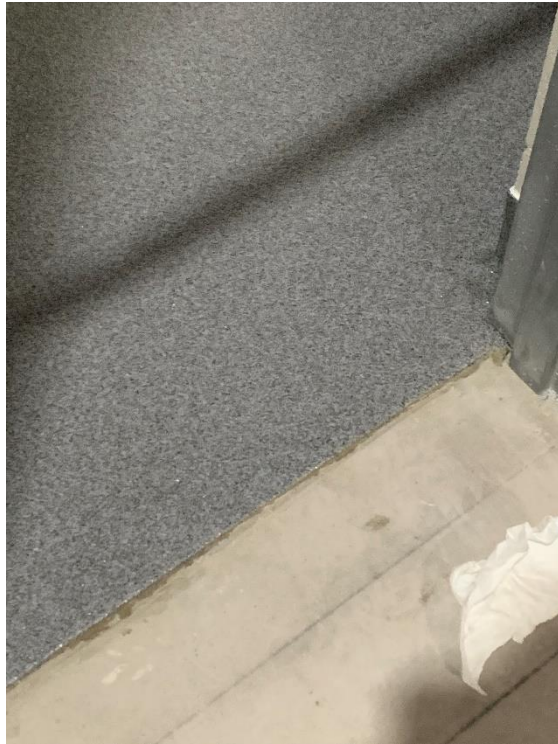
47. Area 6 – Epoxy flooring in locker rooms in progress.

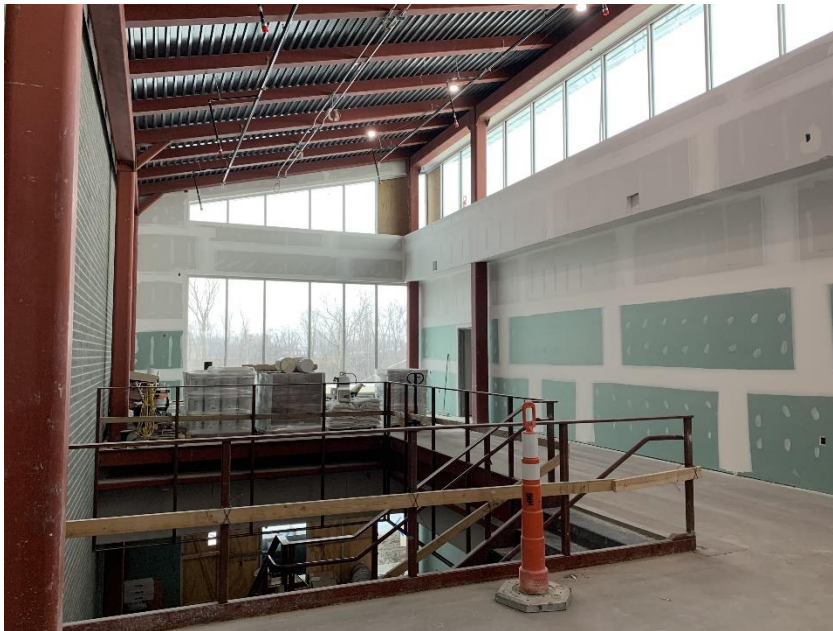
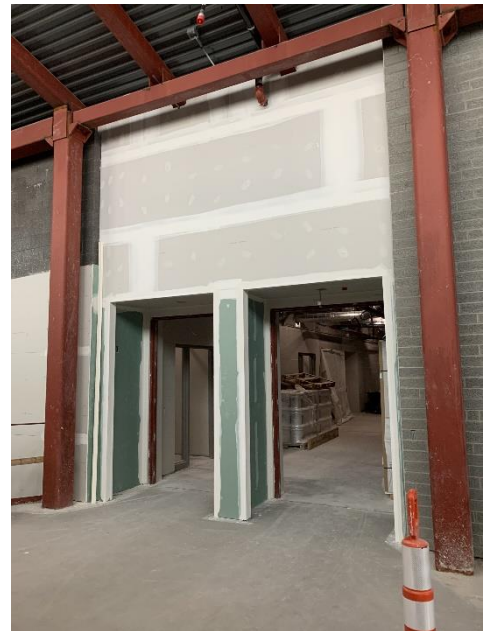
48. Area 1B – Gyp board taping and mudding in second floor center spine in progress.

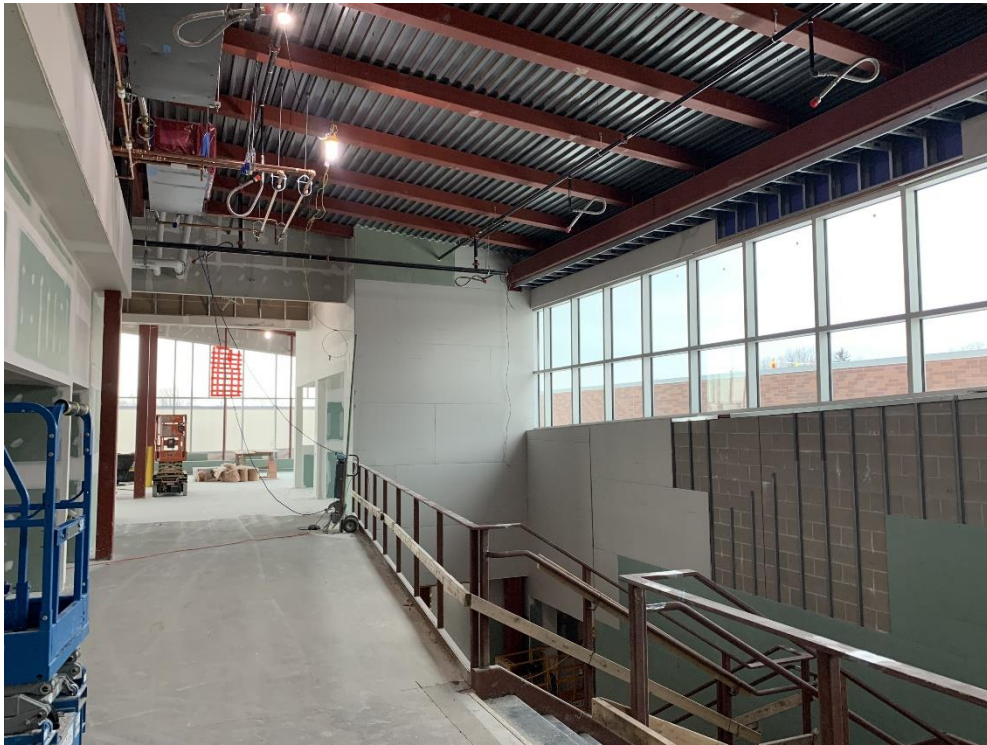
49. Area 1A – Metal furring strip, gyp board install, taping and mudding in second floor center spine in progress.

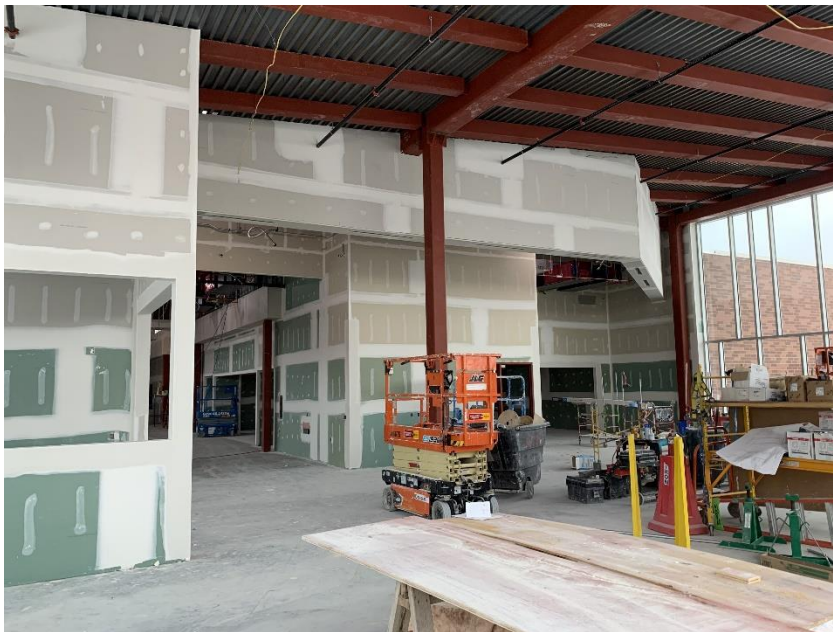
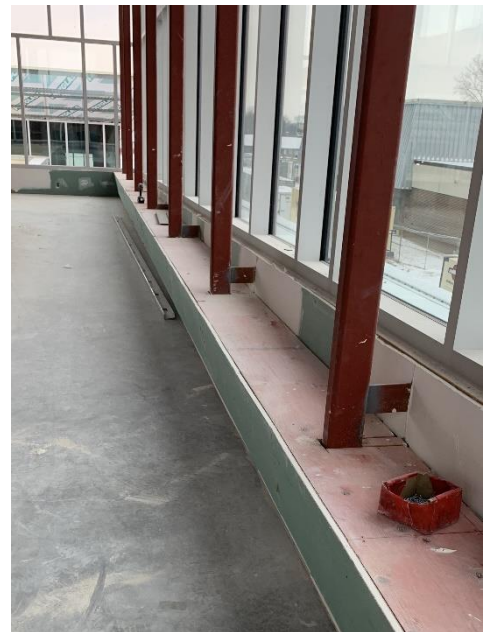
50. Area 1A – Taping and mudding in LMC in progress. Perimeter seat wall in progress.

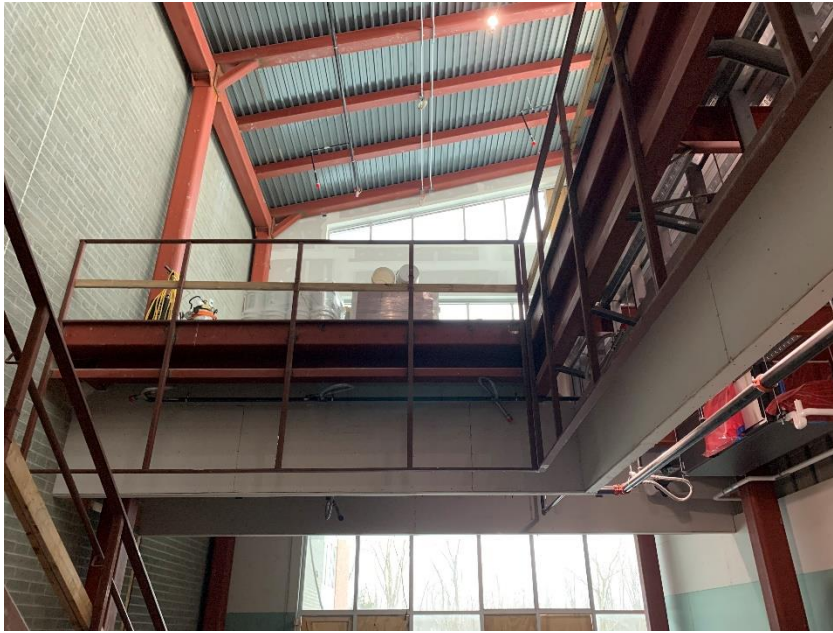
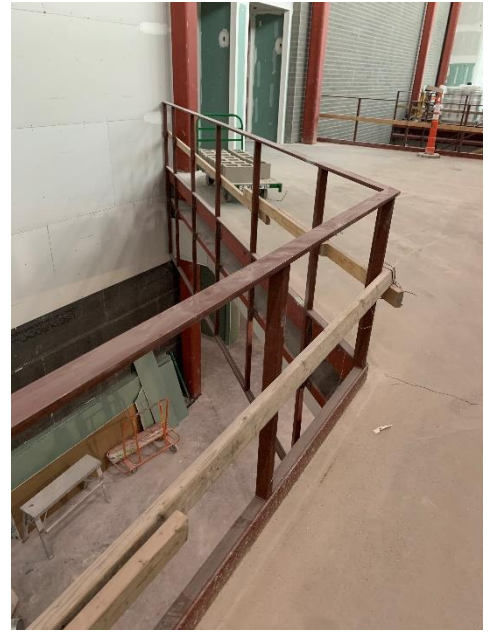
51. Area 1A&B – Steel railing system in center spine appears to be installed. Under rail gyp board soffit install in progress.

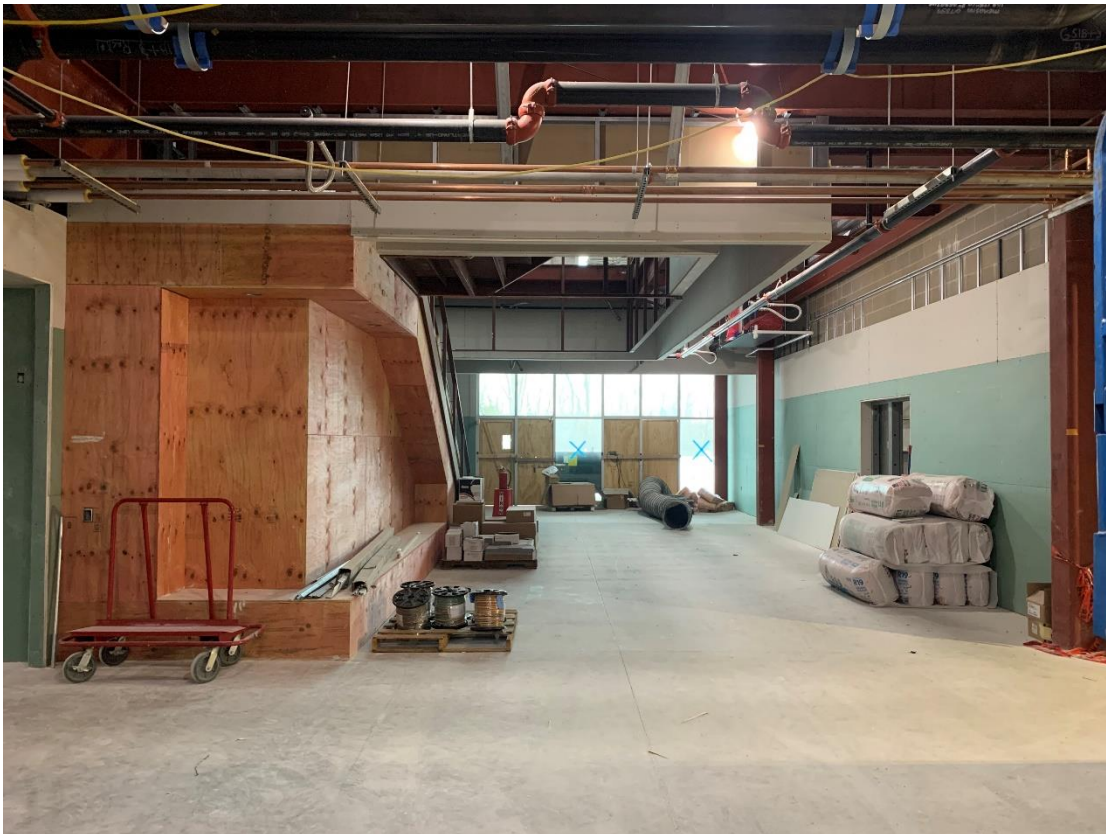
52. Area 1B – Gyp board install at north building entrance in progress.
