Construction Observation Report 012 – September 6, 2024

Maplewood School

PROJECT NUMBER: 321169-01

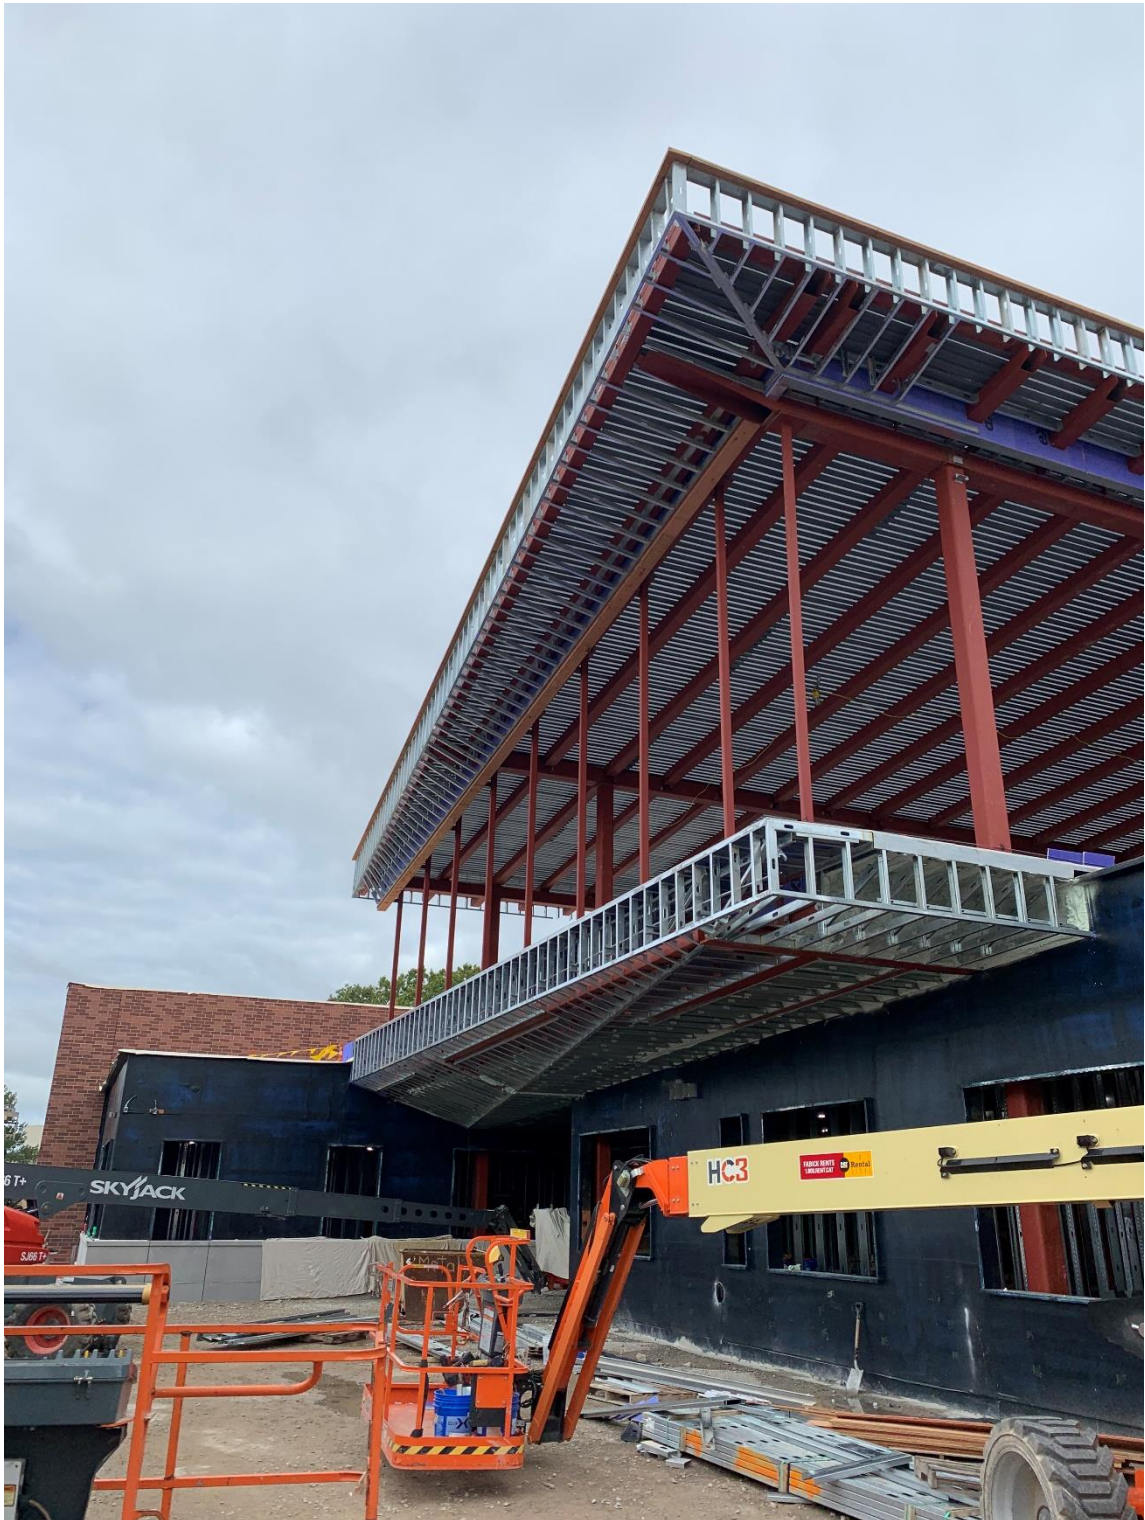
1. Area 1A South – Spray applied AVB, spray foam insulation, metal roof decking, cold form framing, and cast stone panel installation in progress.

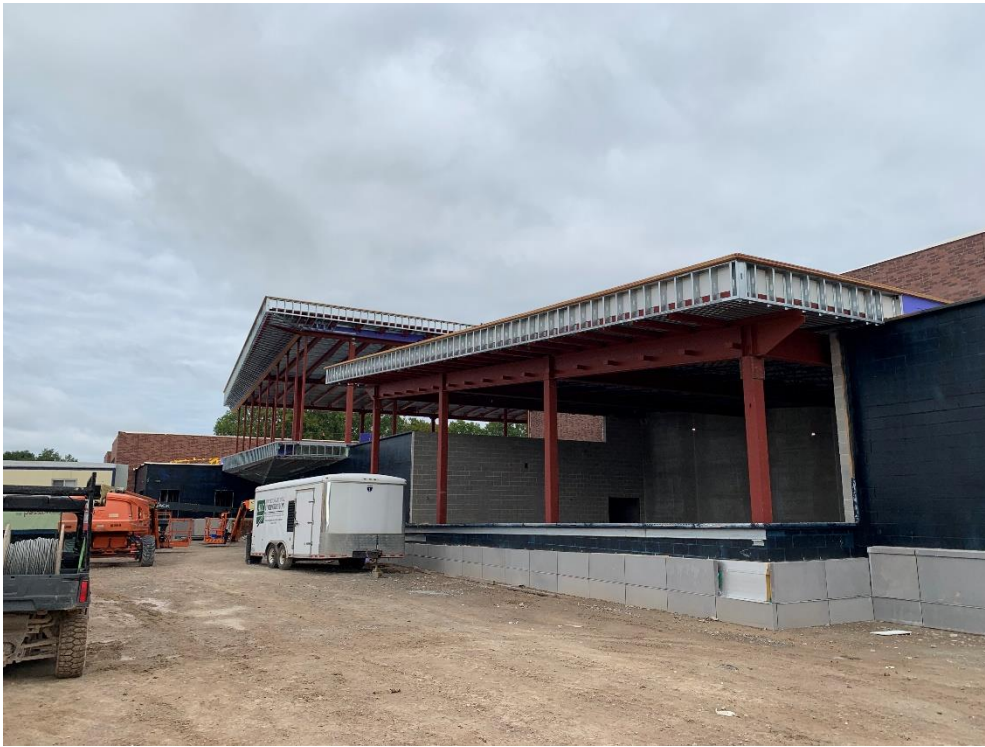
2. Area 2B South – Cast stone panel, cold form framing, and roofing installation in progress.

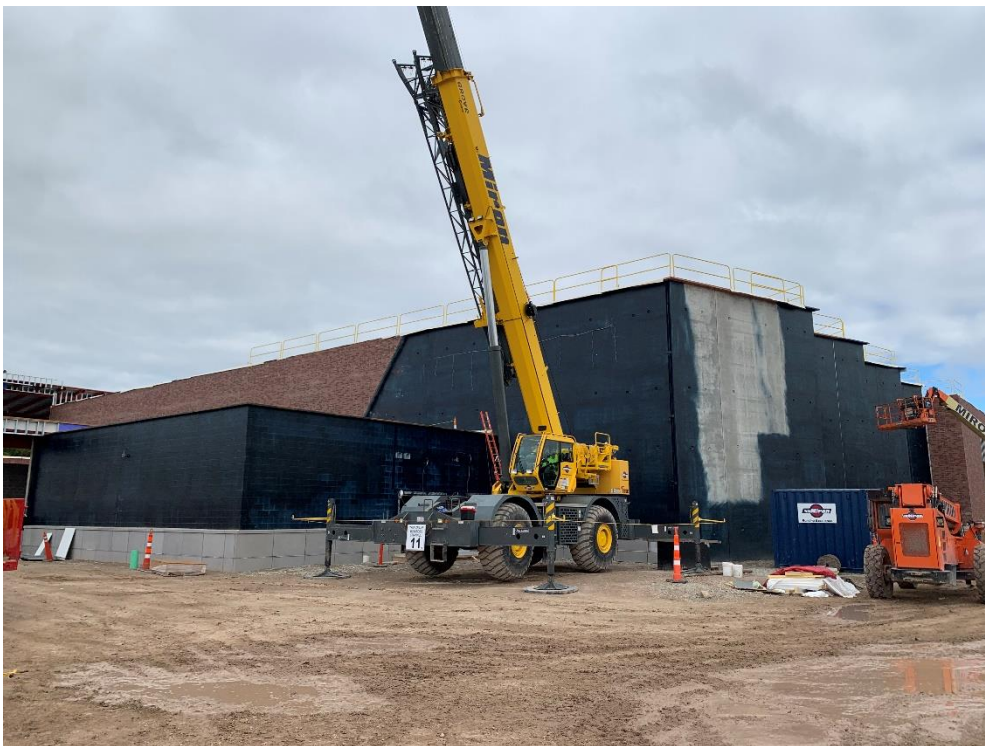
3. Area 2B & 6 South East – Brick veneer on gym box installed. Spray applied AVB and electrical runs for building sign are in progress.

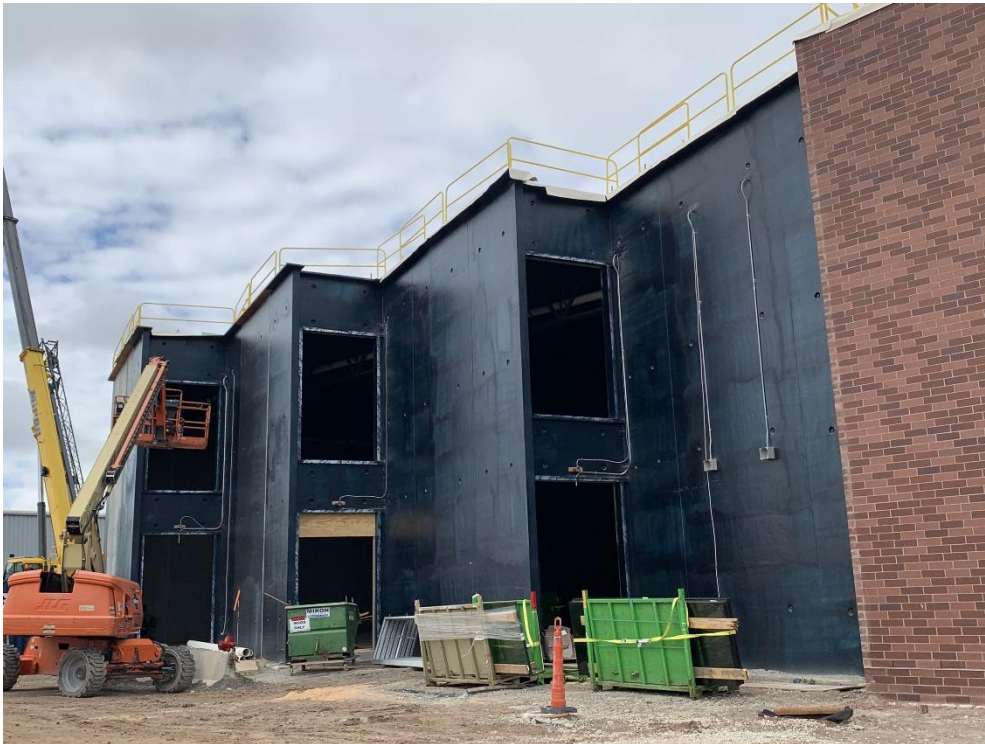
4. Area 6 East – Spray applied AVB, weather proofing membrane at window openings, and structural precast panels are installed. Install of electrical conduit in progress.

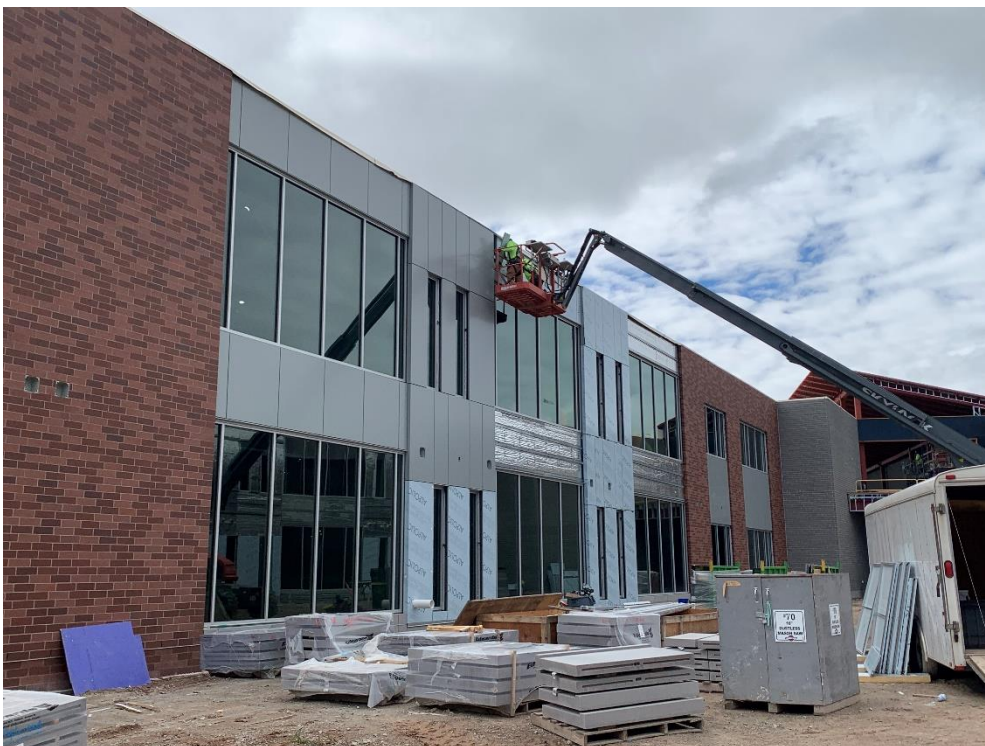
5. Area 5 West – Storefront glazing installed. Composite metal panel installation in progress.

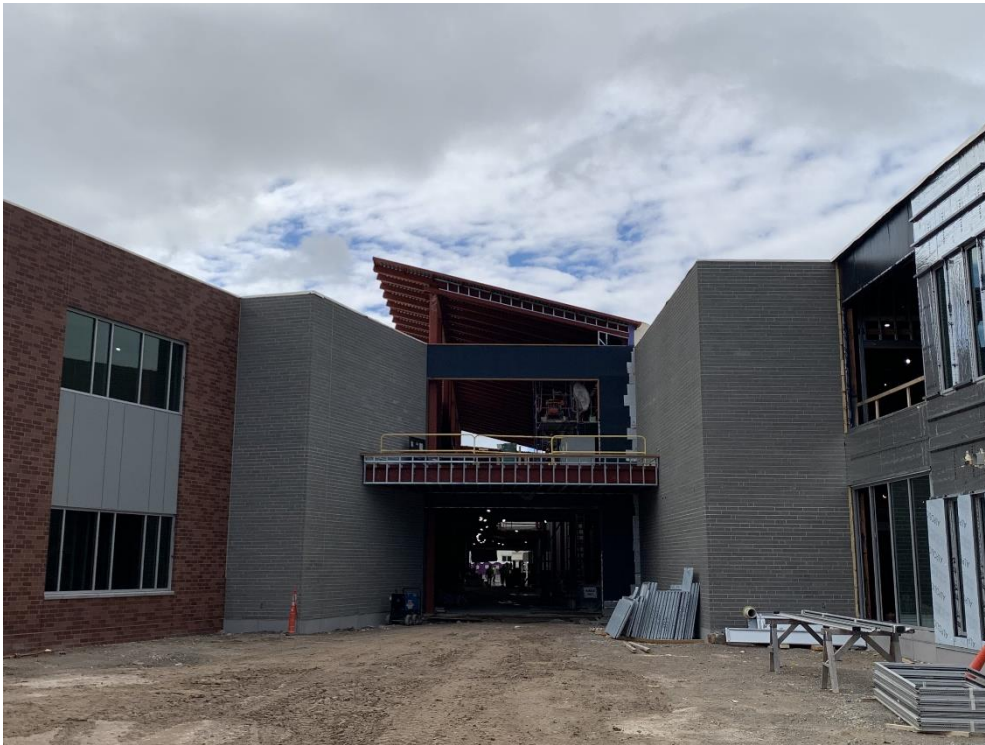
6. Area 1B North – Exterior Brick veneer installed.

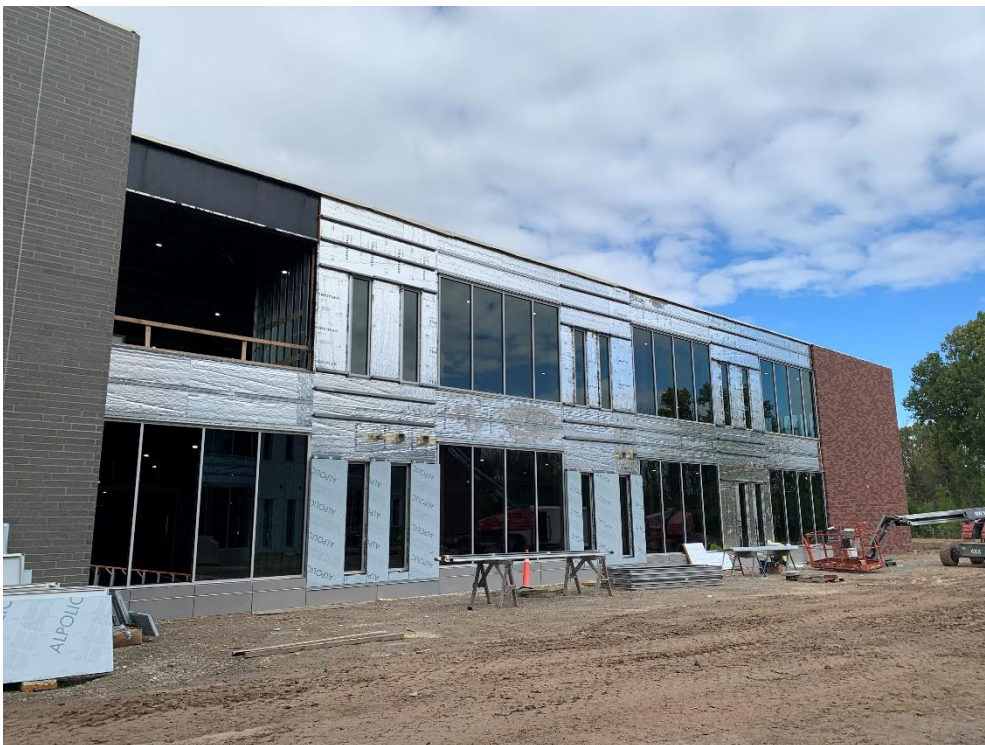
7. Area 4 East – Board insulation, sub girt system, and composite metal panel installation in progress.

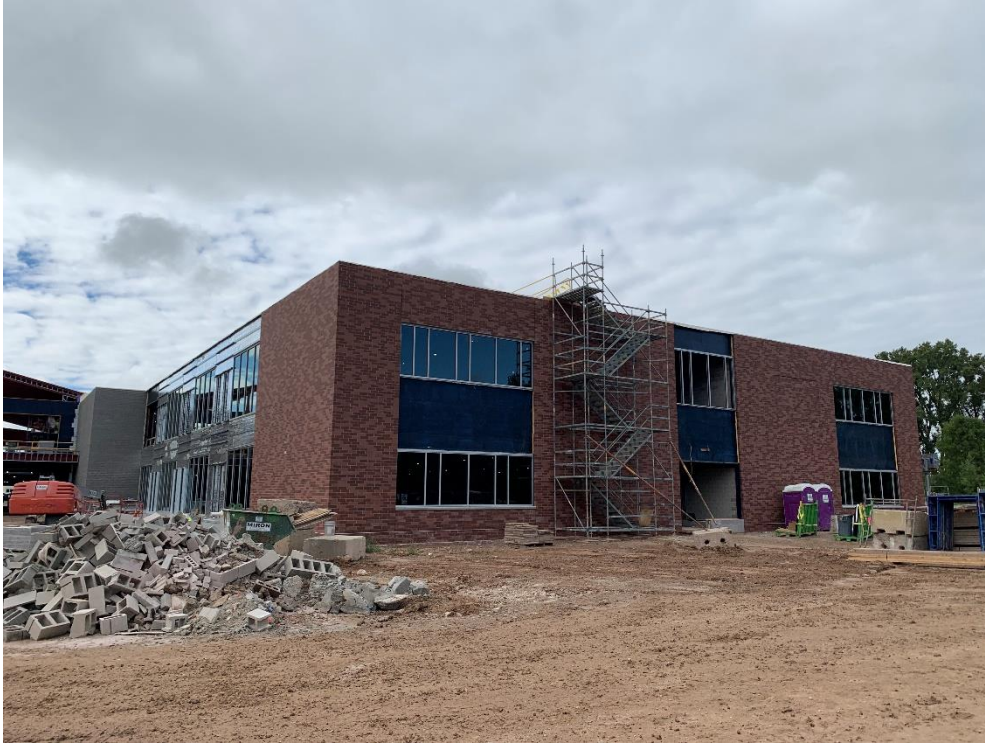
8. Area 4 North – Exterior brick veneer installed. Storefront glazing installation in progress.

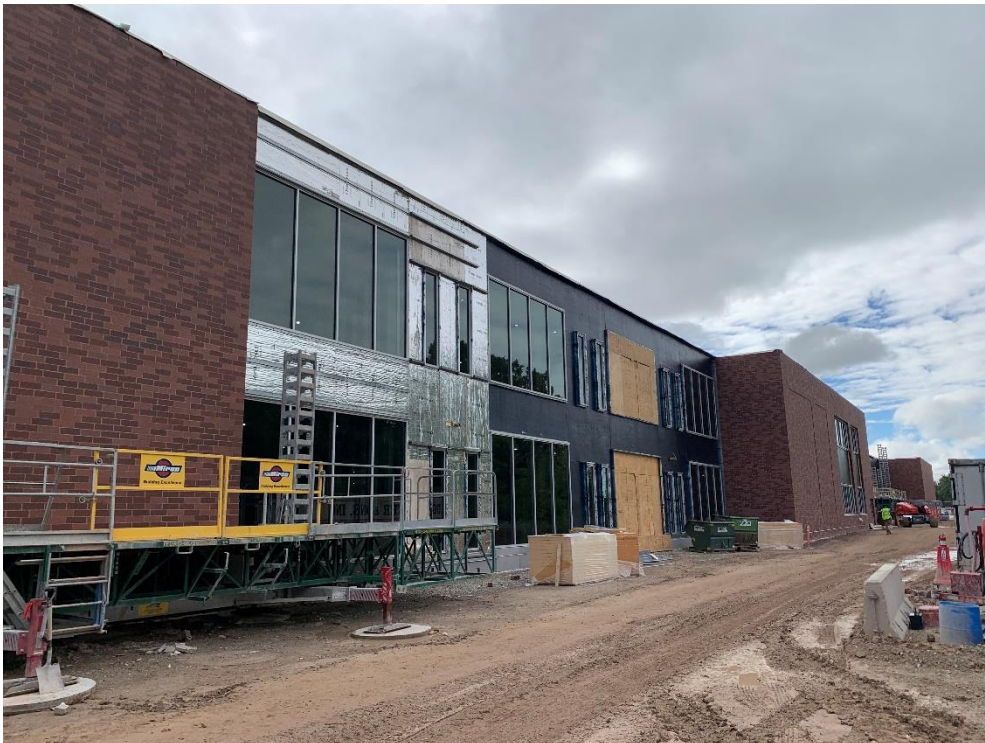
9. Area 4 West – Board insulation, sub girt system, and storefront glazing installation in progress.

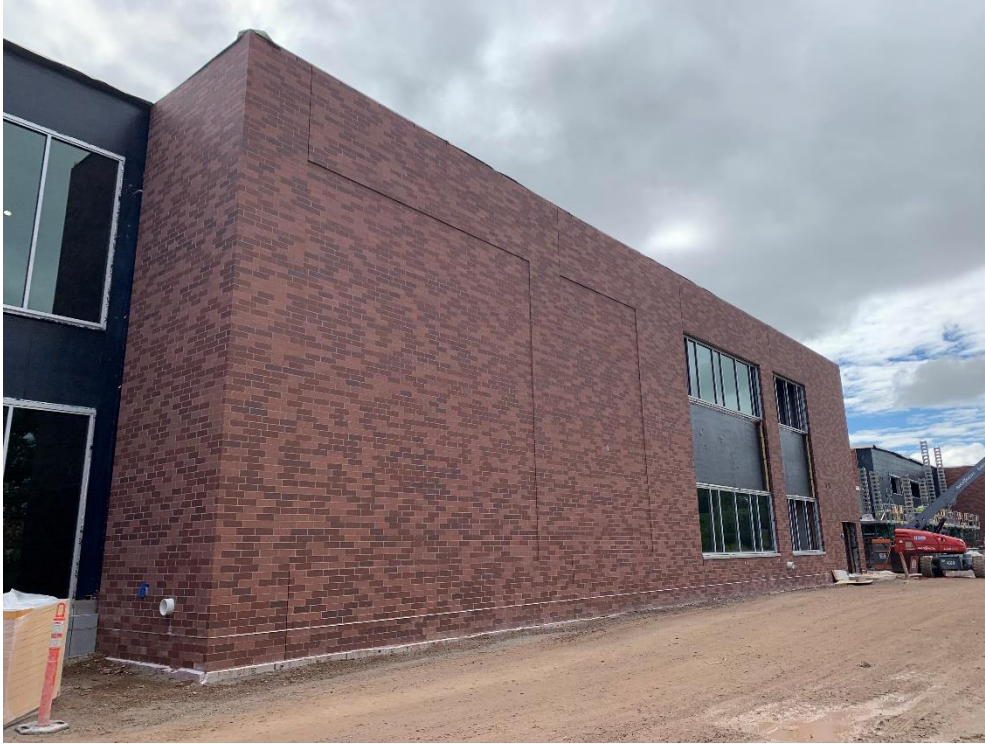
10. Area 3 West – Exterior brick veneer installed. Storefront glazing installation in progress.

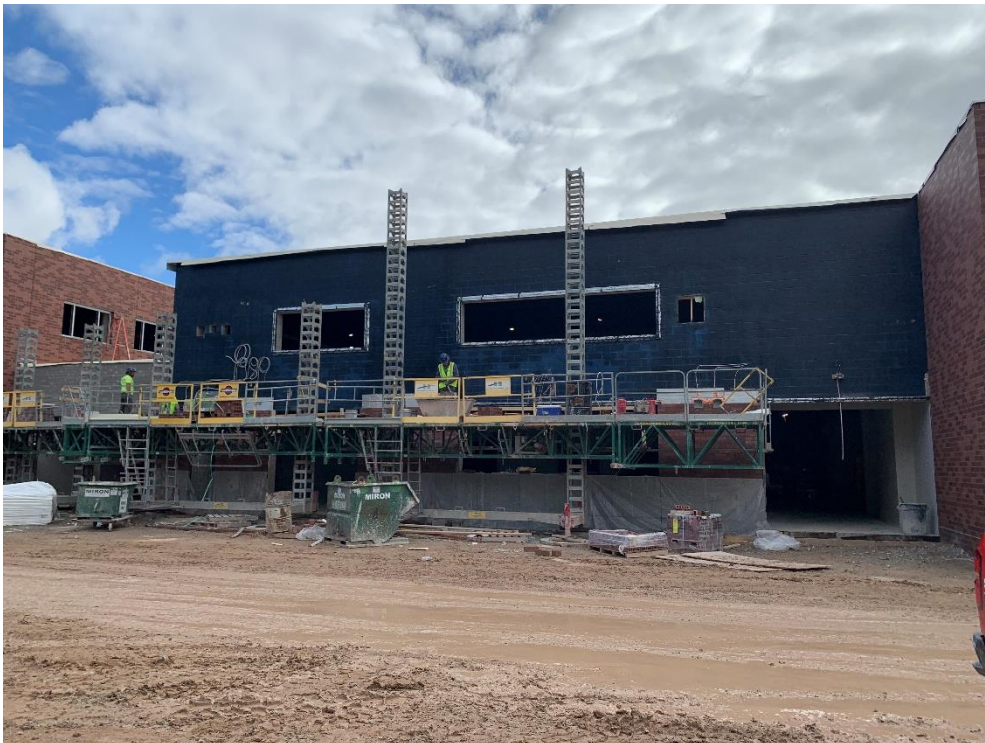
11. Area 3 West – Cast stone panels installed. Exterior brick veneer installation in progress.

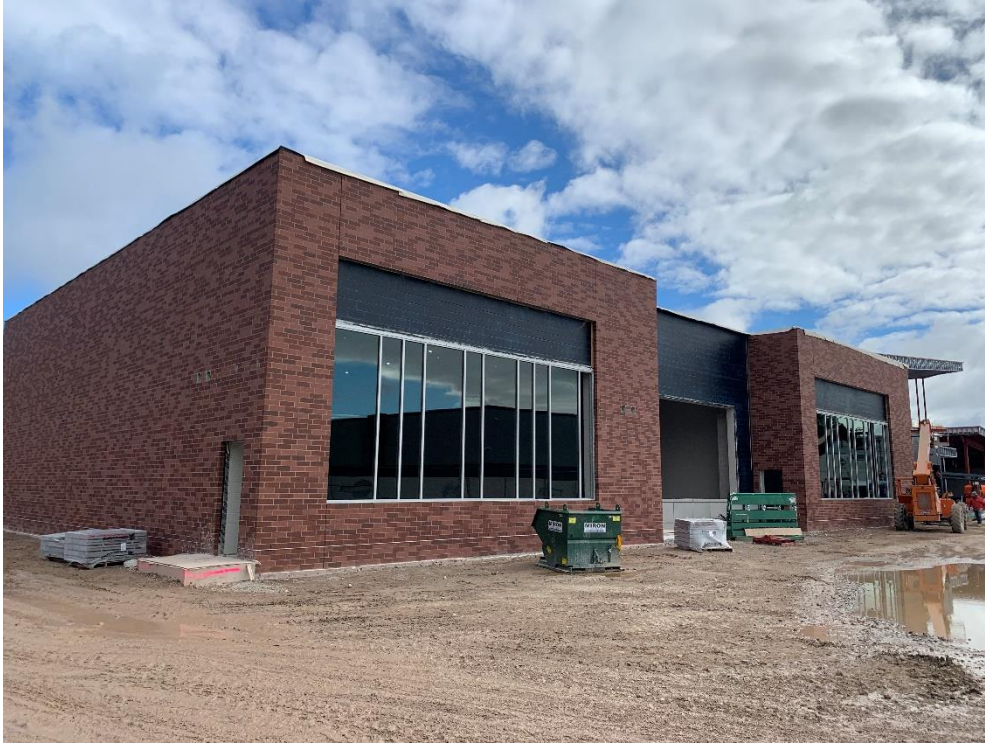
12. Area 2A South – Storefront glazing installation in progress.

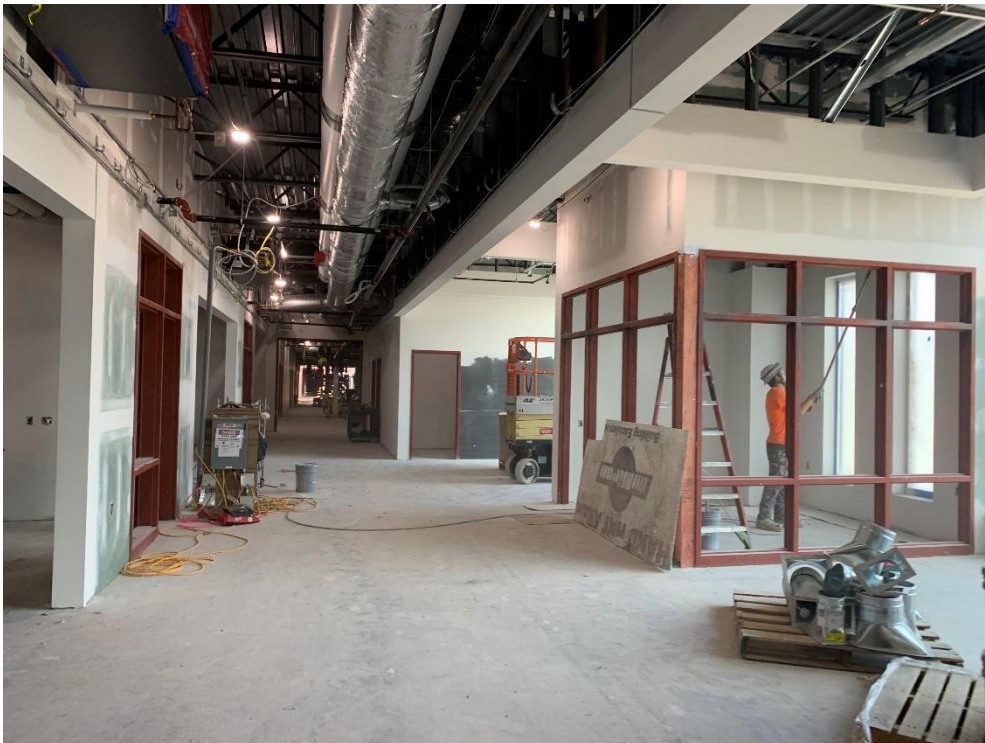
13. Area 6 – gyp board taping, mudding, and priming in progress.

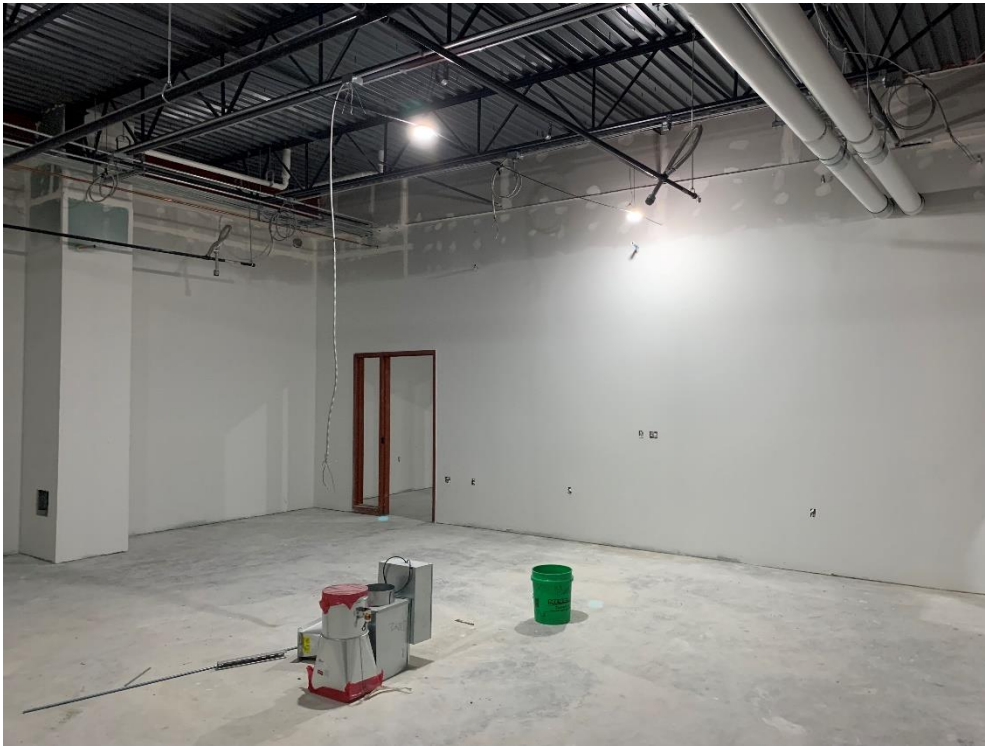
14. Area 6 – Painting in progress in EBD room.

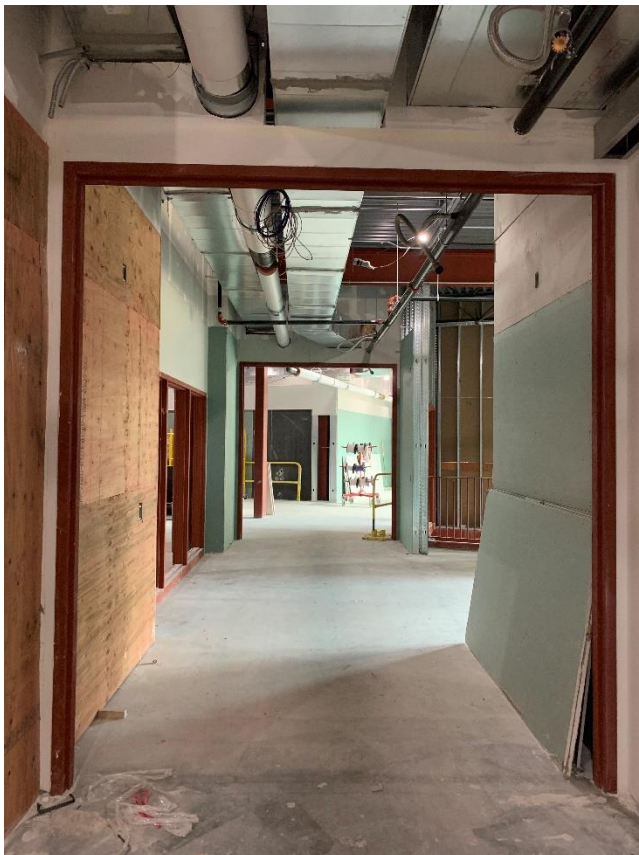
15. Area 5 – Gyp board installation in stairwell corridor in progress.

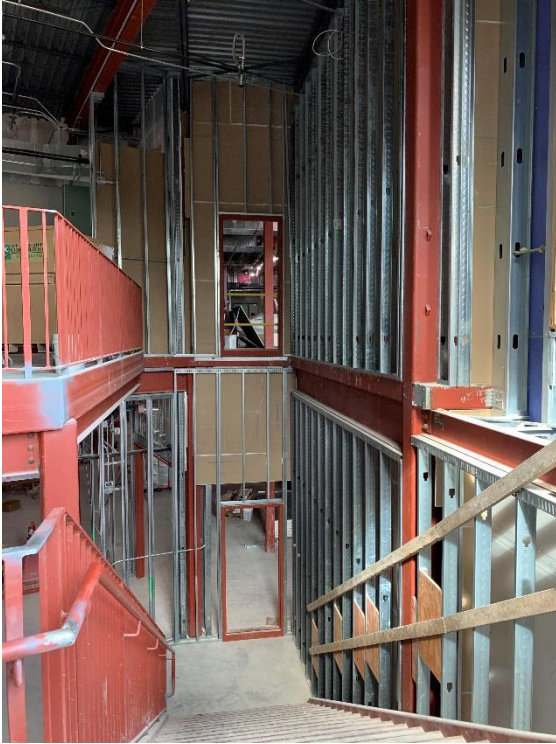
16. Area 5 – Knuckle stair interior metal framing installation in progress.

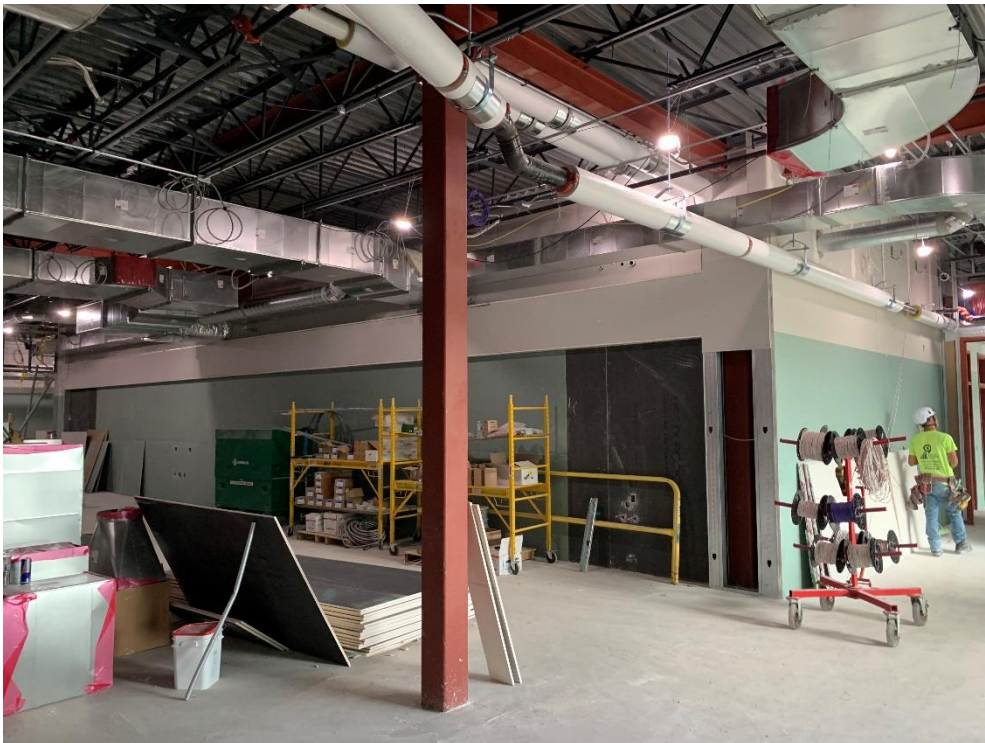
17. Area 5 Second Floor – Gyp board, duct work, and pipe insulation installation in progress.

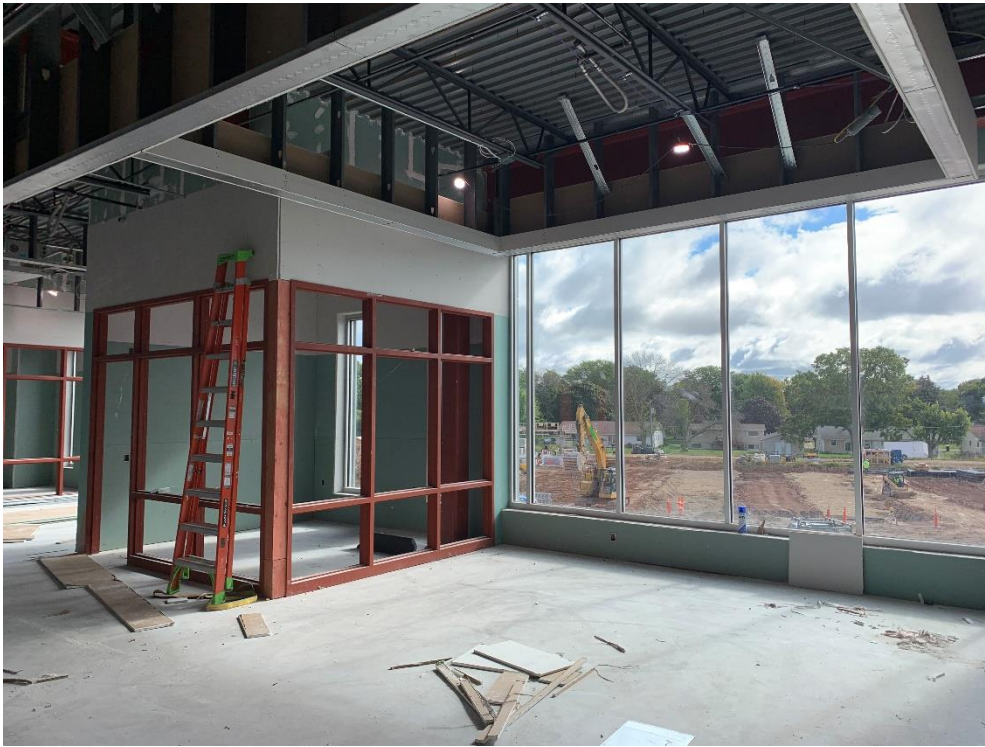
18. Area 5 Second Floor – Gyp board installation in progress.

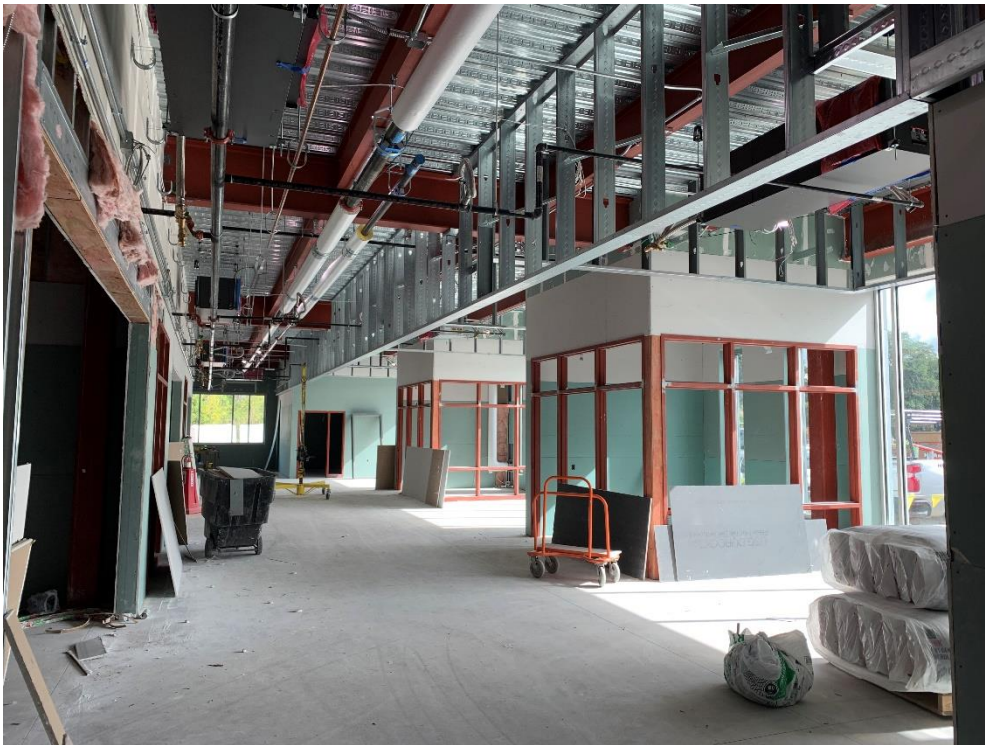
19. Area 5 First Floor – Gyp board, pipe insulation, and heat pump installation in progress.

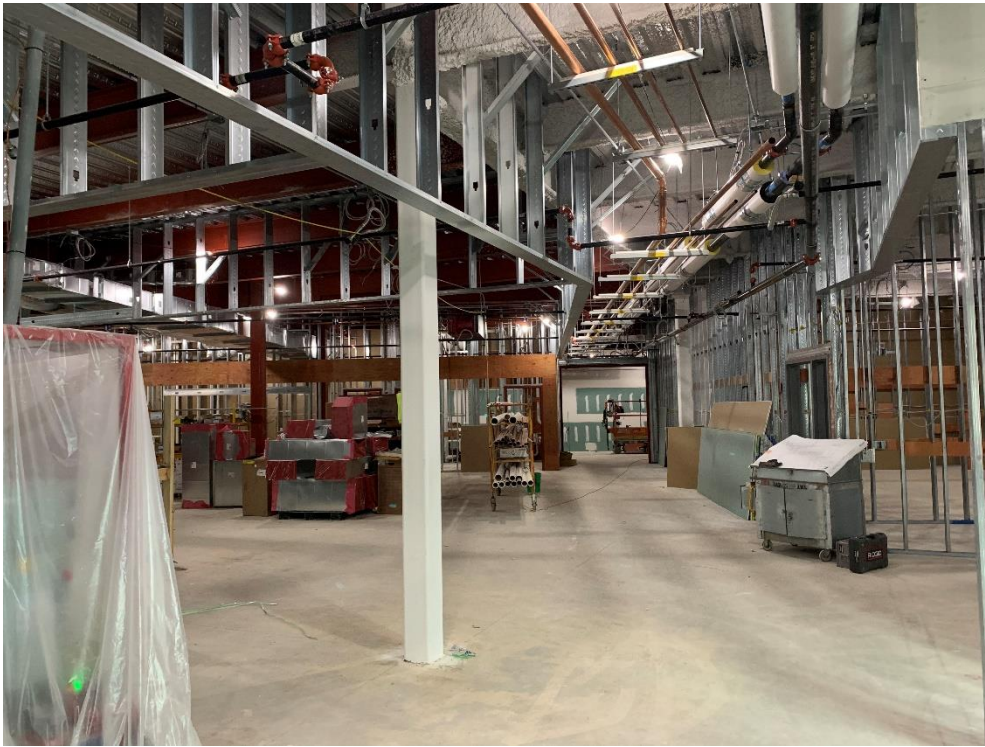
20. Area 5 First Floor – Duct work, pipe insulation, and heat pump installation in progress.

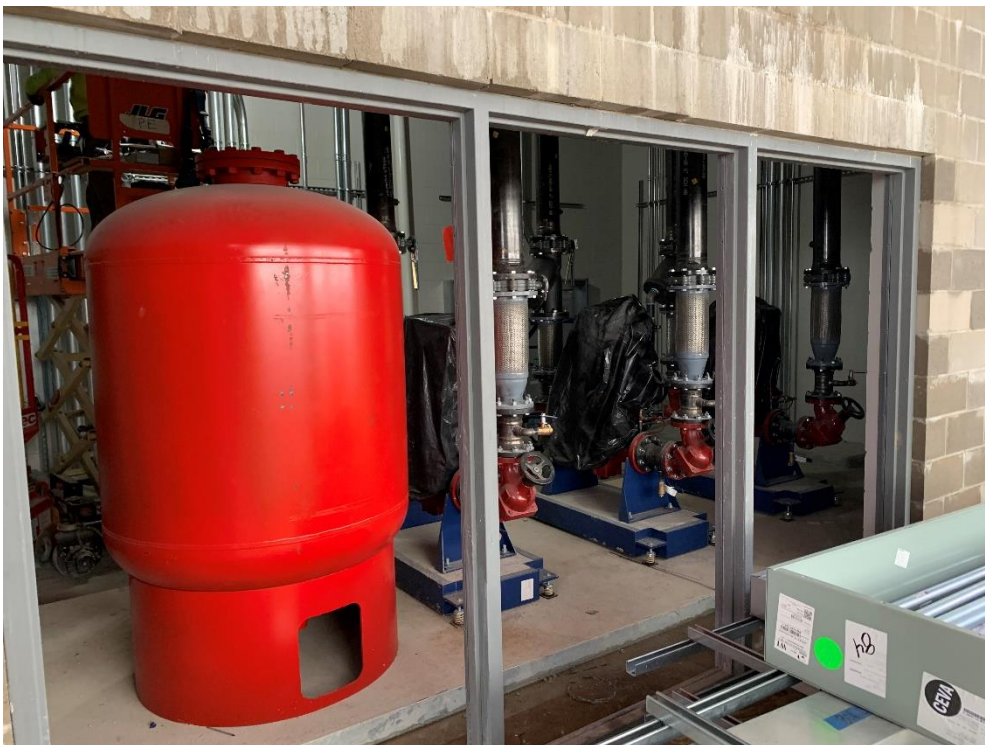
21. Area 1B First Floor – Geothermal pump room equipment installation in progress.

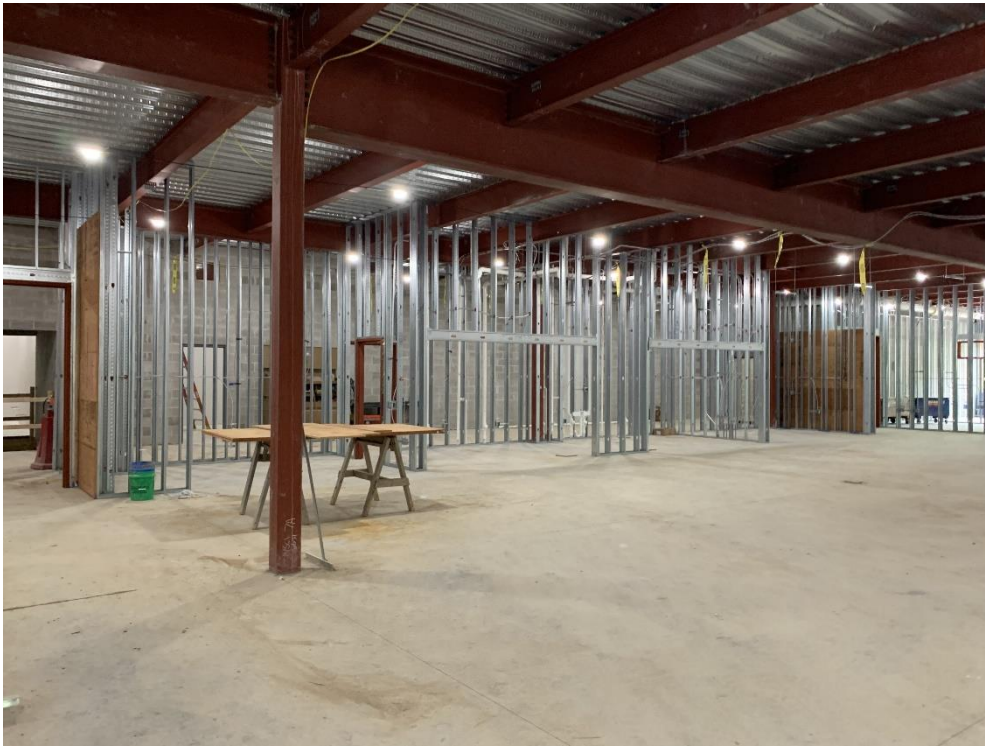
22. Area 4 First Floor – Interior metal stud framing installation in flex cafe in progress.

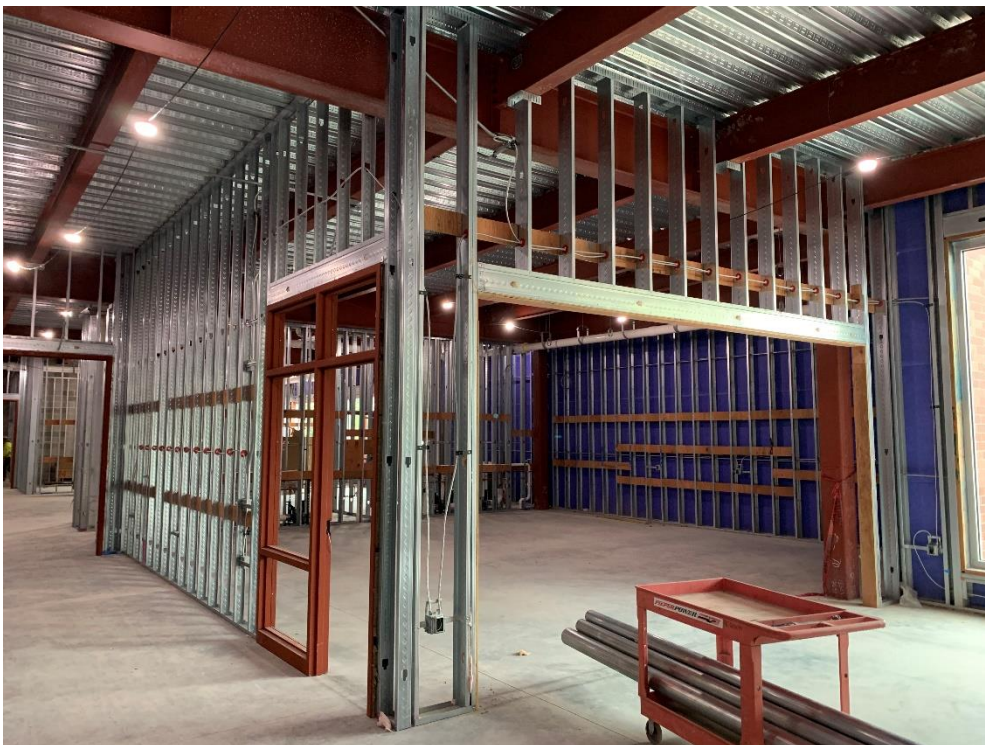
23. Area 4 First Floor – Interior metal stud framing, blocking, and in wall conduit installation in progress.

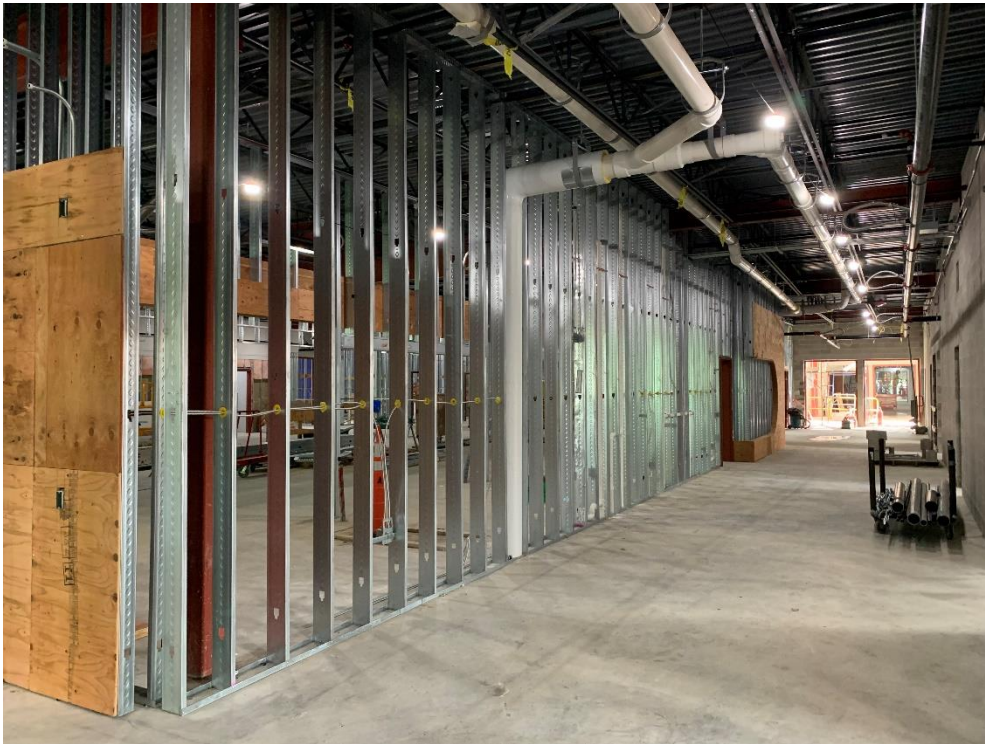
24. Area 4 Second Floor – roof drain piping, geothermal piping, in wall conduit, metal stud framing, and blocking installation in progress.

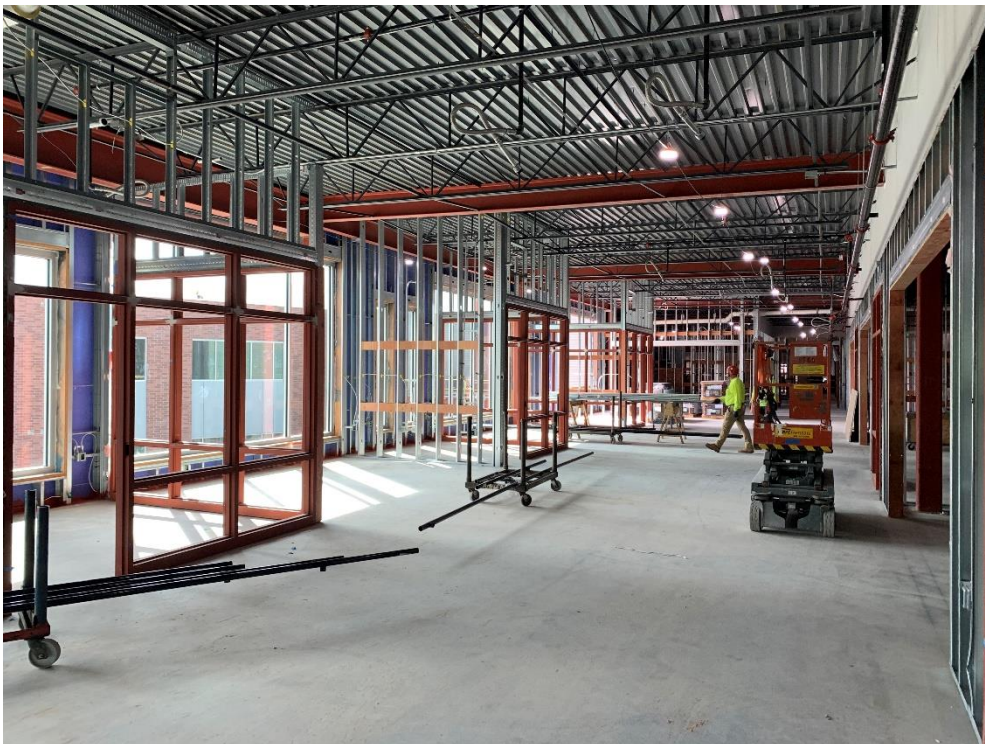
25. Area 4 Second Floor – Interior metal stud framing, blocking, in wall conduit, geothermal piping installation in progress.

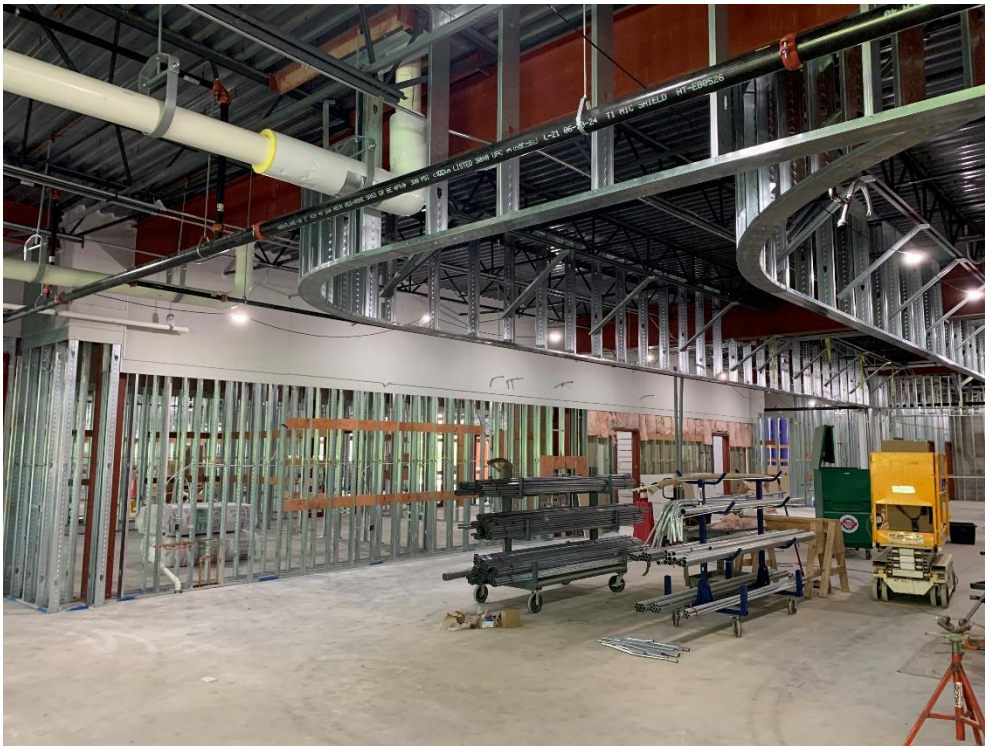
26. Area 4 Second Floor – Piping insulation, conduit, and gyp board installation in progress.

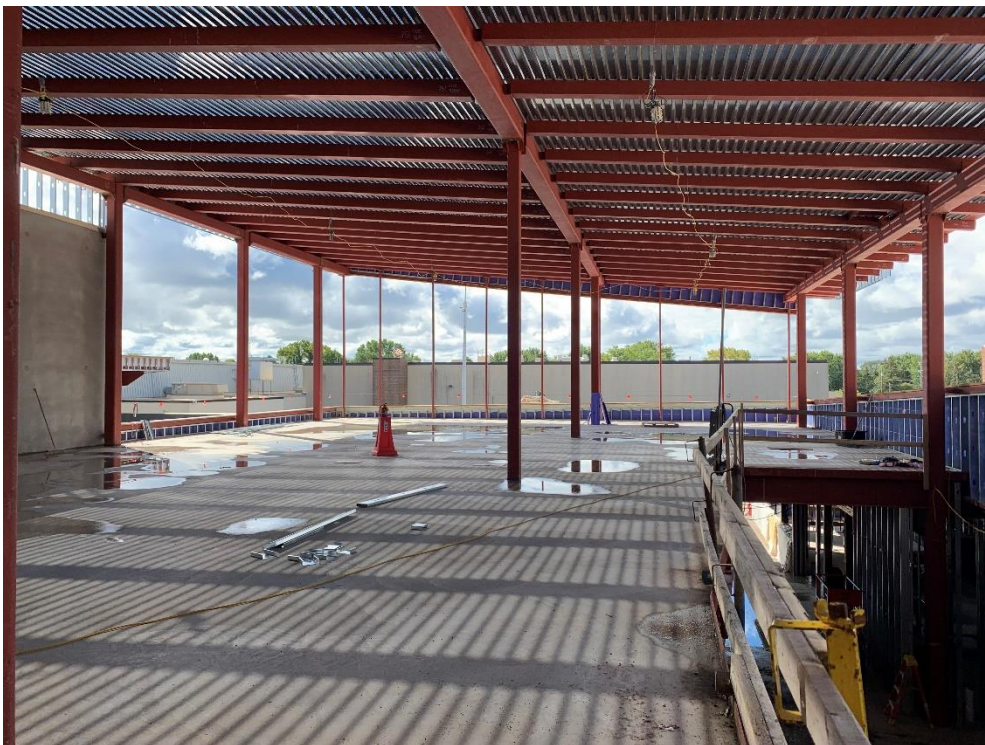
27. Area 1A Second Floor – Acoustic roof decking installed.

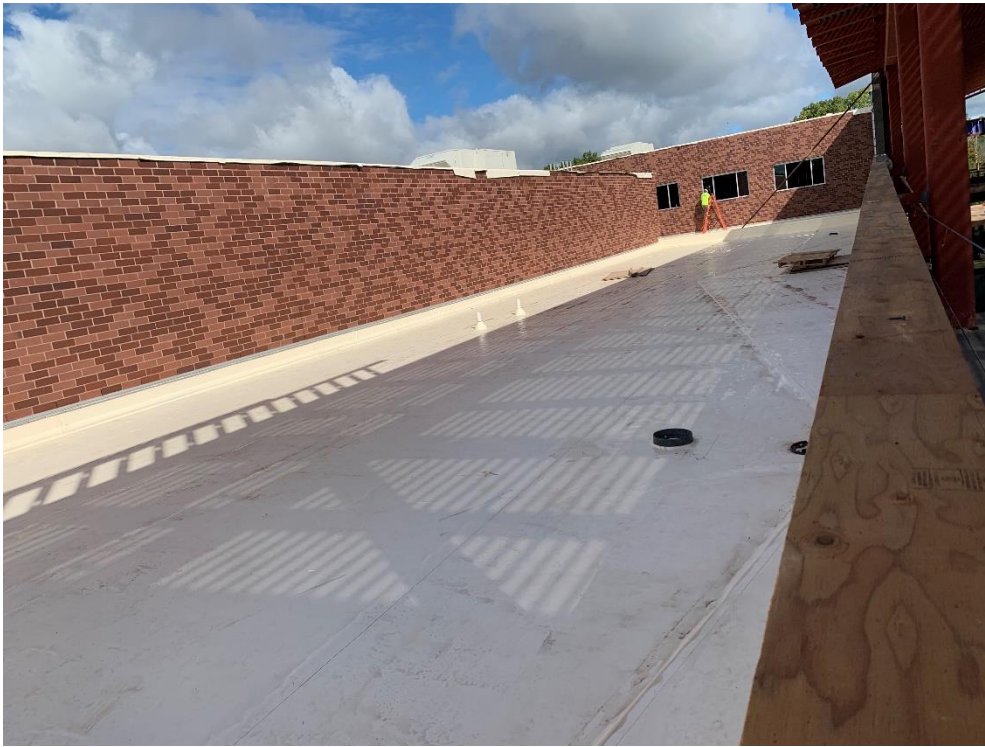
28. Area 1A – Roofing installed.

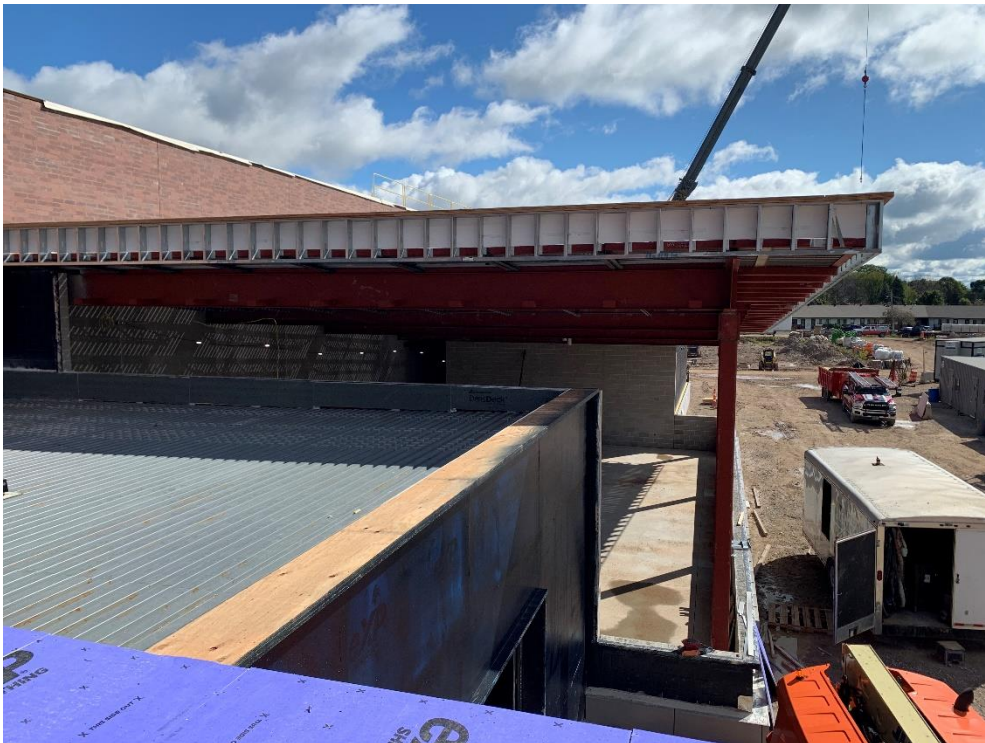
29. Area 1A/2B – Roof decking installed. Exterior cold form framing installation in progress.

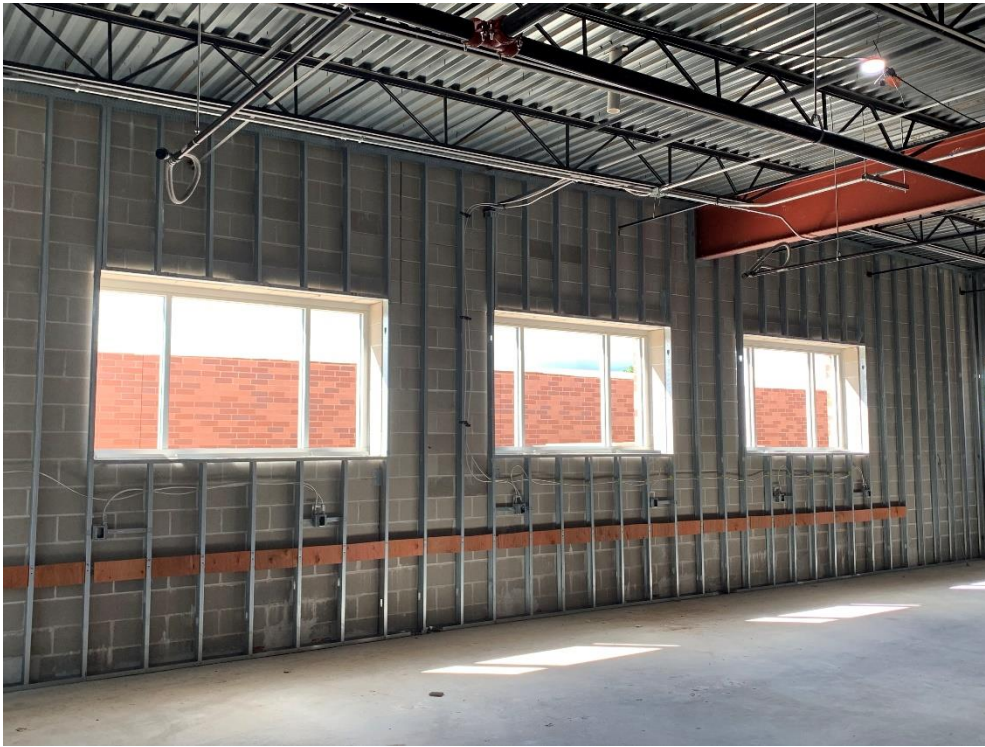
30. Area 3 Second Floor – Installation of exterior storefront glazing in art rooms in progress.
