Construction Observation Report 012 – September 6, 2024

Maplewood School

PROJECT NUMBER: 321169-01

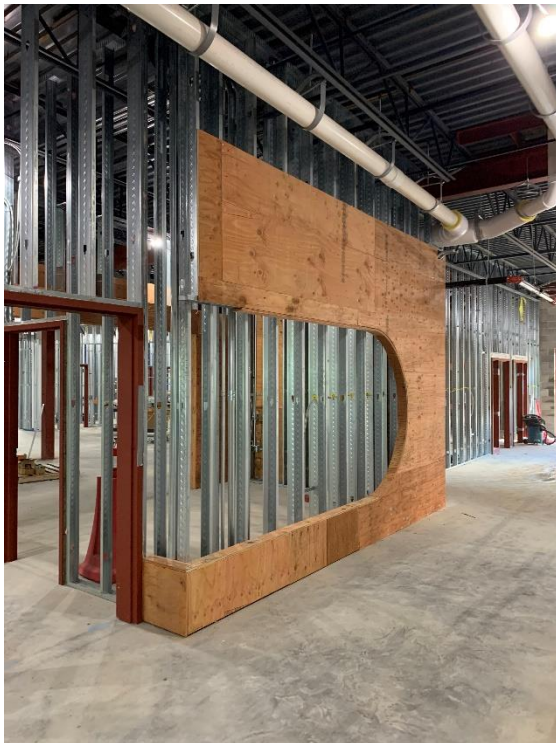
31. Area 3 Second Floor – Gradewing entry feature blocking and framing installation in progress.

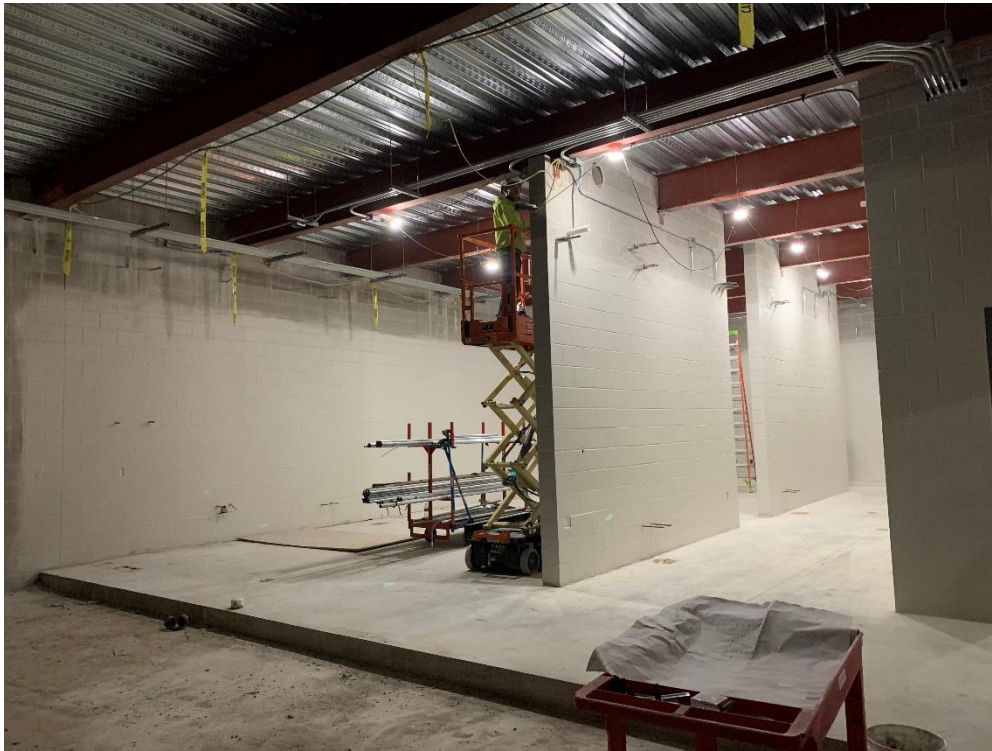
32. Area 4 Second Floor – Piping insulation, conduit, and gyp board installation in progress.

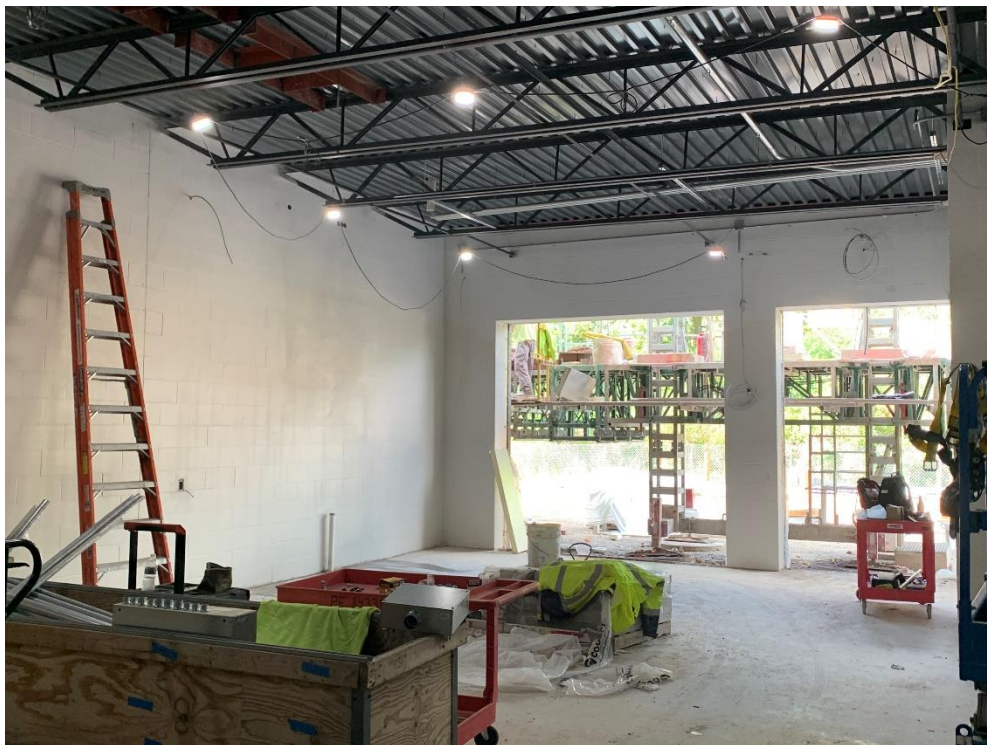
33. Area 3 First Floor – Painting in receiving in progress.

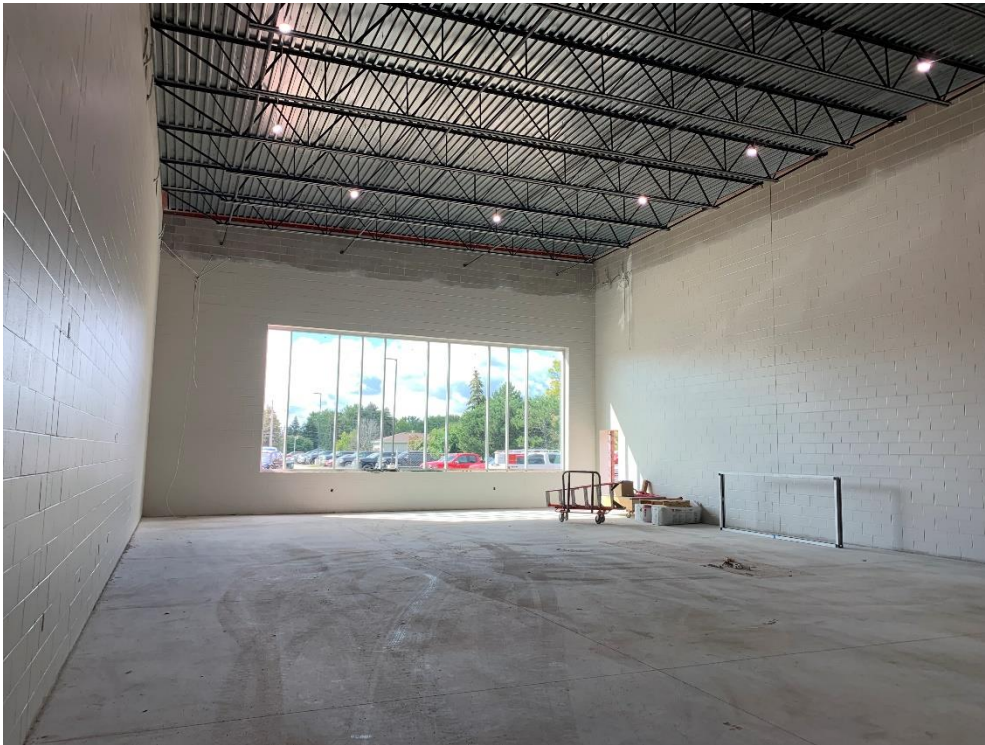
34. Area 2A – Painting in music suite in progress.

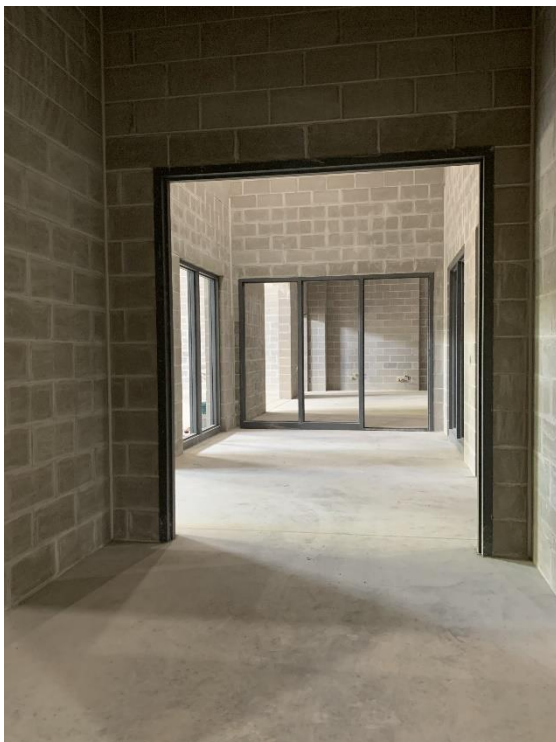
35. Area 3 – Interior cmu walls and hollow metal frames installed in tech ed area.

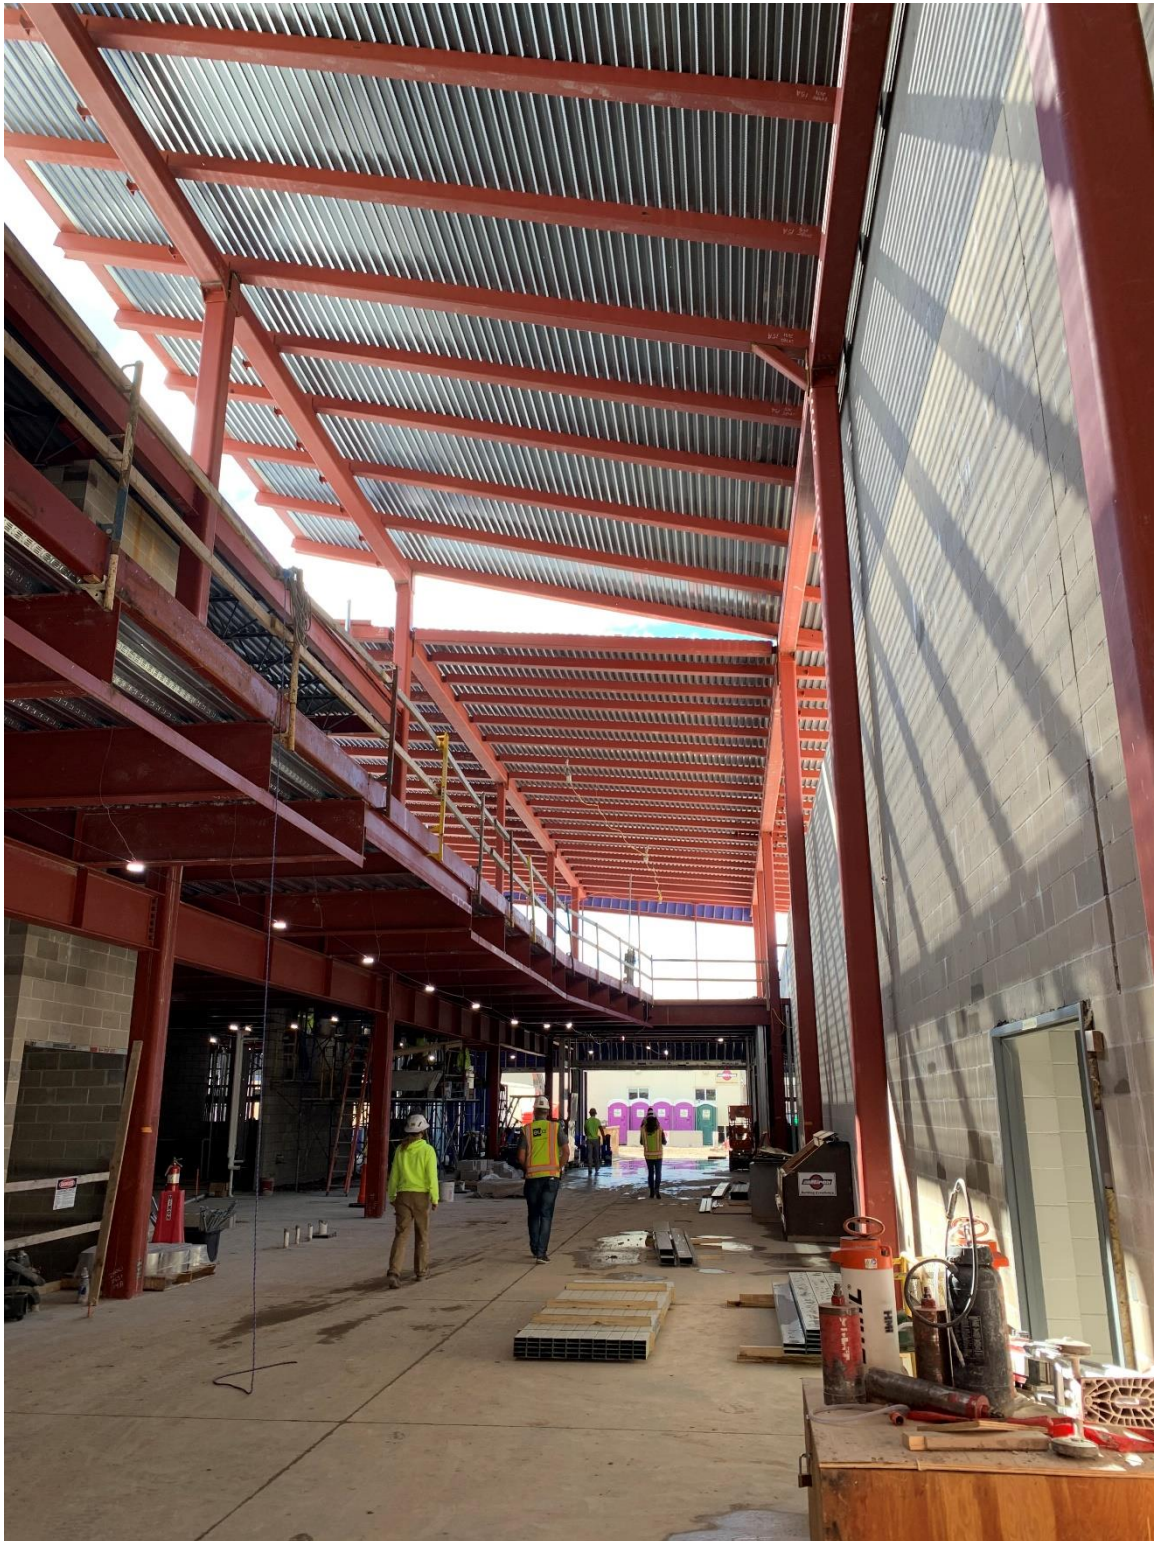
36. Area 1A – Acoustic roof decking installed in center spine.
