Construction Observation Report 013 – September 20, 2024

Maplewood School

PROJECT NUMBER: 321169-01

OWNER:	MENASHA JOINT SCHOOL DISTRICT
From ARCHITECT/ENGINEER:	EUA
To CONTRACTOR	MIRON CONSTRUCTION CO, INC
SITE OBSERVATION TYPE	ARCHITECTURAL
DATE OF ISSUANCE:	October 2, 2024

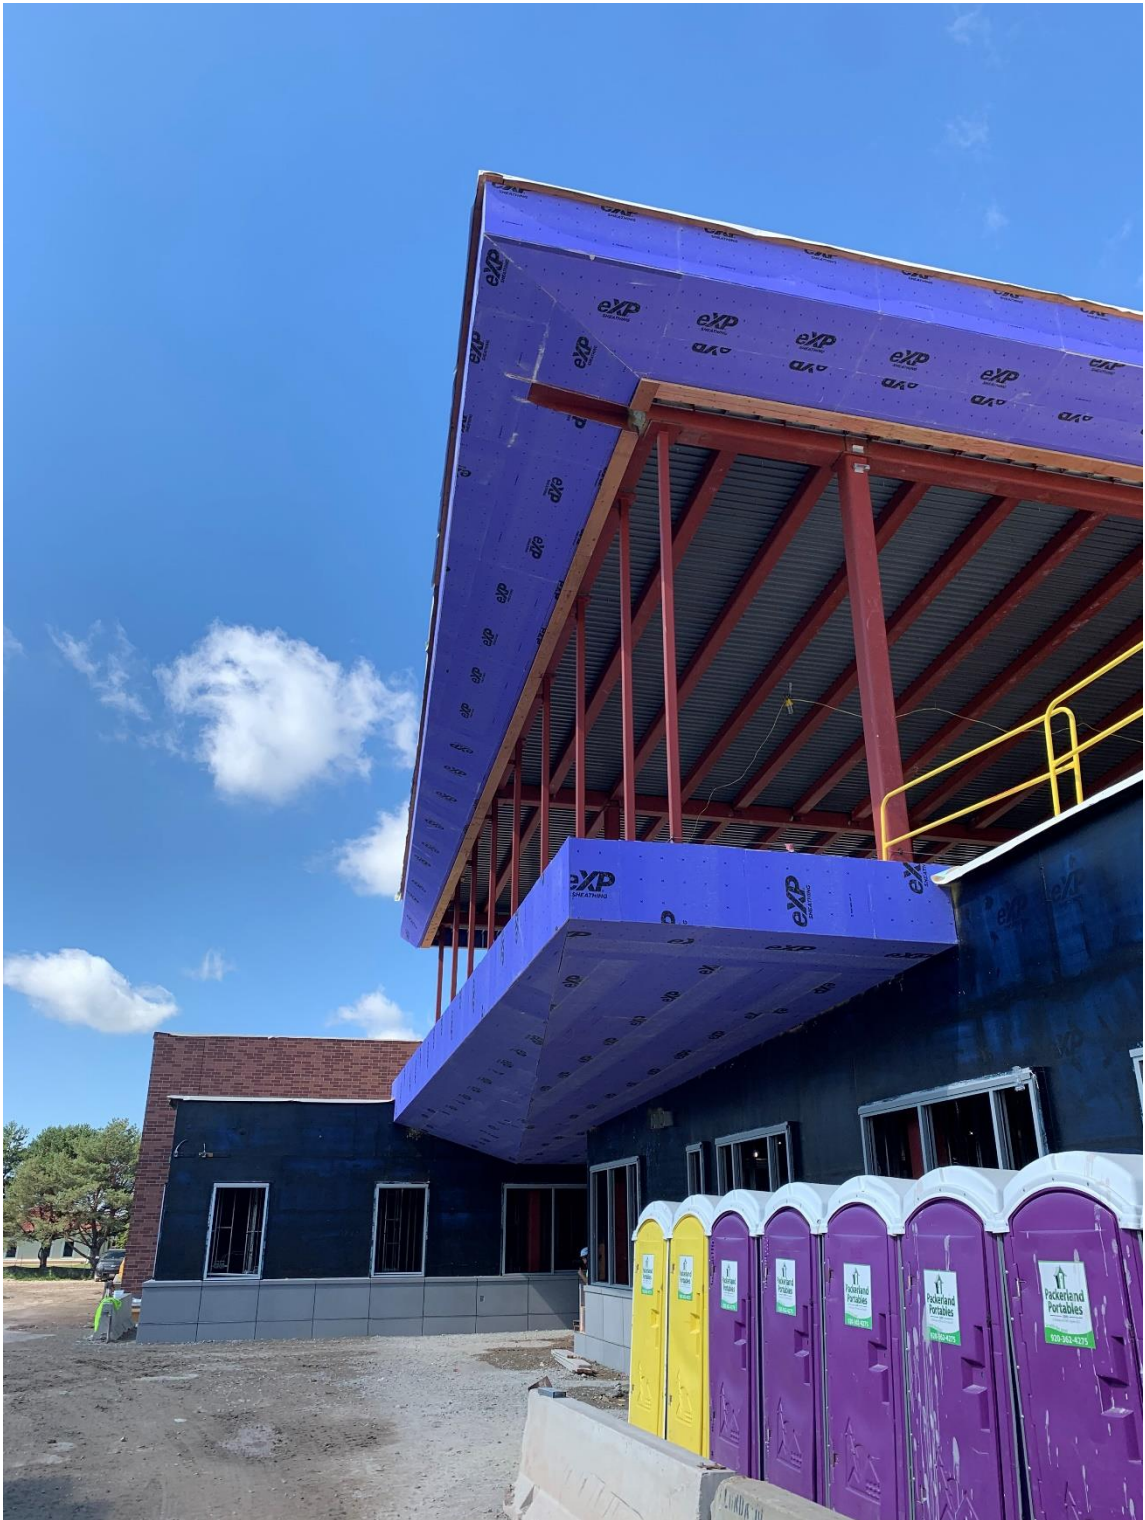
1. Area 1A South – Exterior sheathing board and wood blocking installation in progress. Cast stone panels are installed. First floor storefront glazing install in progress.

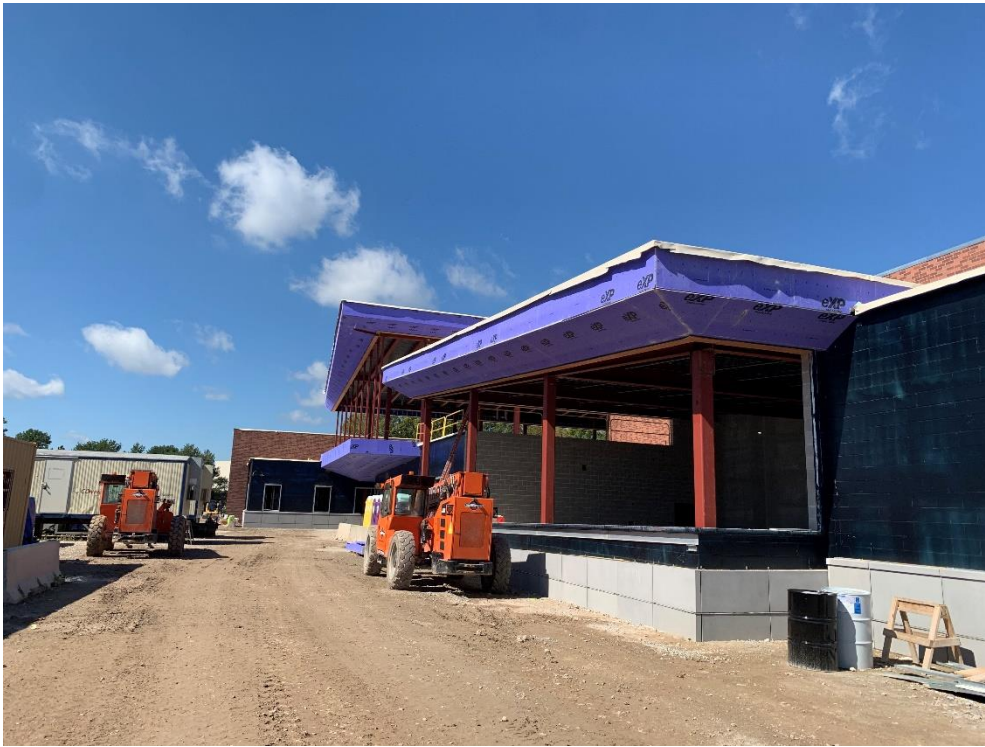
2. Area 2B South – Exterior sheathing board, cold form framing, and wood blocking install in progress.

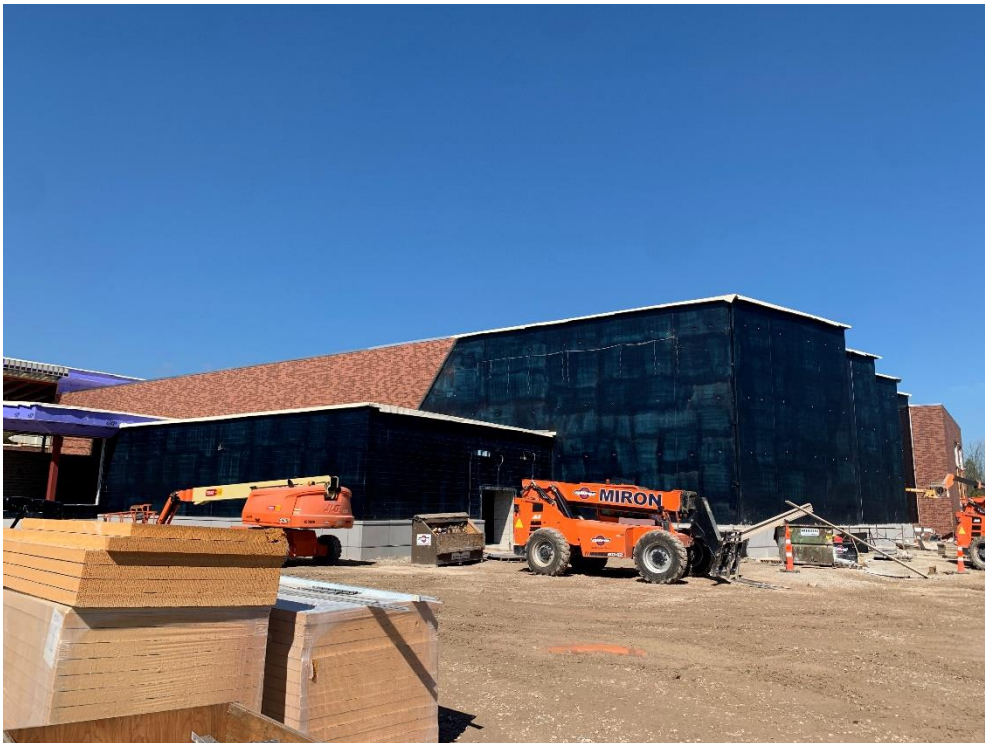
3. Area 2B & 6 South East – Spray applied AVB installed. Cast stone panel and roof coping install in progress.

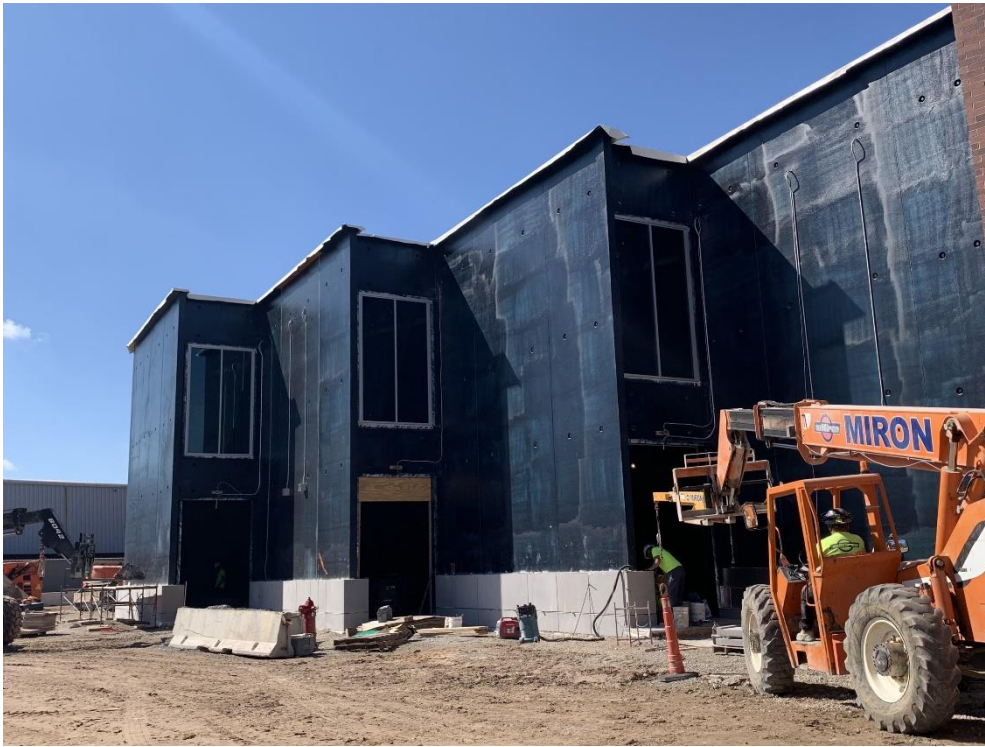
4. Area 2B South – Exterior storefront glazing and cast stone installation in progress.

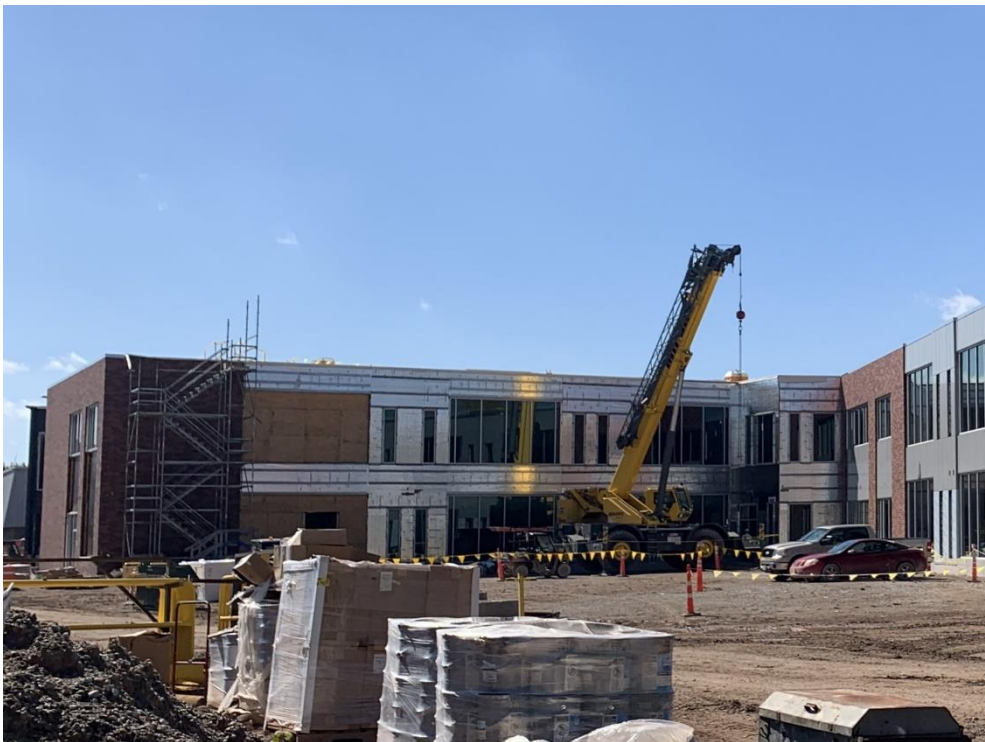
5. Area 6 North – Board insulation installed. Metal wall panel girt system, storefront glazing, and roof coping install in progress.

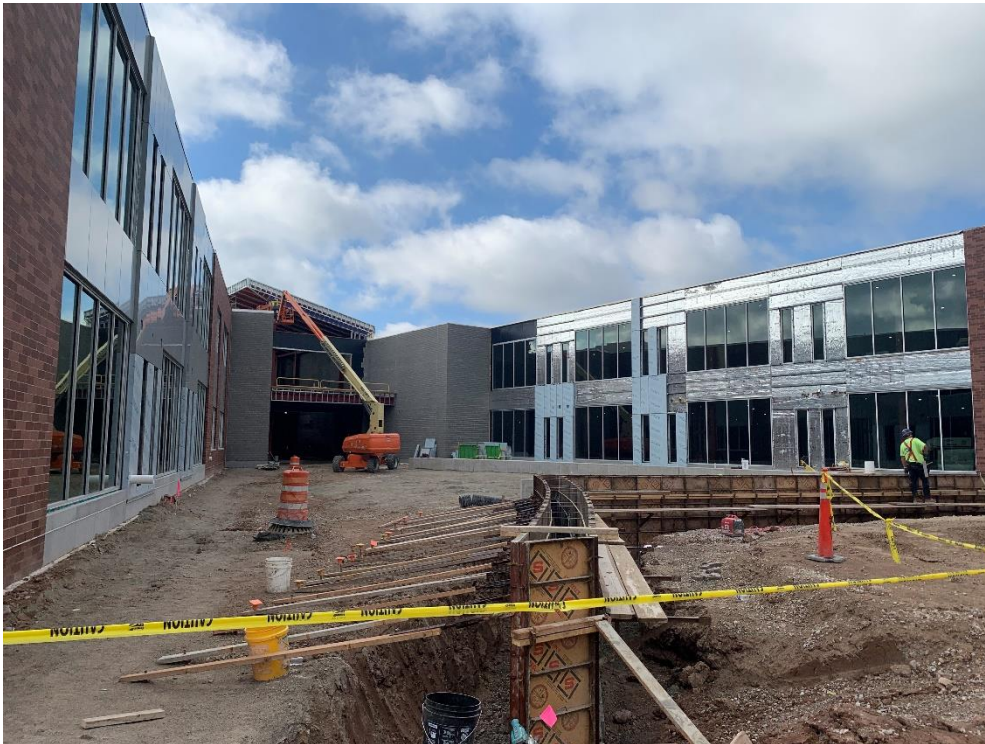
6. Area 1B,4,5 – Concrete seat walls are getting formed and poured. Composite wall installation on area 4 East in progress. Cold form framing of area 1B canopy and clerestory in progress. Roof coping install in progress.

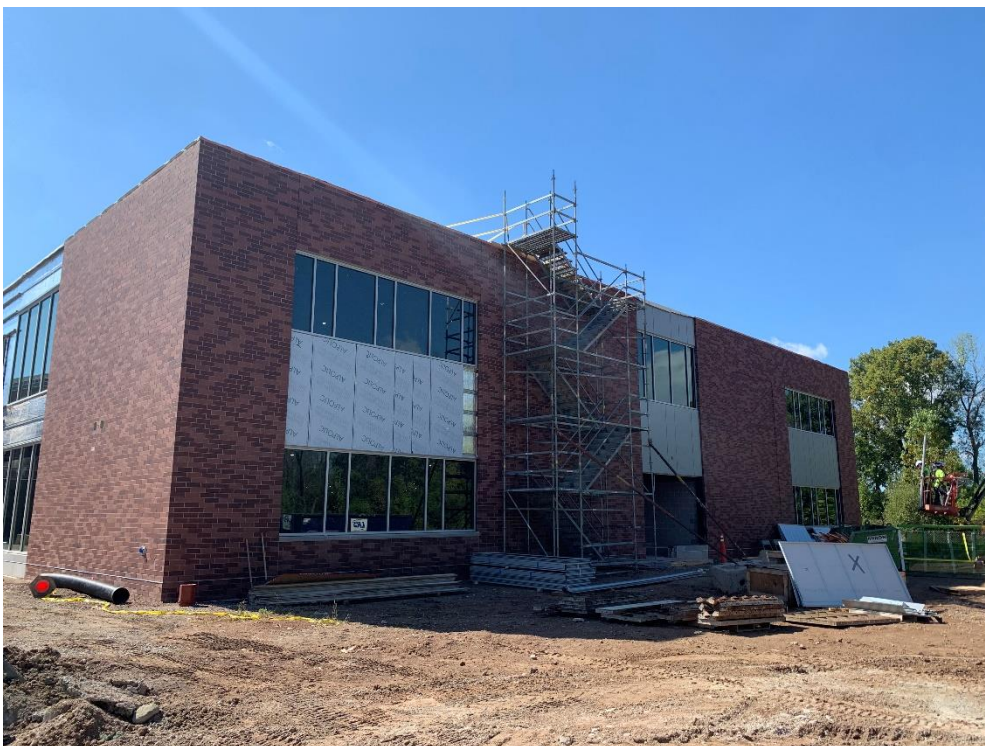
7. Area 4 North – Composite wall panel and storefront install in progress.

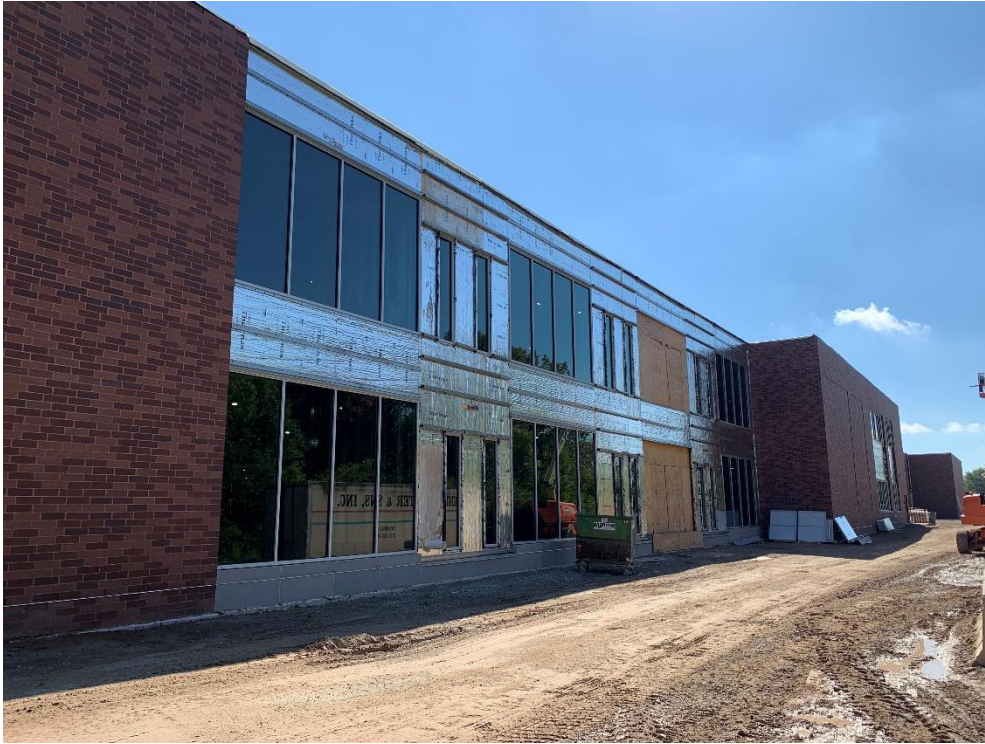
8. Area 4 East – Metal wall panel girt system and storefront glazing install in progress.

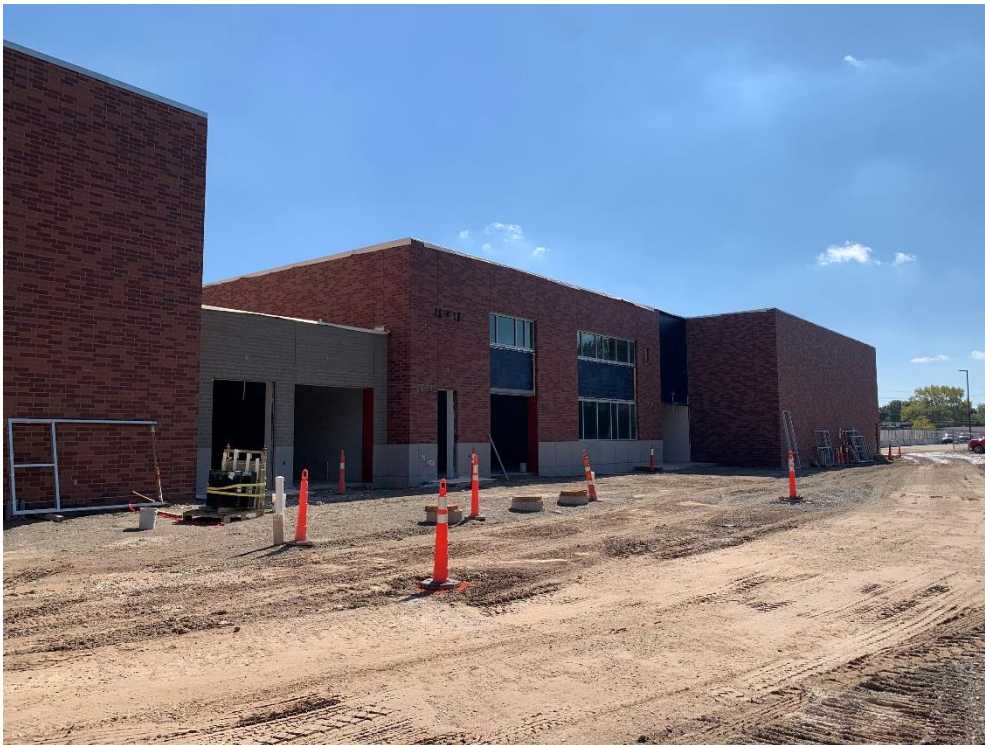
9. Area 2A & 3 East – Masonry is installed. Metal wall panel girt system and storefront glazing install in progress.

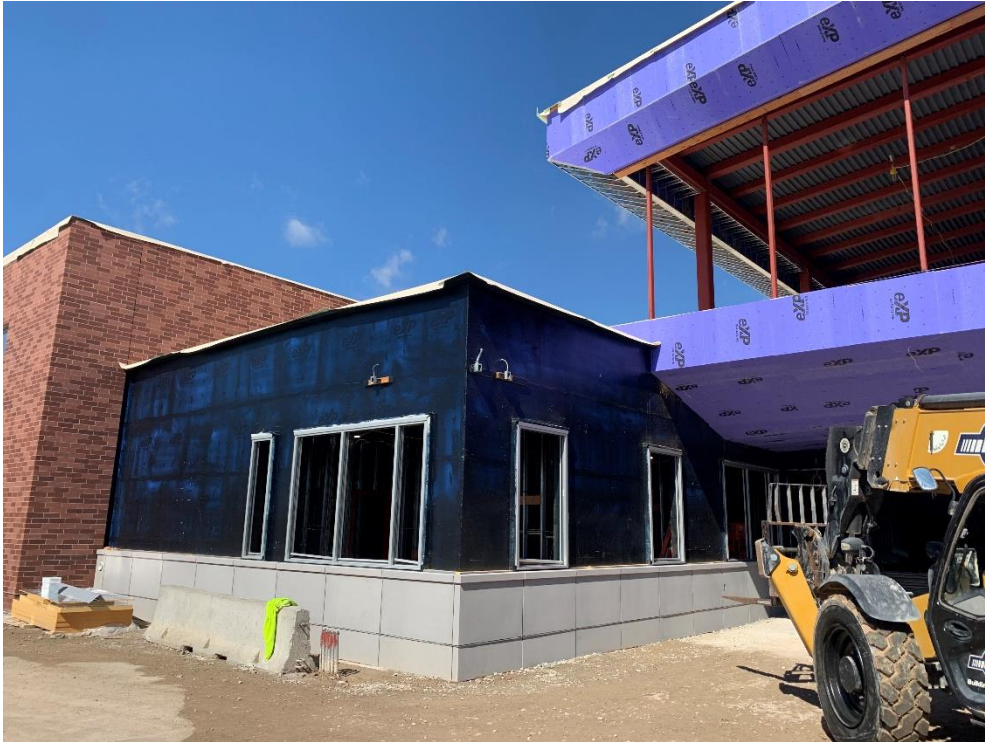
10. Area 1A West – Storefront glazing and exterior sheathing board installation in progress. Through wall device conduit in progress.

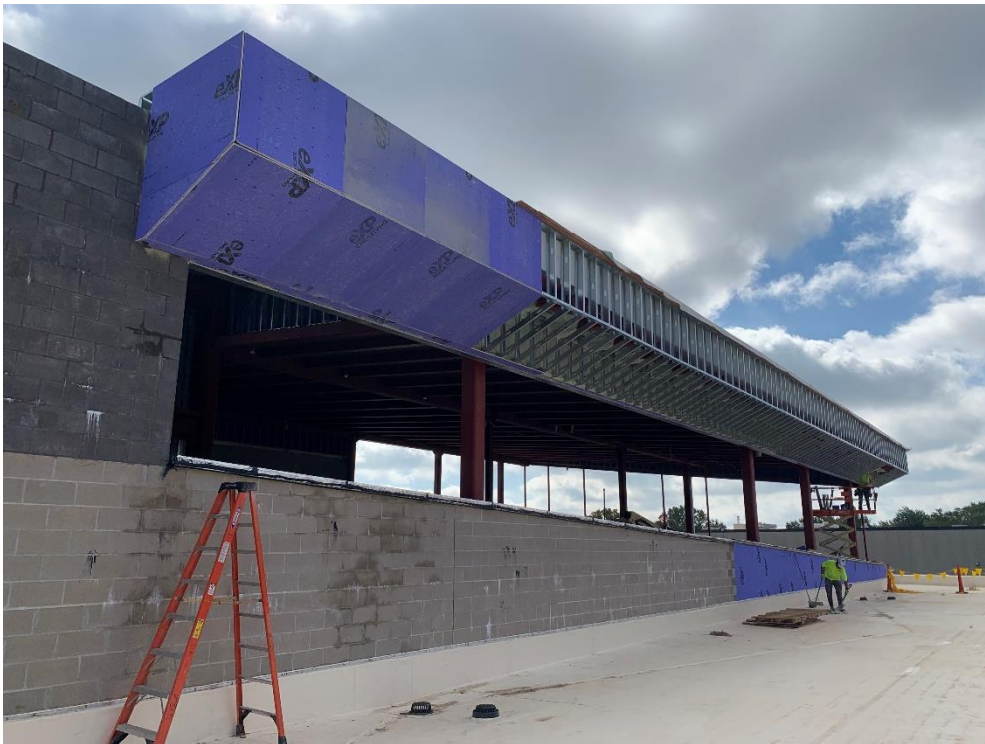
11. Area 1A – West clerestory cold form framing and sheathing board install in progress. Spray foam insulation has been applied.

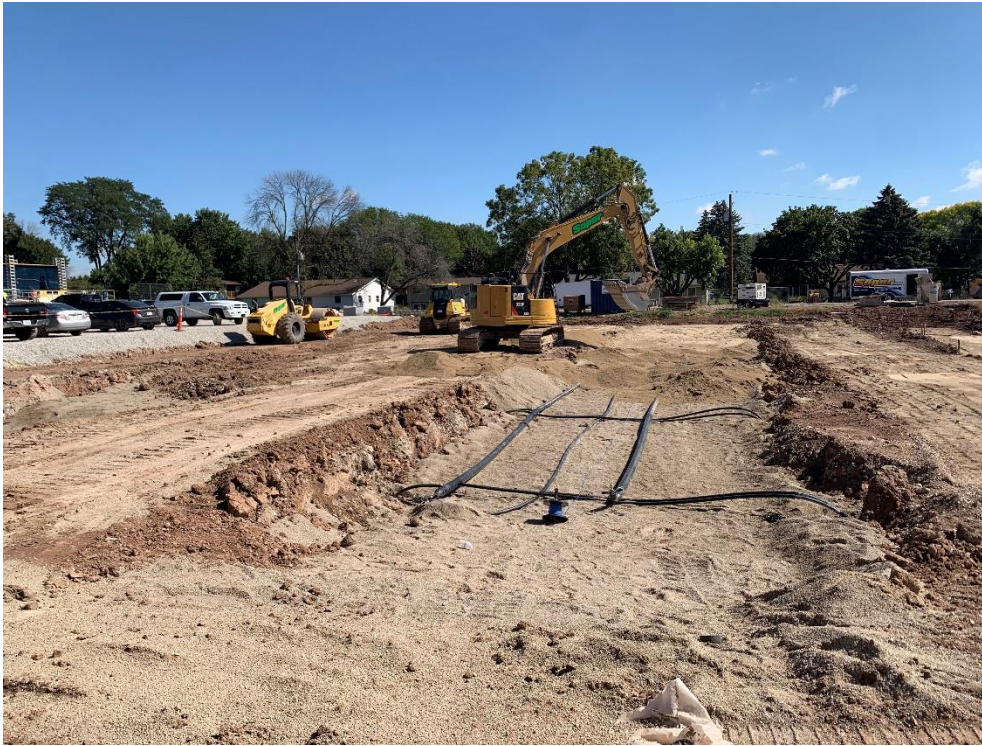
12. Geothermal piping connections to building and backfilling in progress.

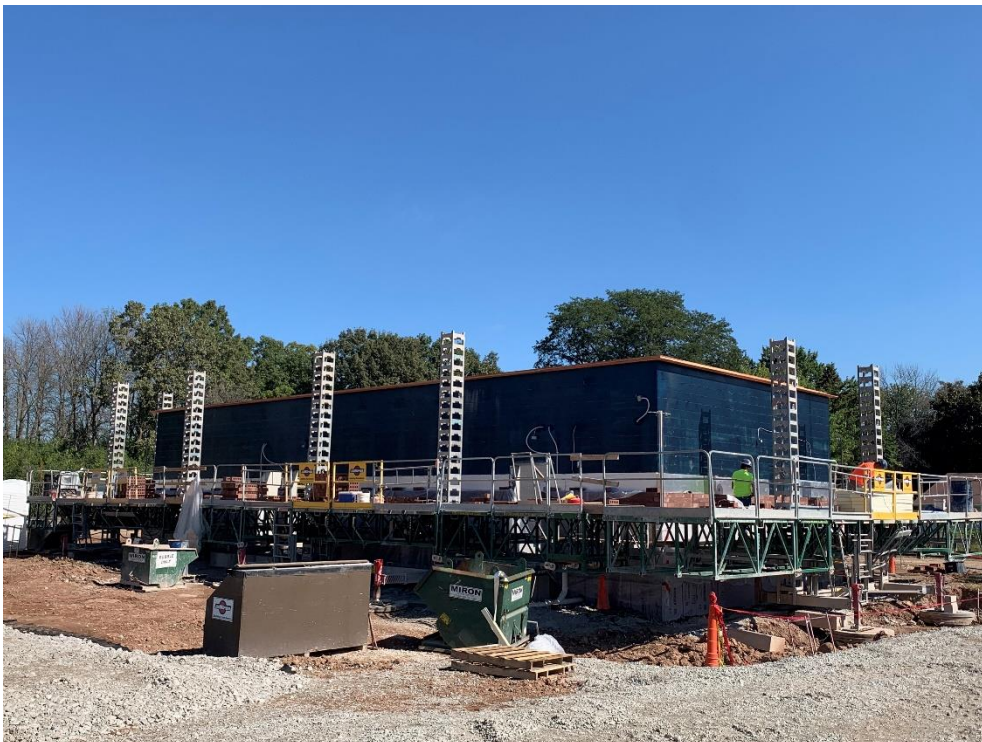
13. Locker room building masonry install in progress. Spray applied AVB and top of wall blocking installed.

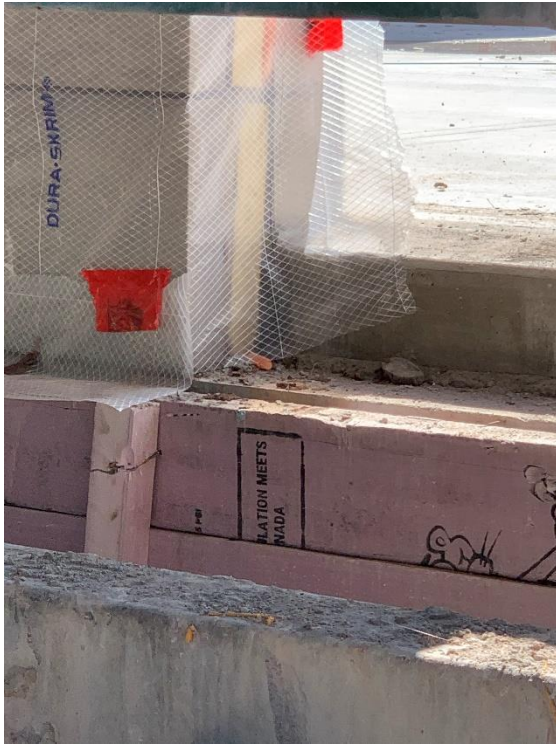
14. Locker room building board insulation at foundation wall and cavity wall installed. Cast stone panels installed.

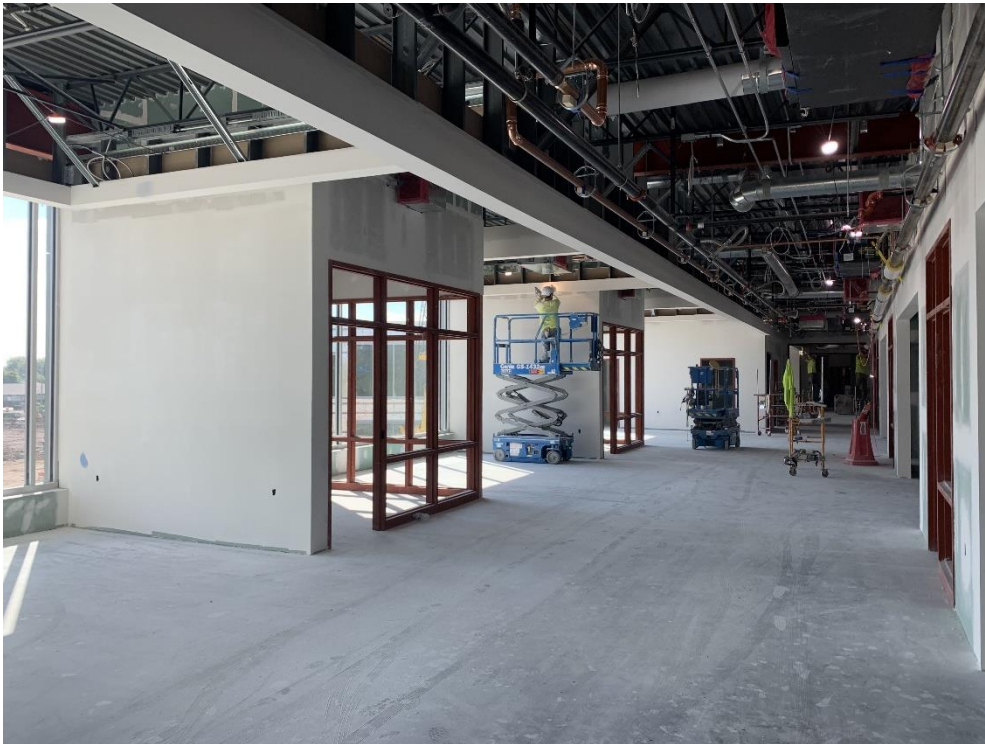
15. Area 6 North – Interior painting in collab area in progress. Above ceiling MEP installation continues.

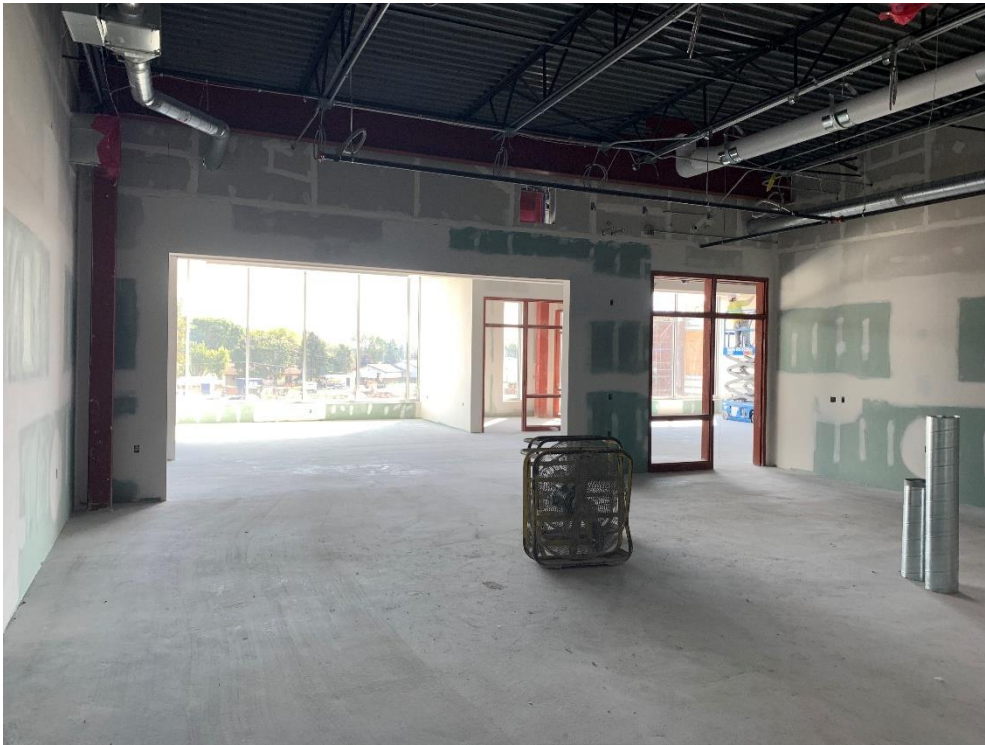
16. Area 6 North – Interior gyp board taping and mudding in progress. Above ceiling MEP installation continues.

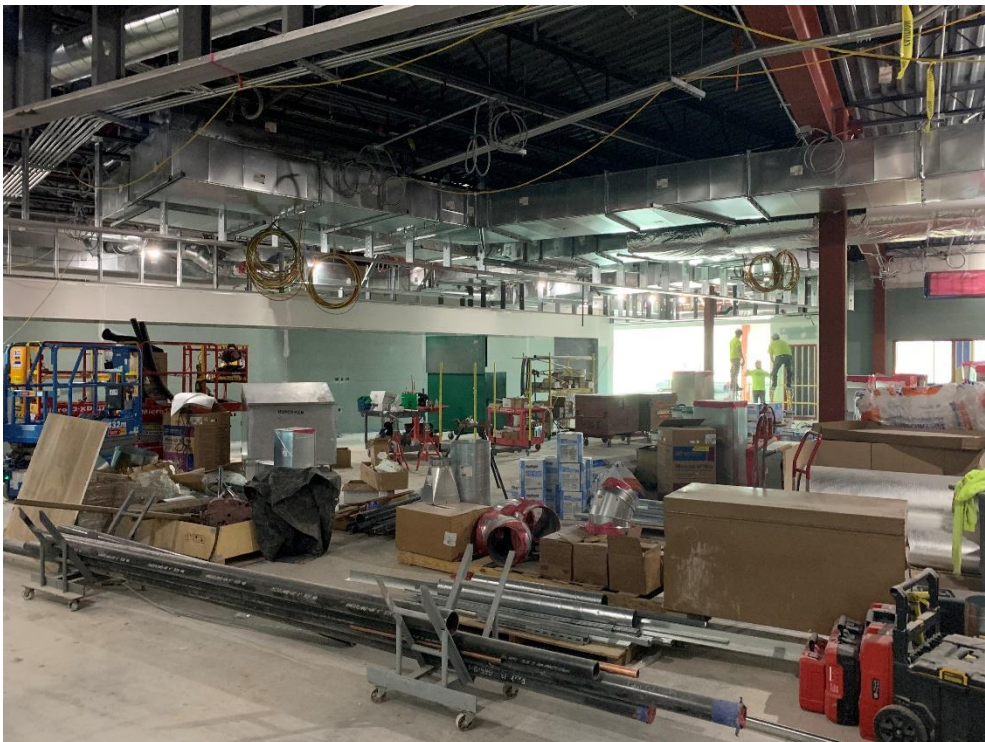
17. Area 5 - Above ceiling MEP installation and soffit cold form framing in progress.

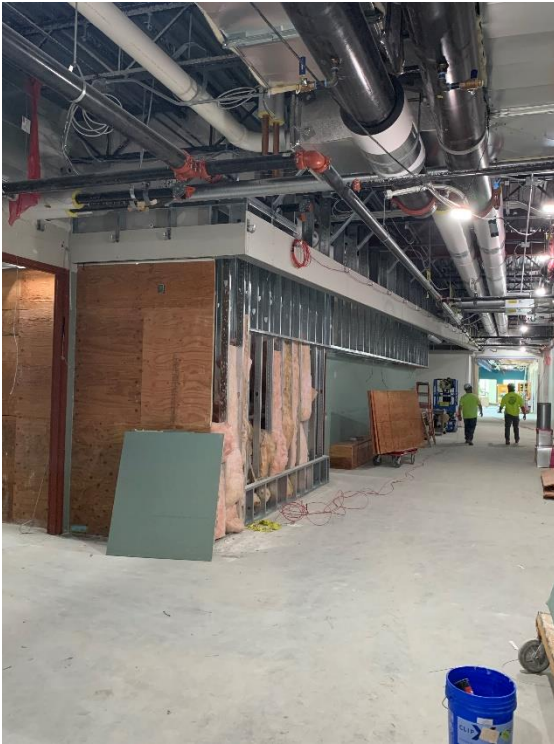
18. Area 6 – Grade wing entrance sheathing and gyp wrap install in progress. Geothermal pipe insulation install in progress.

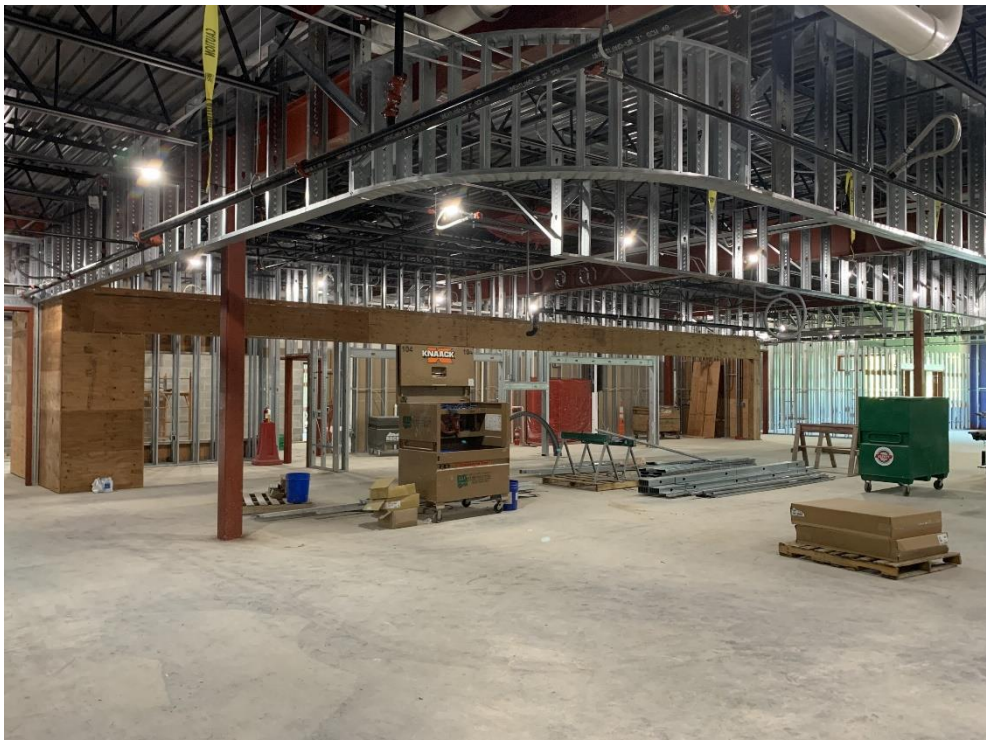
19. Area 4 – Soffit cold form framing and install of server accent plywood backing in progress. Sprinkler piping and above ceiling MEP install in progress.

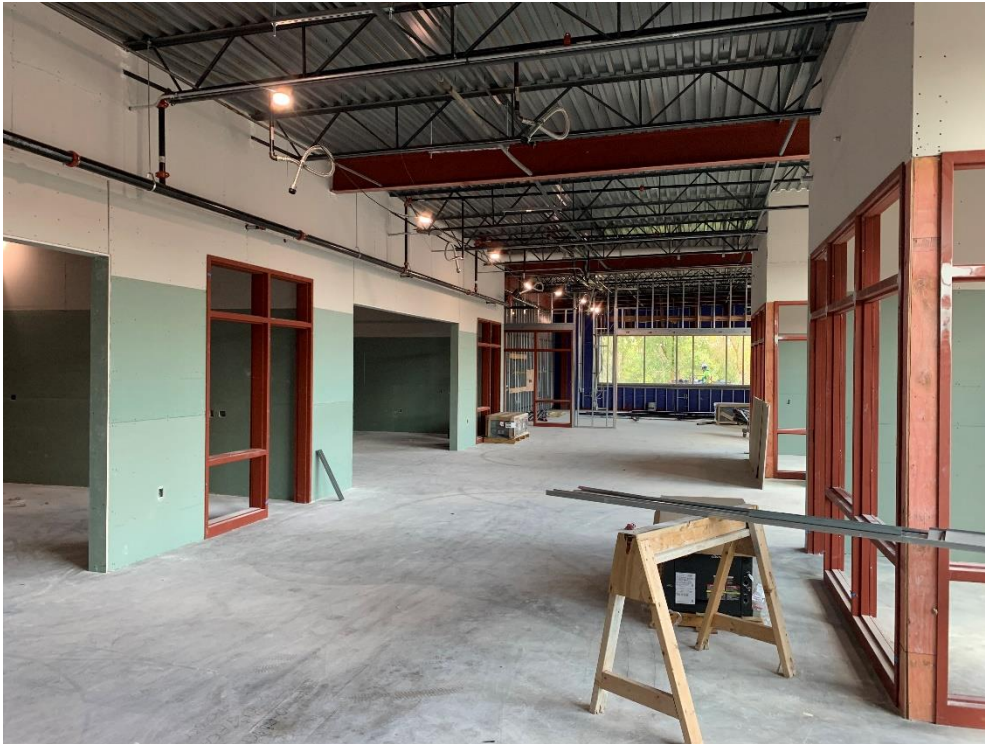
20. Area 4 West – Interior metal stud wall framing and gyp board install in progress. Sprinkler piping continues installation.

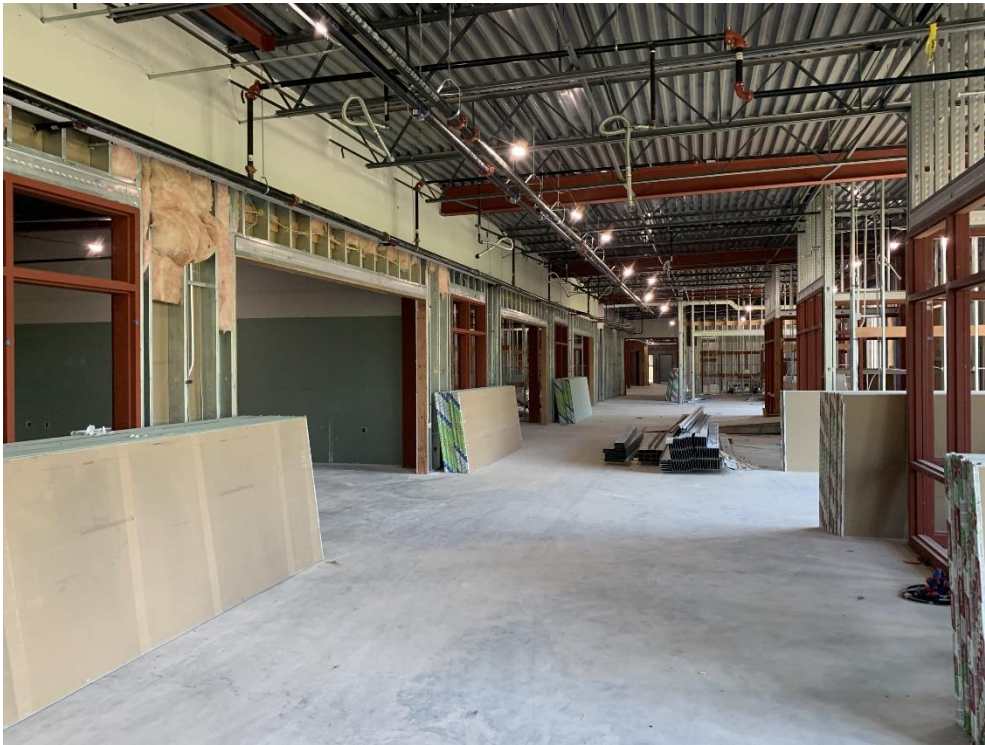
22. Area 4 – East metal stud framing, gyp board, and sprinkler piping install in progress.

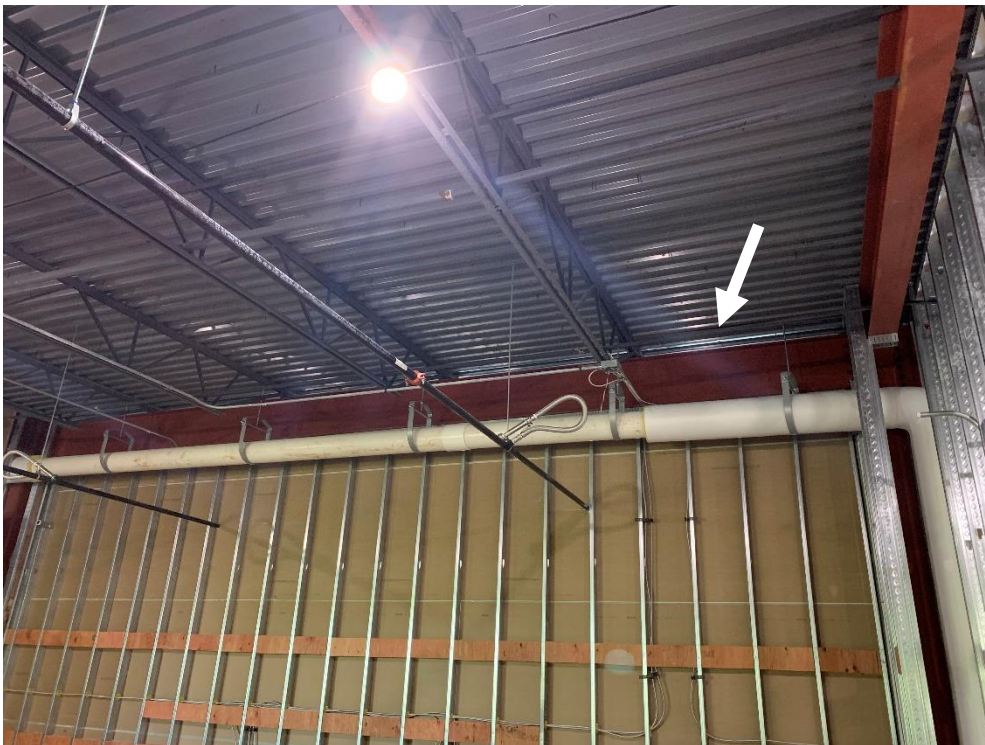
23. Area 4 – Install of gyp and sound insulation to deck at classroom demising walls in progress.

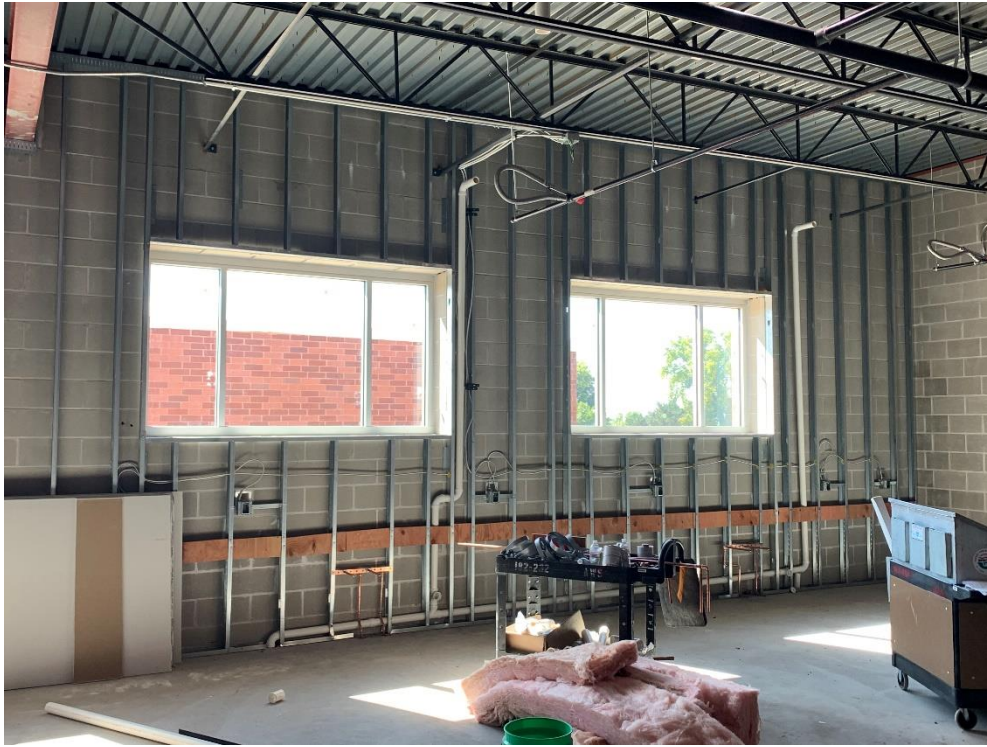
24. Area 3 – Exterior storefront installed. In wall plumbing and metal stud furring in progress.

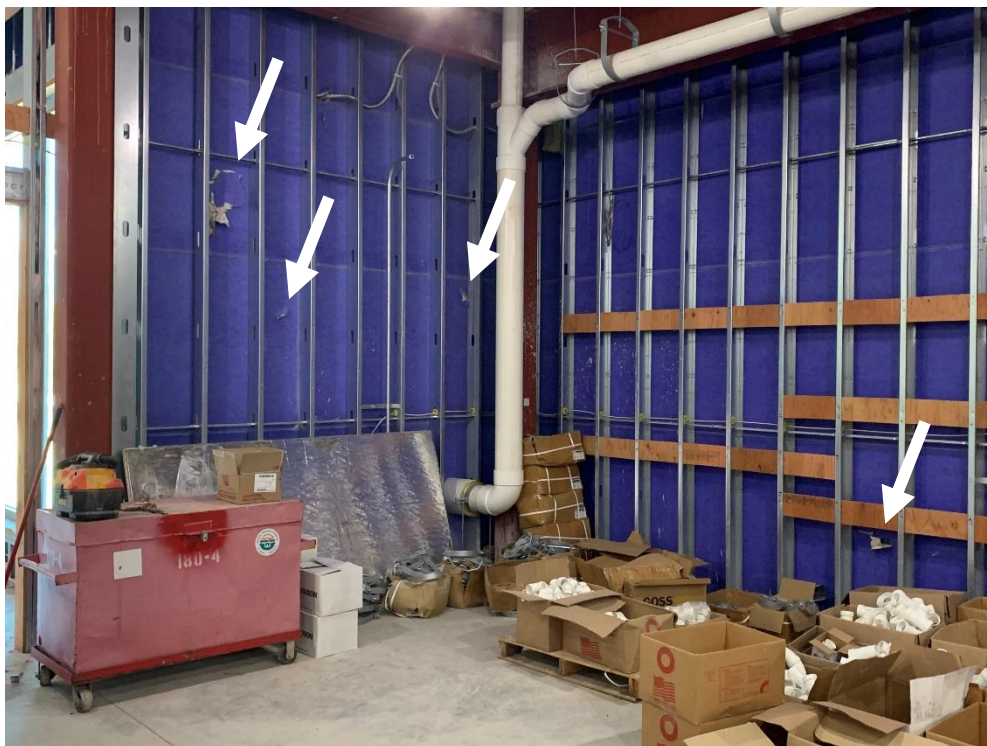
25. Area 3 Northeast – Damage to exterior sheathing board.

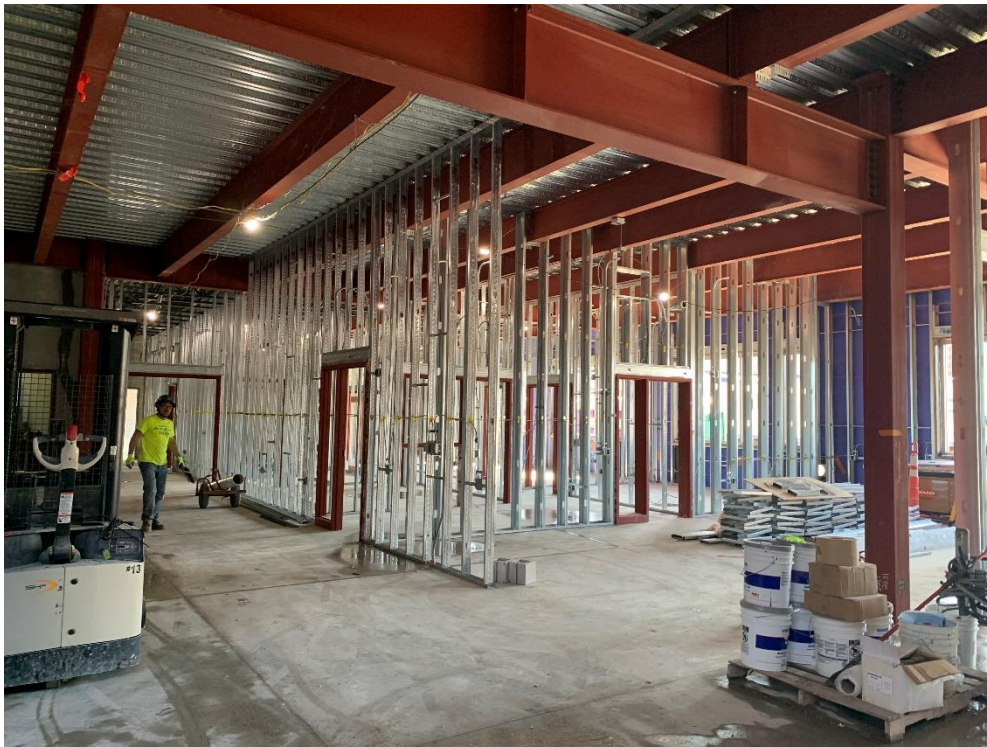
26. Area 1A – Interior metal stud wall framing install in progress at 7/8 school office area.

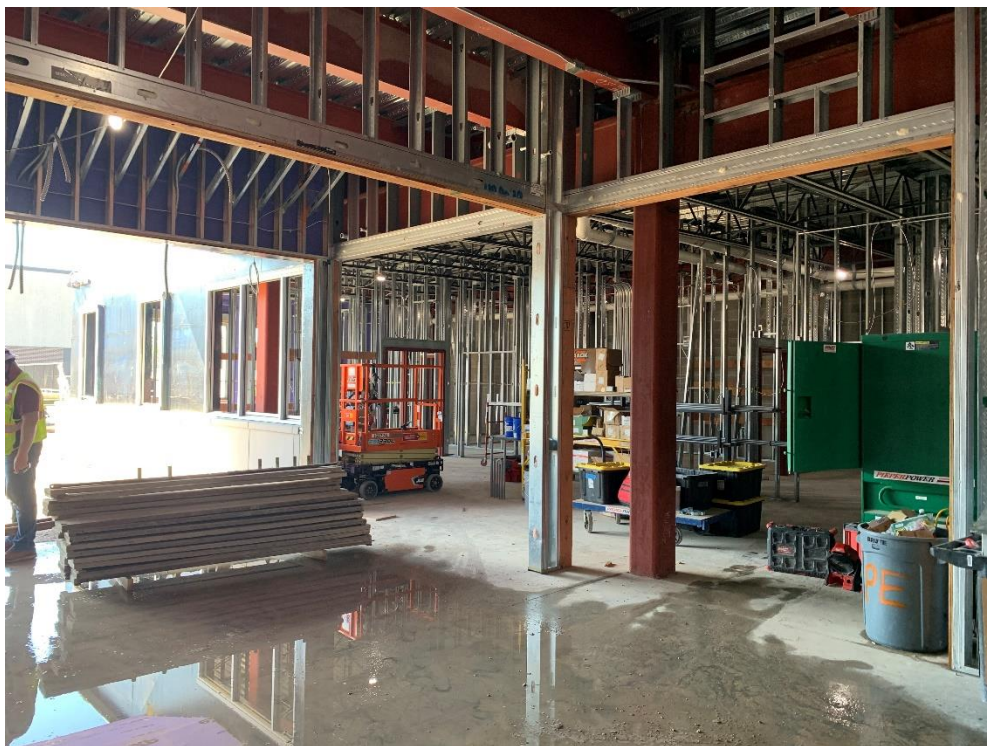
27. Area 1A – Interior metal stud wall framing install in progress at 5/6 school office area.

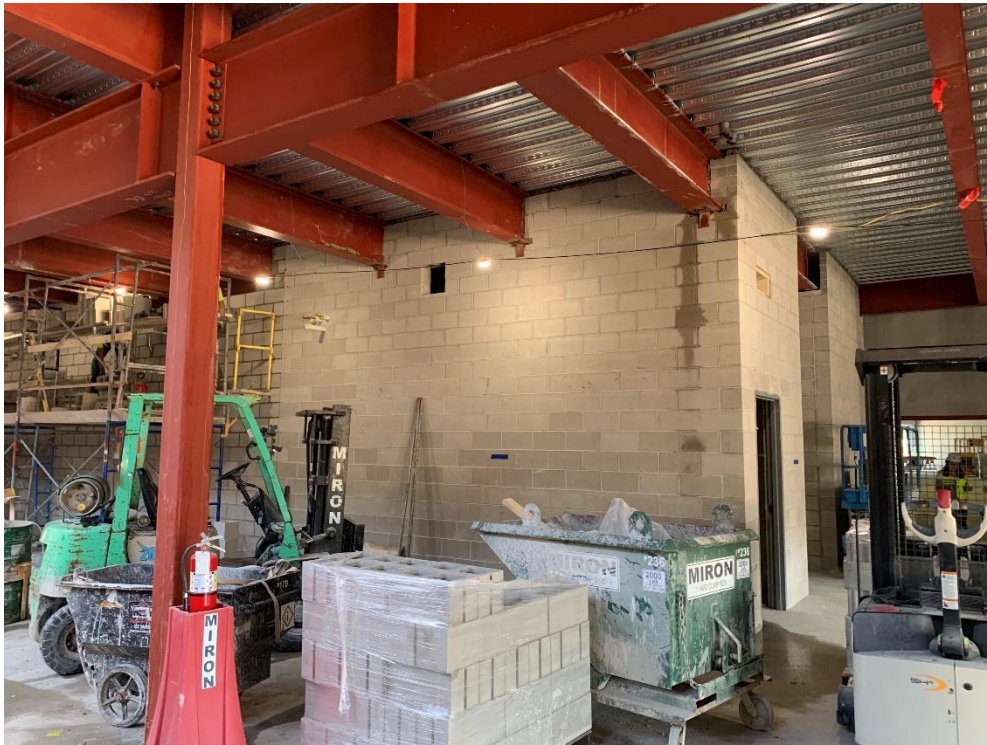
28. Area 1A – Interior cmu locker room walls are being laid.

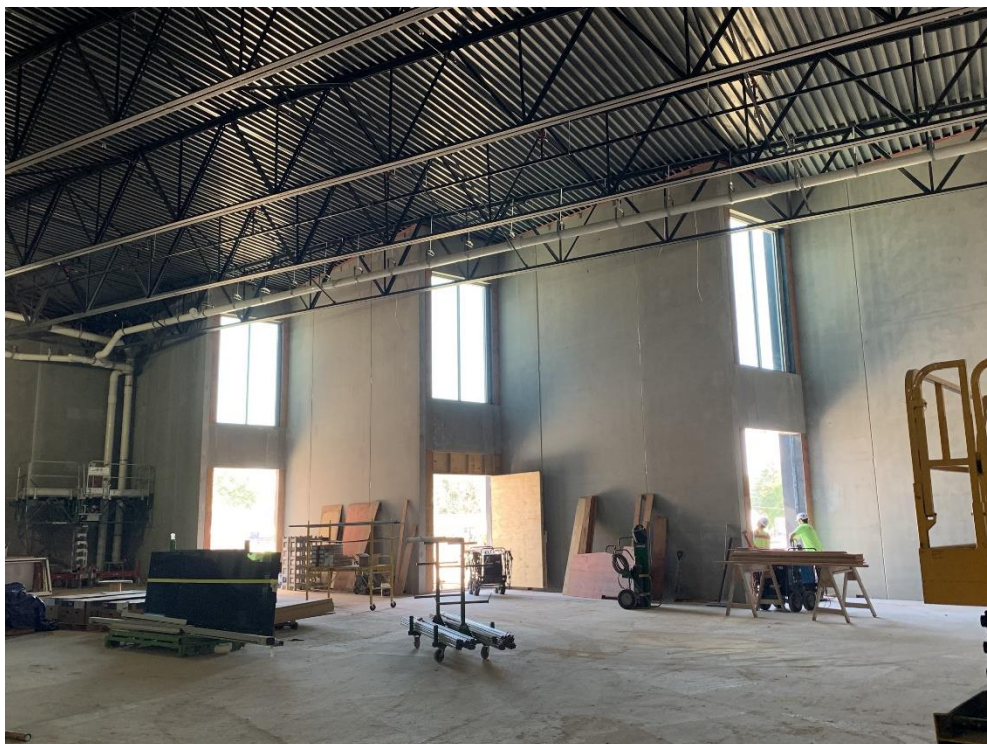
29. Area 6 – Install of exterior storefront at east gym wall in progress. Above ceiling MEP install in progress.

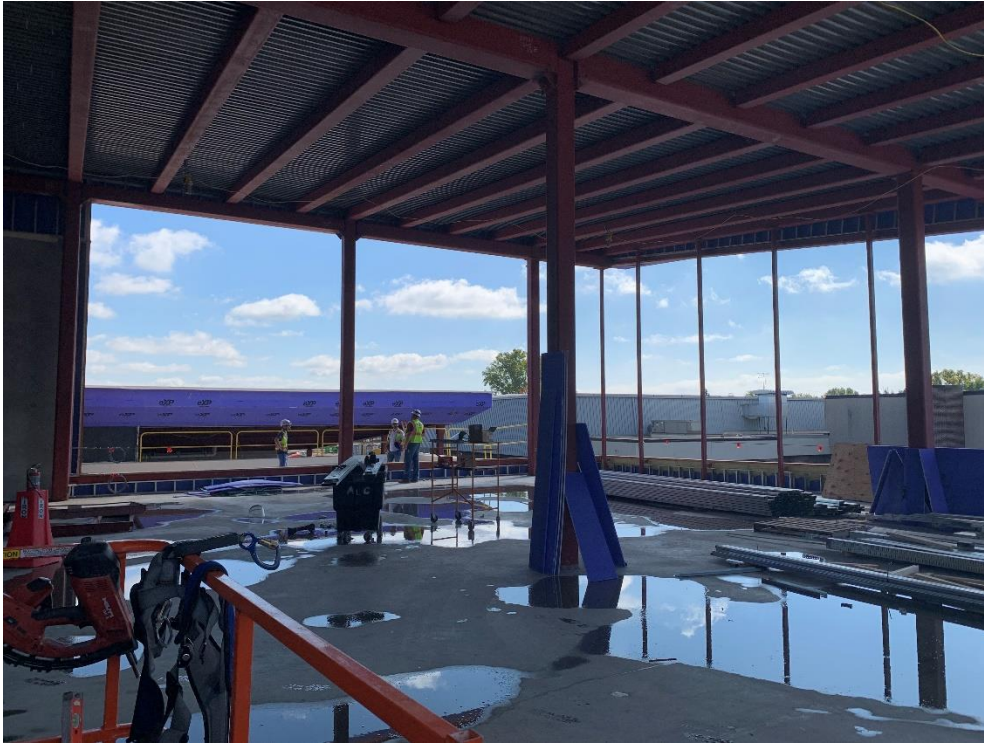
30. Area 1A LMC – Blocking for exterior curtainwall in progress.
