Construction Observation Report 013 – September 20, 2024

Maplewood School

PROJECT NUMBER: 321169-01

OWNER:	MENASHA JOINT SCHOOL DISTRICT
From ARCHITECT/ENGINEER:	EUA
To CONTRACTOR	MIRON CONSTRUCTION CO, INC
SITE OBSERVATION TYPE	ARCHITECTURAL
DATE OF ISSUANCE:	October 2, 2024

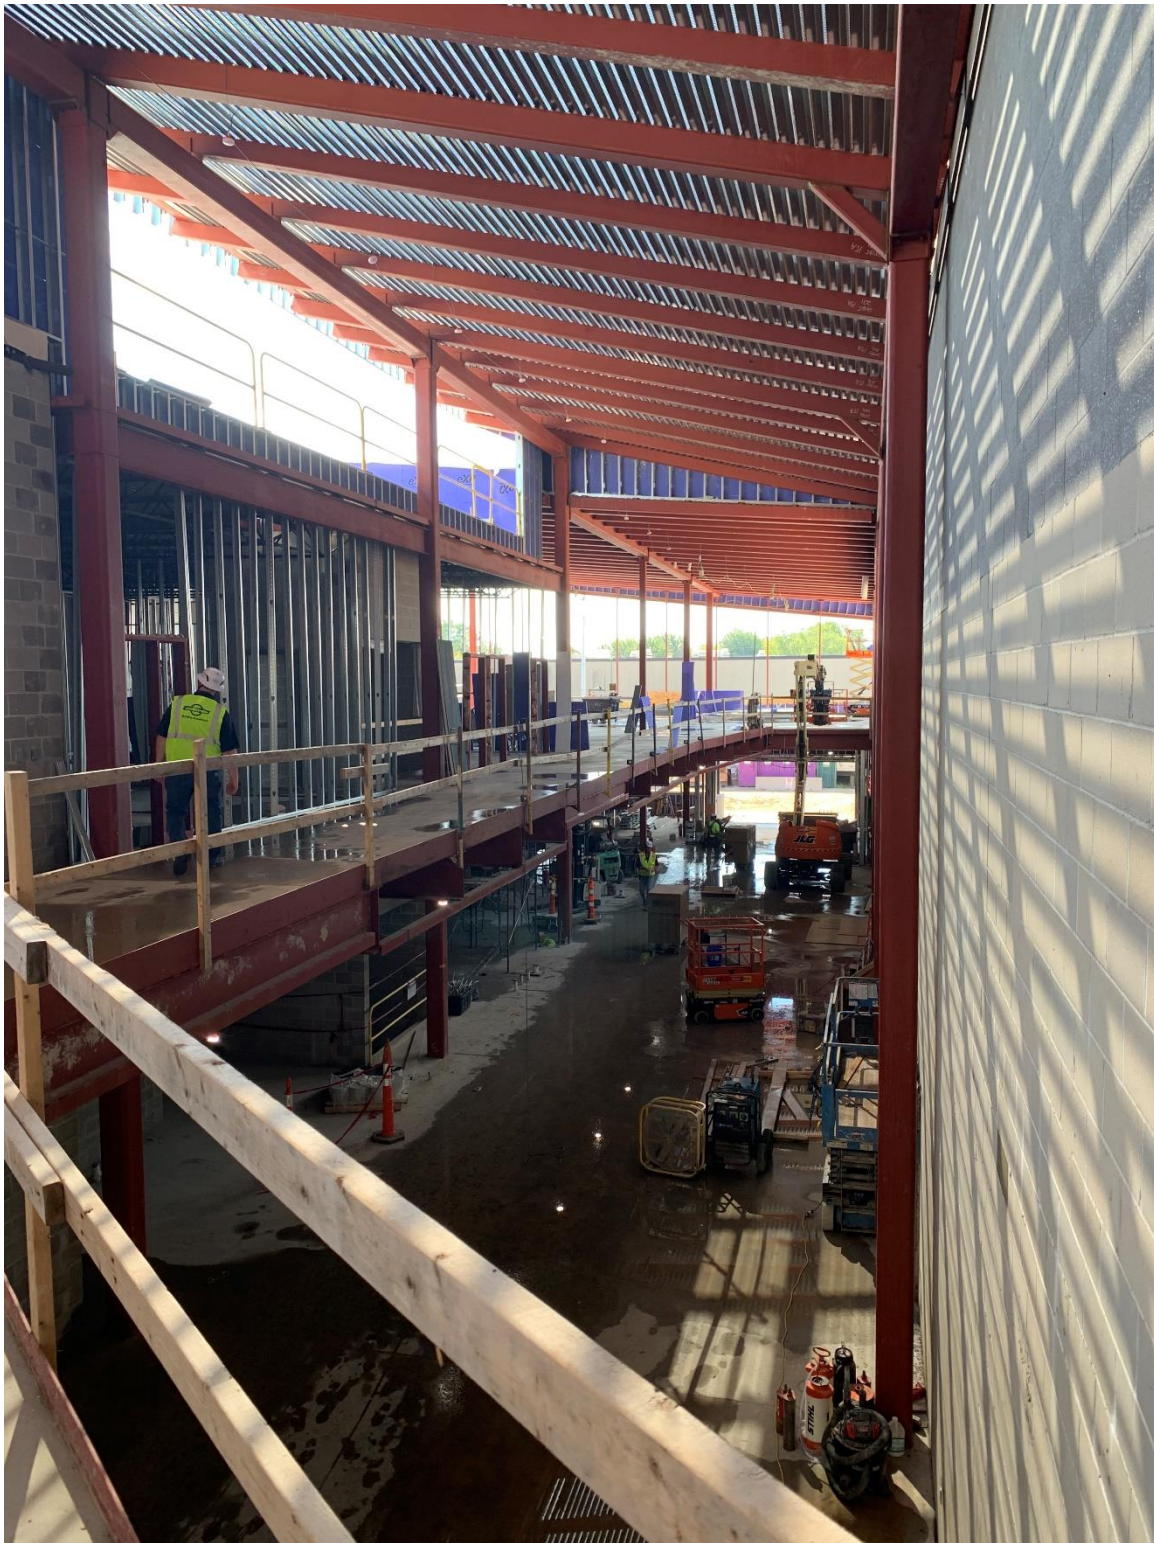
31. Area 1A – Exterior framing and sheathing install in progress. Interior metal stud wall framing in progress.
