# Construction Observation Report 018 – November 22nd, 2024

Maplewood School

PROJECT NUMBER: 321169-01

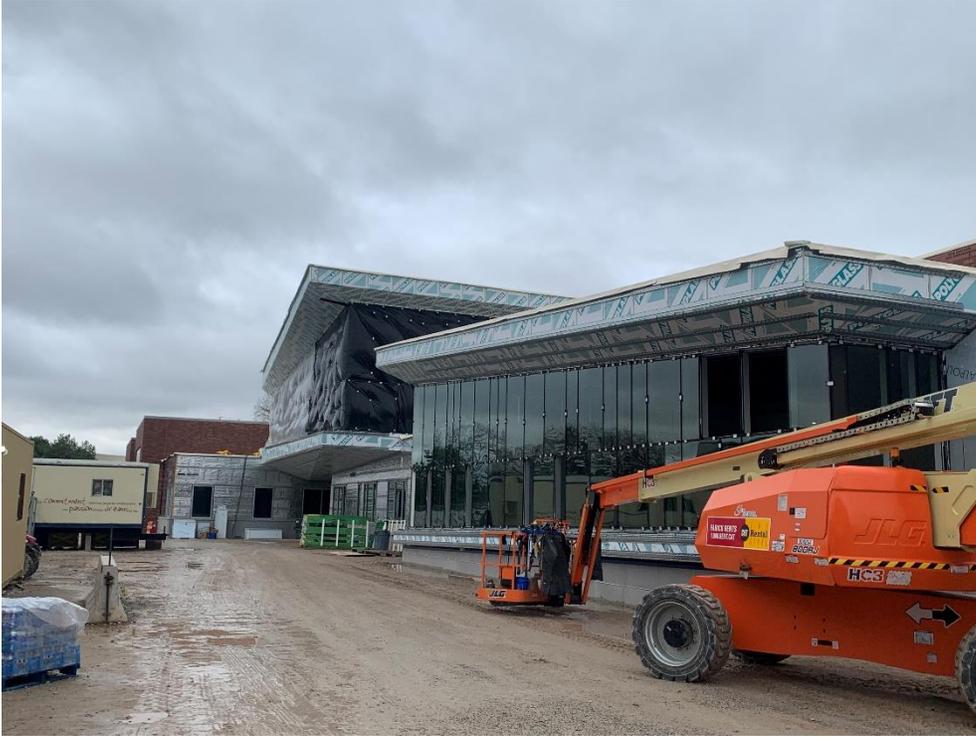
1. Area 1A & 2B South – Curtainwall glazing, blue metal flashing, board insulation, and metal girt system install continues.

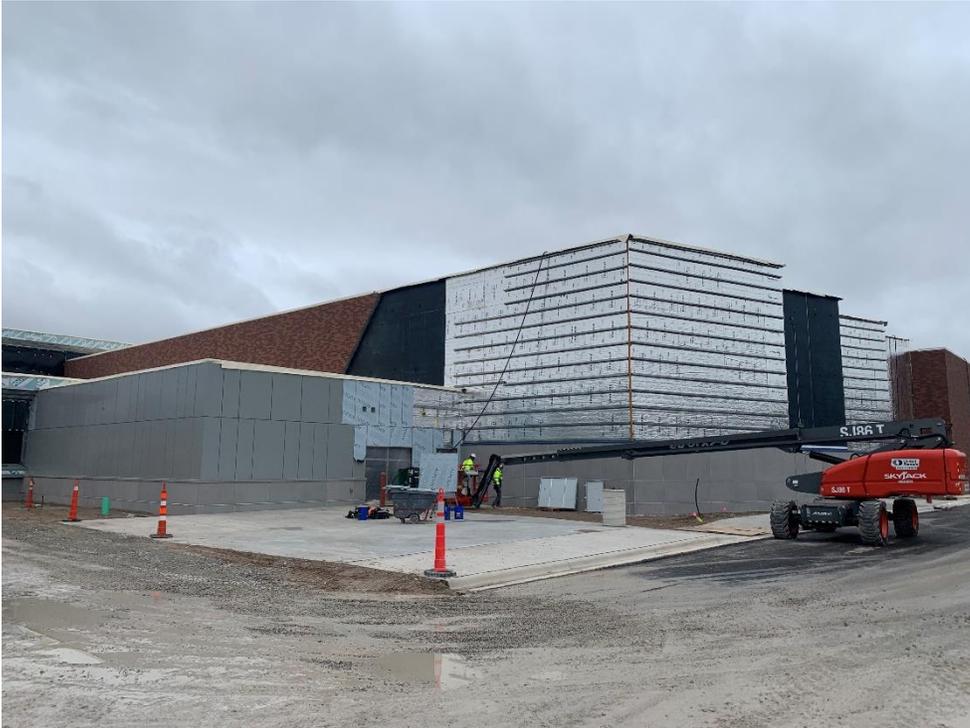
2. Area 2B & 6 Southeast – Composite wall panel on athletic storage nearing completion. Board insulation and metal girt system install continues on gym.

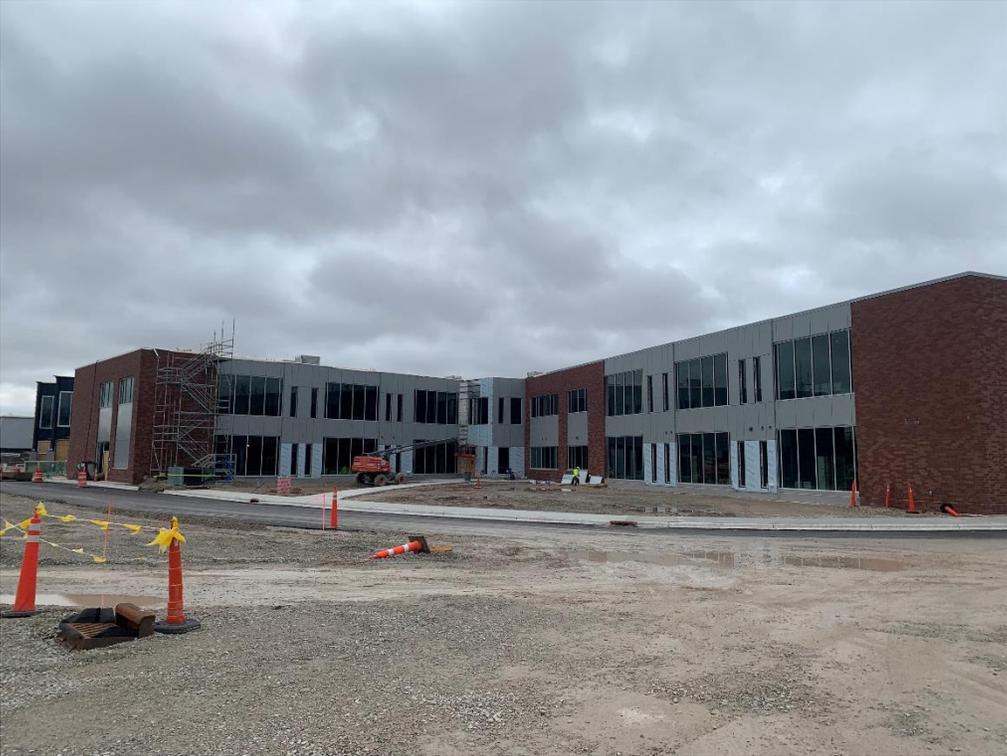
3. Area 5 & 6 Northeast – Composite wall panel install near completion. Metal coping install in progress. Exterior electrical device install beginning.

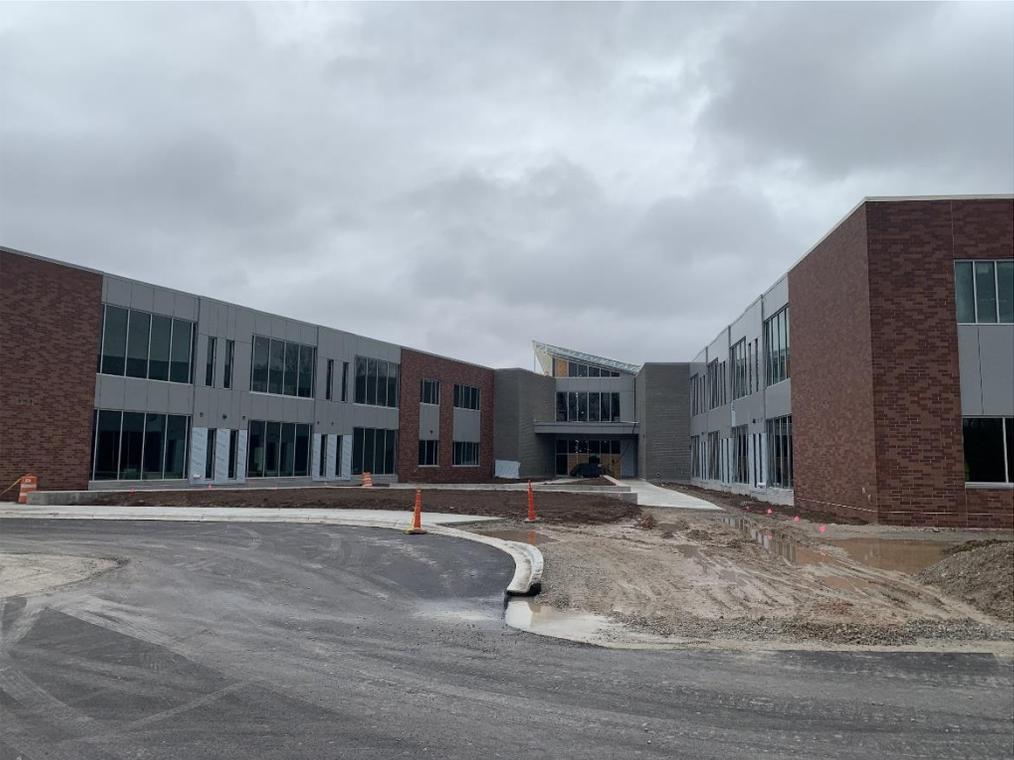
4. Area 1B North – Composite wall panel install near completion. Metal coping install in progress. Site paving, curb, and sidewalk continues to progress around site. Exterior electrical device install beginning.

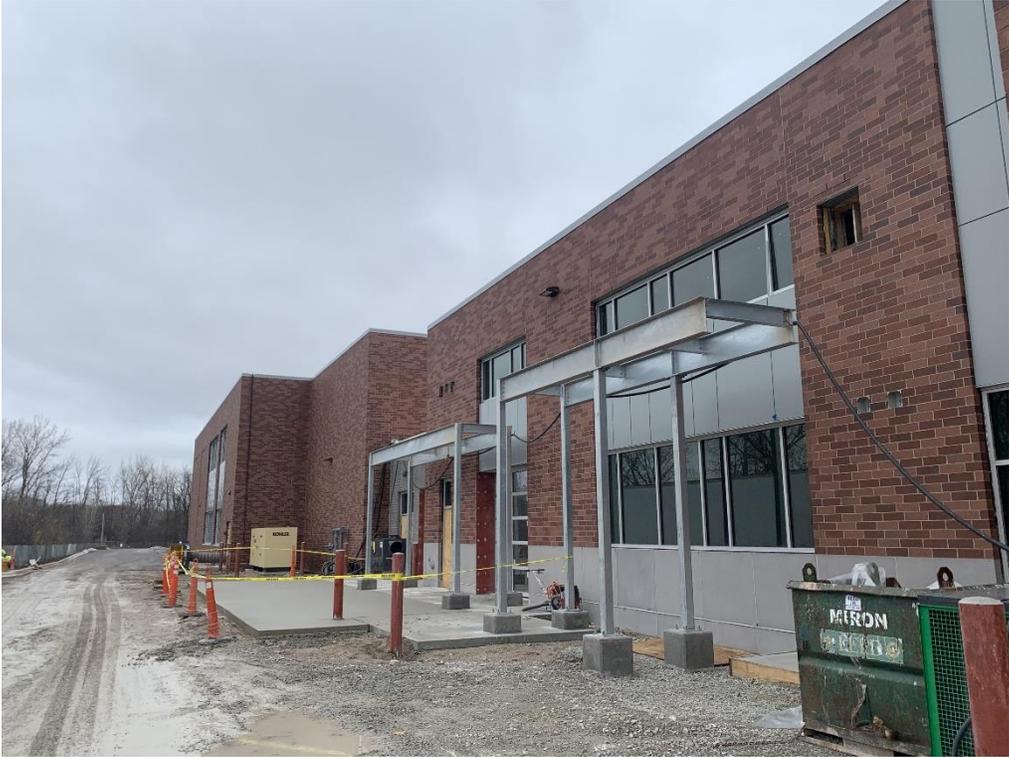
6. Area 3 West – Metal coping installed. Concrete apron to receiving doors poured. Exterior electrical device install beginning.

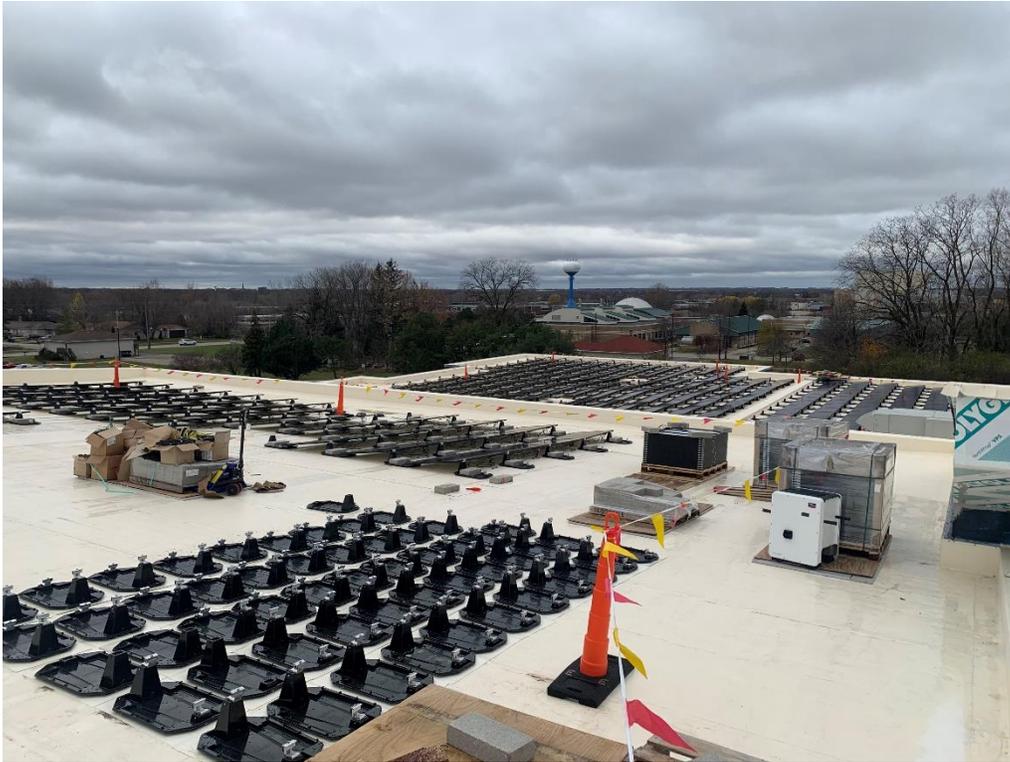
7. Area 1A & 2B – Rooftop solar array install continues.

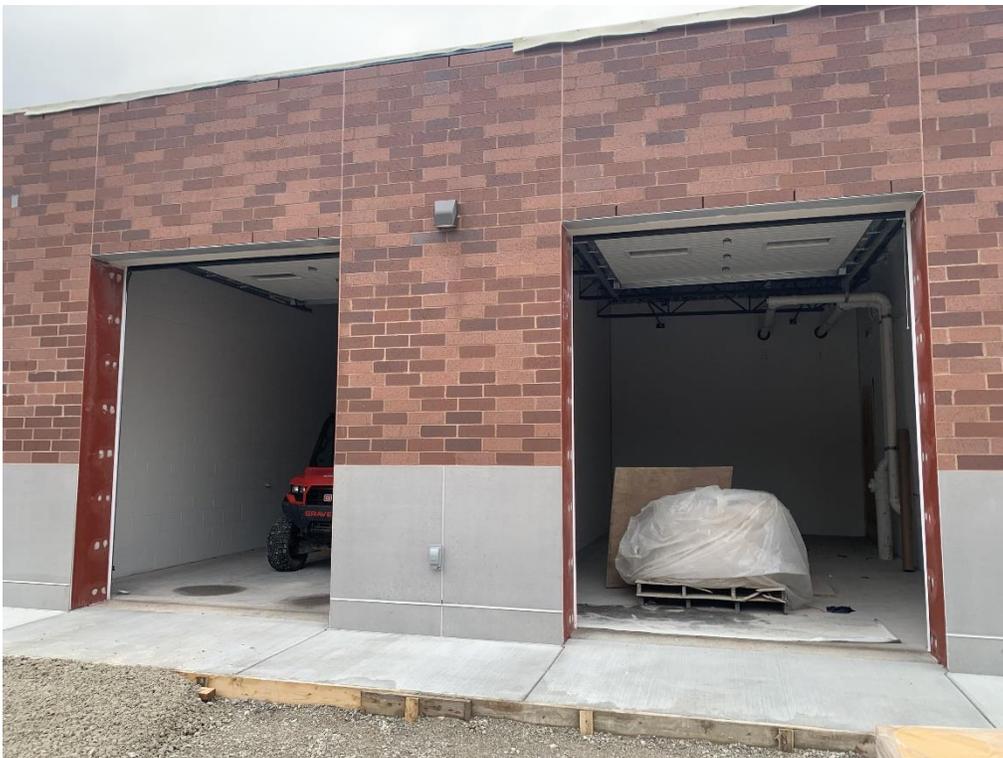
8. Locker Room Building – Overhead doors installed. Exterior electrical device install beginning.

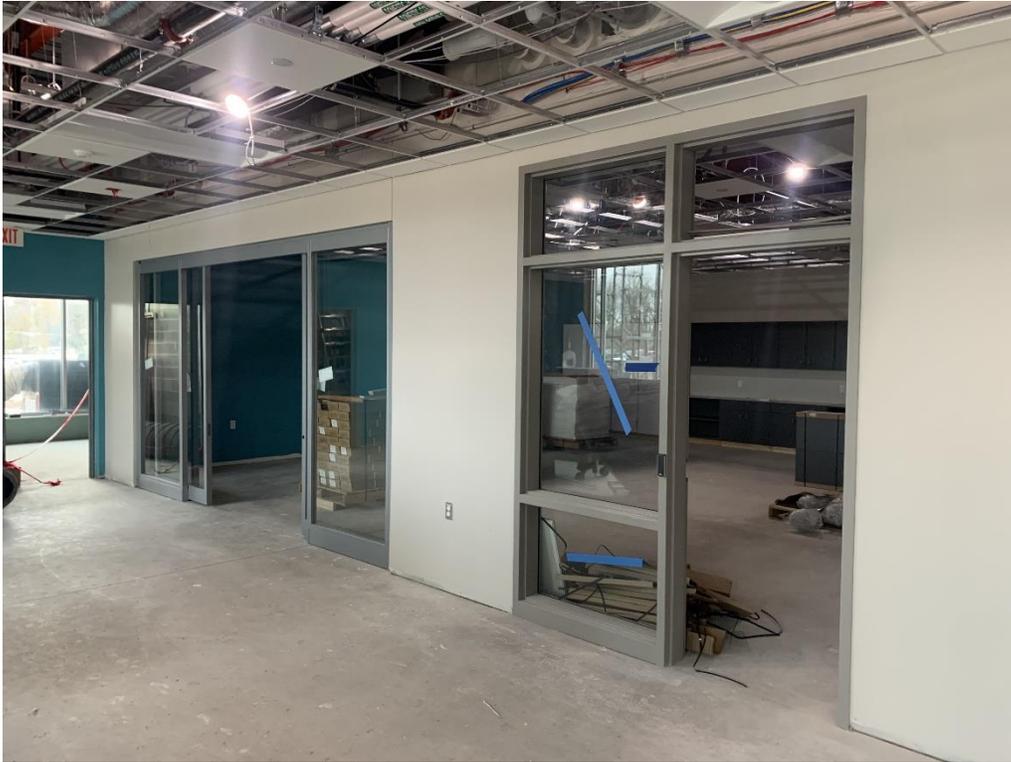
9. Area 6 North – Sliding door system install beginning at first floor classrooms.

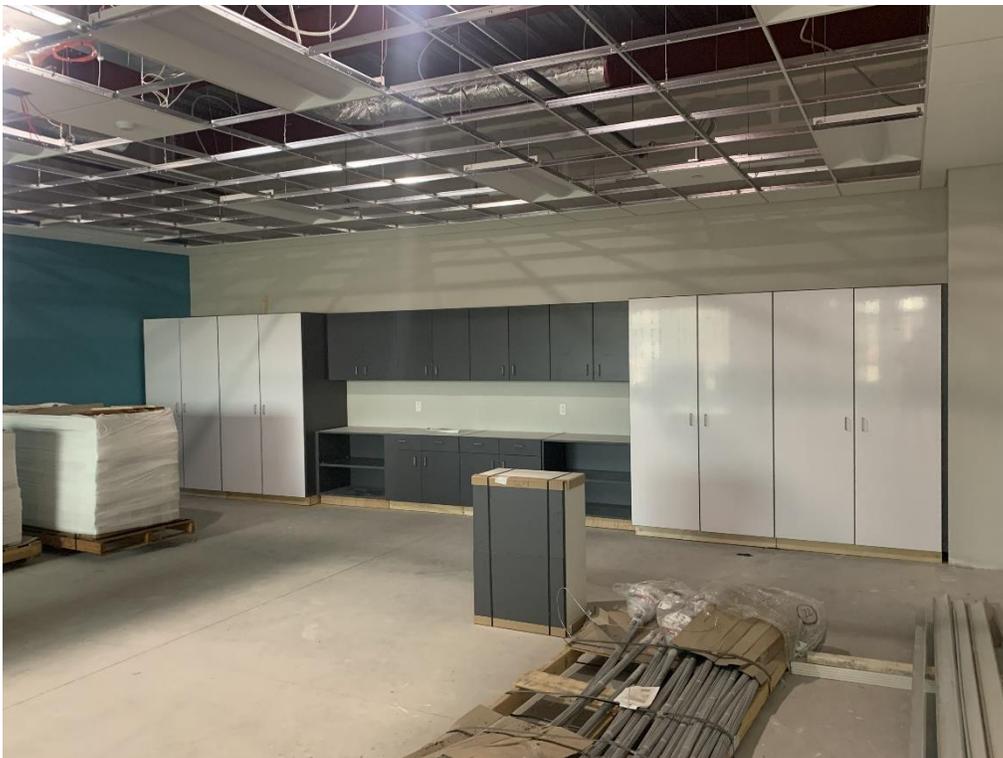
10. Area 6 North - Casework install beginning at first floor classrooms.

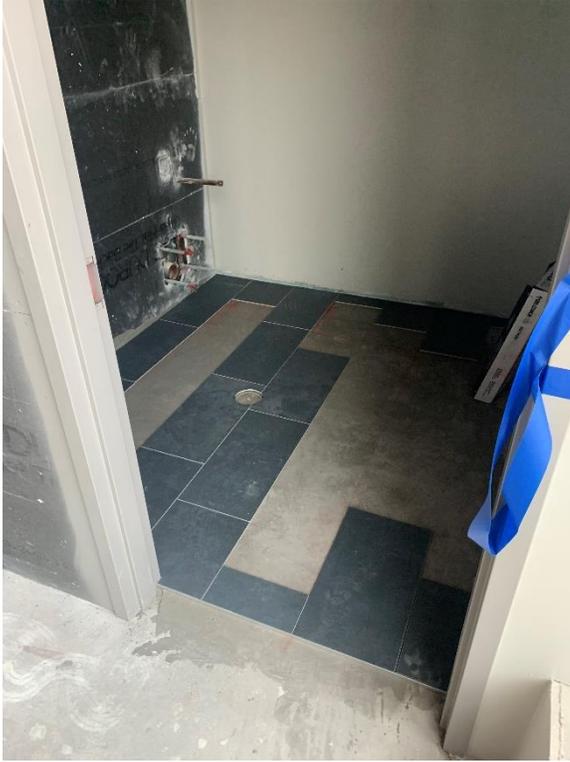
11. Area 6 North – First floor tile install beginning.

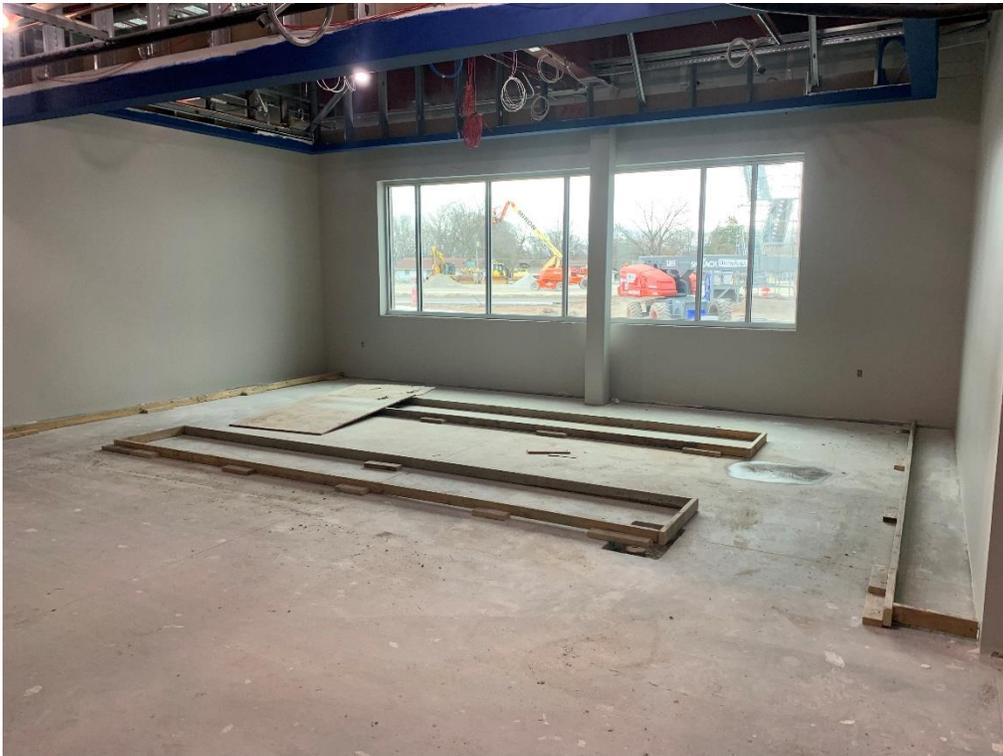
12. Area 5 – Forms for concrete locker pads are in progress.

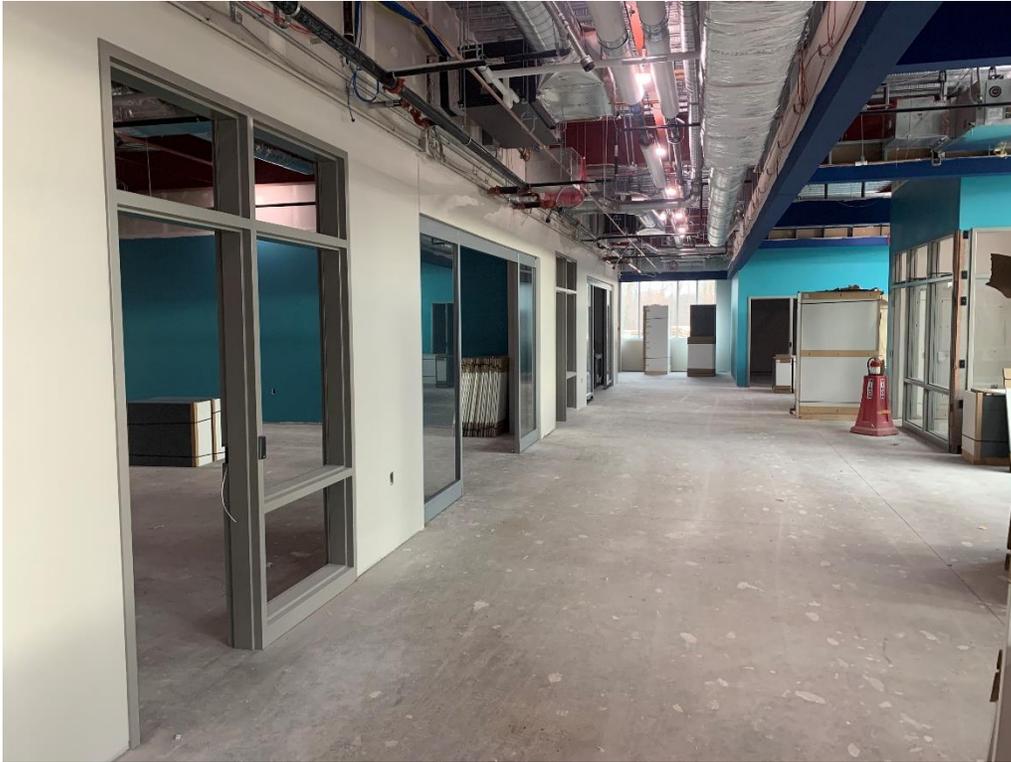
13. Area 5 – First floor classroom glass sliding doors, interior storefront glazing, and casework install are in progress.

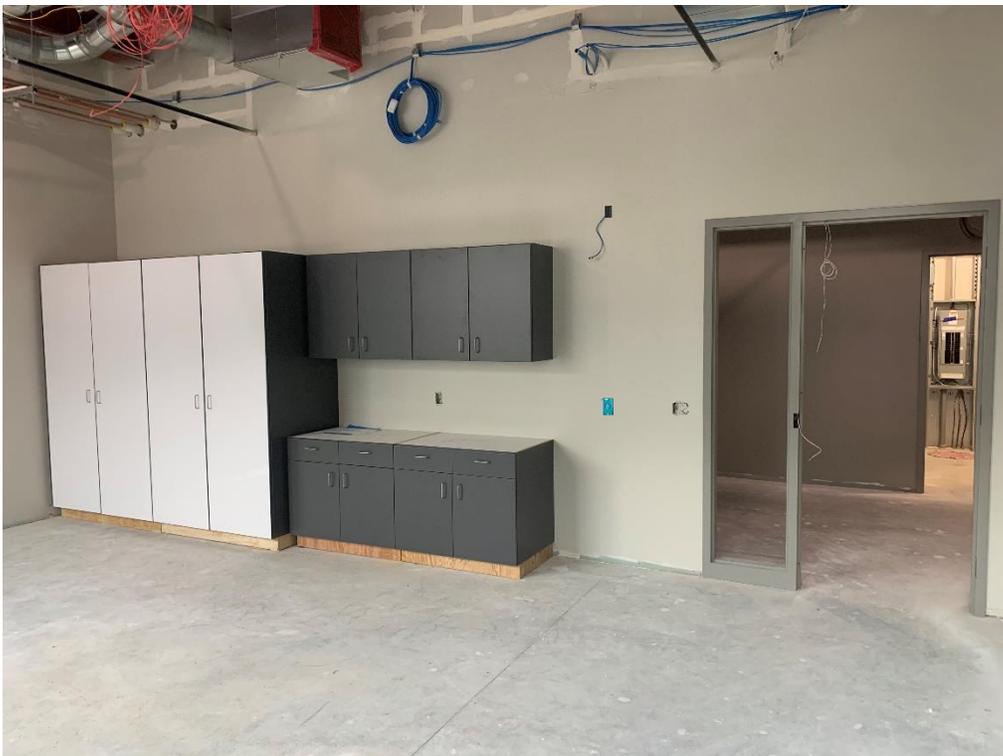
14. Area 5 – Casework install in first floor special ed and student support spaces in progress.

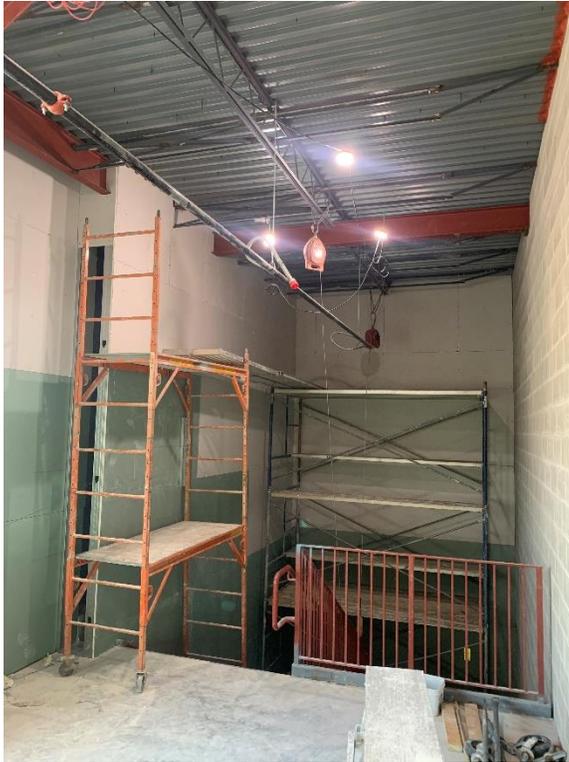
15. Area 6 – Gyp board install in east stairwell near completion.

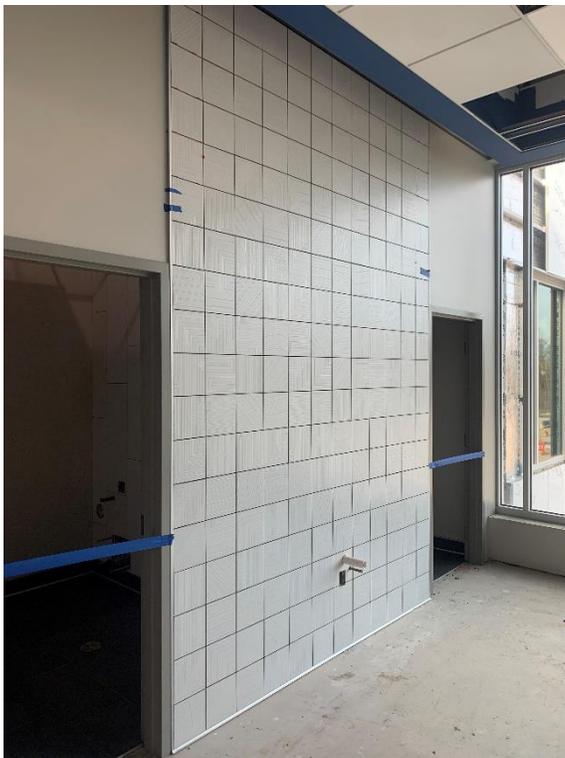
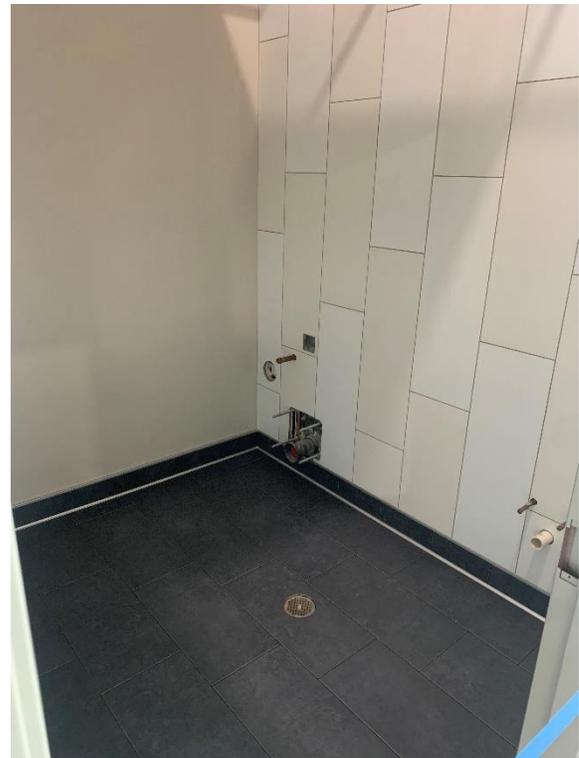
16. Area 6 – Wall and floor tile install at second floor continues.

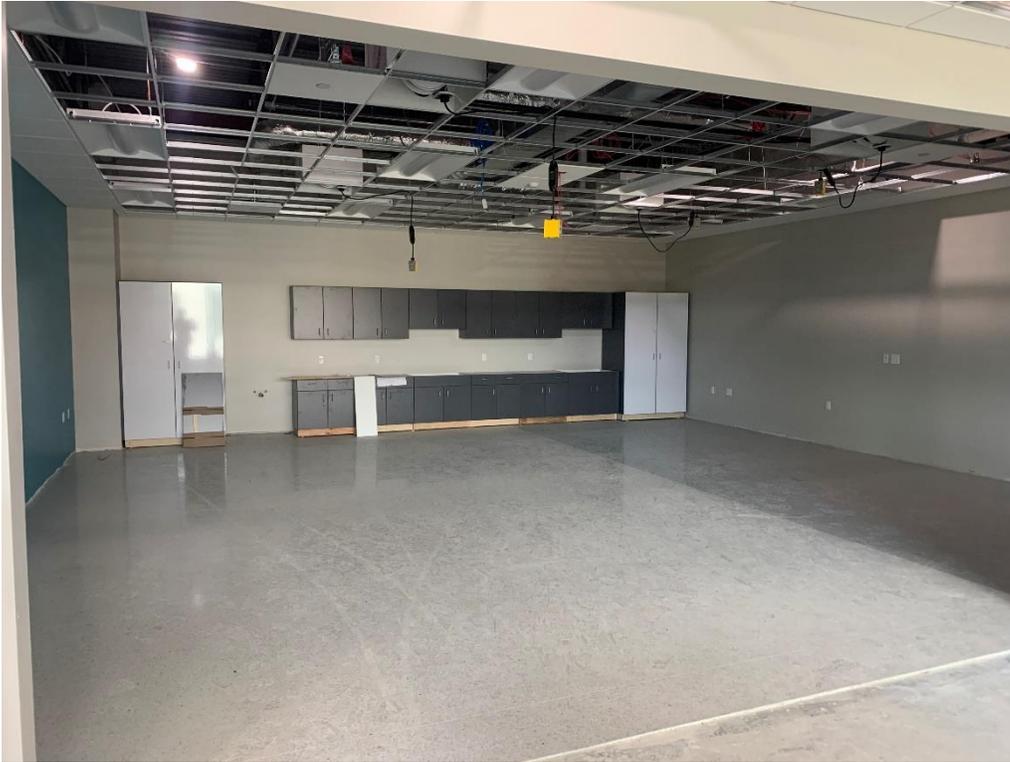
17. Area 6 North – Second floor classroom casework install in progress.

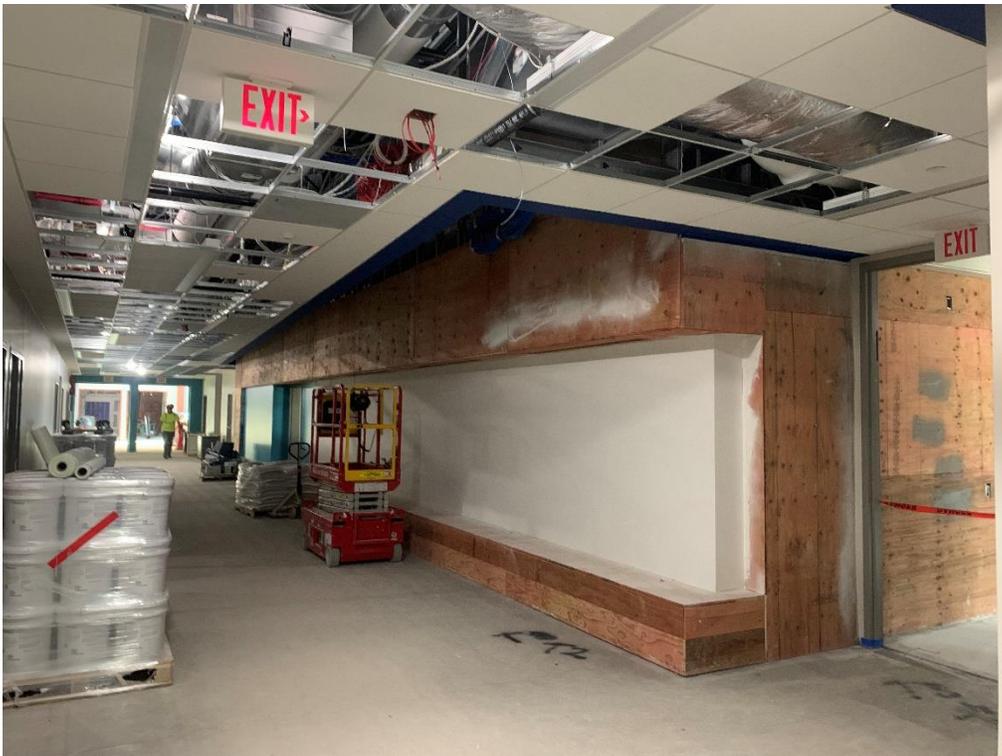
18. Area 6 – Second floor gradeweging entry corridor ceiling grid installed. Electrical fixture install in progress.

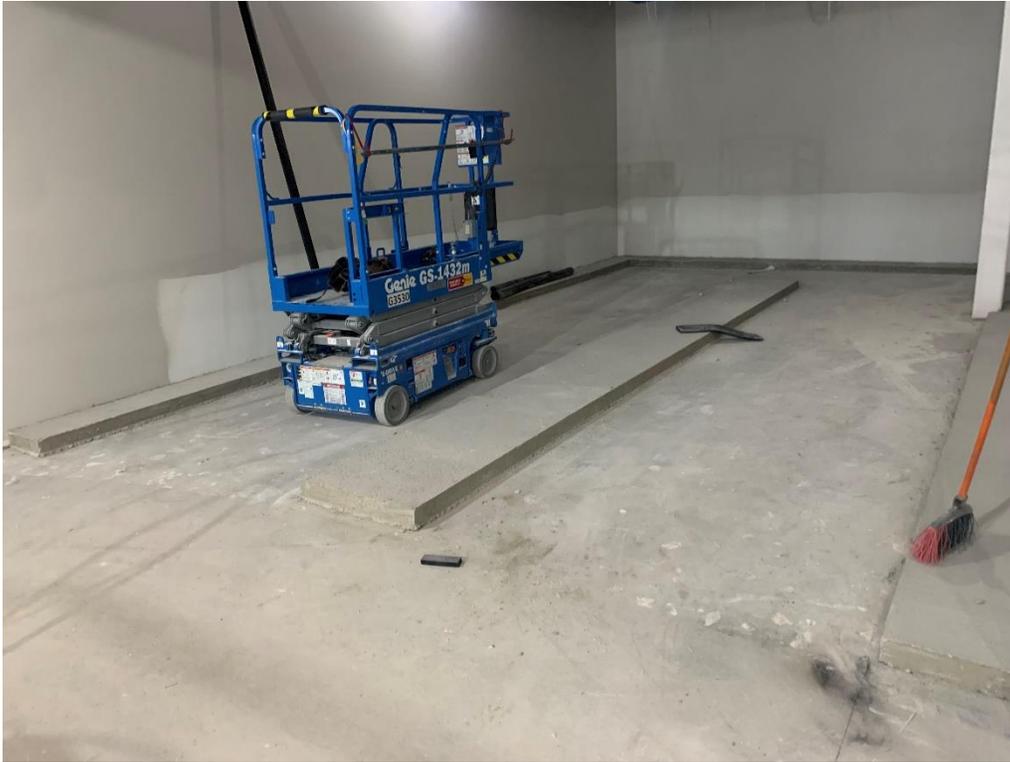
19. Area 5 – Second floor locker pads installed.

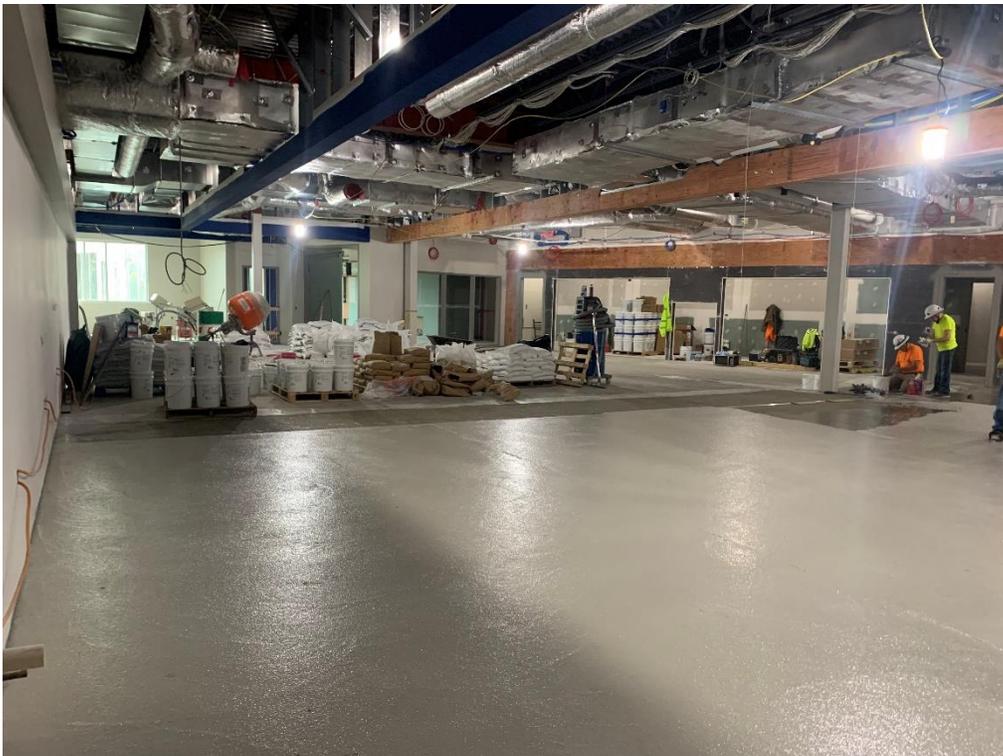
20. Area 5 – Second floor flex café terrazzo flooring install in progress.

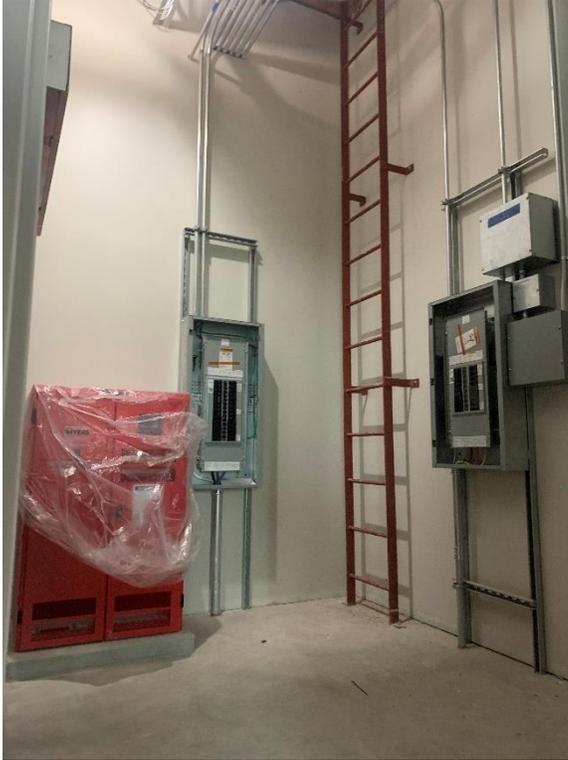
19. Area 5 – Equipment install in electrical and data rooms continues.

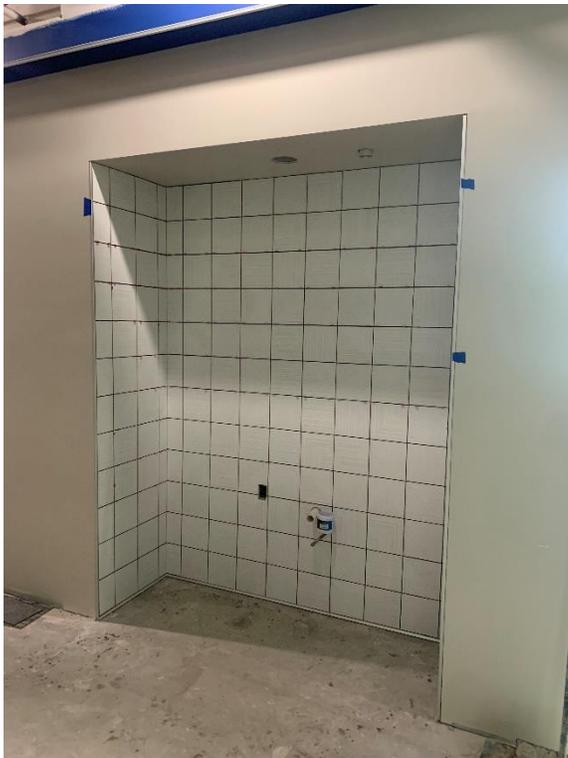
20. Area 5 – Tile install at second floor continues.

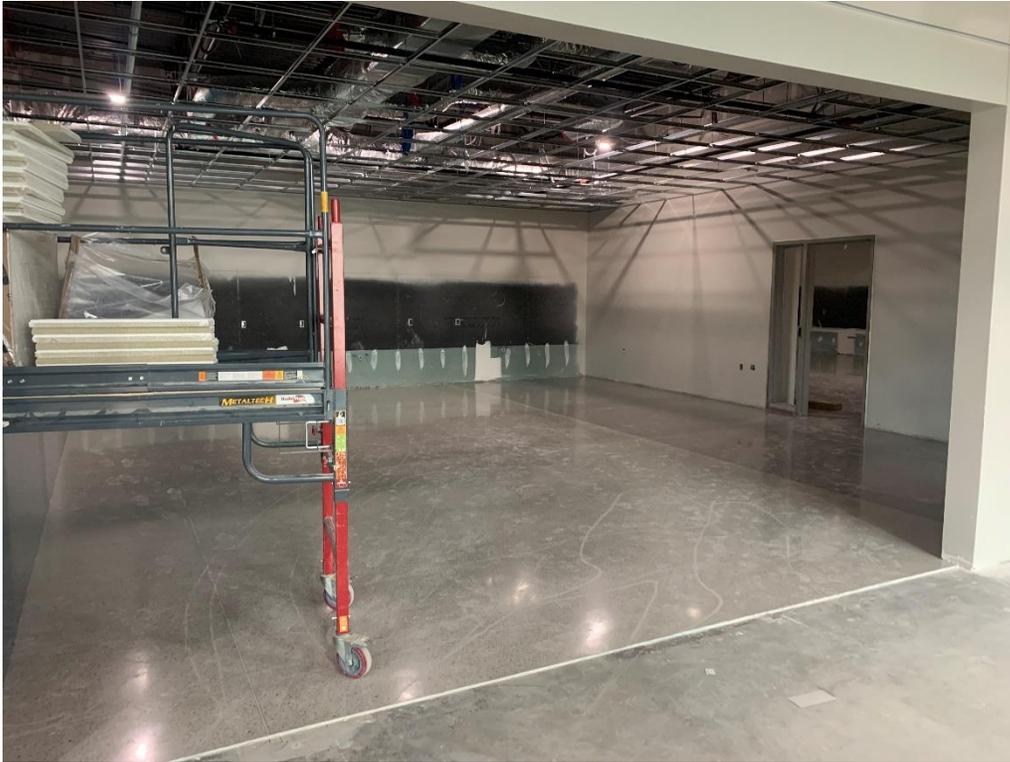
21. Area 5 – Second floor science lab and classroom terrazzo flooring installed. Classroom ceiling grid install continues throughout area.

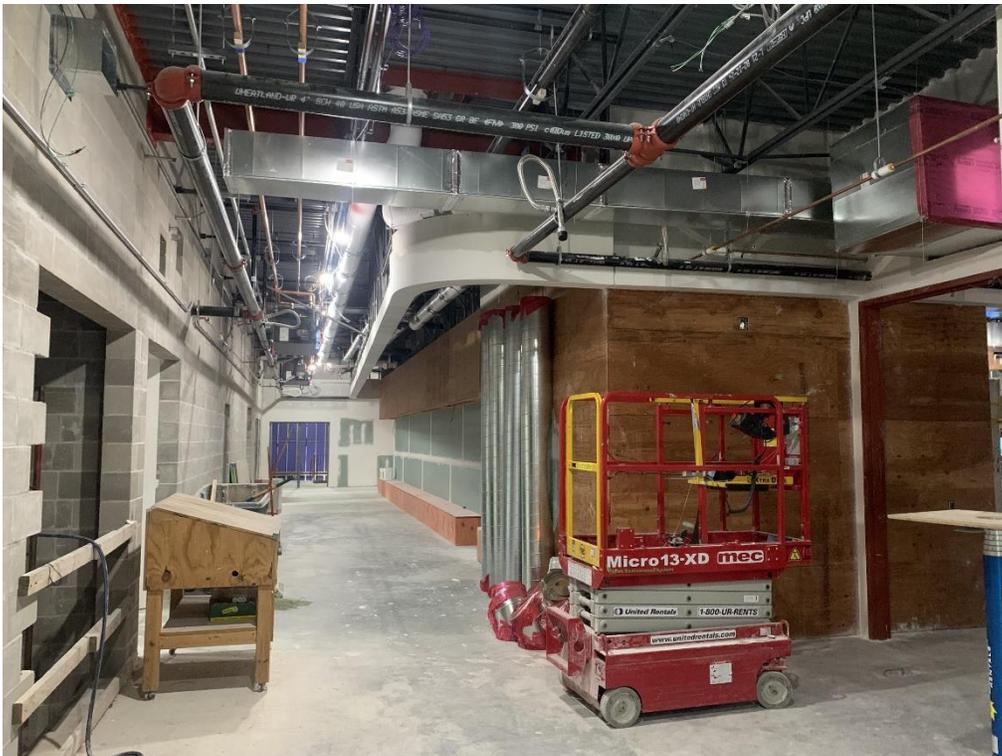
22. Area 3 – Above ceiling MEP and gyp board taping/mudding in second floor gradewing entry corridor in progress.

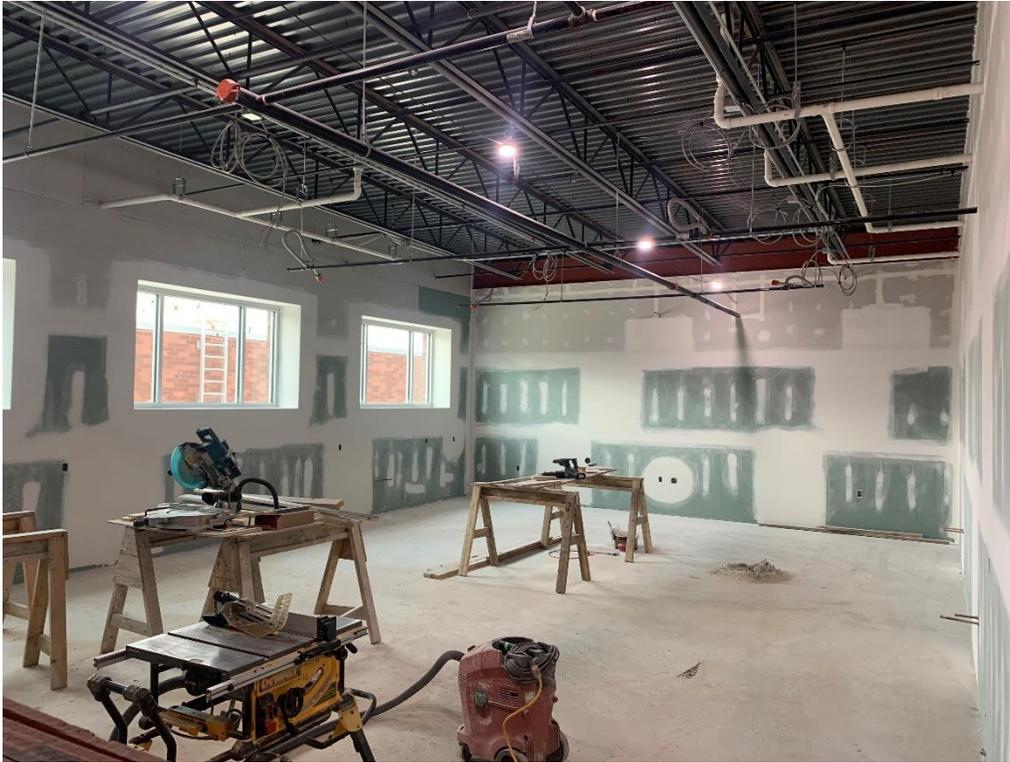
23. Area 3 – Taping and mudding in second floor art rooms in progress.

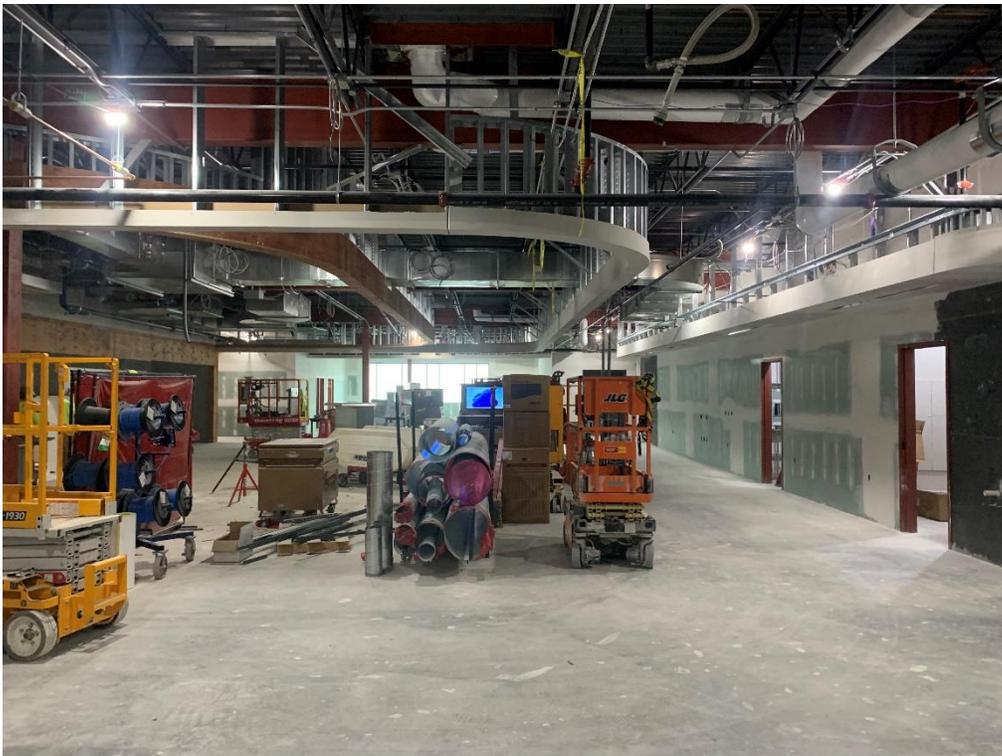
24. Area 3 – Gyp board taping, mudding, and ceiling soffit continues in second floor flex café.

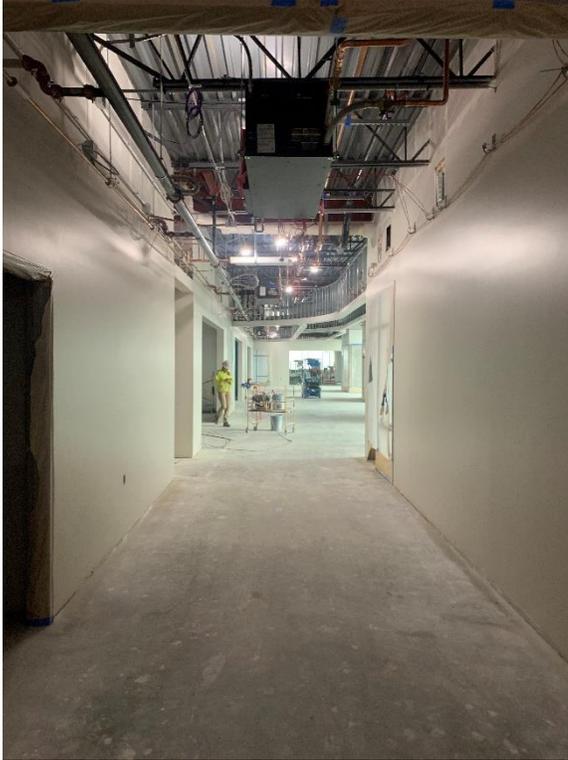
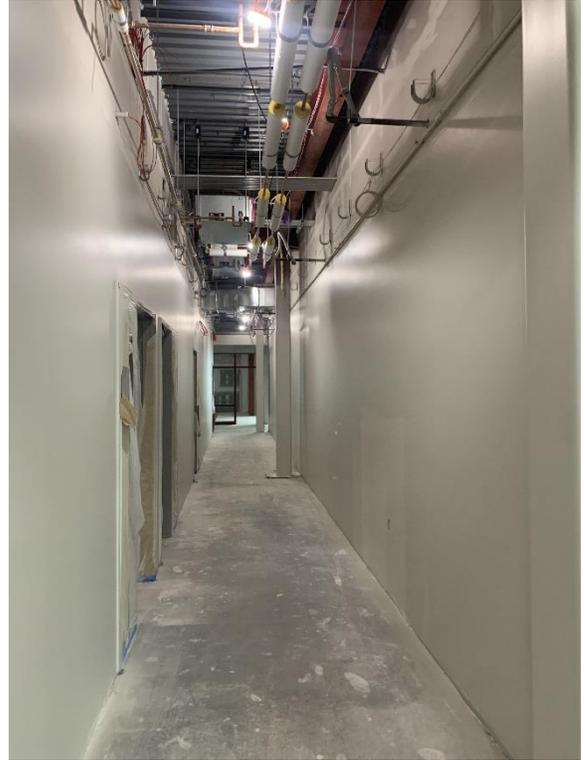
25. Area 4 – Painting throughout second floor in progress.

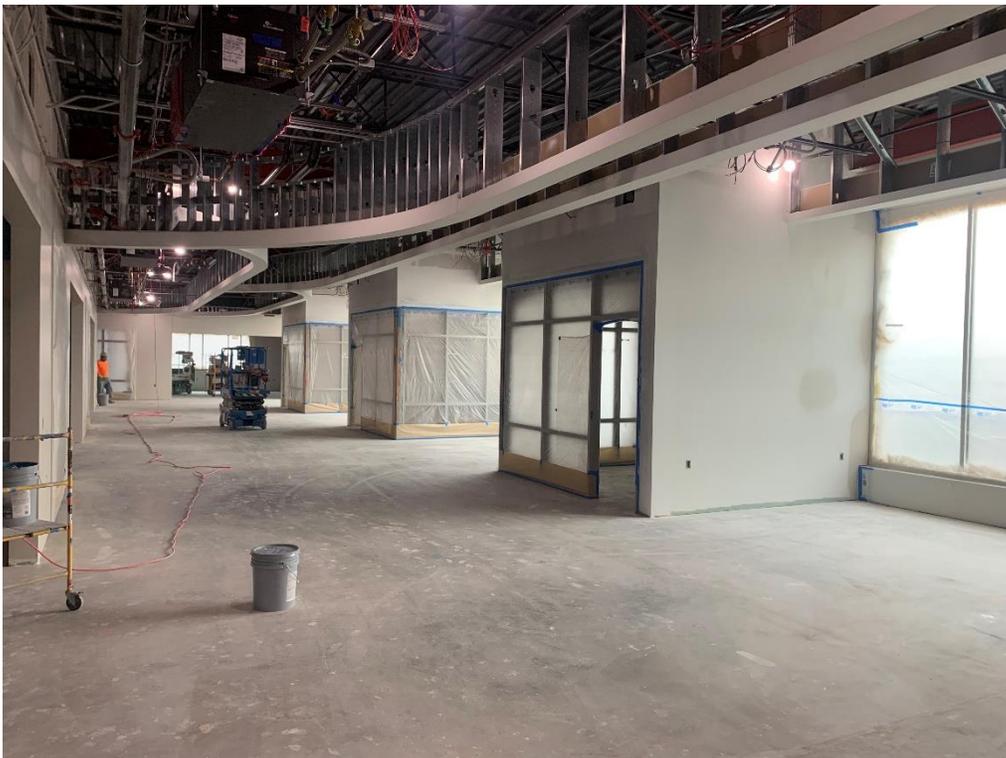
26. Area 4 – Collab area ceiling soffits are installed.

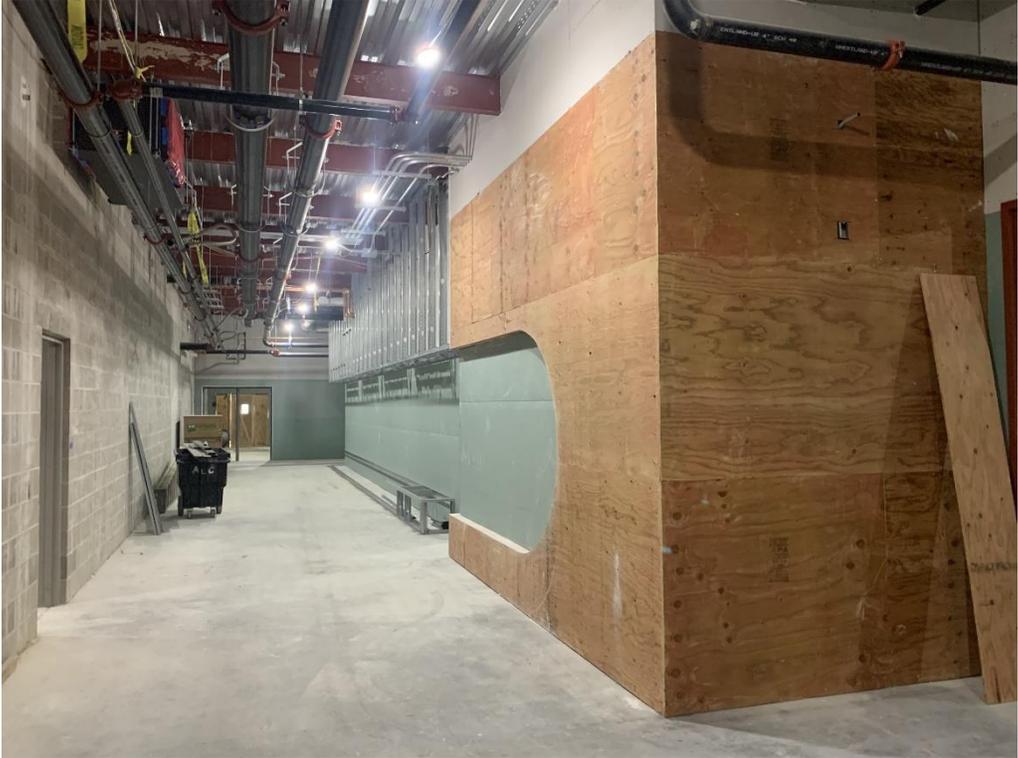
27. Area 3 – Plywood backing, gyp board, and metal stud framing in gradewing entry corridor in progress.

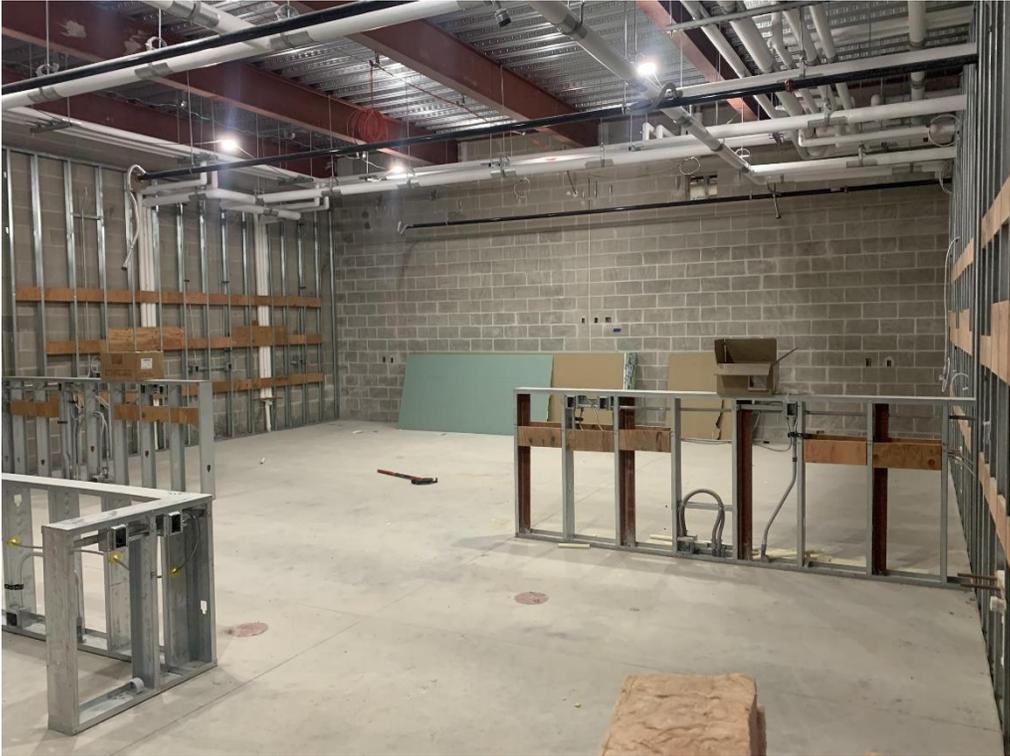
28. Area 3 – MEP work in culinary lab continues. Half height walls and wall blocking installed.

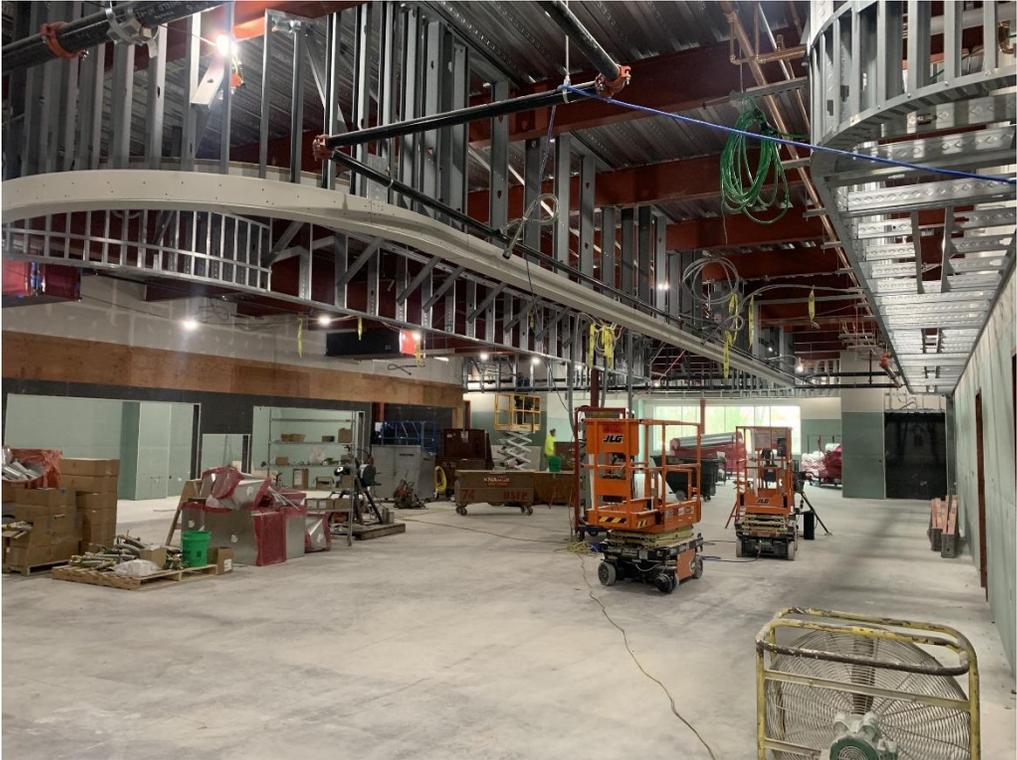
29. Area 3 – Heat pump, above ceiling MEP, and ceiling soffit install in progress.

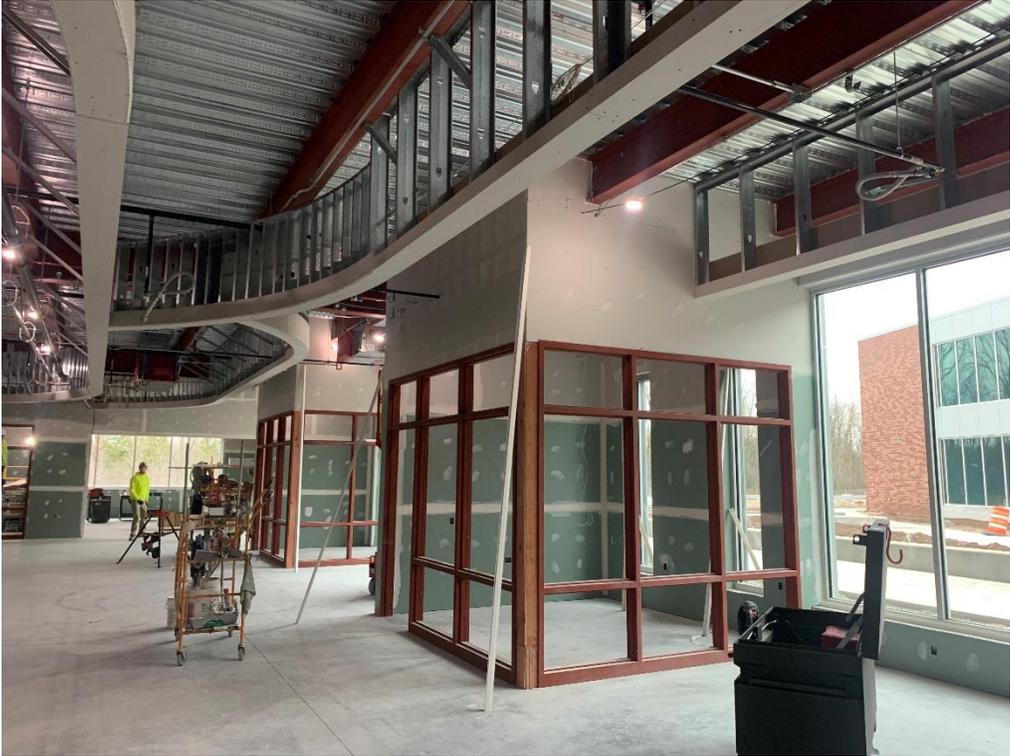
30. Area 4 – First floor gyp board taping and mudding in progress.
