# Construction Observation Report 018 – November 22nd, 2024

Maplewood School

PROJECT NUMBER: 321169-01

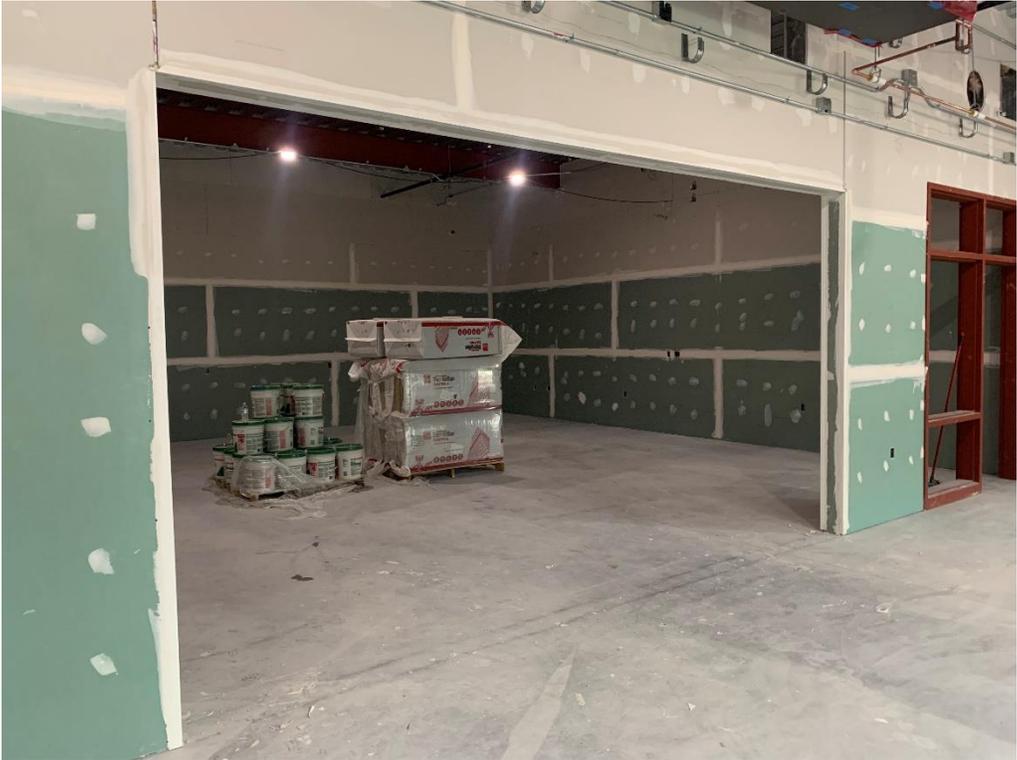
31. Area 4 – First floor gyp board taping and mudding in progress.

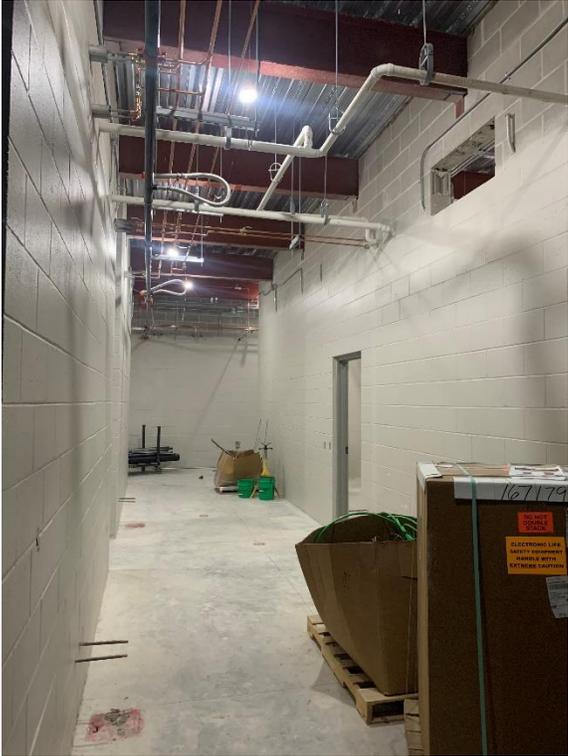
32. Area 3 – Plumbing work in kitchen continues.

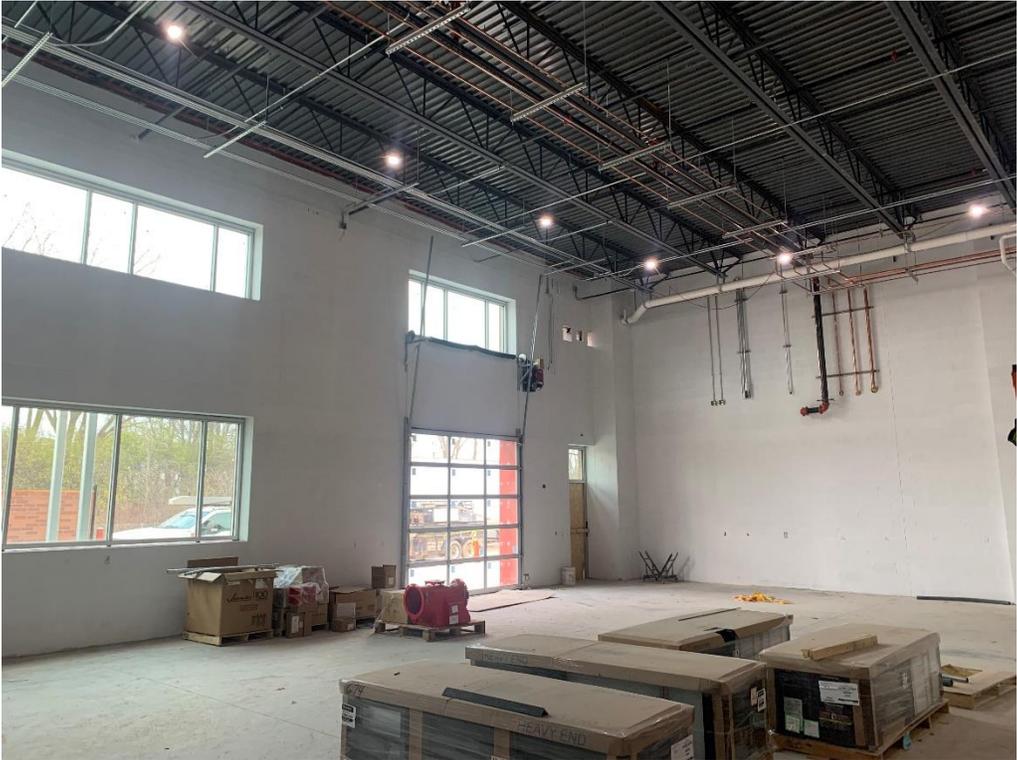
33. Area 3 – Plumbing and conduit install in tech ed suite continues.

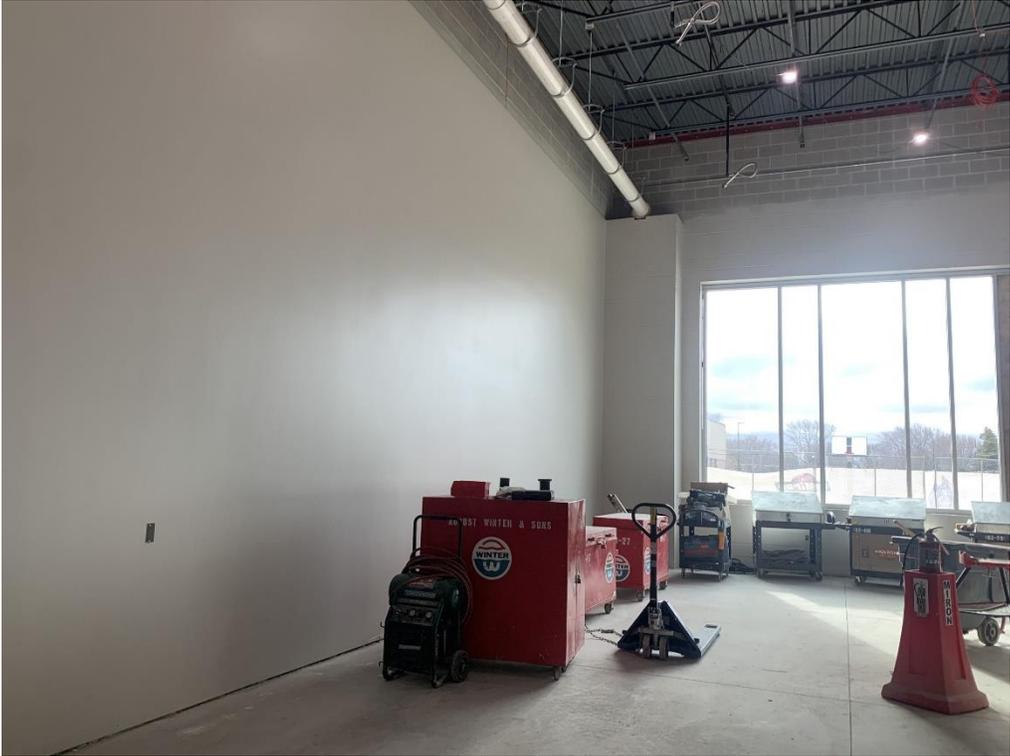
34. Area 2A – Painting in music rooms continues.

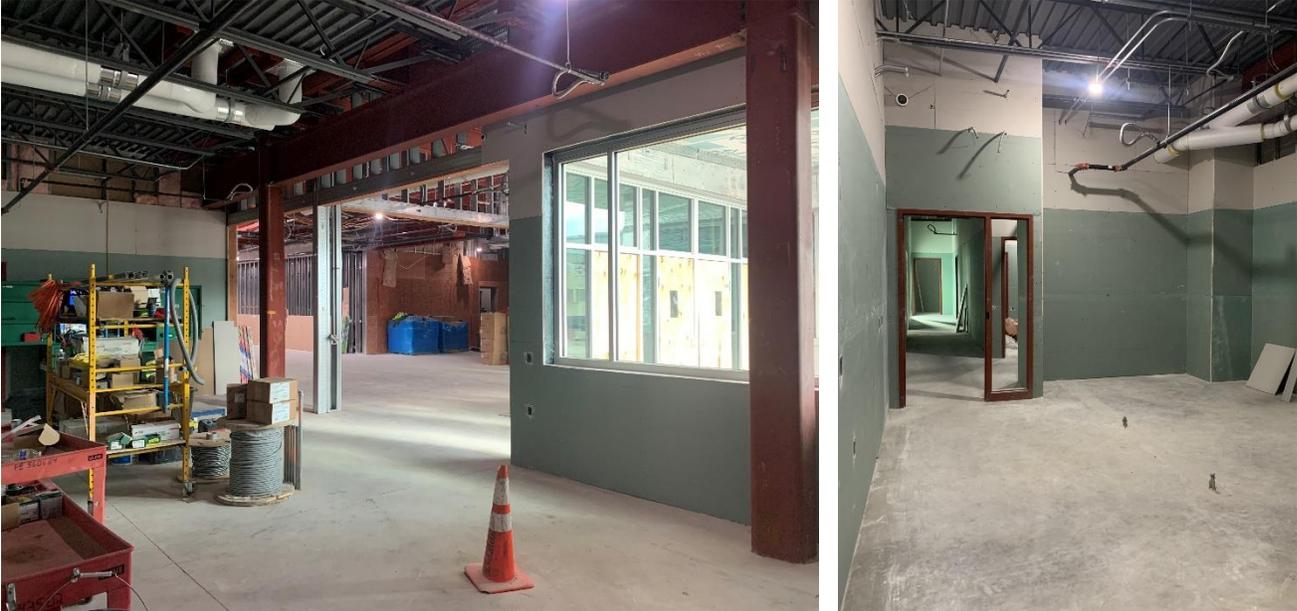
35. Area 1A &1B – Gyp board install in school offices near completion.

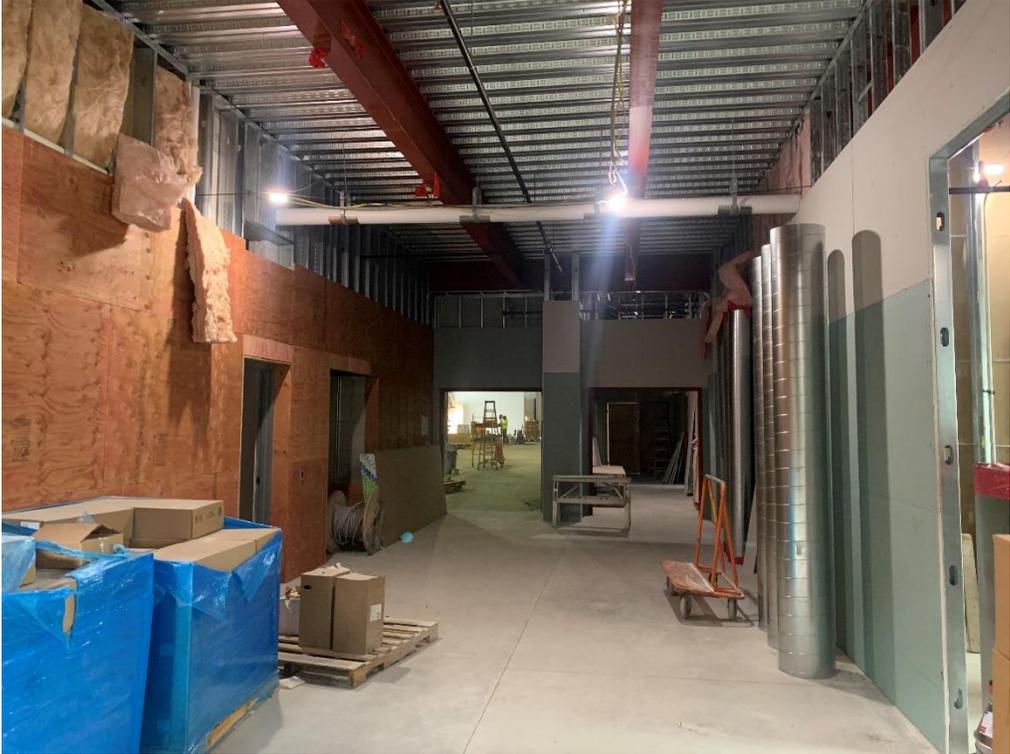
36. Area 1A – Gyp board and plywood backing install continues in gym entry corridor.

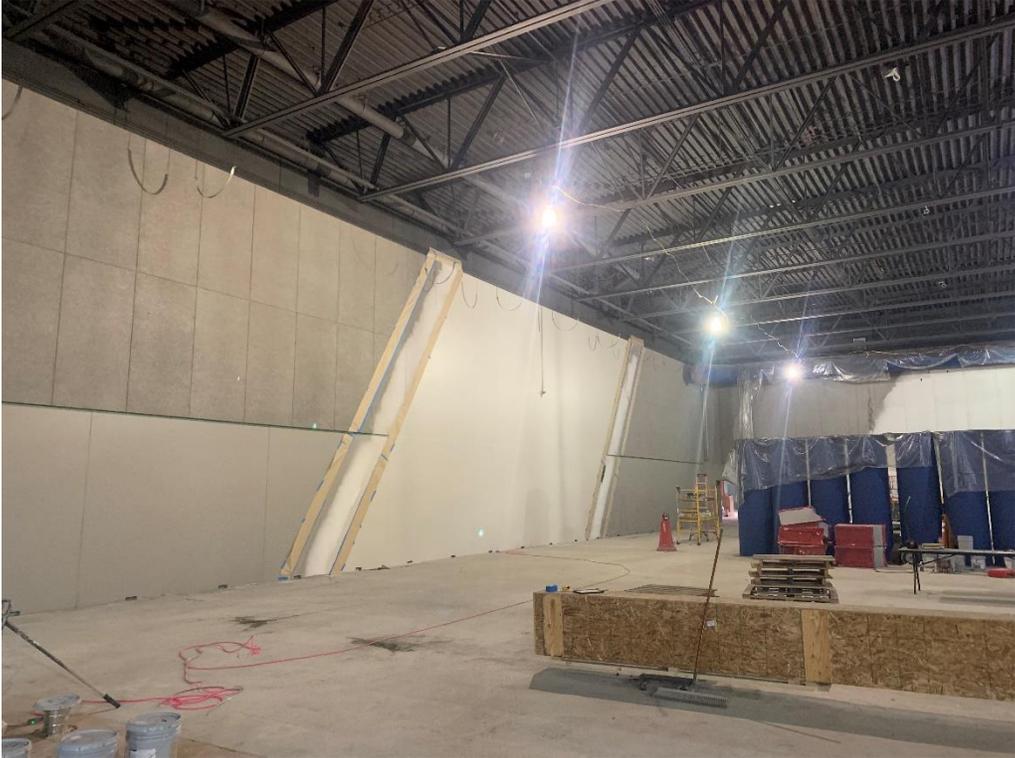
37. Area 6 – Acoustic panel install and painting in gym in continues.

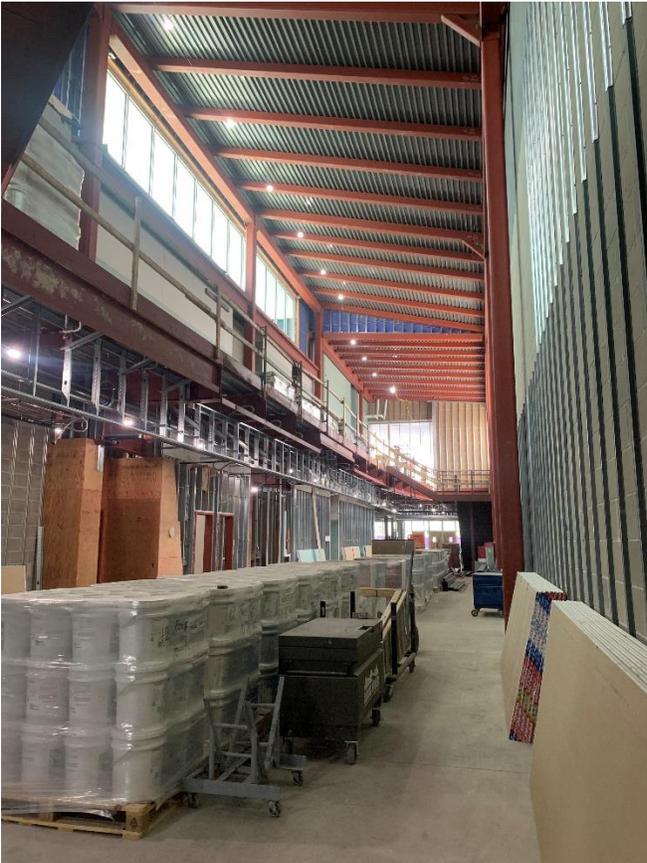
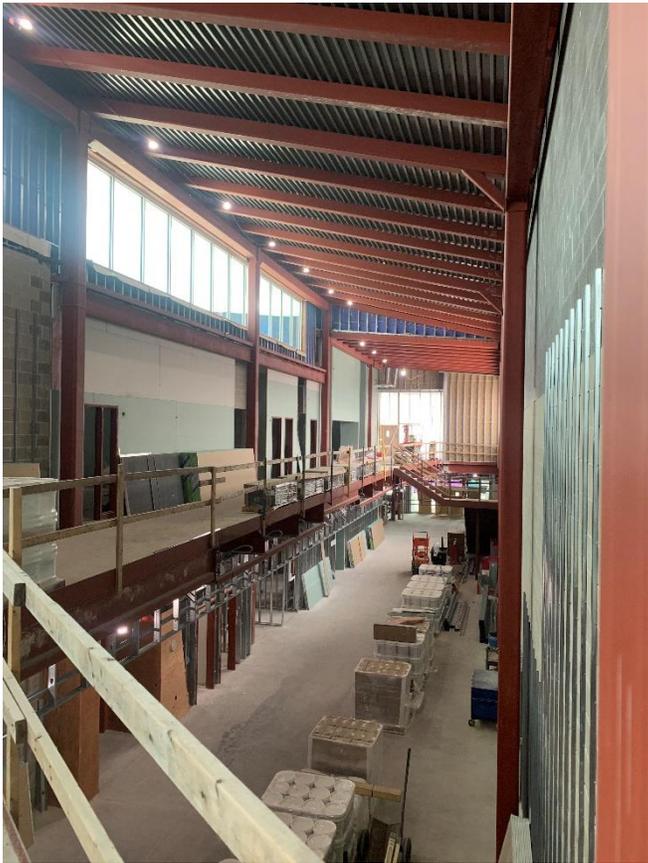
38. Area 1A & 1B – Metal stud, ceiling soffit, and gyp board install continues in center spine

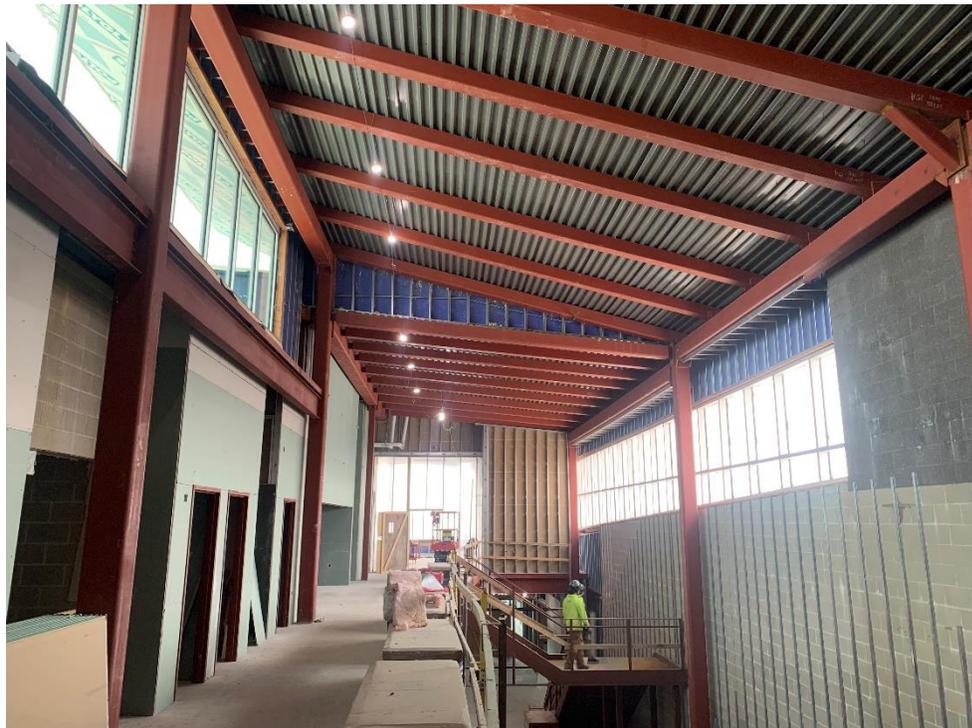
37. Area 1A – Gyp board and metal stud furring strip install at LMC entry in progress.

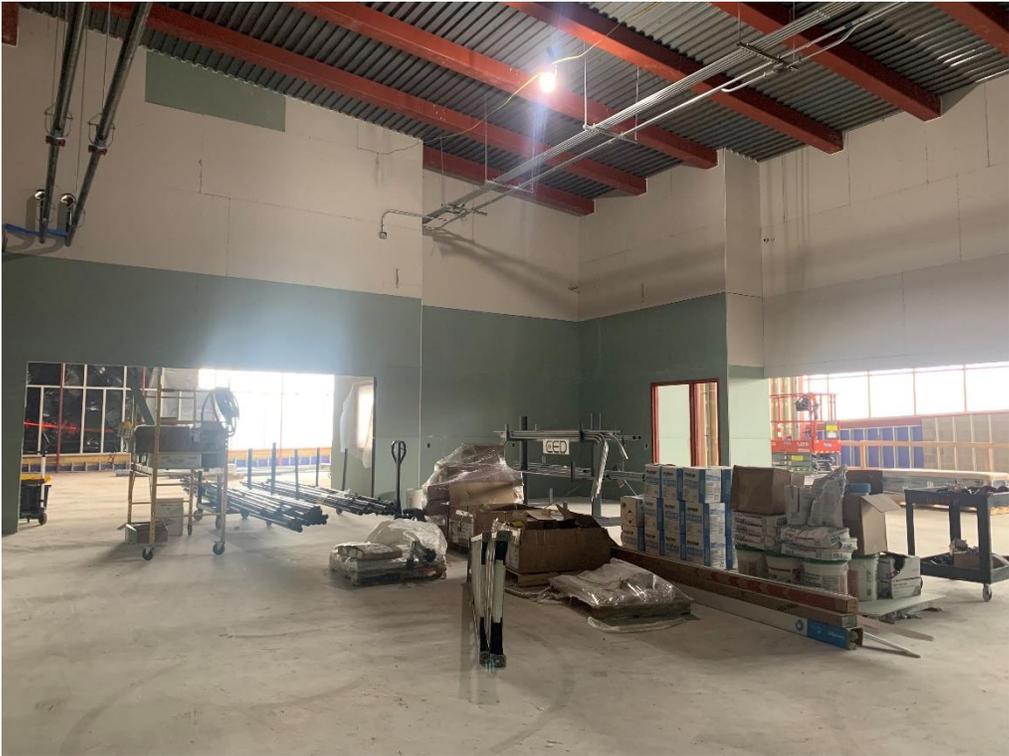
38. Area 1A – Gyp board, sprinkler piping, and conduit install in second floor rooms and LMC in progress.

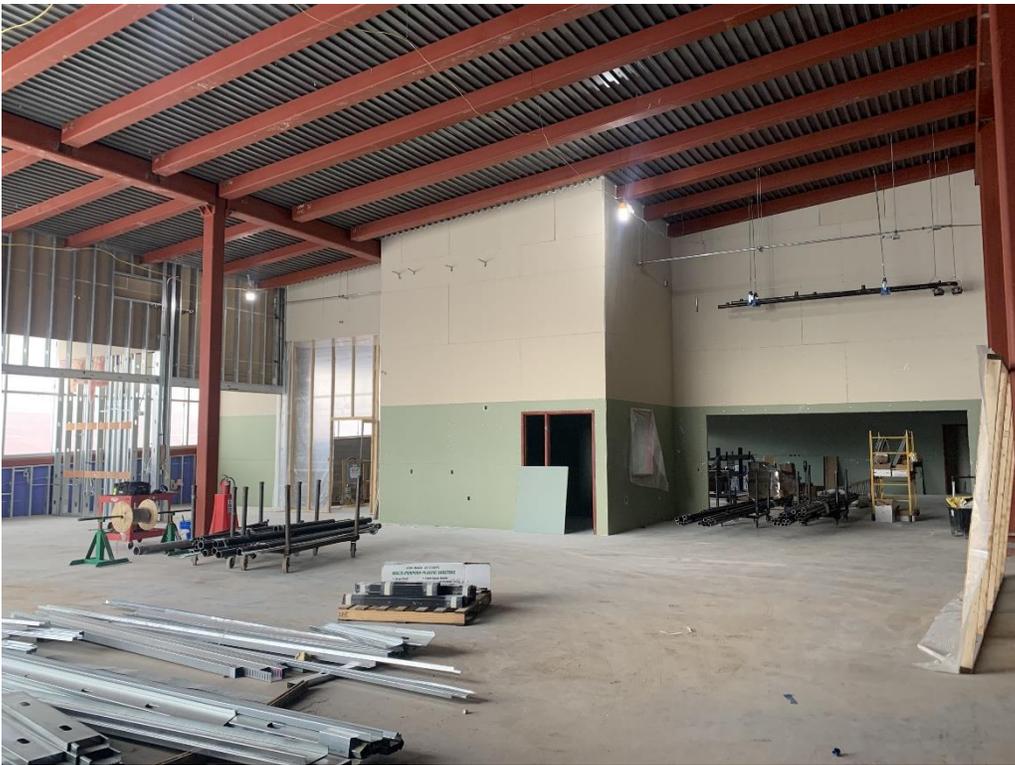
39. Area 1A – Gyp board, sprinkler piping, and conduit install in LMC in progress.
