Construction Observation Report 019 – December 4th, 2024

Maplewood School

PROJECT NUMBER: 321169-01

OWNER:	MENASHA JOINT SCHOOL DISTRICT
From ARCHITECT/ENGINEER:	EUA
To CONTRACTOR	MIRON CONSTRUCTION CO, INC
SITE OBSERVATION TYPE	ARCHITECTURAL
DATE OF ISSUANCE:	December 11th, 2024

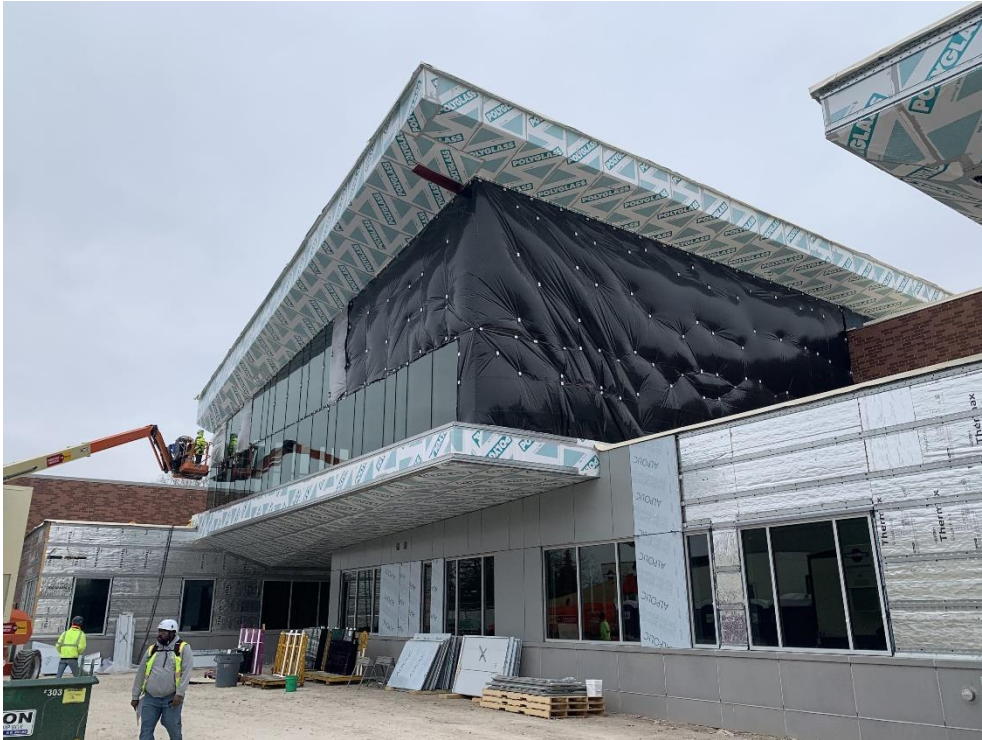
1. Area 1A South – Curtainwall glazing install at second floor LMC in progress. Composite wall panel install at first floor in progress. Metal girt system install on exterior soffits beginning.

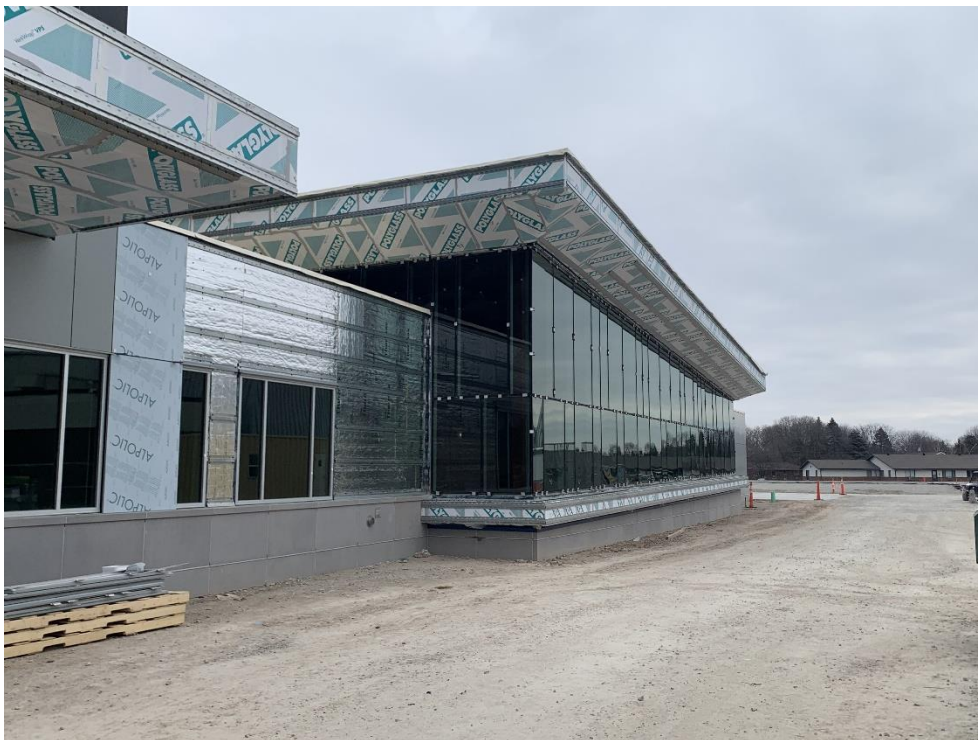
2. Area 2B South – Curtainwall glazing installed. Metal girt system install at soffits in progress.

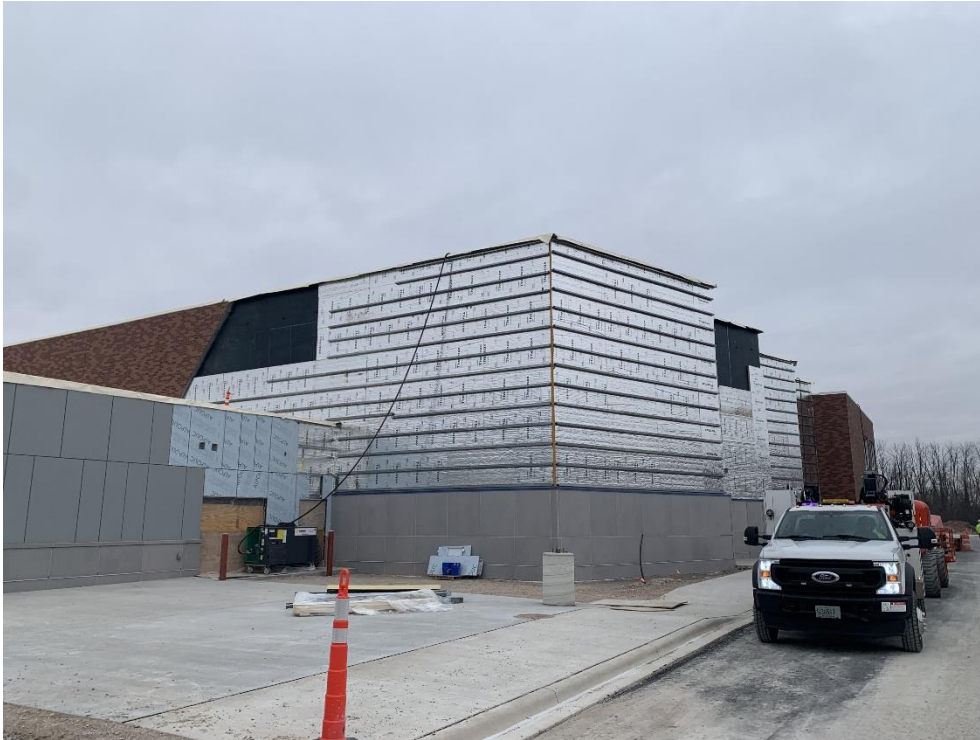
3. Area 2B East – Composite wall panel install nearly complete. Board insulation and metal girt system install continues on gym.

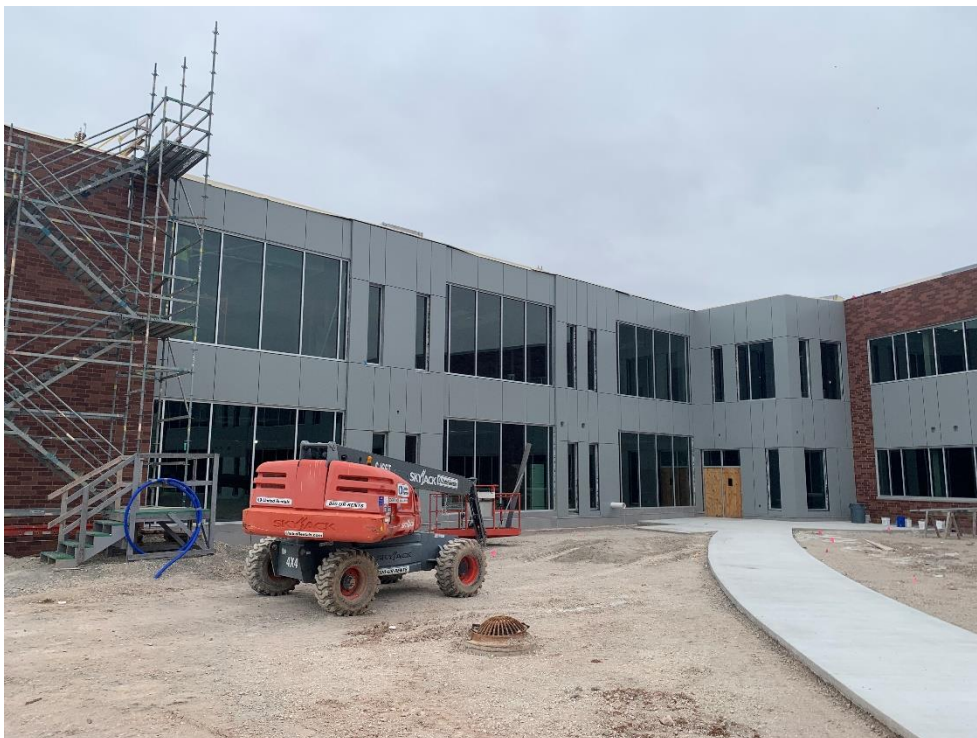
4. Area 6 North - Composite wall panels are installed. Metal coping install continues.

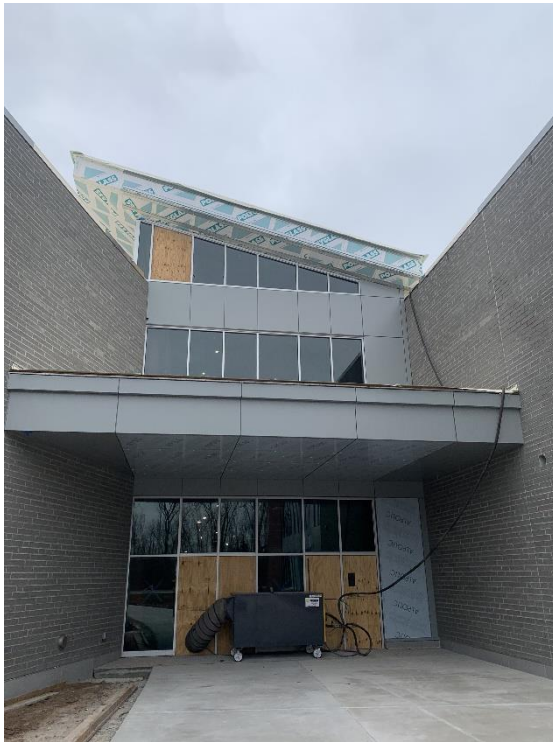
5. Area 1B North - Composite wall panels are installed. Clerestory glazing still in progress.

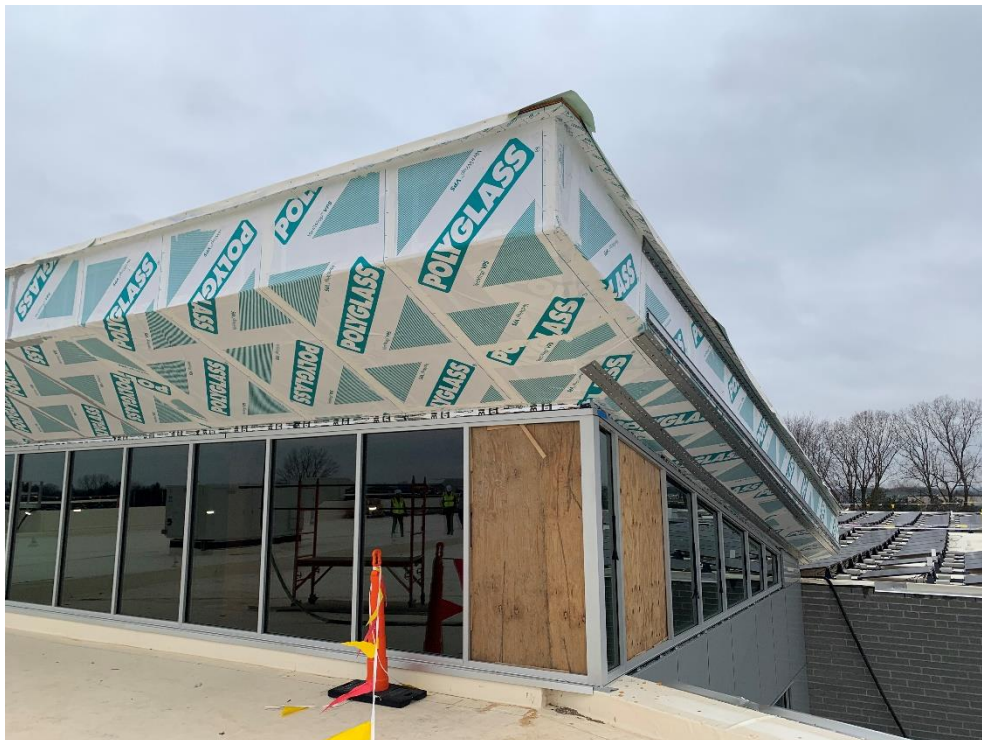
6. Area 1B Clerestory – Storefront glazing and metal girt system install still in progress.

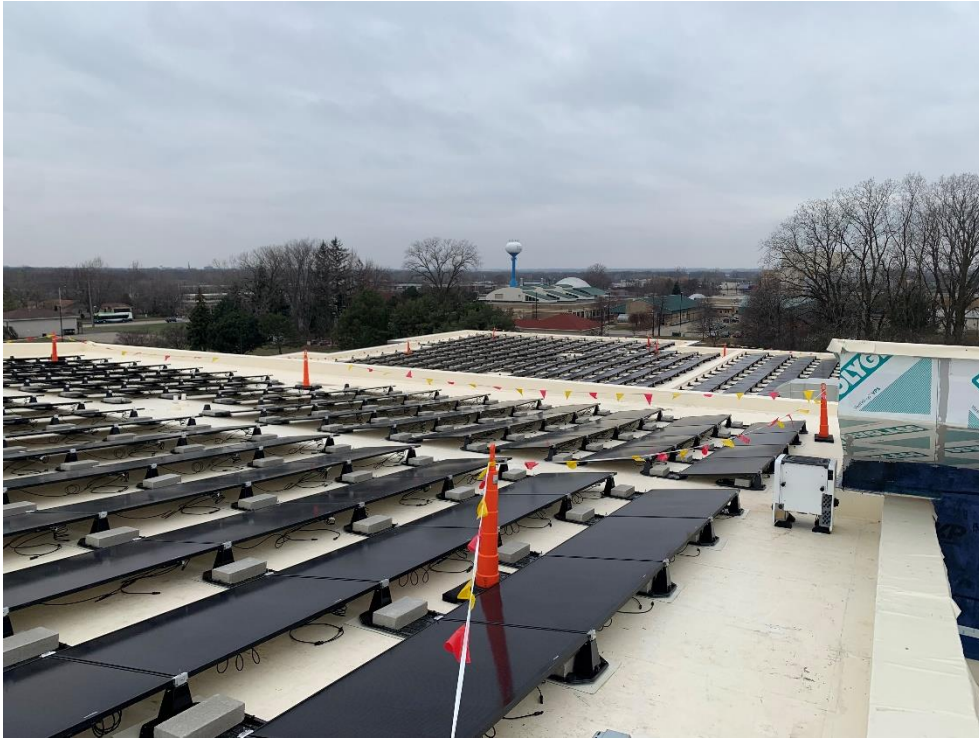
7. Rooftop solar array install continues.

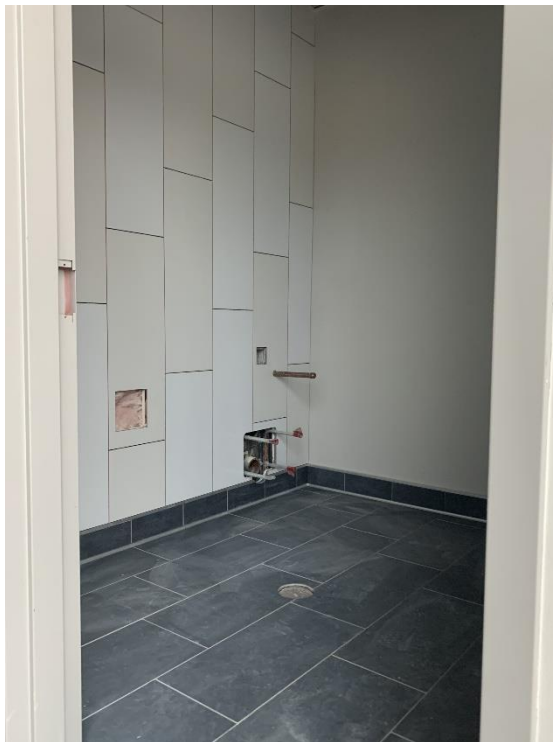
8. Area 6 – Floor and wall tile install continues.

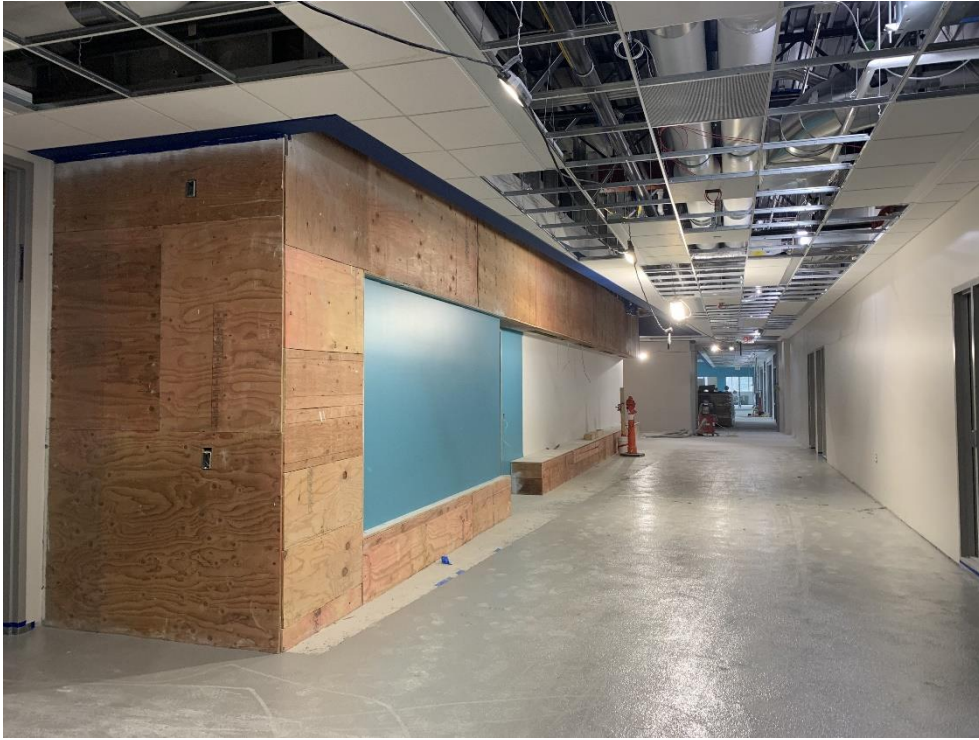
9. Area 6 – Terrazzo continues to be installed in gradewing entry corridor.

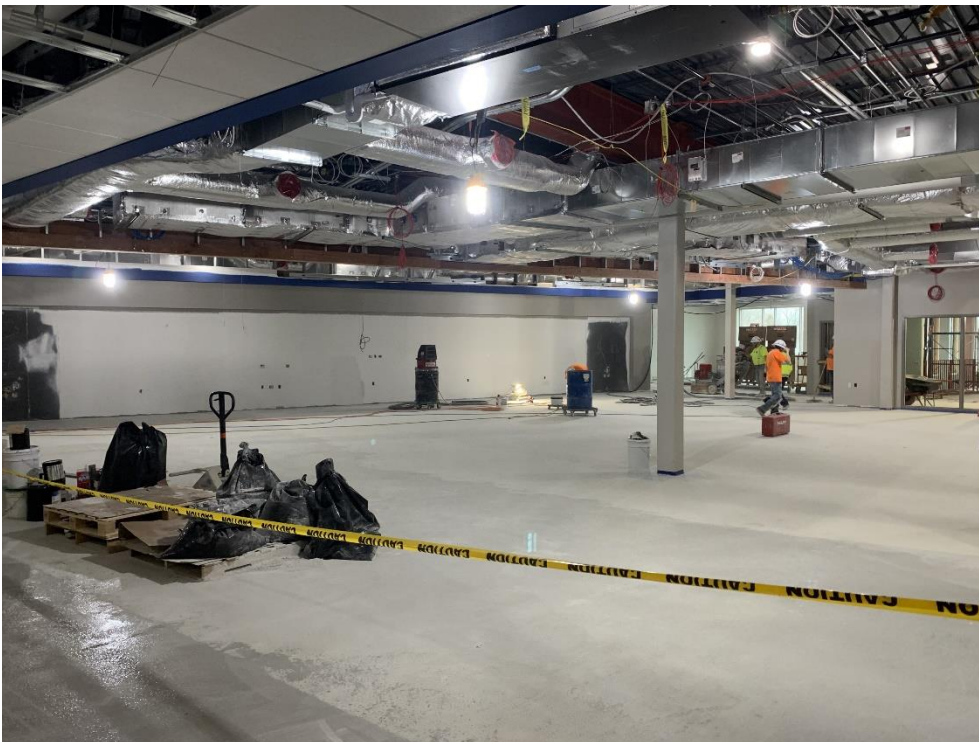
10. Area 5 – Terrazzo install in second floor flex café continues.

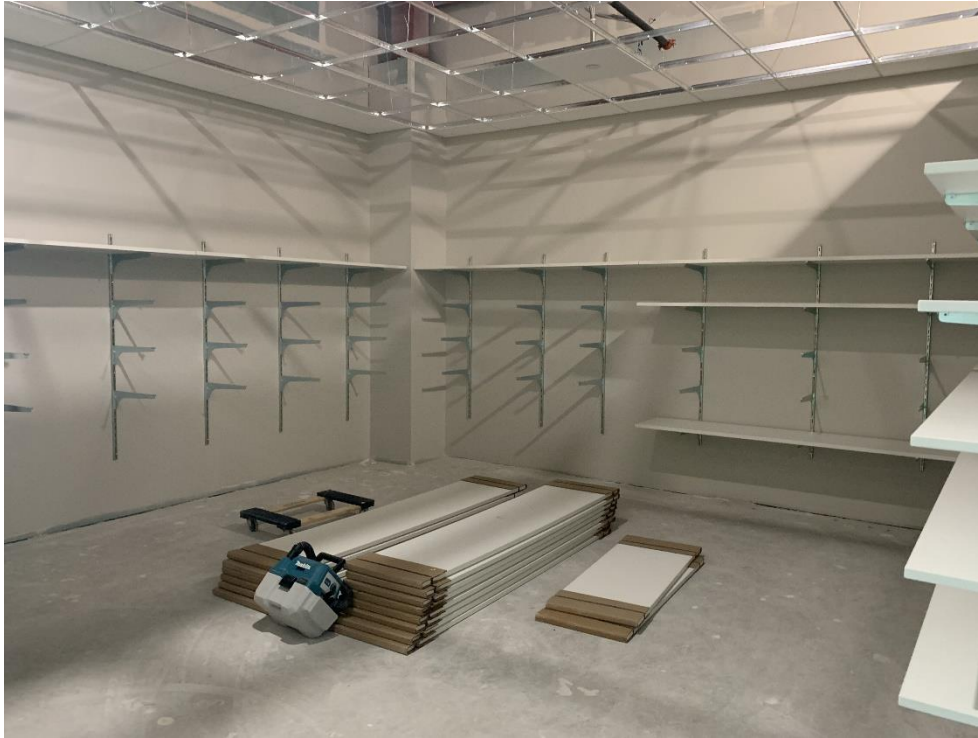
11. Area 5 – Shelving in staff storage rooms are getting installed.

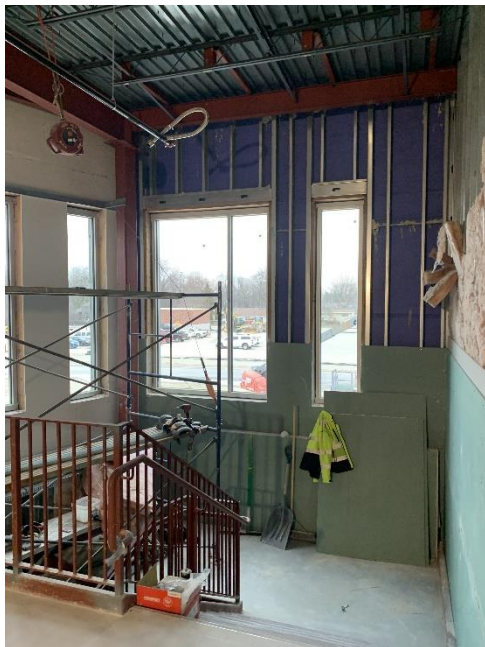
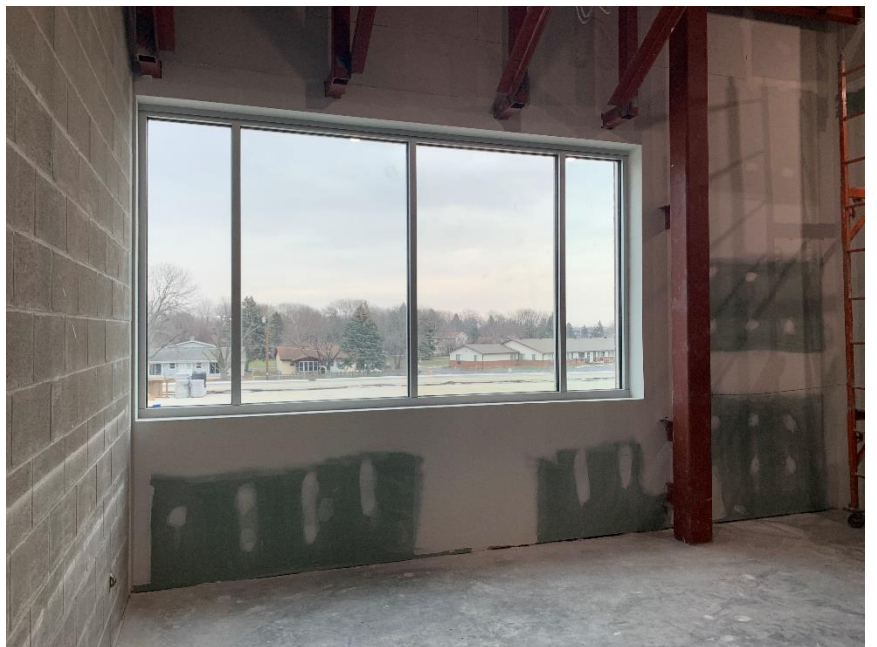
12. Gyp board install, taping, and mudding in stairs continues.

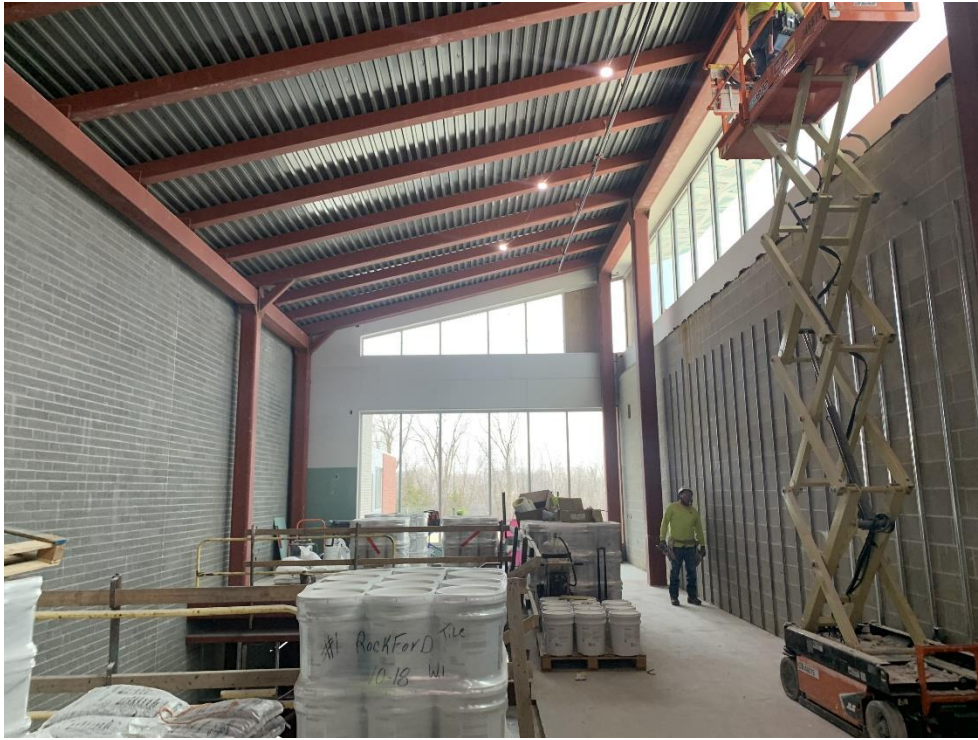
13. Area 1B – Gyp board install continues in center spine.

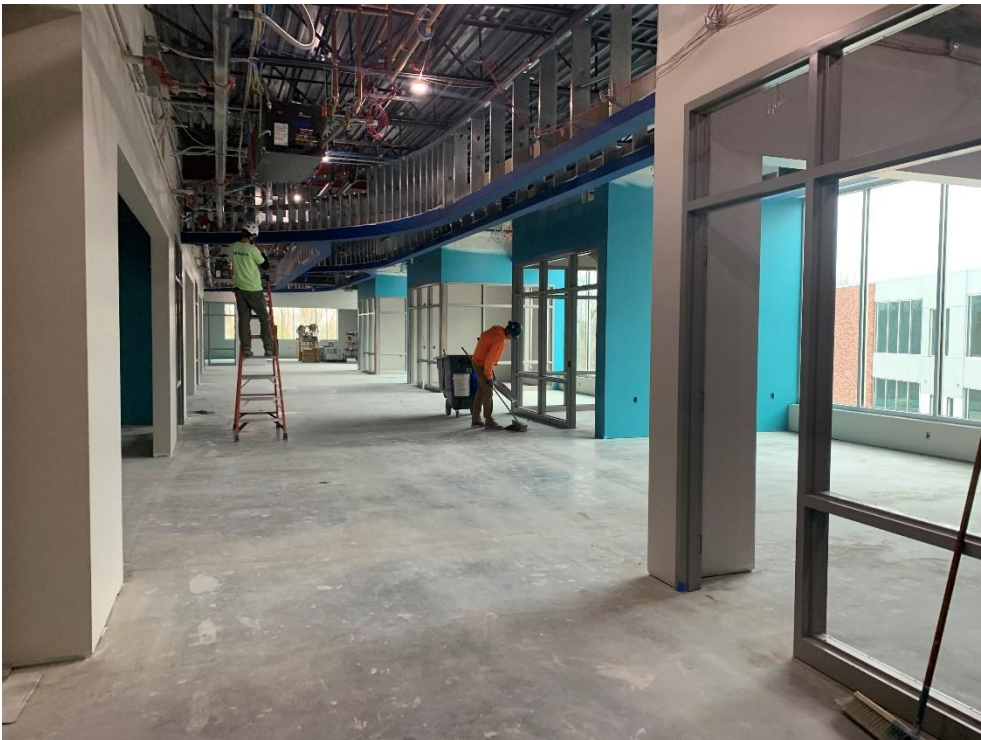
14. Area 4 – Finish painting in progress in gradewing neighborhoods.

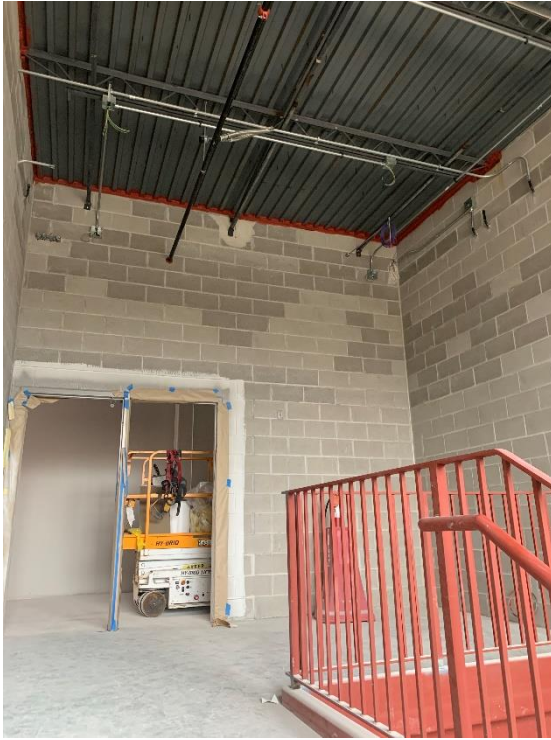
15. Area 4 – Fire safing insulation install at stairs in progress.

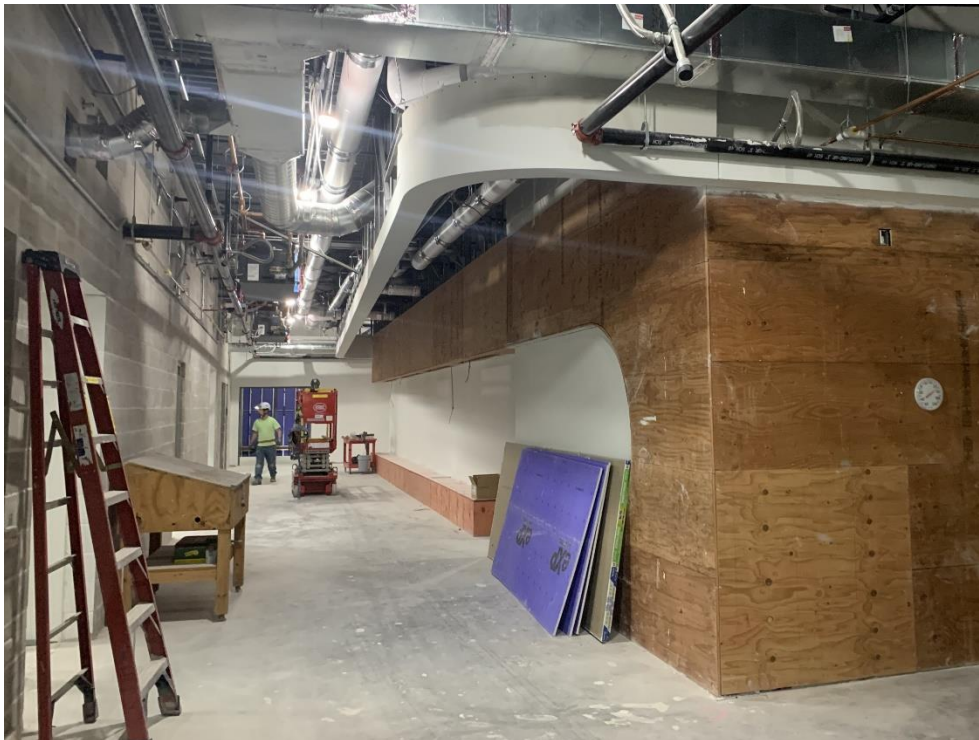
16. Area 3 – Work on second floor gradewalling entry feature continues. Painting has begun.

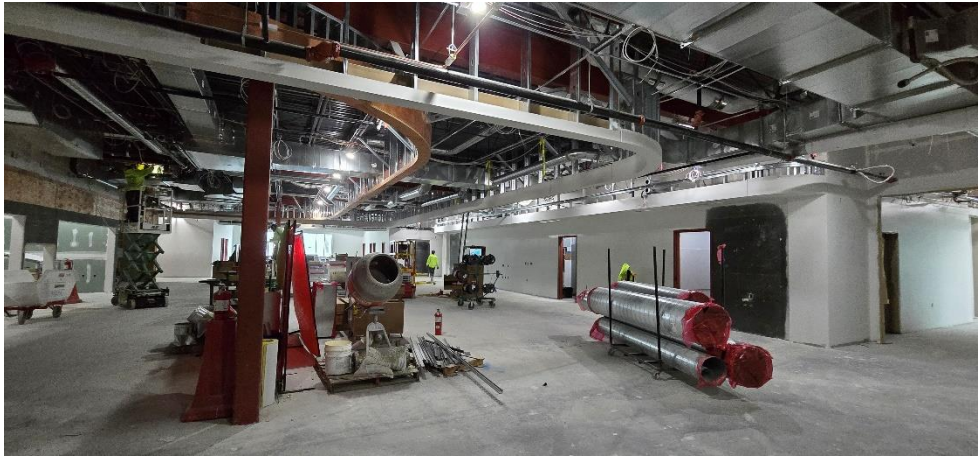
17. Area 3 – Painting and above ceiling MEP work continues in second floor flex café.

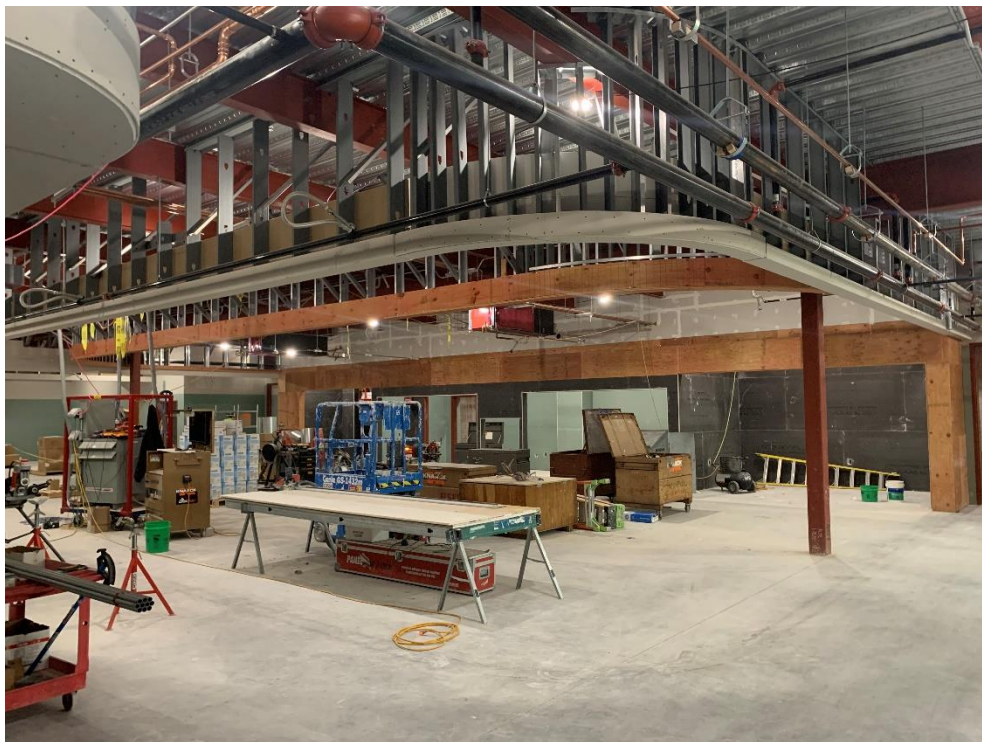
18. Area 3 – Gyp board install in first floor flex café continues.

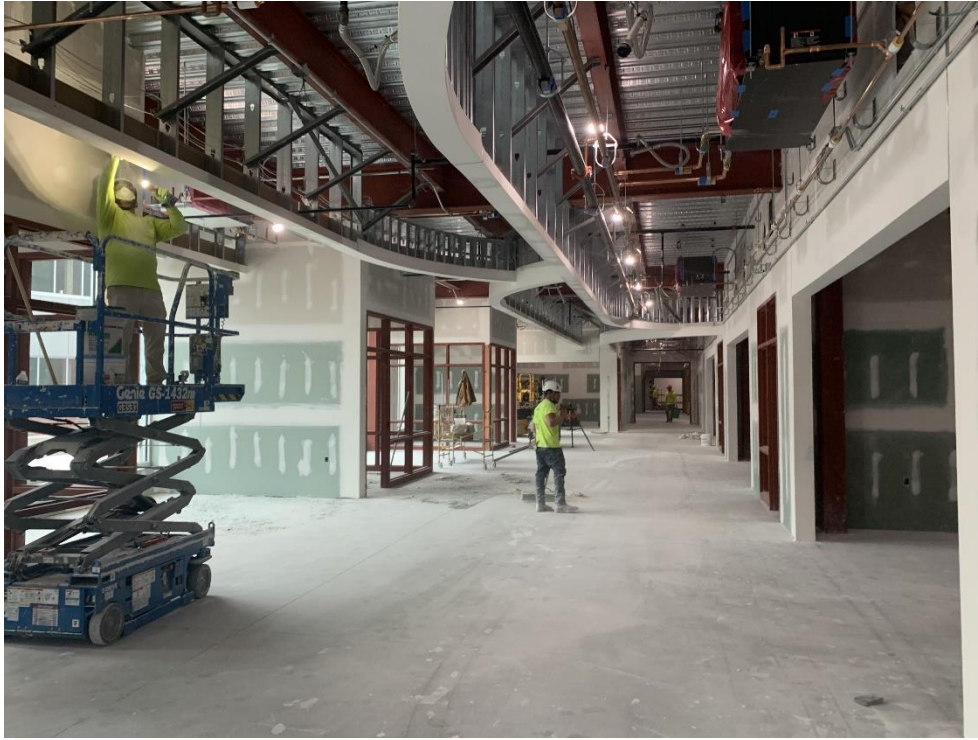
19. Area 4 – Gyp board install in first floor gradewalling neighborhood continues.

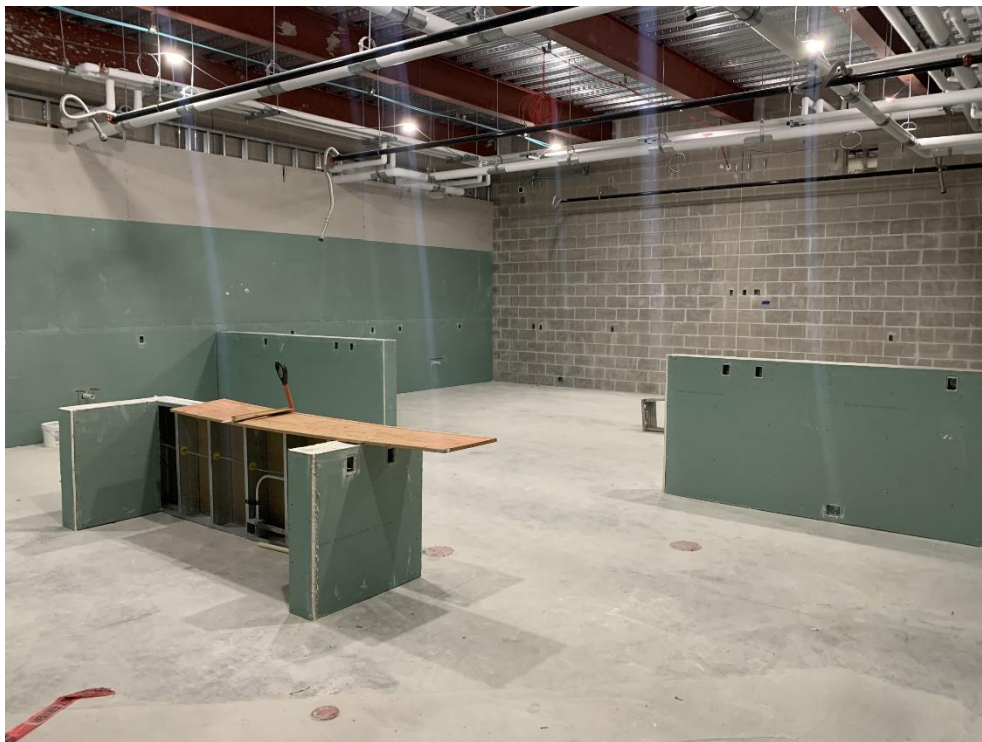
20. Area 3 – Gyp board install in culinary lab in progress.

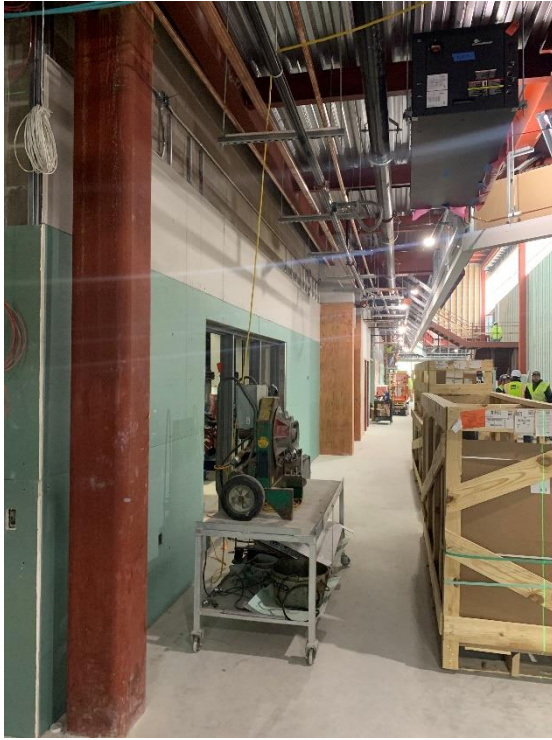
21. Area 1A/1B – Gyp board install in center spine continues.

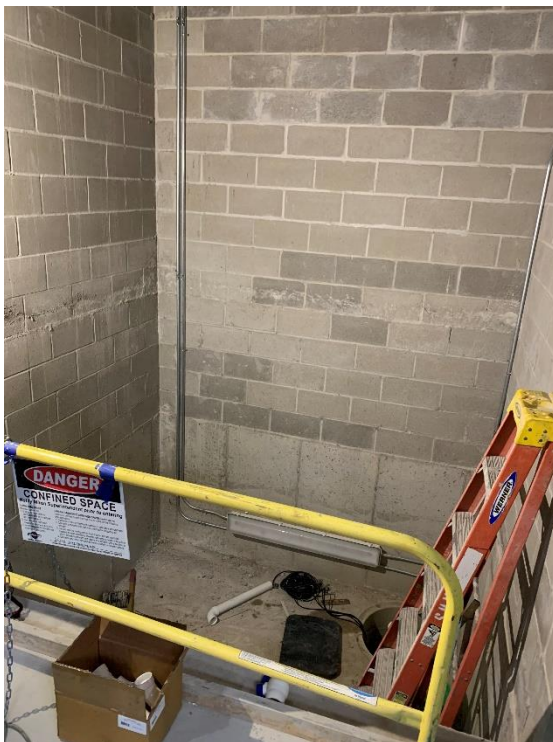
22. Elevator pits/ shafts prepping for elevator install.

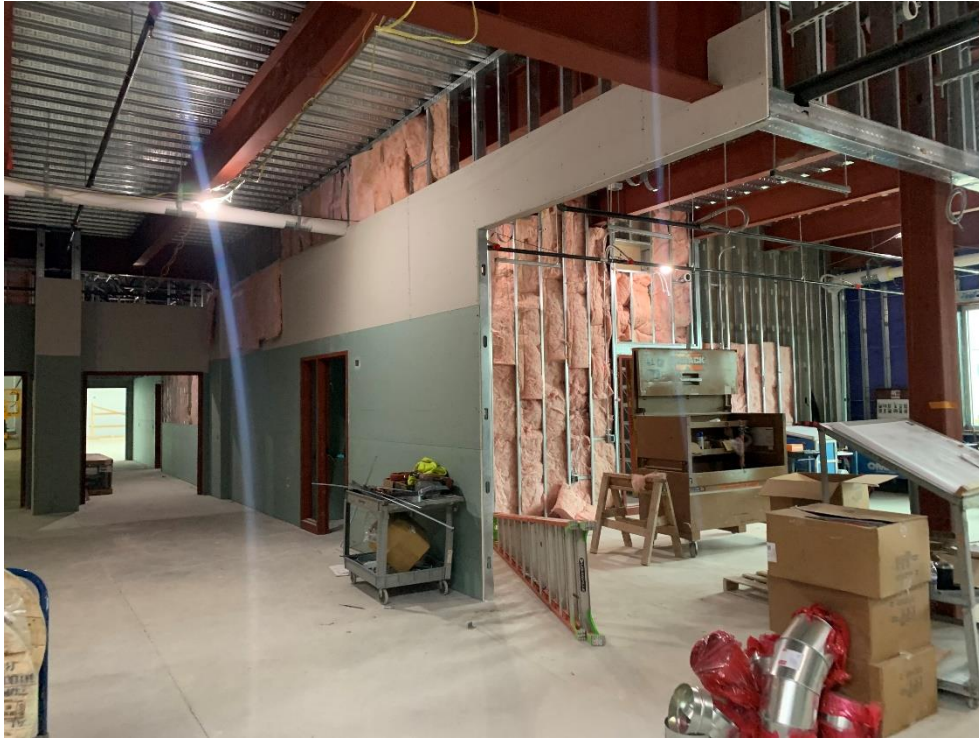
23. Area 1A – Gyp board and wall insulation continues to be installed at 7/8 school office.

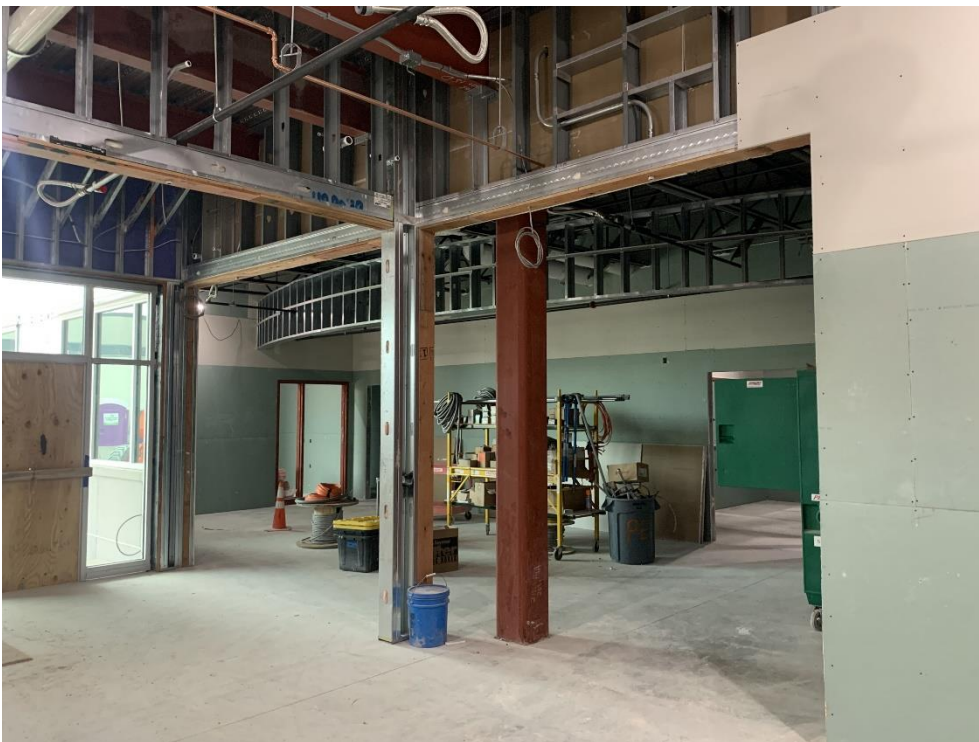
24. Area 1A – Gyp board and wall insulation continues to be installed at 5/6 school office.

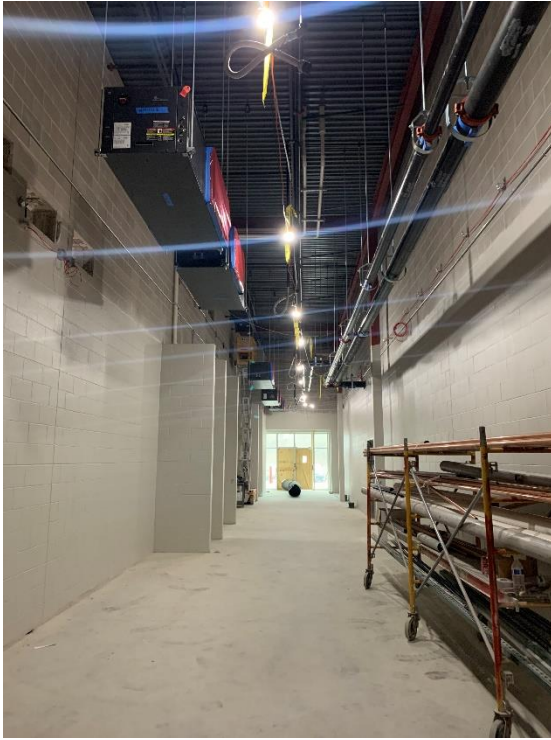
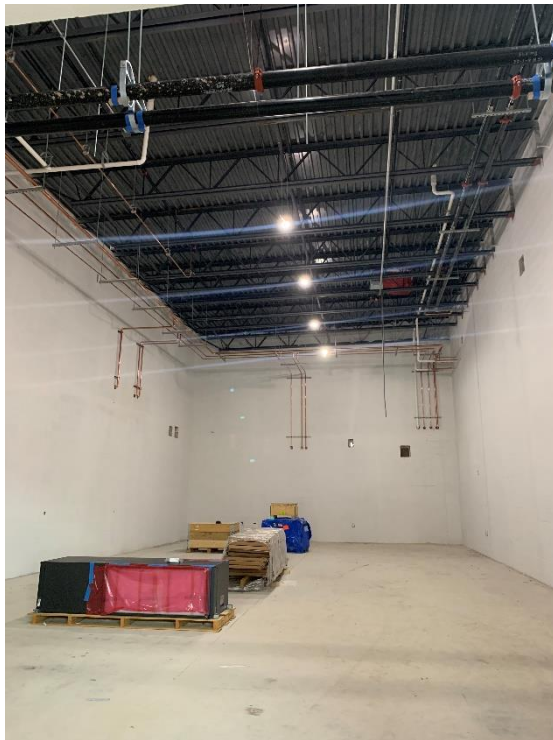
25. Area 2A & 3 – Heat pumps and above ceiling MEP install continues.

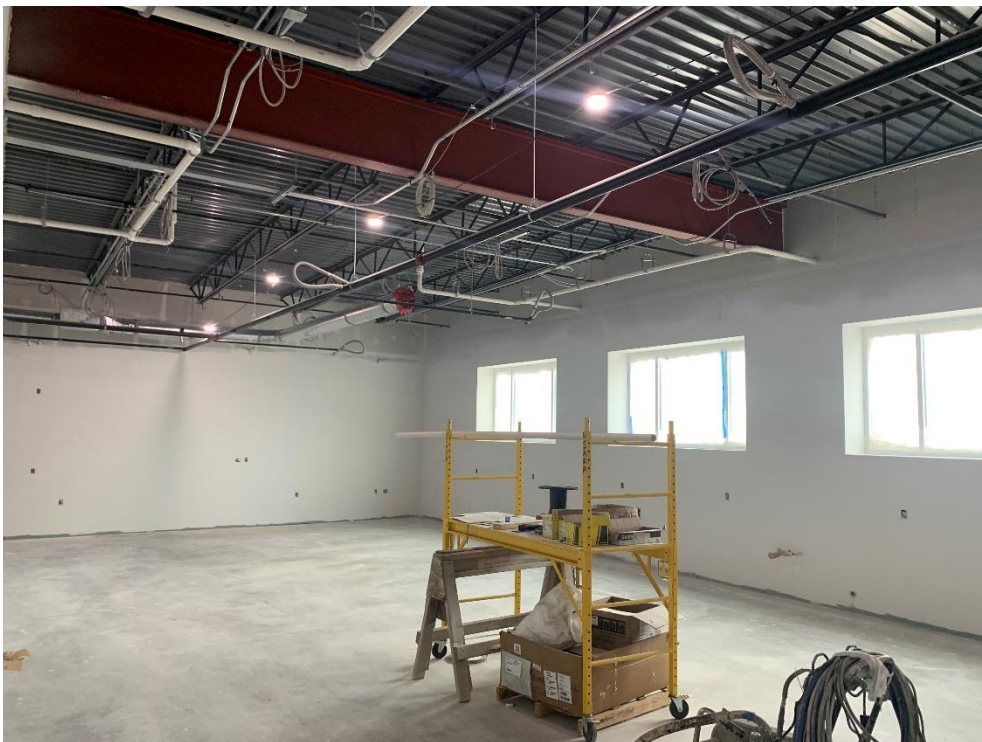
26. Area 3 – Painting and above ceiling MEP work continues in second floor art rooms.

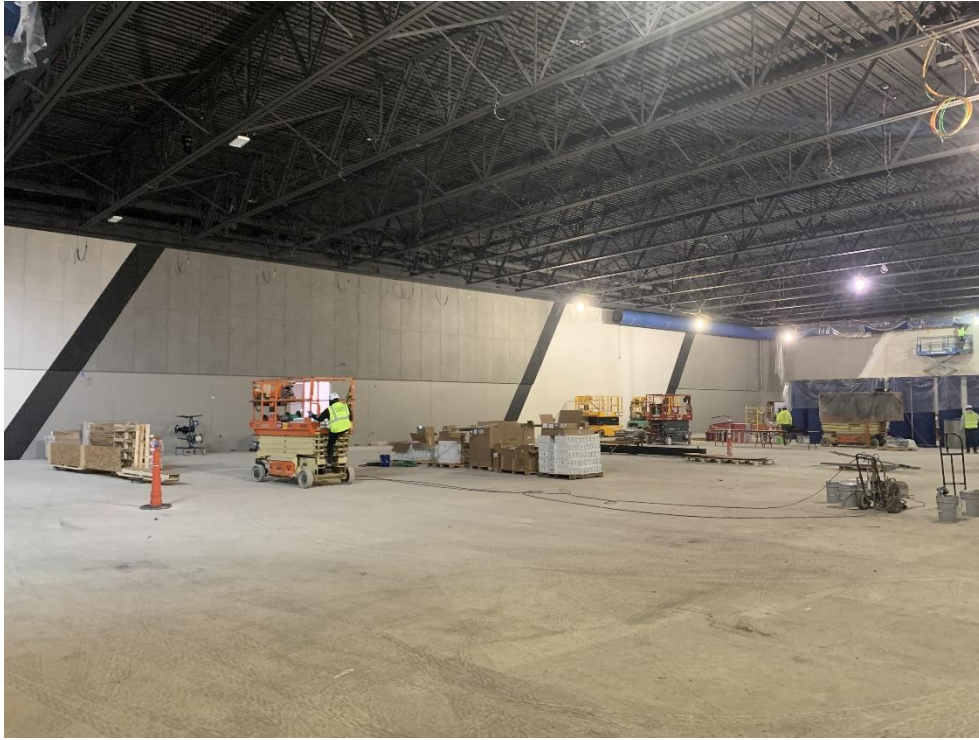
27. Area 6 – Painting in gym continues.

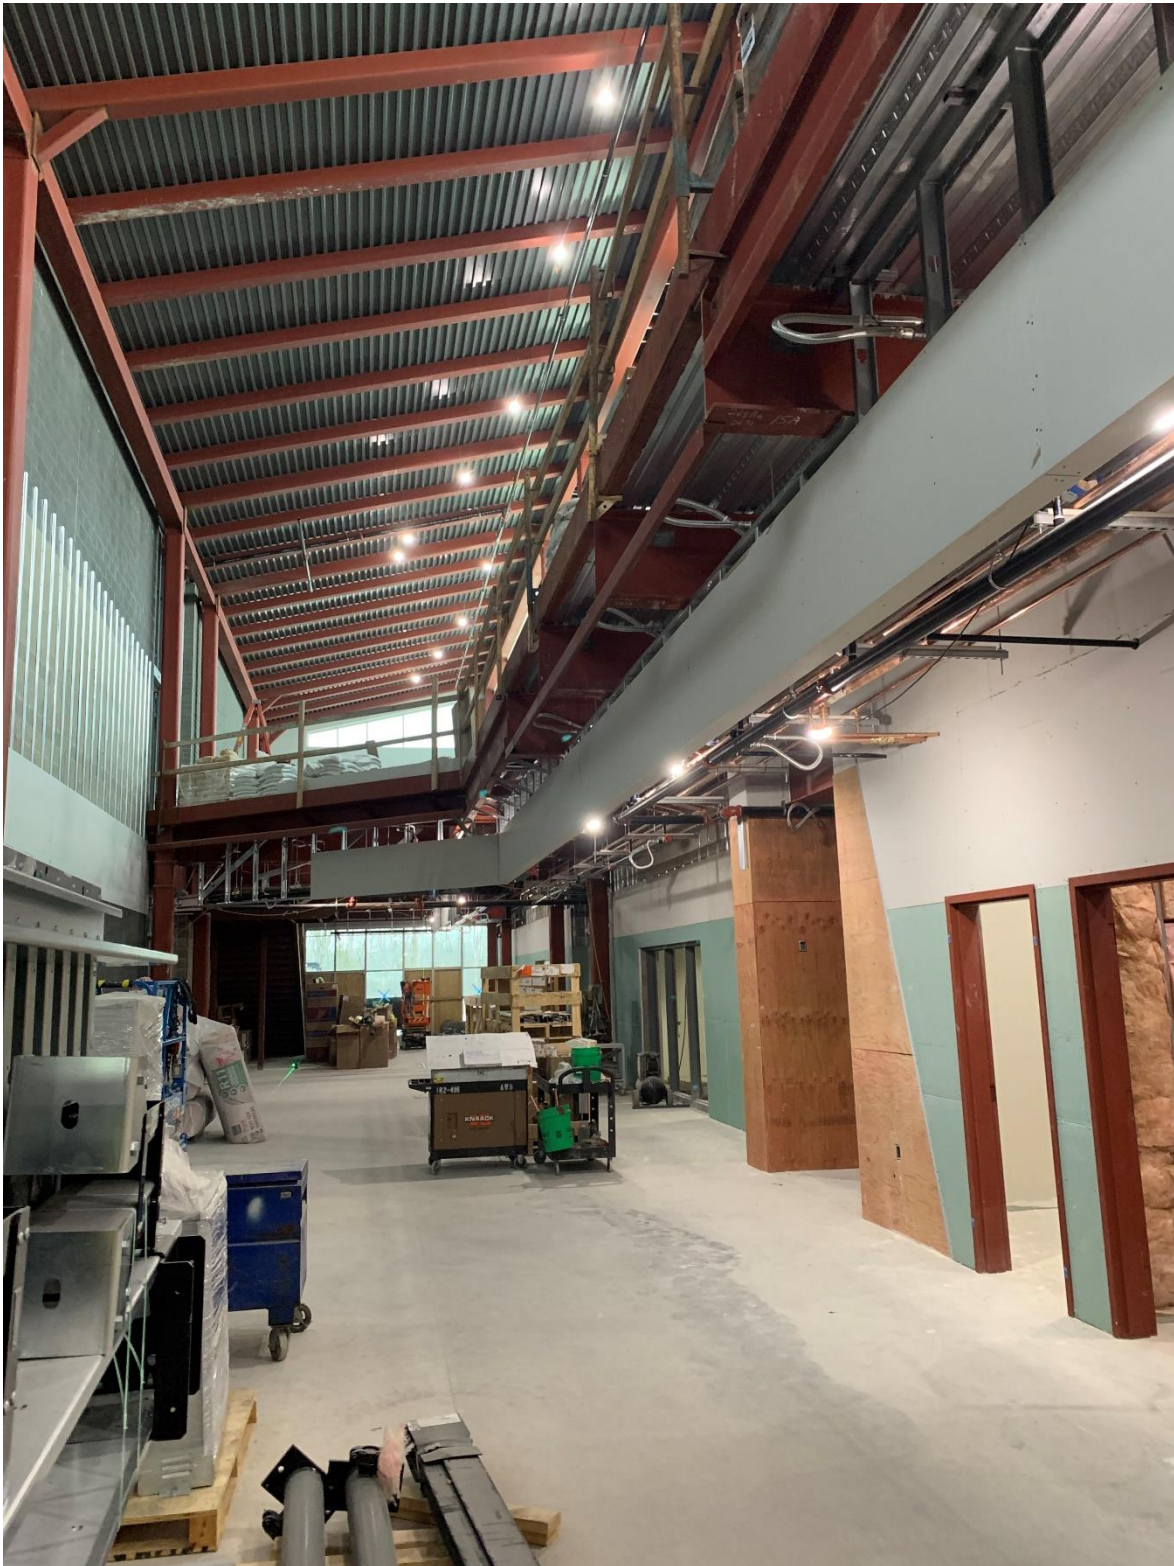
28. Area 1A/1B – Progress photo of center spine.
