Construction Observation Report 020 – December 20th, 2024

Maplewood School

PROJECT NUMBER: 321169-01

OWNER:	MENASHA JOINT SCHOOL DISTRICT
From ARCHITECT/ENGINEER:	EUA
To CONTRACTOR	MIRON CONSTRUCTION CO, INC
SITE OBSERVATION TYPE	ARCHITECTURAL
DATE OF ISSUANCE:	December 30th, 2024

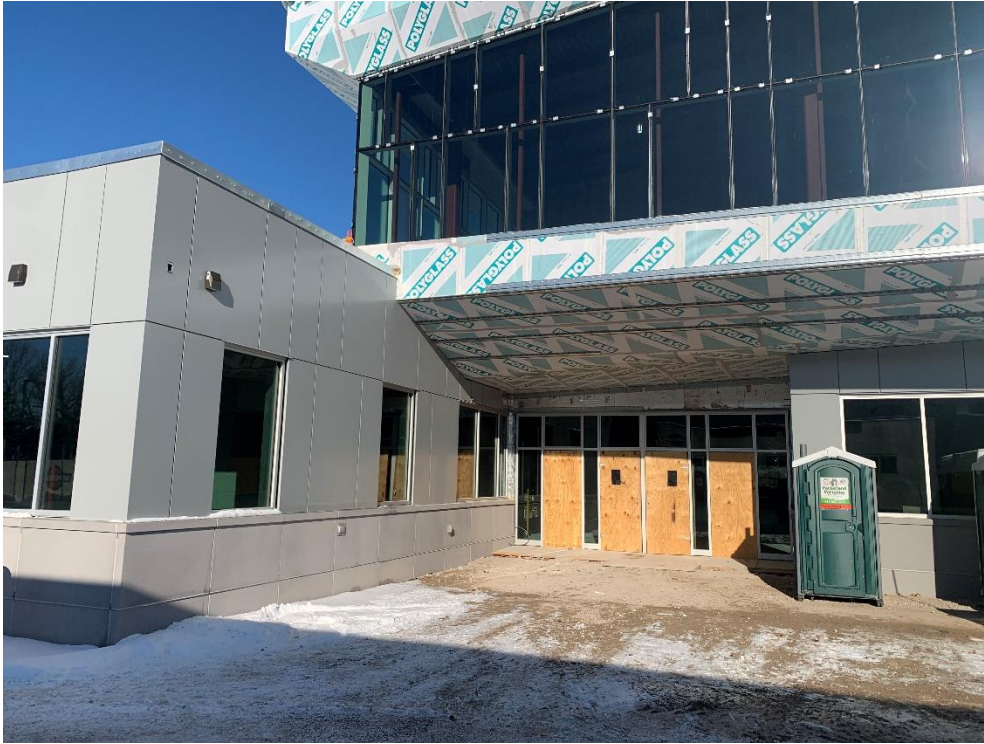
1. Area 1A South – Composite wall panel and metal girt system at south entry still in progress.

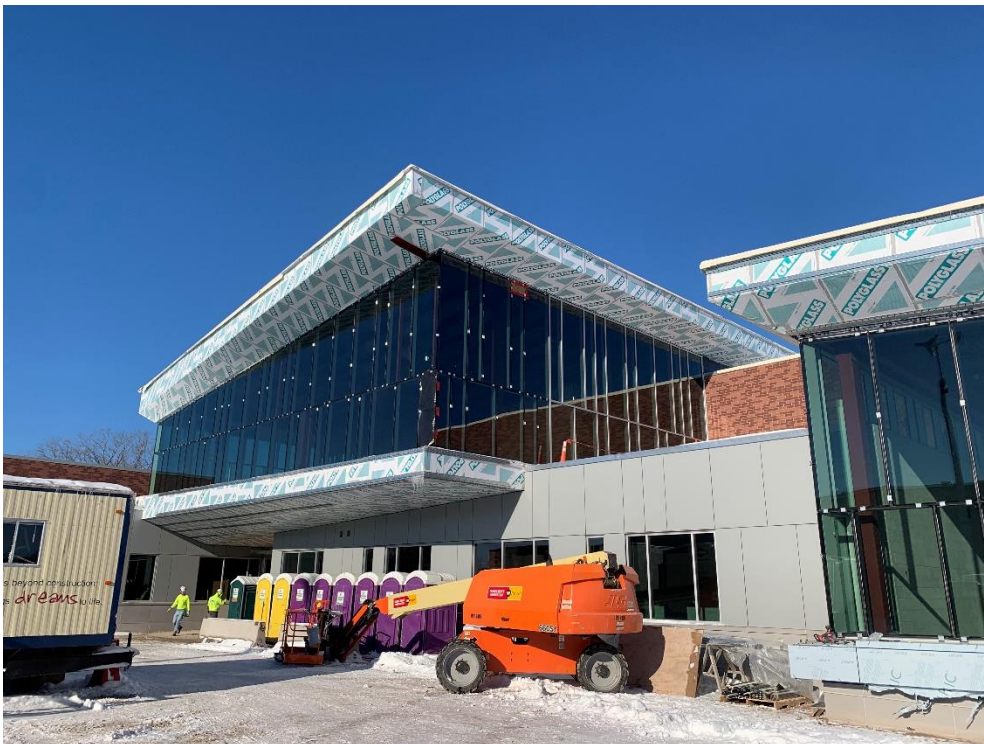
2. Area 1A South – Metal girt system at second story soffits, curtain wall mullion cap, and metal coping install in progress.

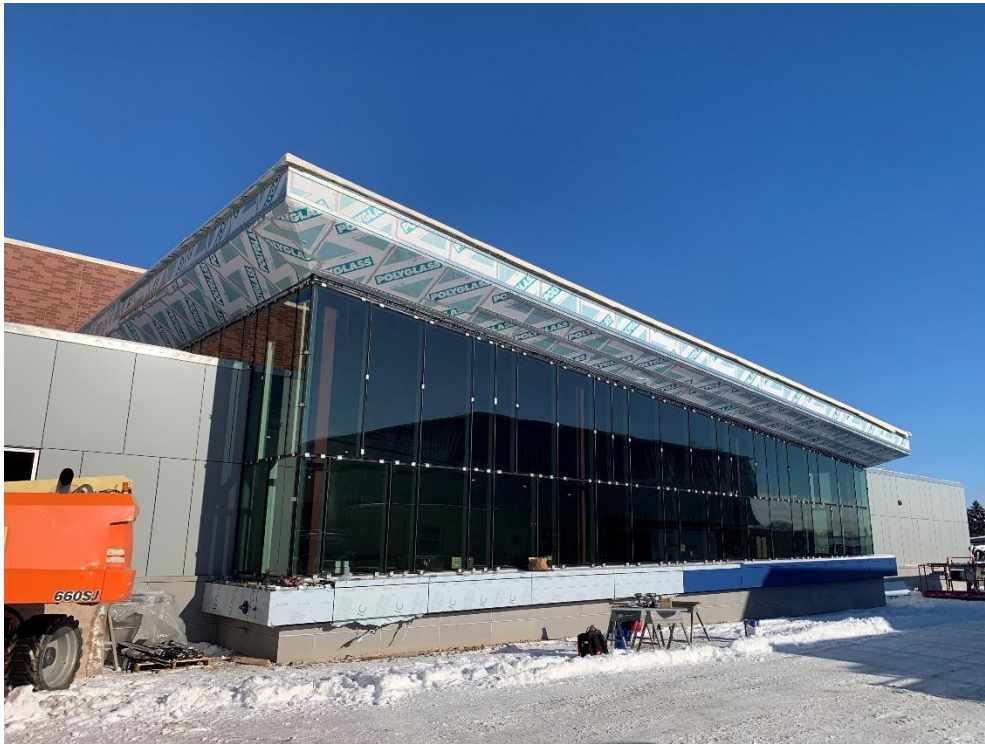
3. Area 2B – Metal girt system at upper soffit and metal coping install in progress. Composite wall panel install at lower soffit in progress.

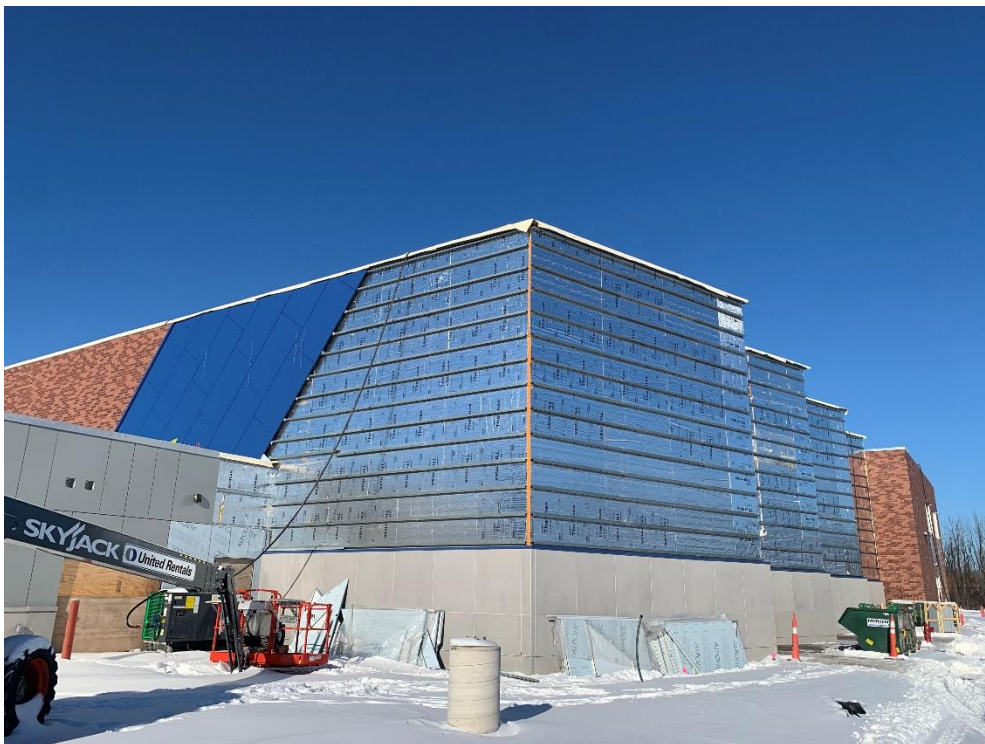
4. Area 2B East & Area 6 Southeast – Composite wall panel install in progress.

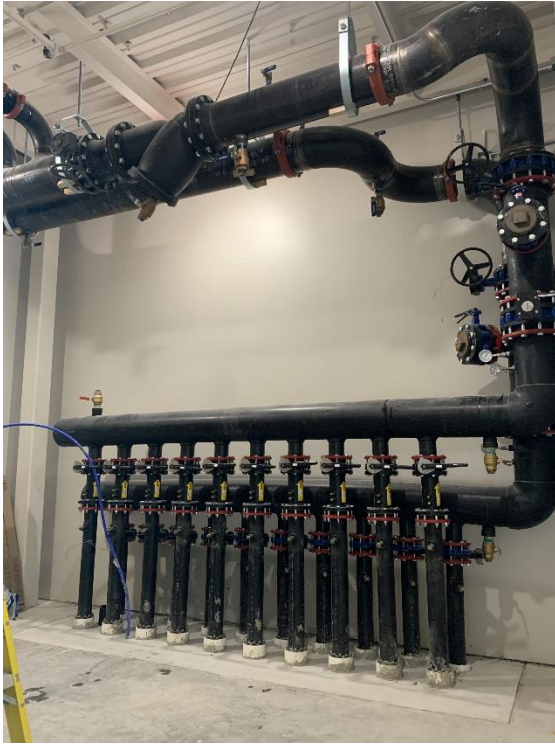
5. Area 6 – Work in manifold room continues.

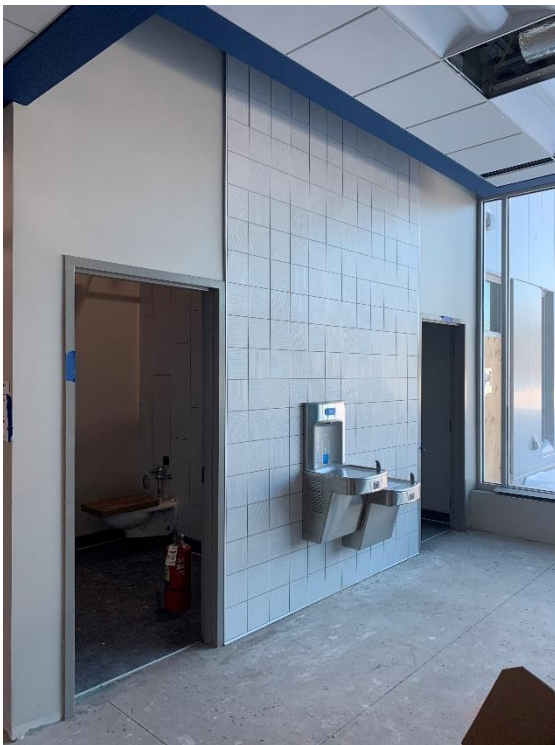
6. Area 6 – Plumbing fixtures, wall, and floor tile install continues throughout area on both floors.

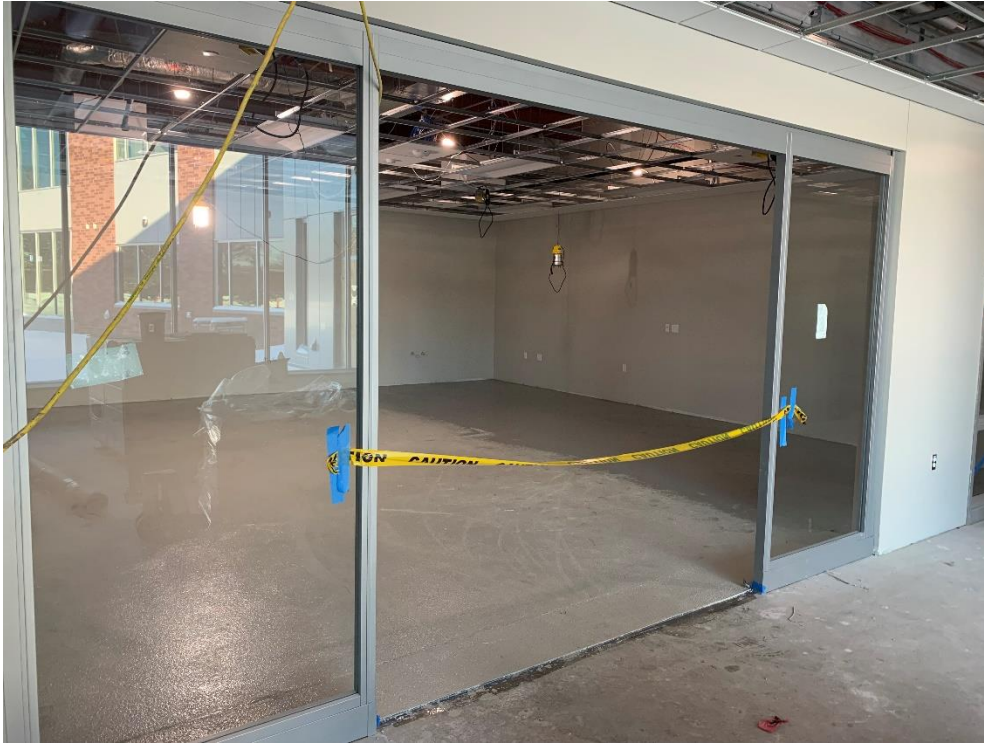
7. Area 6 – Terrazzo in first floor science classroom poured.

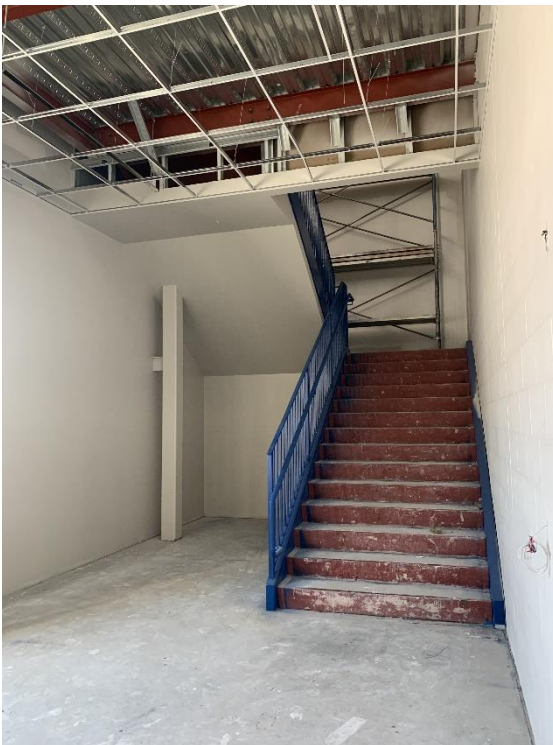
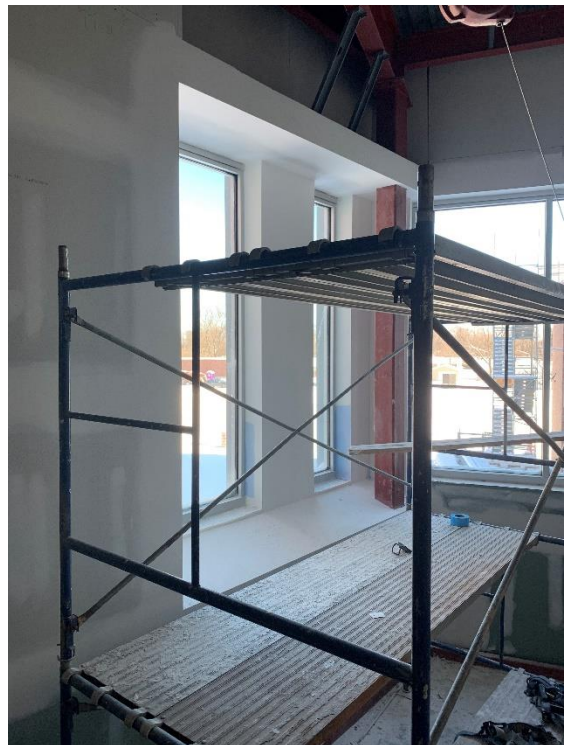
8. Area 5&6 – Gyp board finishing, painting, and ceiling grid install at stairs in progress.

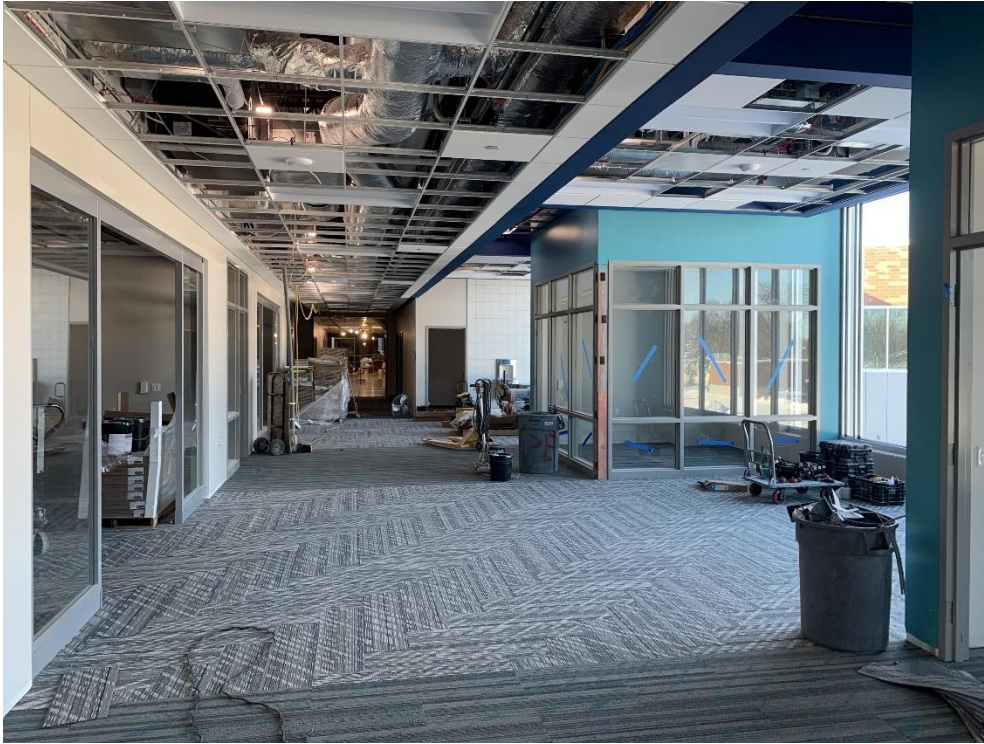
9. Area 6 – Carpet and sliding glass door install in second floor collab areas and classrooms in progress.

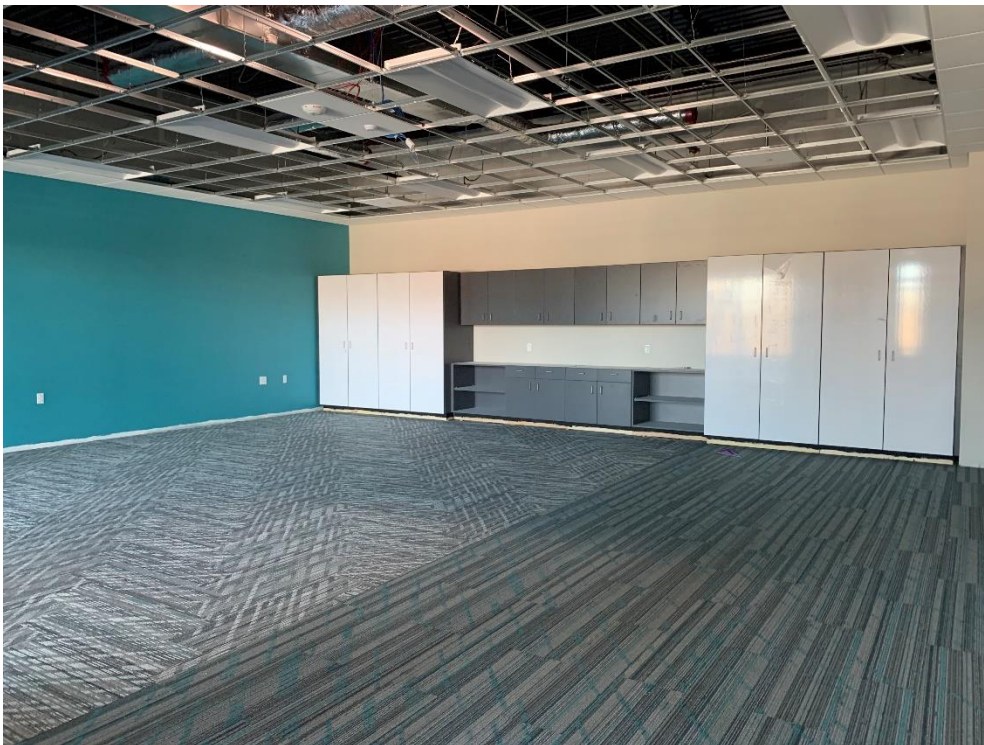
10. Area 6 – Classroom casework install continues throughout area on both floors.

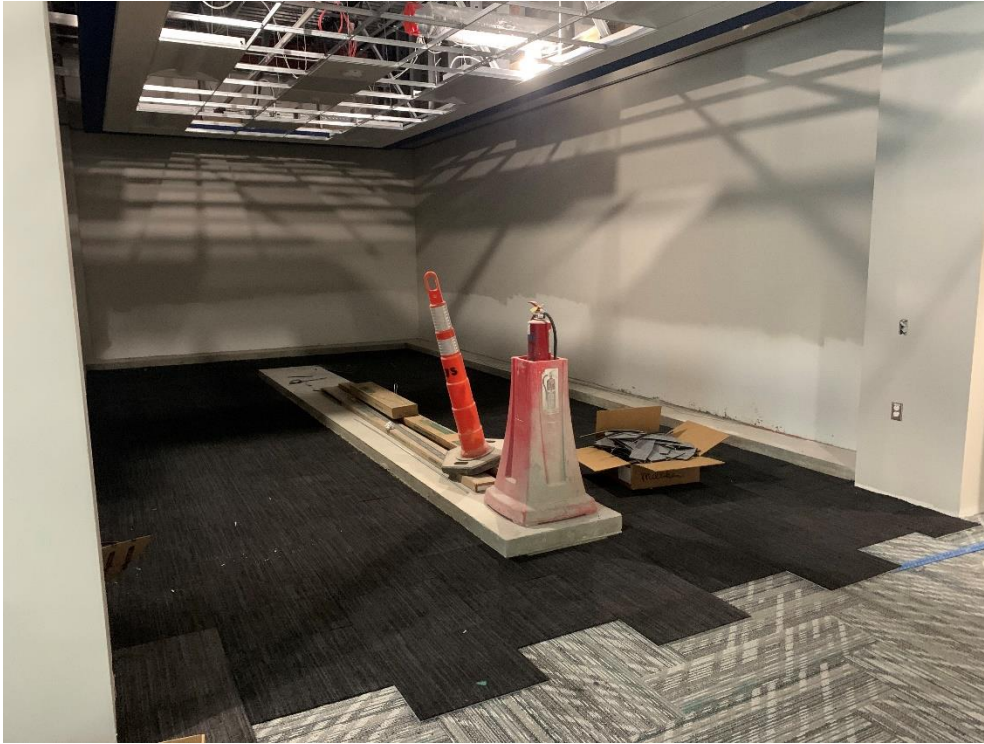
11. Area 6 – Locker alcove carpet install continues.

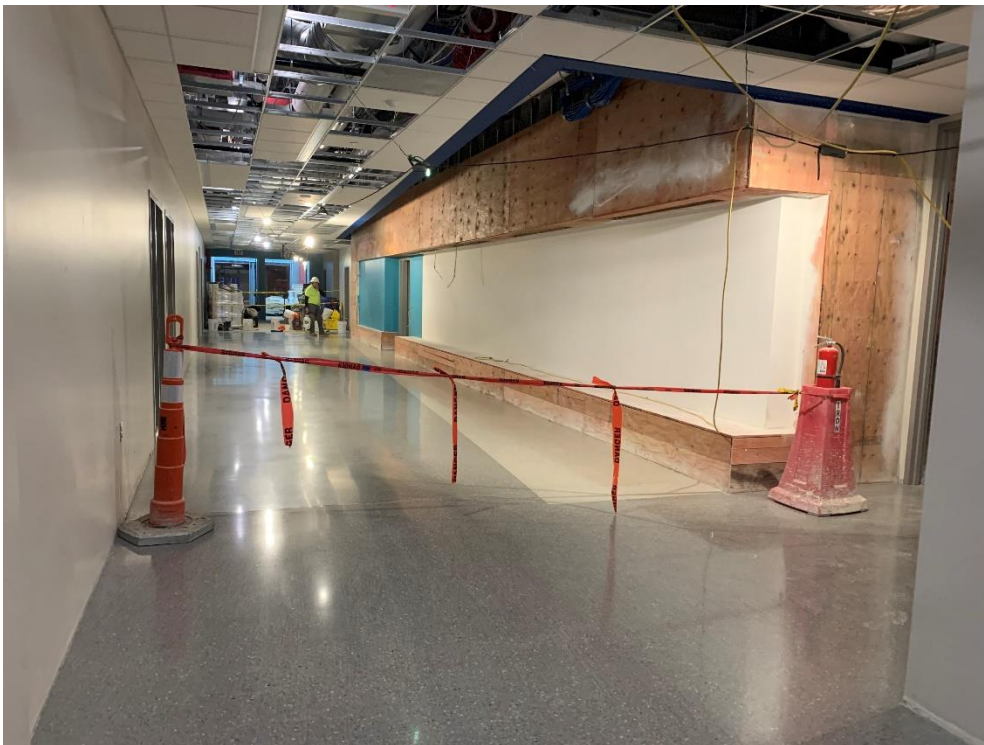
12. Area 6 – Terrazzo in second floor gradewig entry corridor is getting sealed.

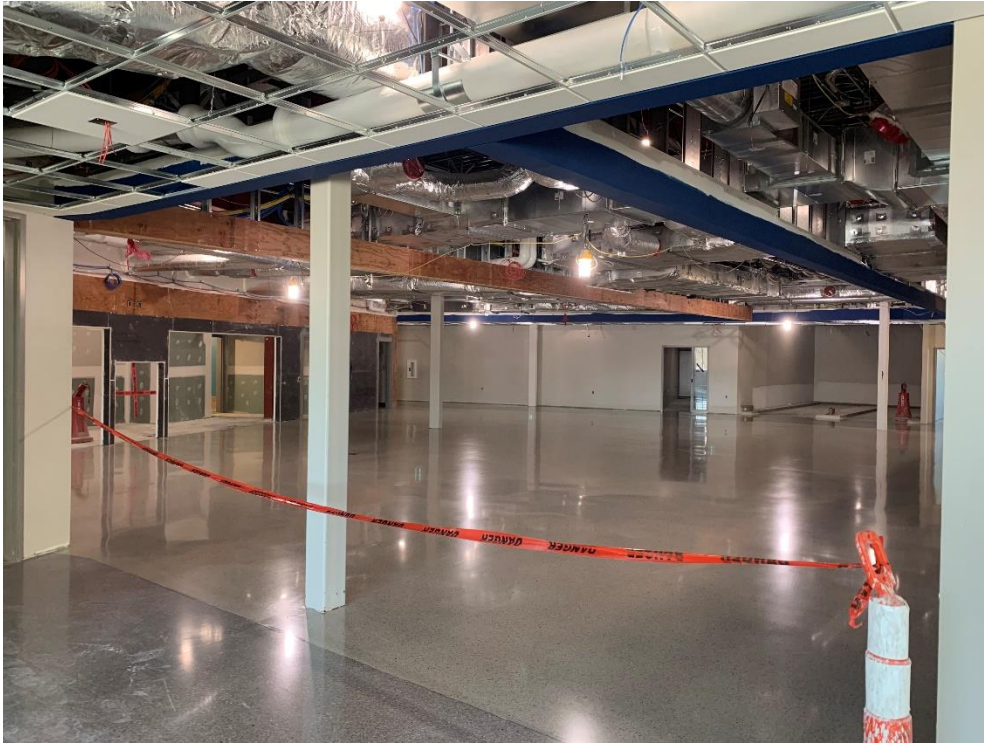
13. Area 5 – Terrazzo in second floor flex café is getting sealed.

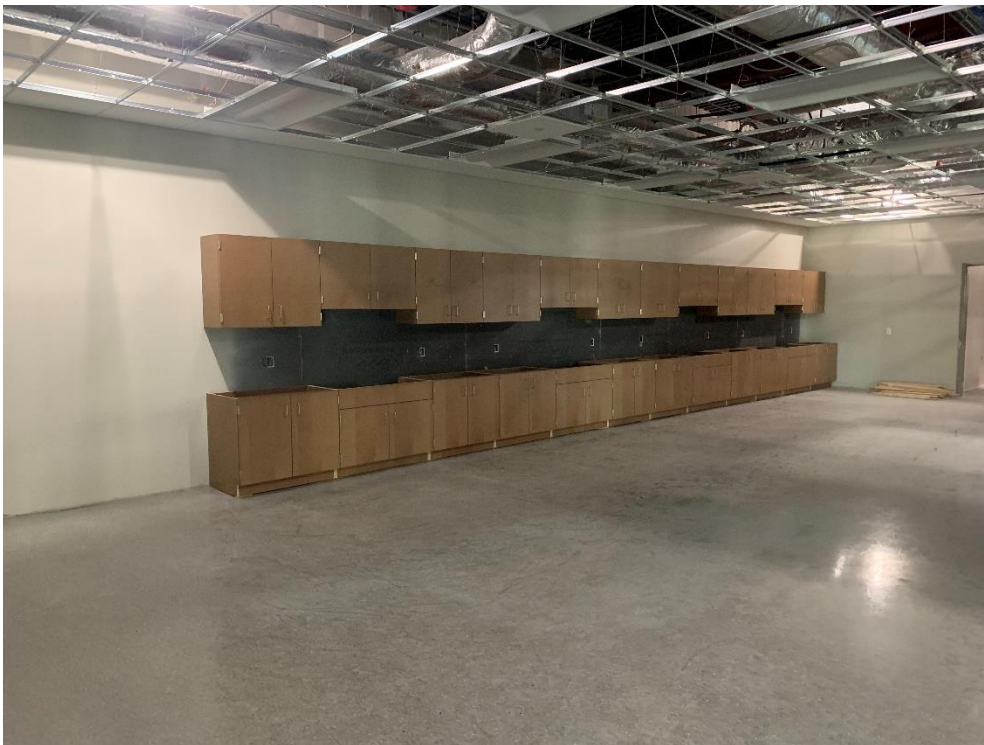
14. Area 5 – Second floor science lab casework install in progress.

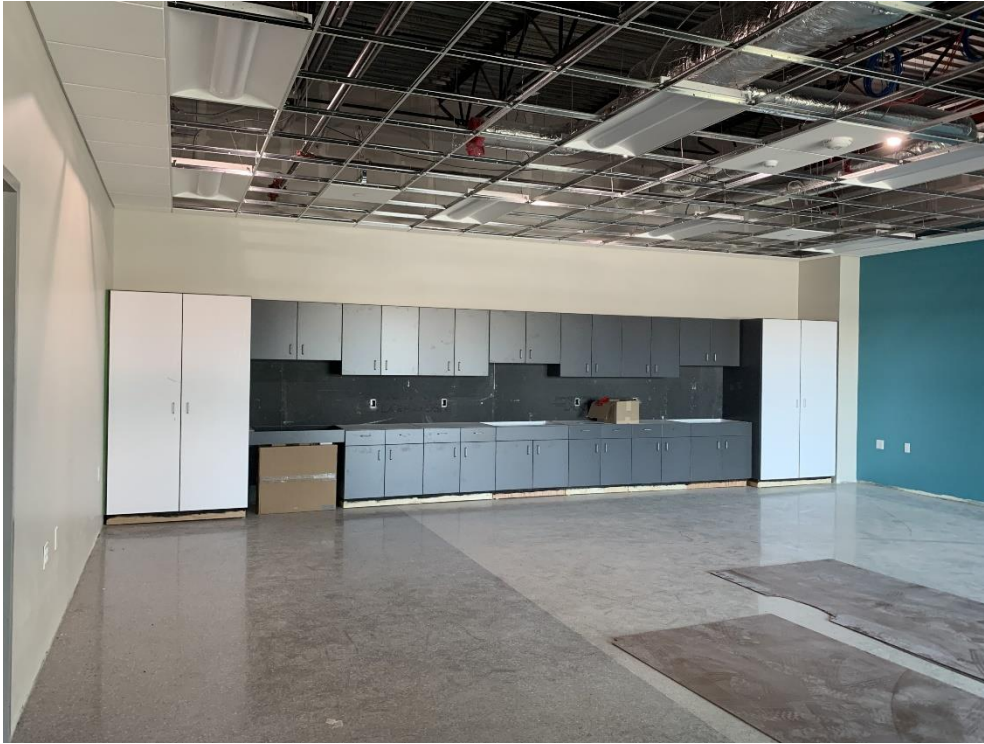
15. Area 5 – Casework install in second floor science classroom in progress.

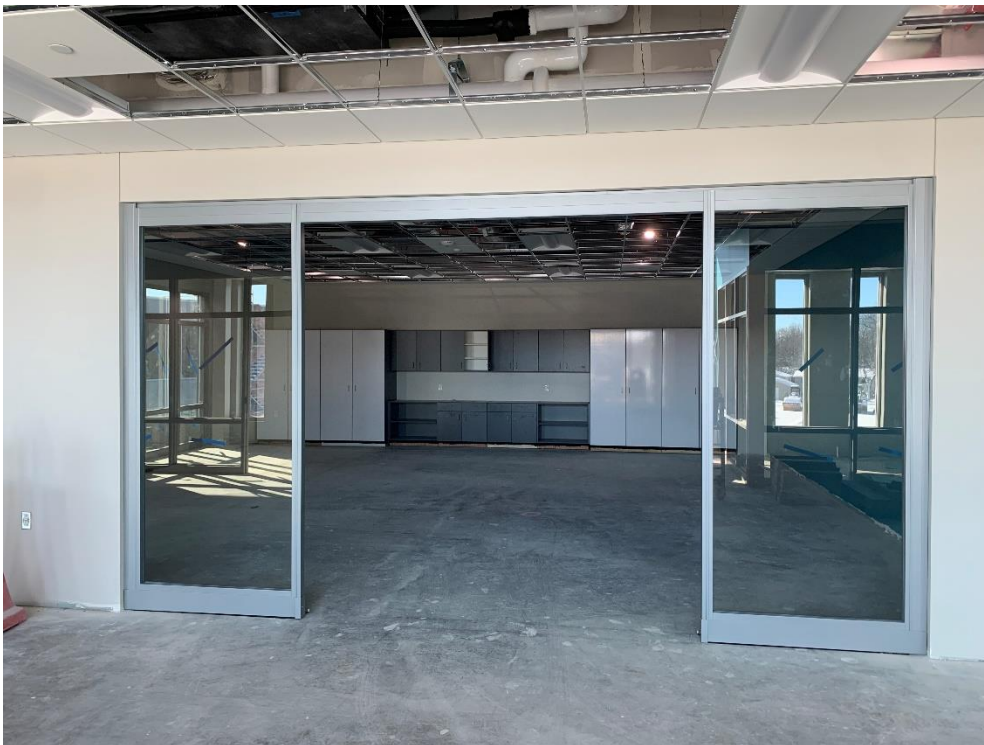
16. Area 5 – Casework and glass sliding door system install in second floor classrooms in progress.

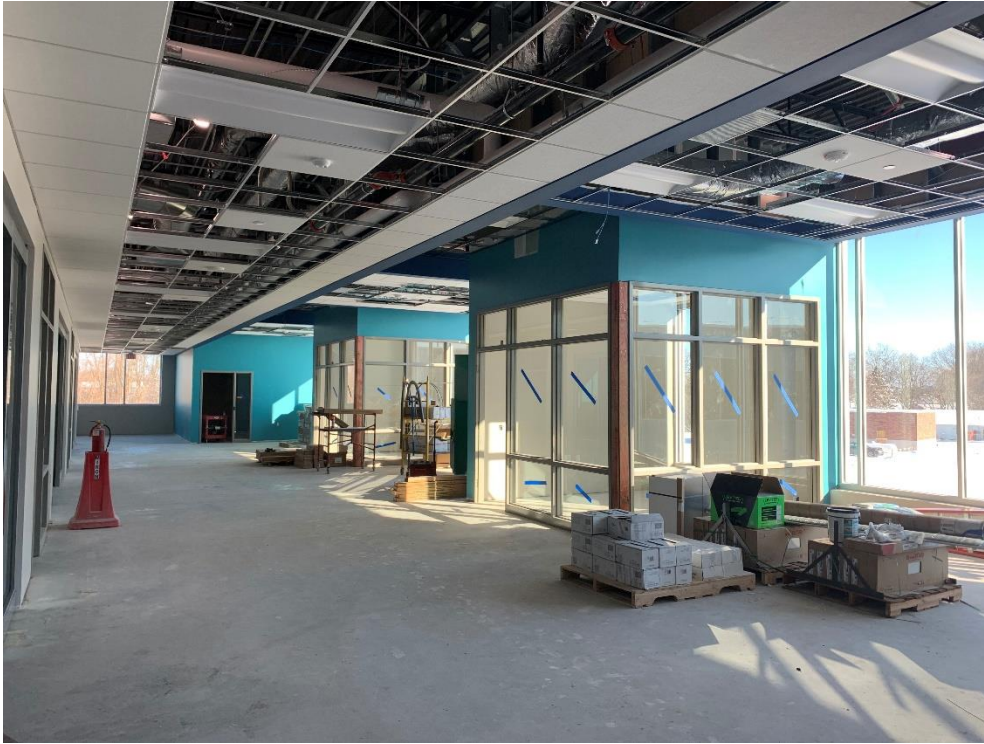
17. Area 5 – Second floor ceiling grid and interior storefront glazing in collab area installed.

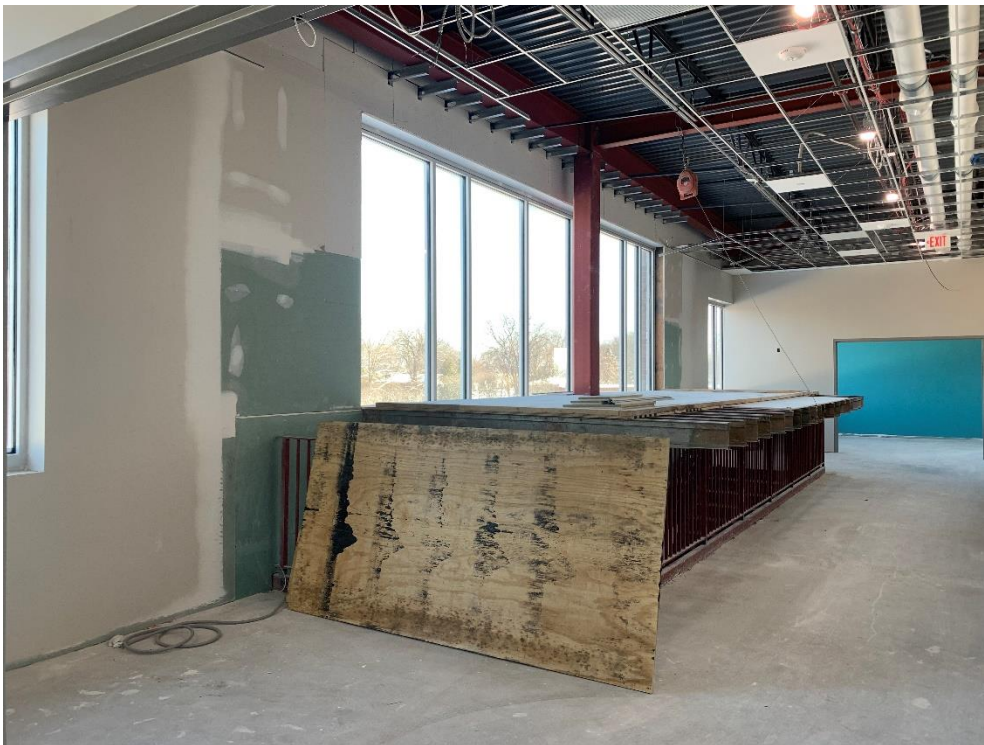
18. Area 5 – Gyp board install, taping, and mudding at north stair in progress. Ceiling grid install continues.

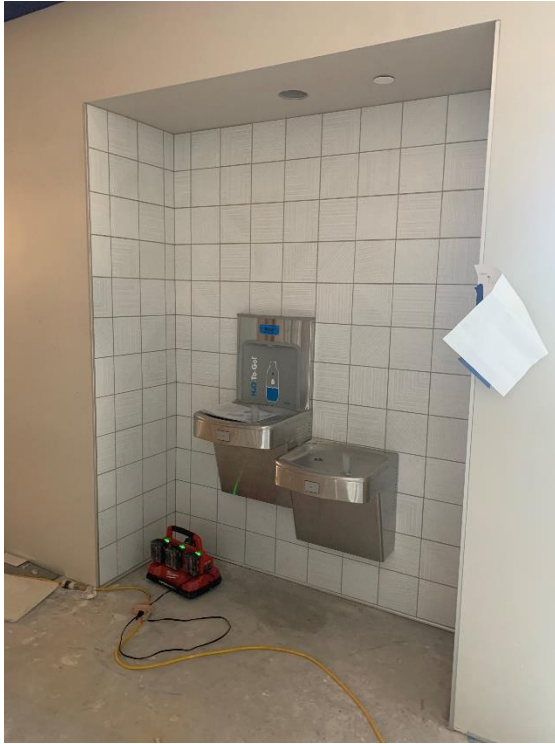
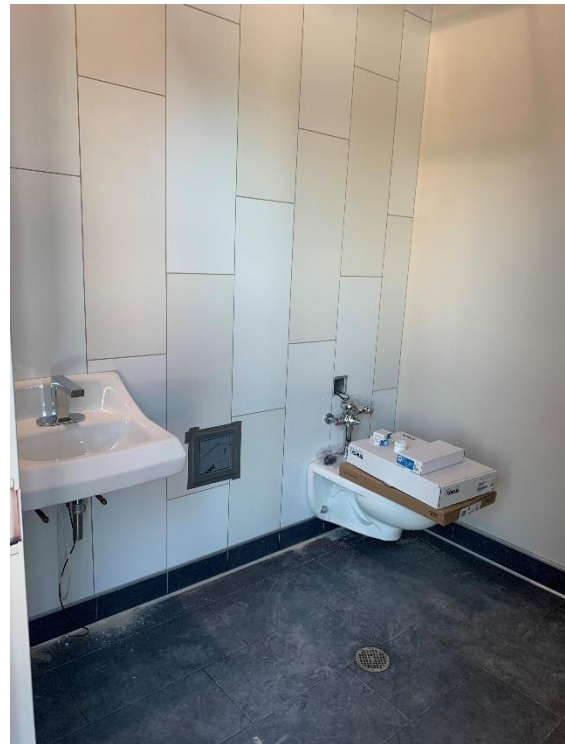
19. Area 5 – Plumbing fixtures, wall, and floor tile install continues throughout area on both floors.

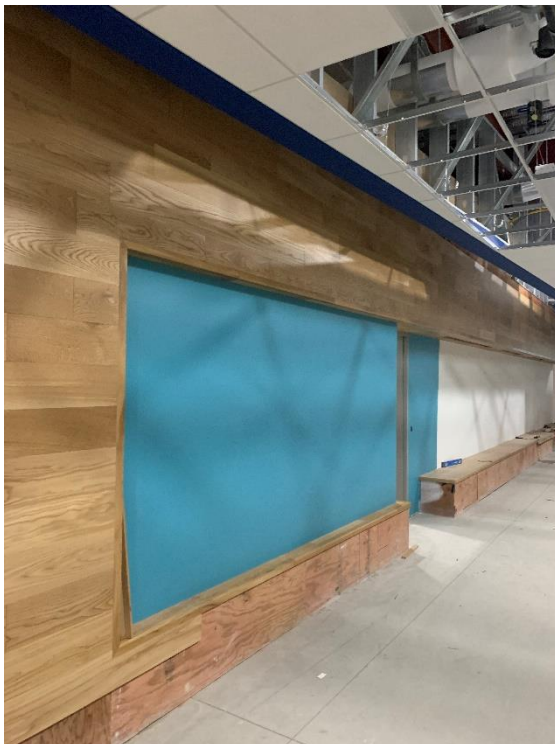
20. Area 6 – Finish wood plank install at first floor gradewalling entry feature in progress.

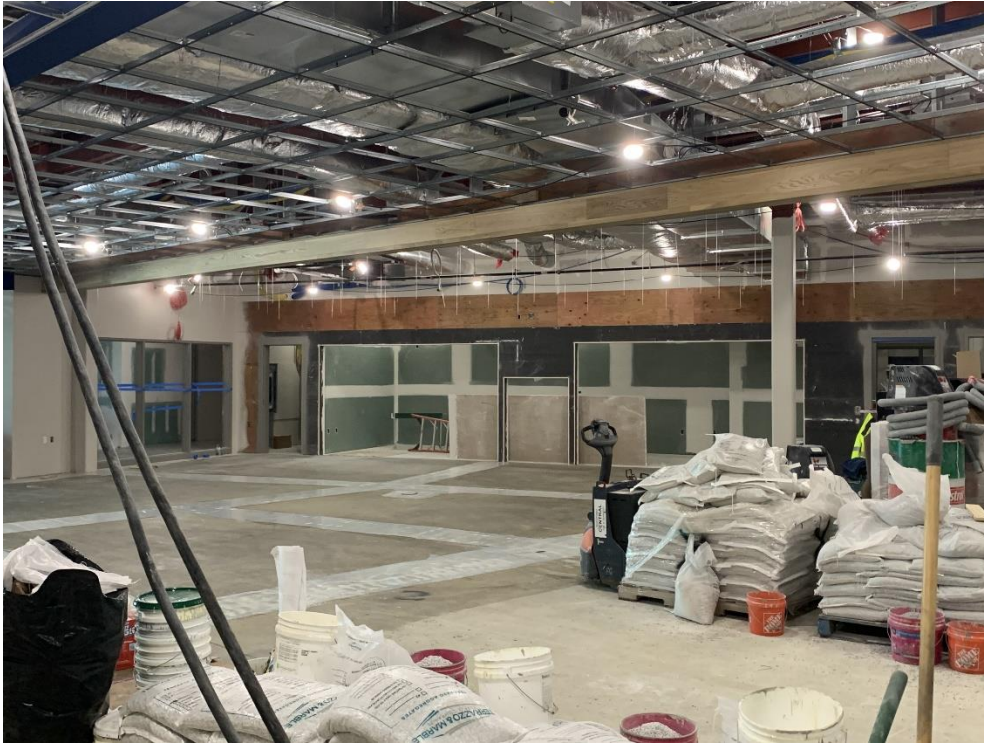
21. Area 5 – Terrazzo floor prep at first floor flex café in progress. Wood plank soffit installed.

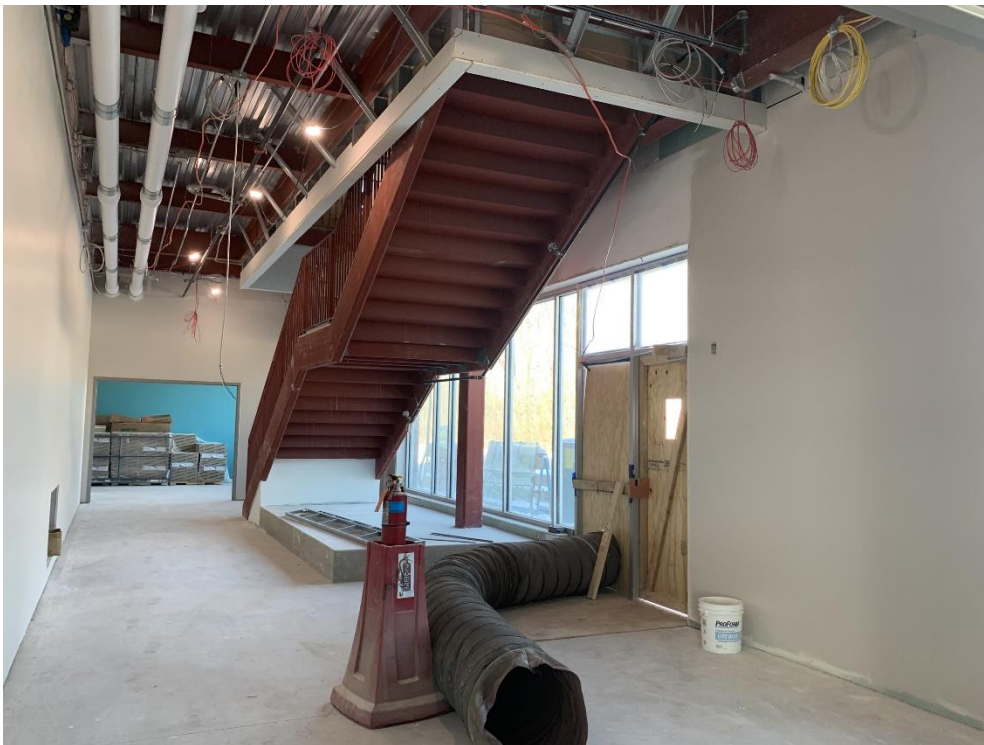
22. Area 5 – First floor gyp board soffit install and painting at north stair in progress.

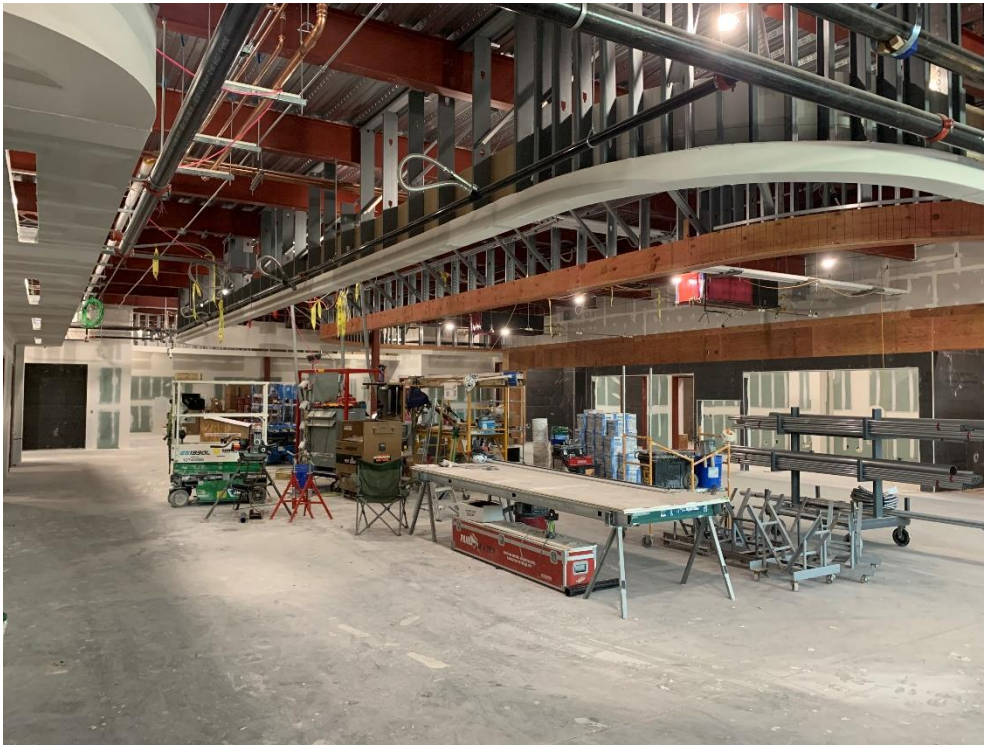
23. Area 4 – Gyp board taping and mudding at first floor flex café in progress.

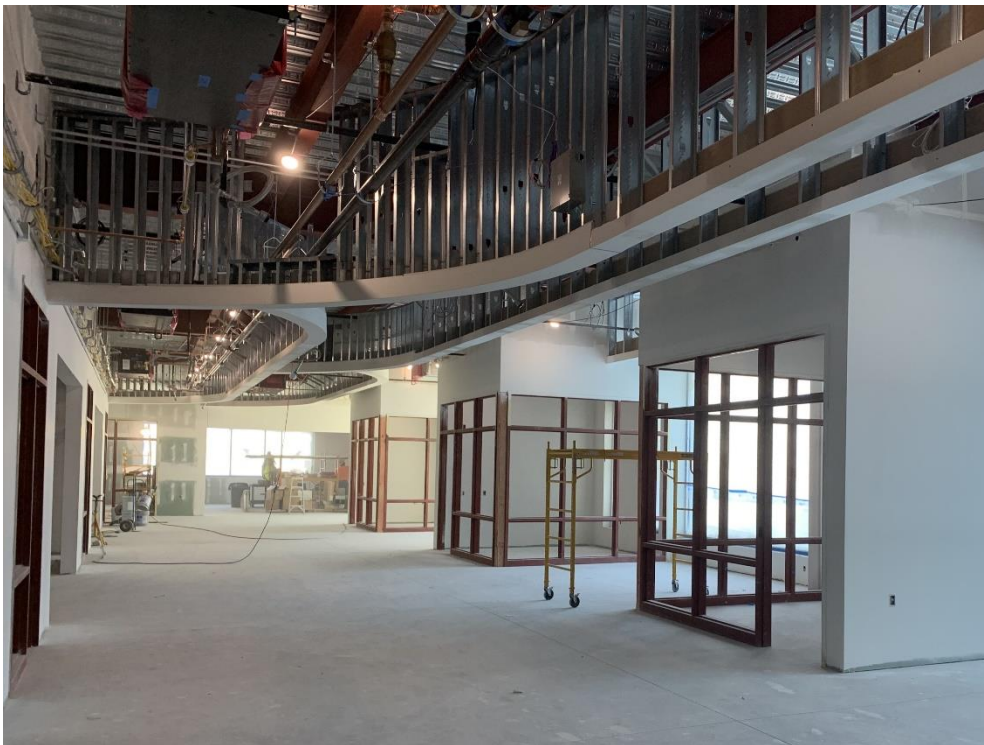
24. Area 4 – Gyp board taping, mudding, and painting at first floor collab areas and classrooms in progress.

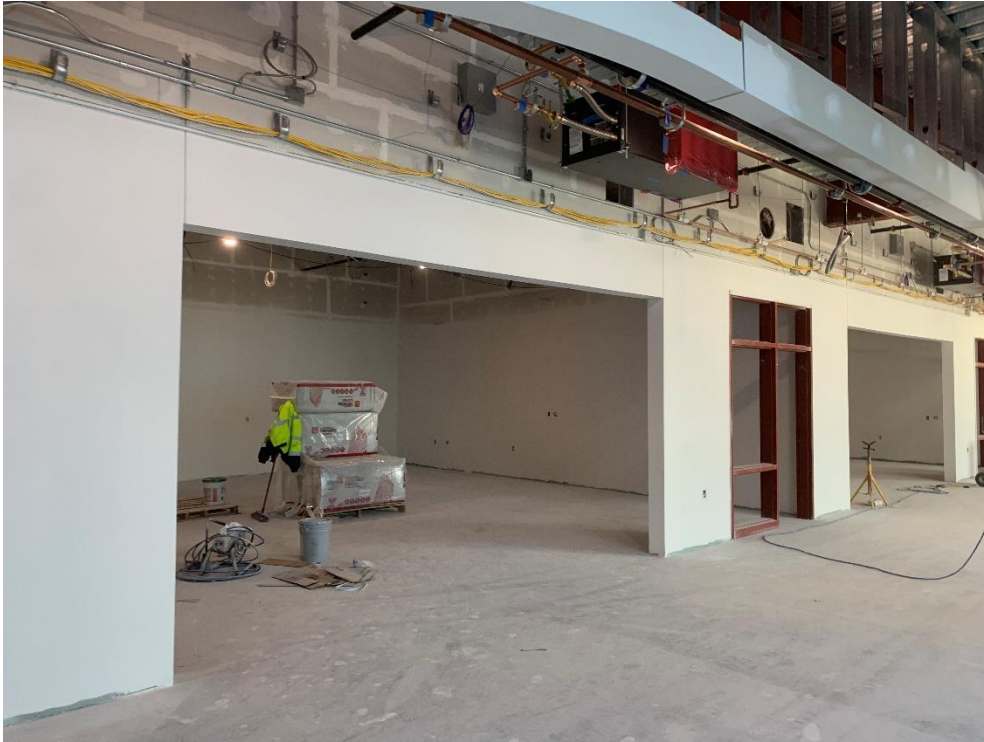
25. Area 4 – Gyp board taping, mudding, and painting at first floor collab areas and classrooms in progress.

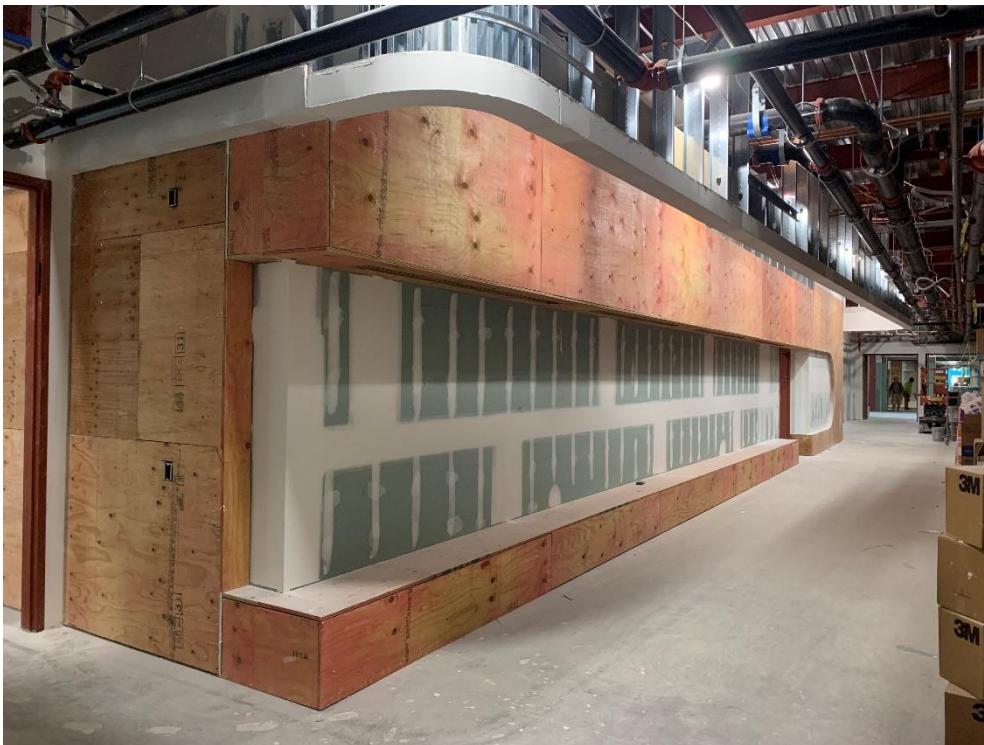
26. Area 4 – Plywood backing install, gyp board taping and mudding of first floor gradewalling entry feature in progress.

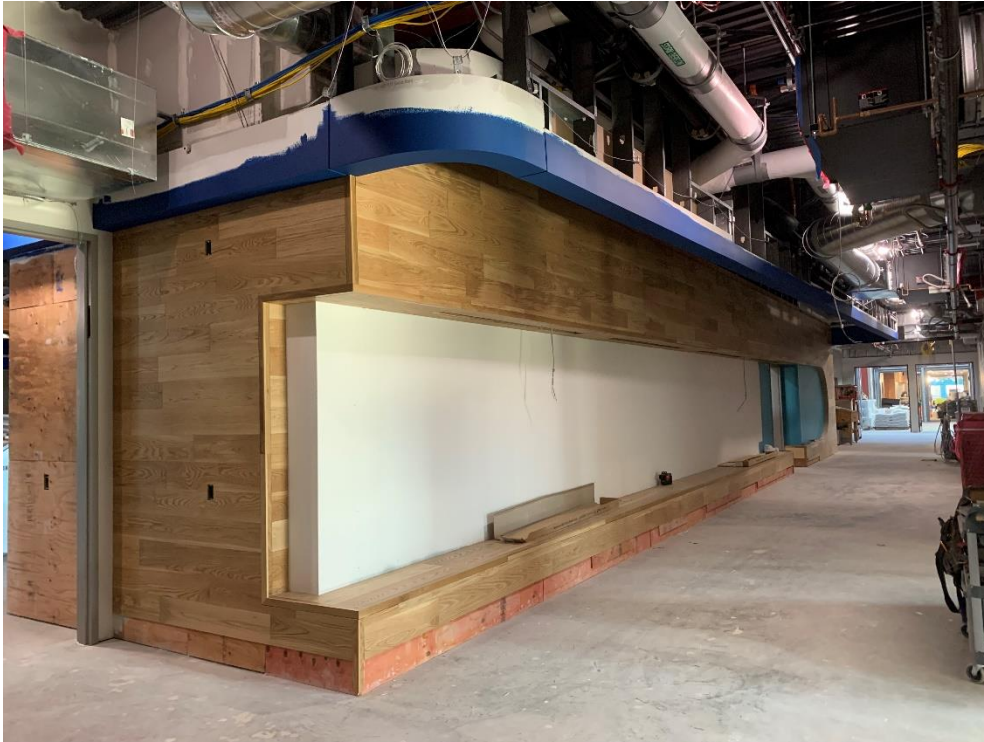
27. Area 4 – Finish wood plank install and painting of second floor gradewing entry feature in progress.

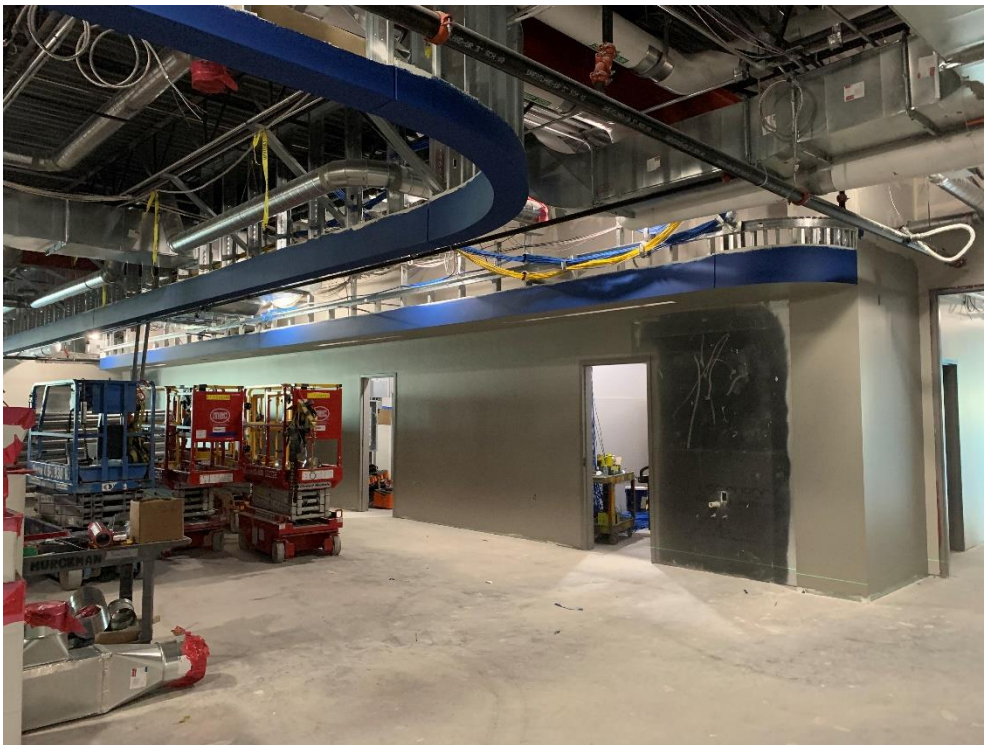
28. Area 4 – Painting and above ceiling MEP work at second floor flex café in progress.

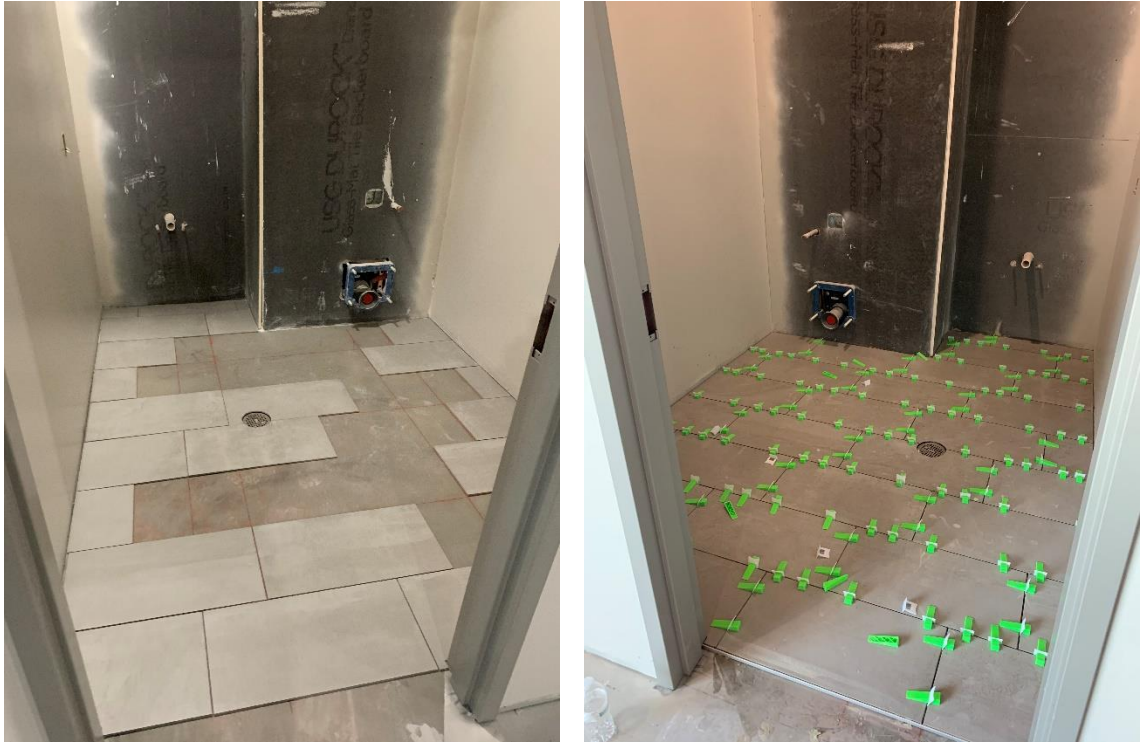
29. Area 4 – Tile install in progress throughout area.

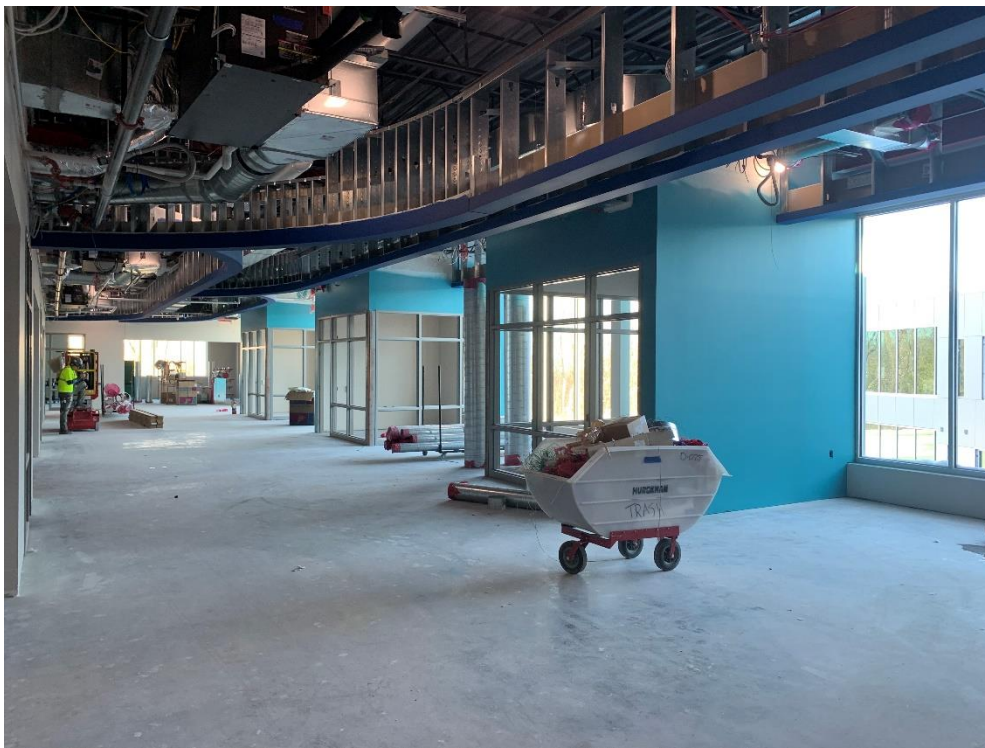
30. Area 4 – Above ceiling MEP work continues in grade neighborhoods.

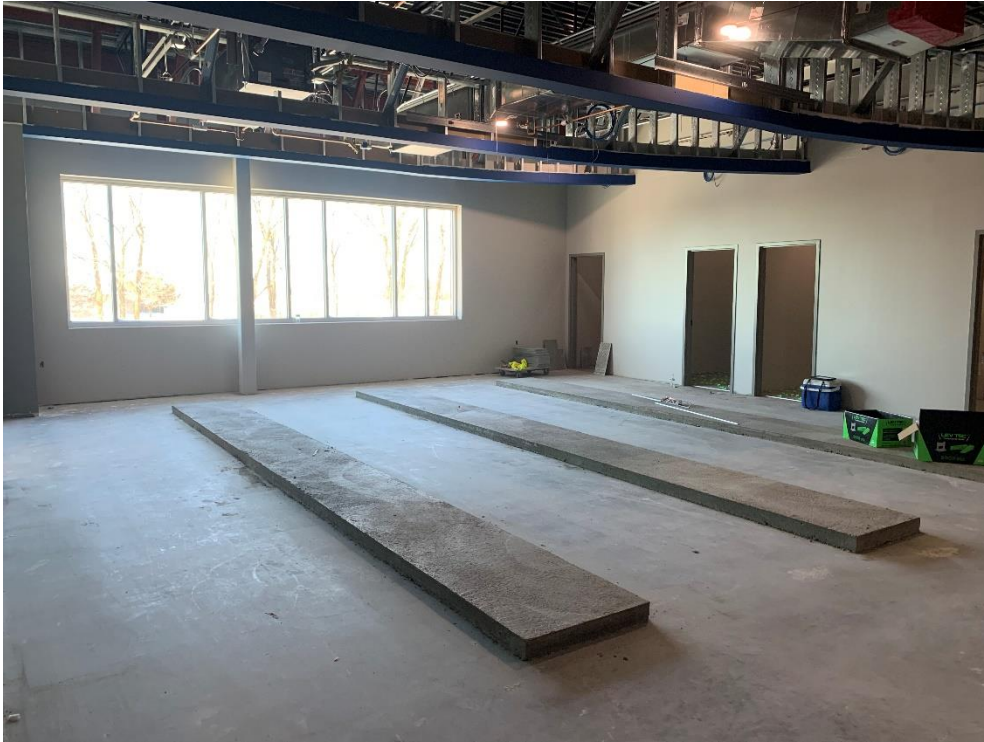
31. Area 4 – Locker curbs are poured.
