Construction Observation Report 020 – December 20th, 2024

Maplewood School

PROJECT NUMBER: 321169-01

OWNER:	MENASHA JOINT SCHOOL DISTRICT
From ARCHITECT/ENGINEER:	EUA
To CONTRACTOR	MIRON CONSTRUCTION CO, INC
SITE OBSERVATION TYPE	ARCHITECTURAL
DATE OF ISSUANCE:	December 30th, 2024

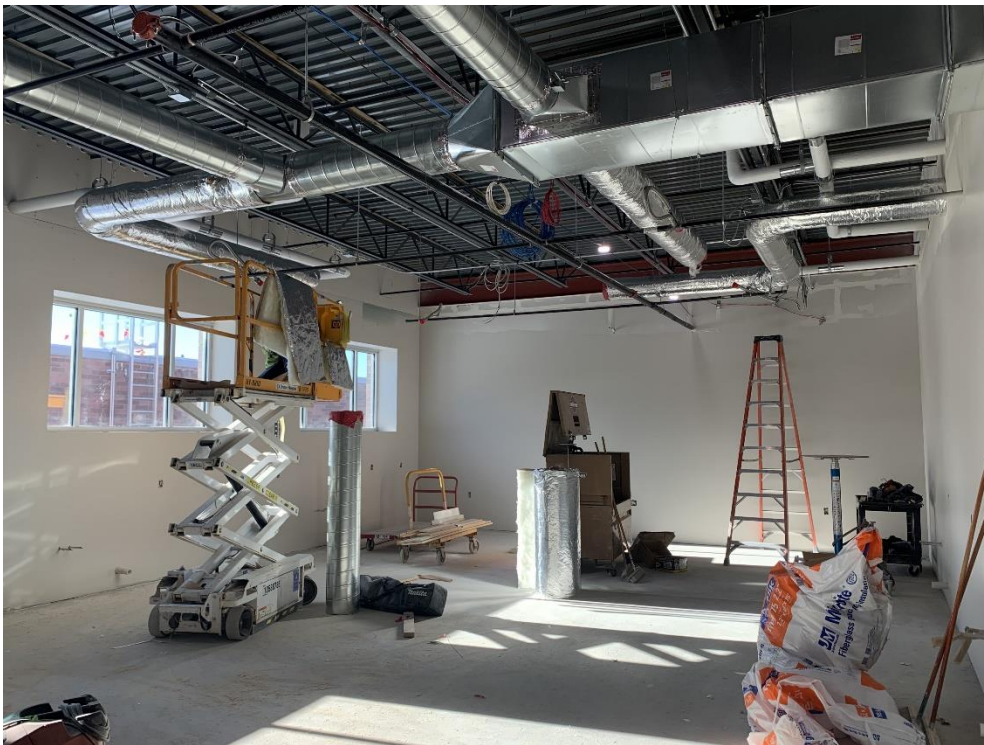
32. Area 3 – Above ceiling MEP work and duct insulation install in progress at second floor art rooms.

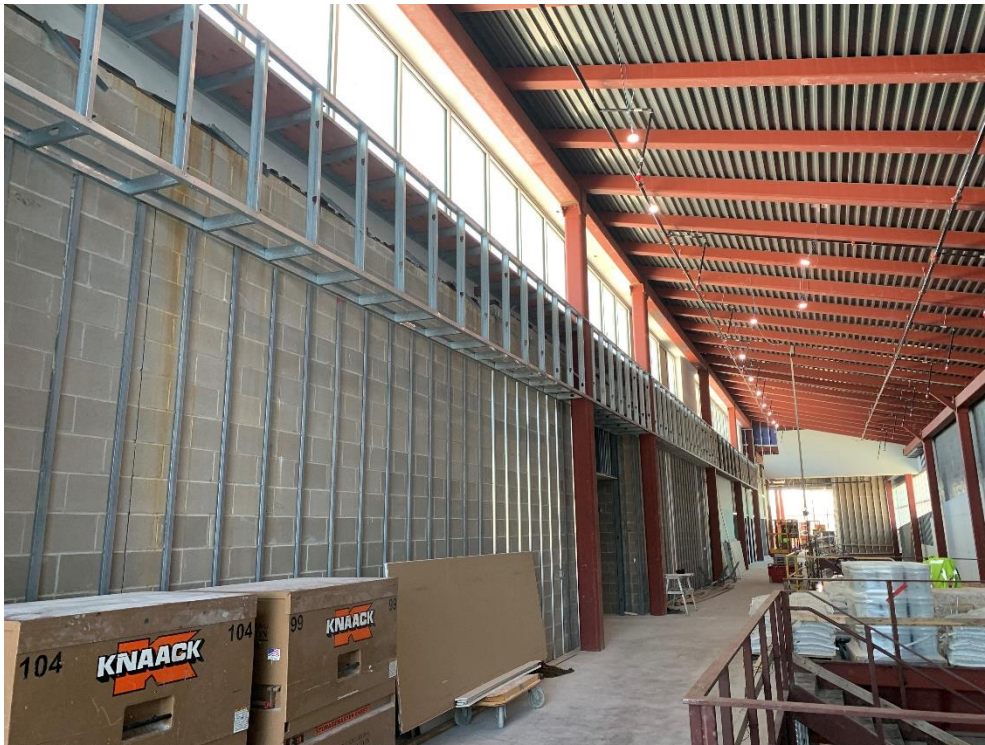
33. Area 1A&B – Interior metal stud framing in progress at center spine.

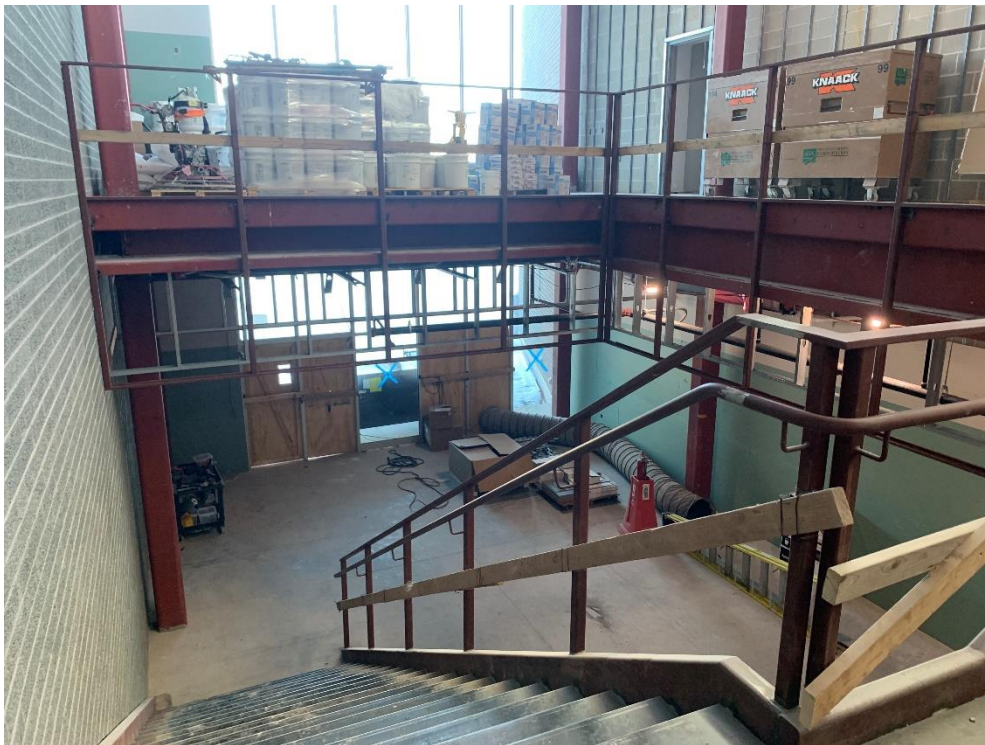
34. Area 1A&B – Center spine guard rail metal frame install in progress.

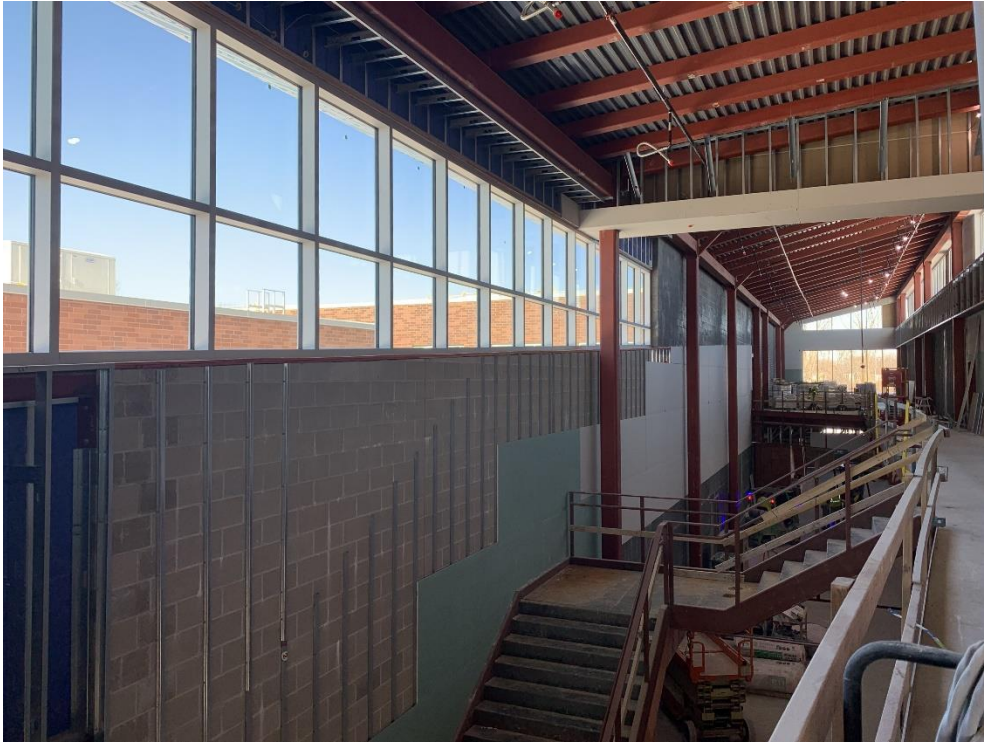
35. Area 1A&B – Metal furring strip, gyp board, and soffit install in progress.

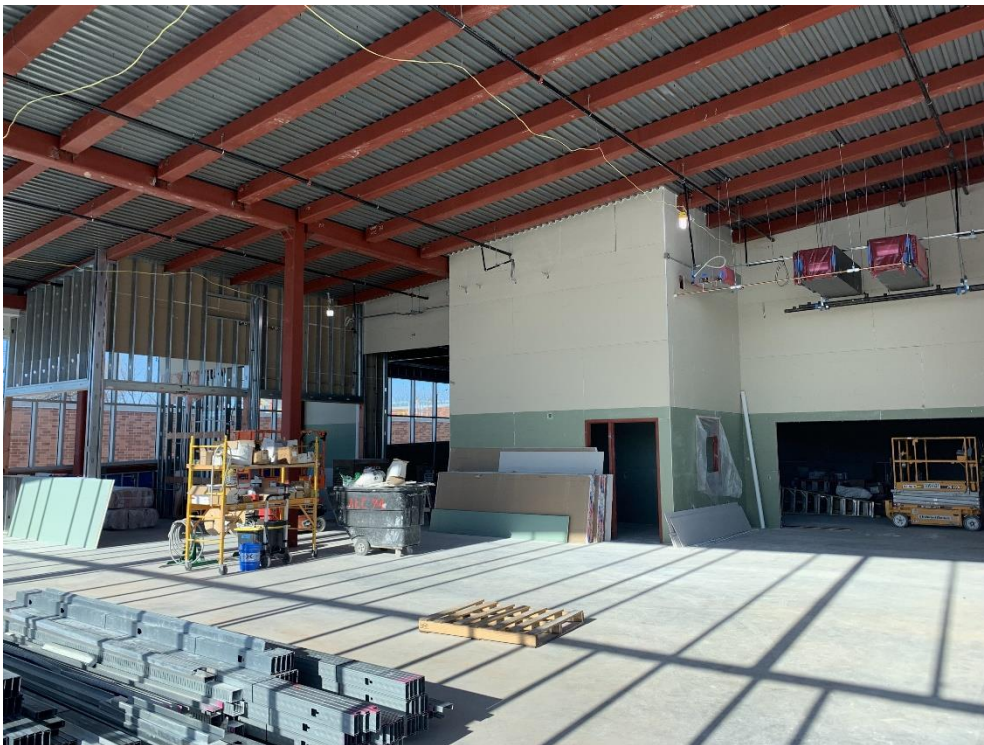
36. Area 1A – Above ceiling MEP and gyp board install in progress at LMC.

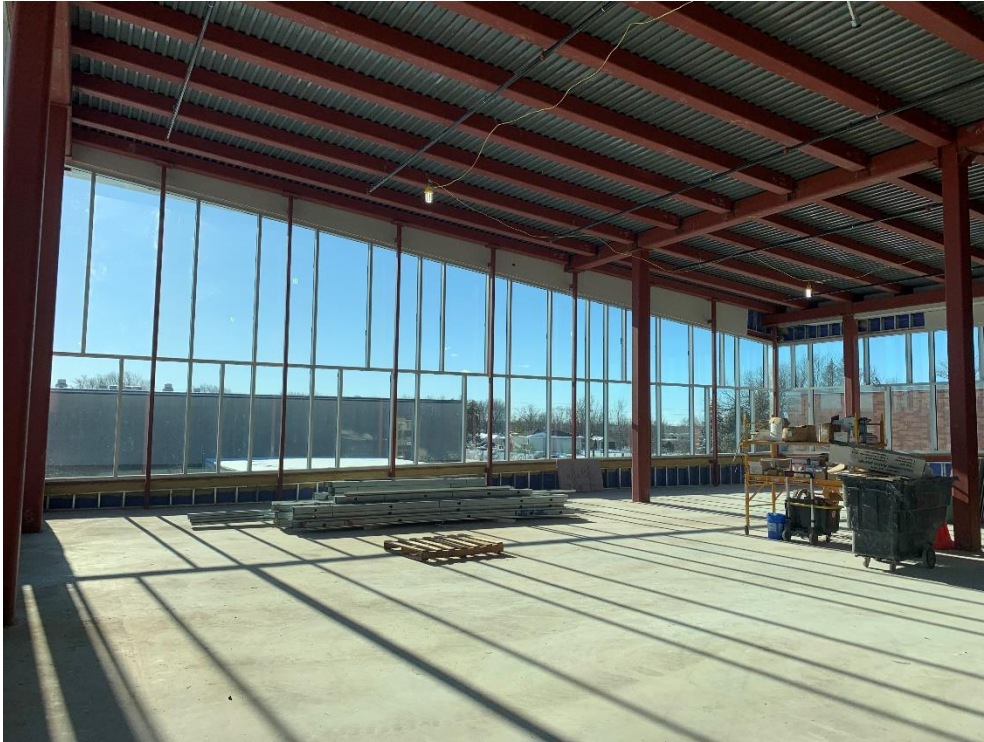
37. Area 1A – Interior progress photo of exterior curtain wall glazing at LMC.

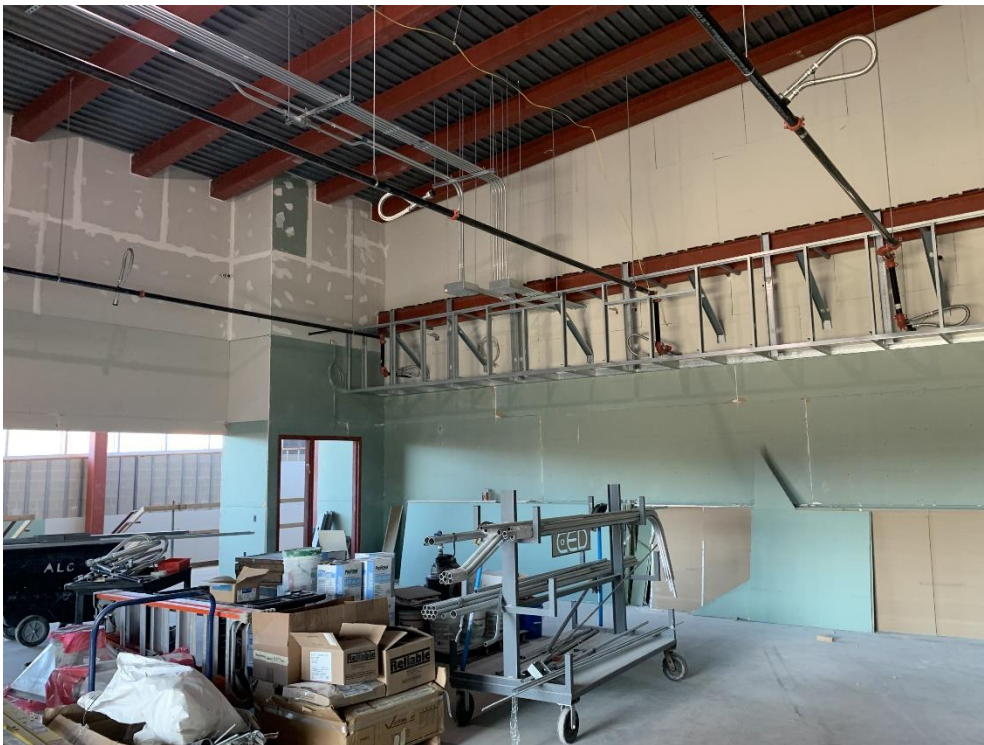
38. Area 1A – Gyp board install, taping, and mudding at second floor community room in progress.

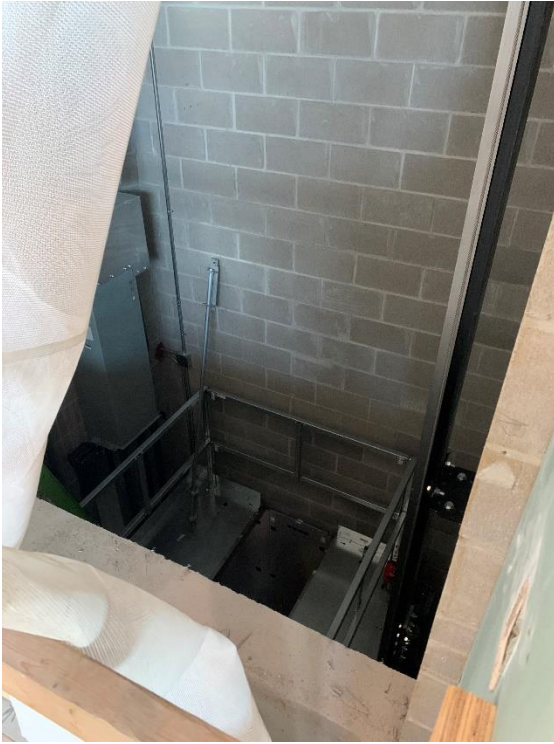
39. Area 1A – Elevator install in progress.

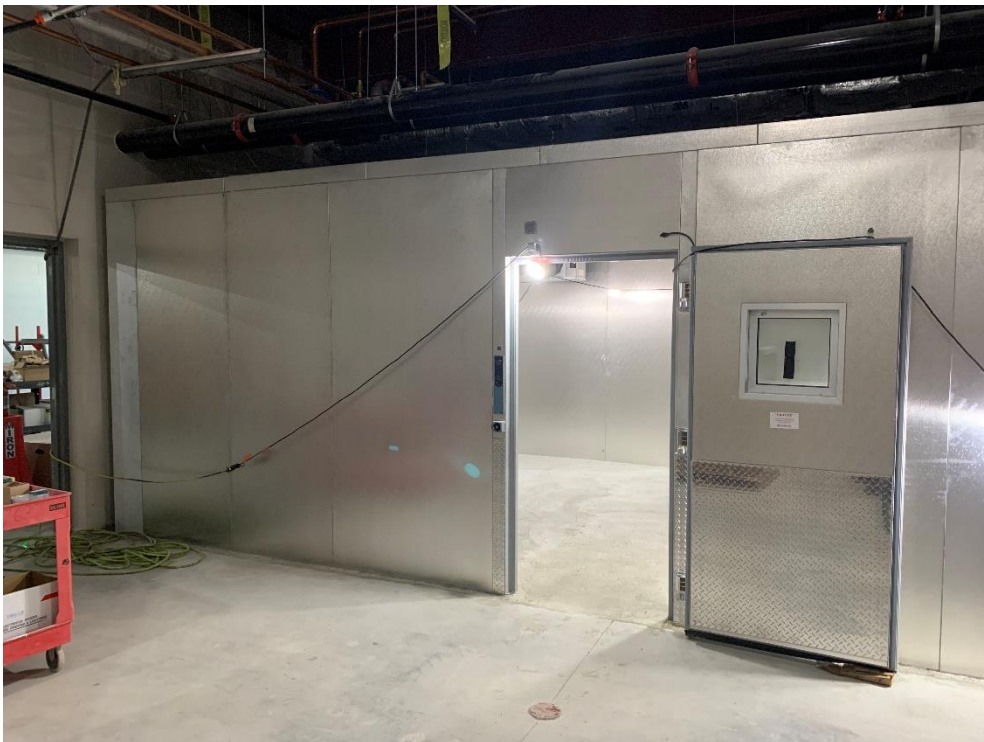
40. Area 3 – Cooler and freezer install at production kitchen in progress.

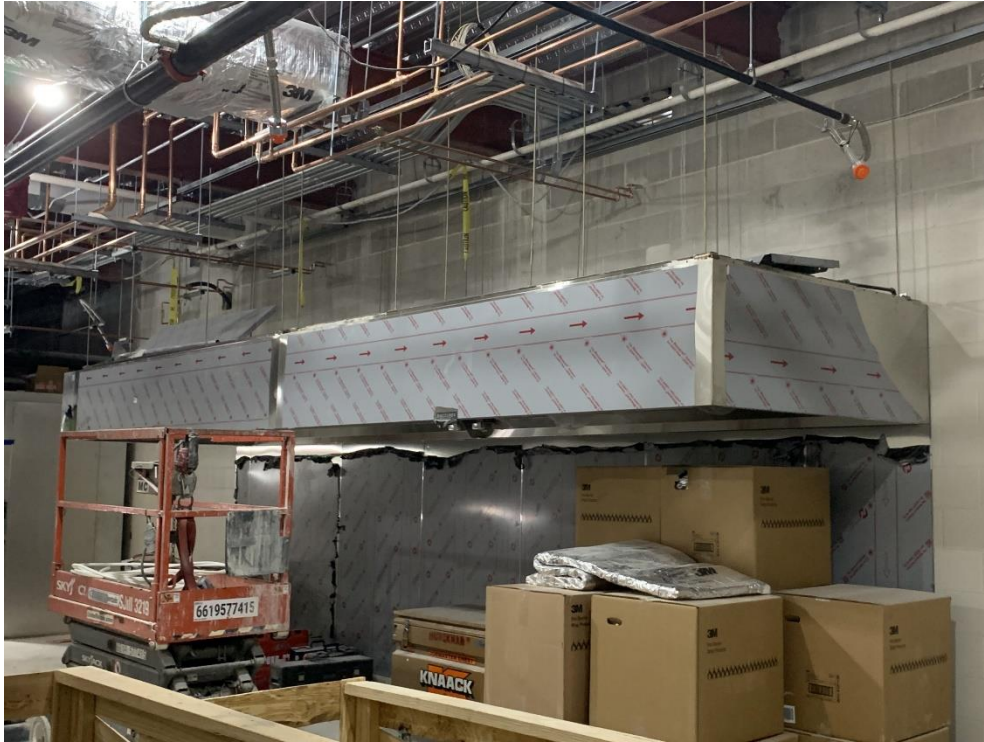
41. Area 3 – Hoods in production kitchen are beginning to be installed.

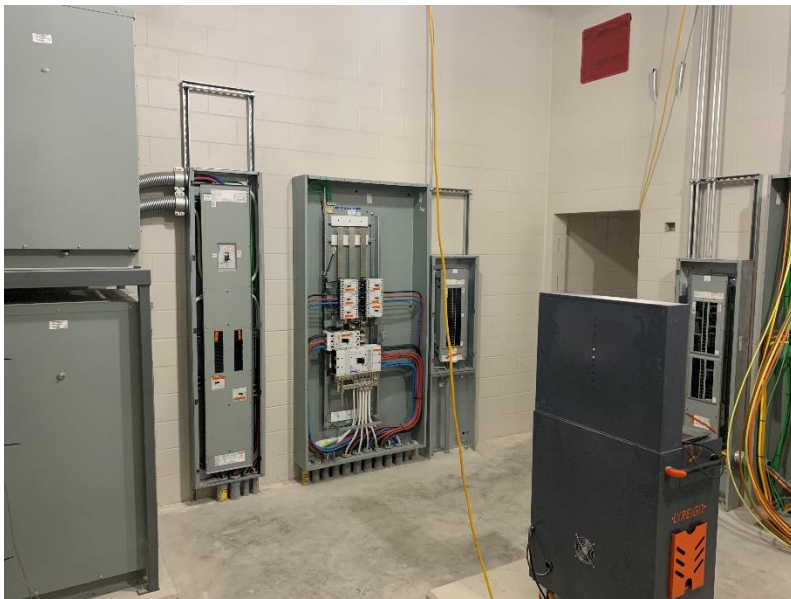
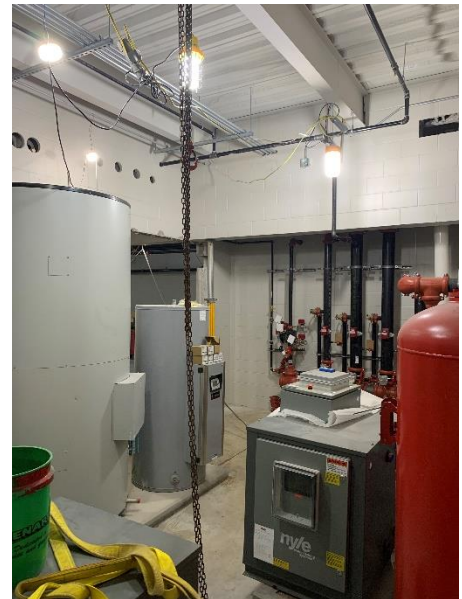
42. Area 3 – Work continues in main electrical and water rooms.

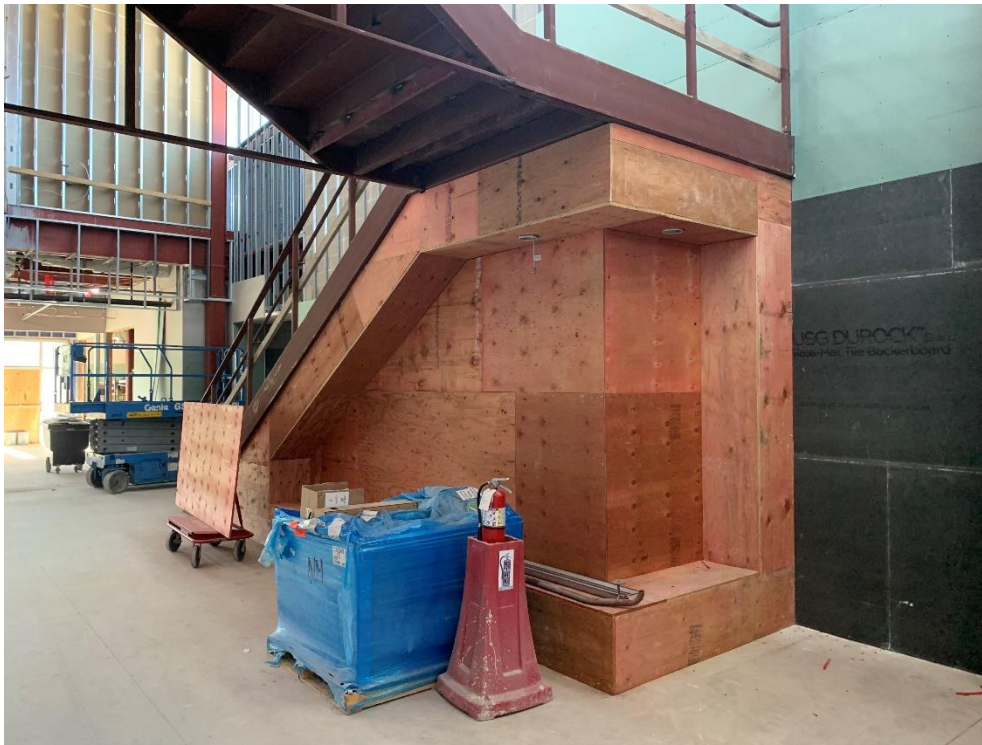
43. Area 1A&B – Plywood backing for under stair feature nooks in progress.

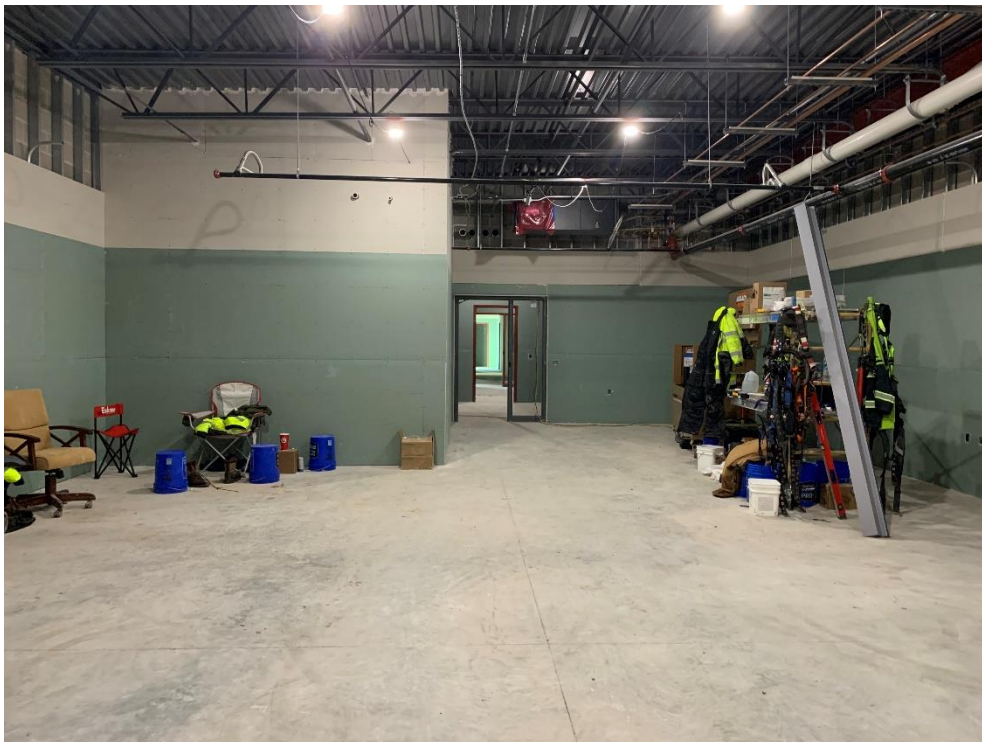
44. Area 3 – Gyp board install at first floor OT/PT and SRO office installed.

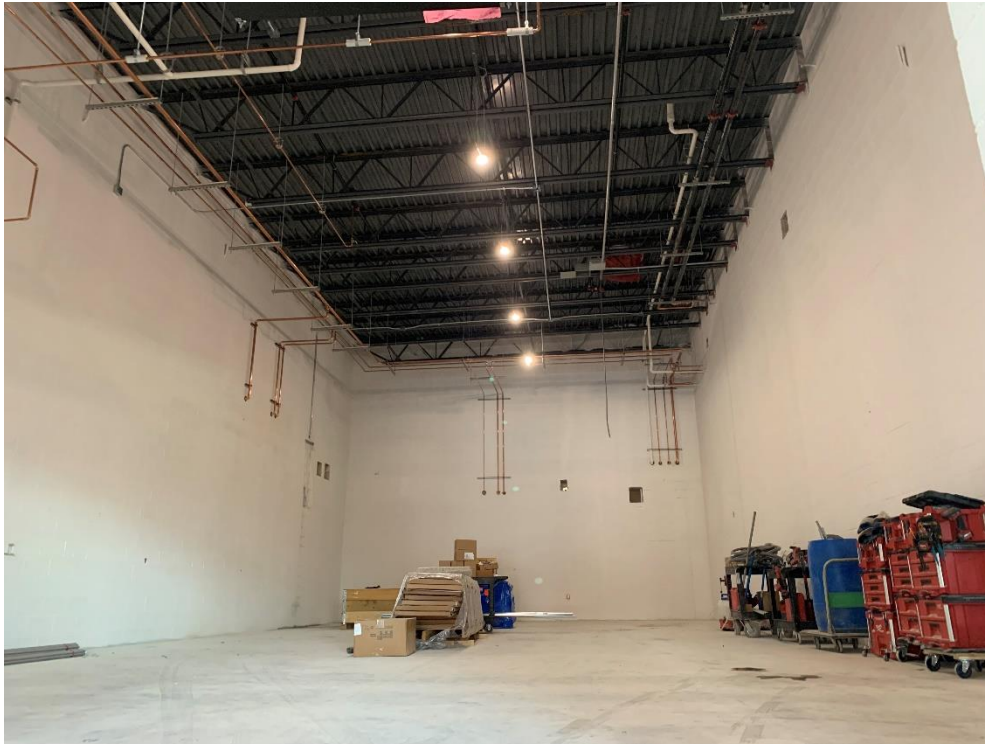
45. Area 3 – MEP work in tech ed rooms continues.

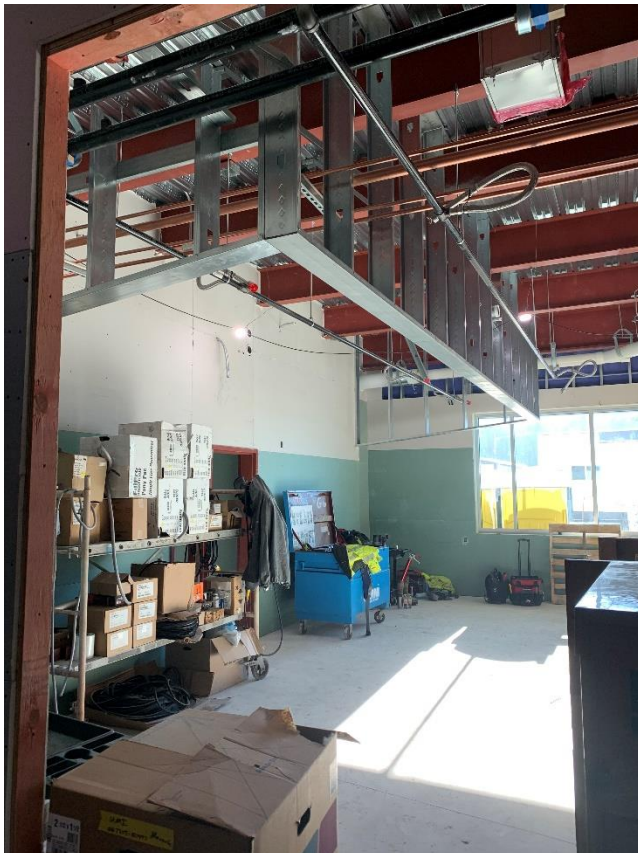
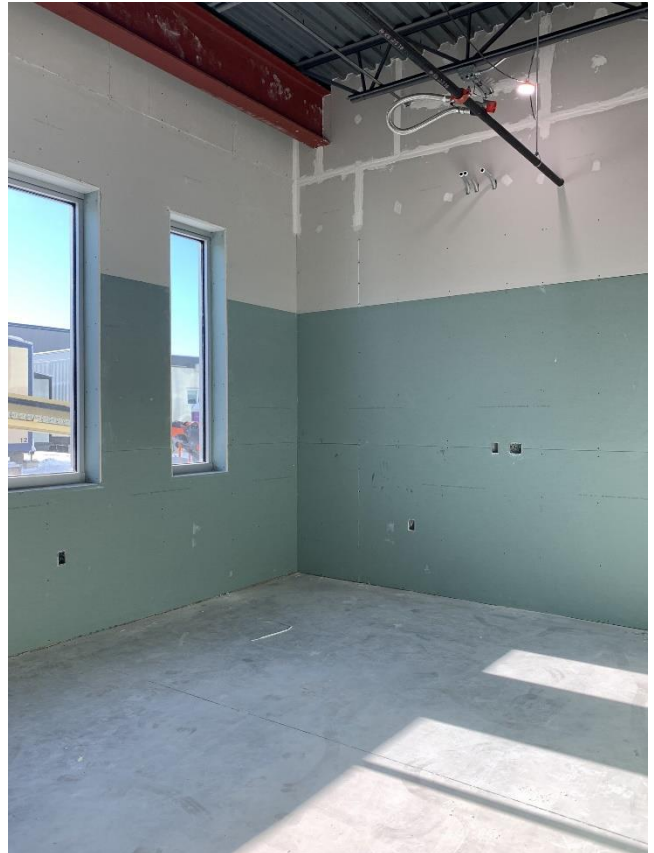
46. Area 2B – Gyp board install, taping, mudding, and above ceiling MEP work in progress at 7/8 front office.

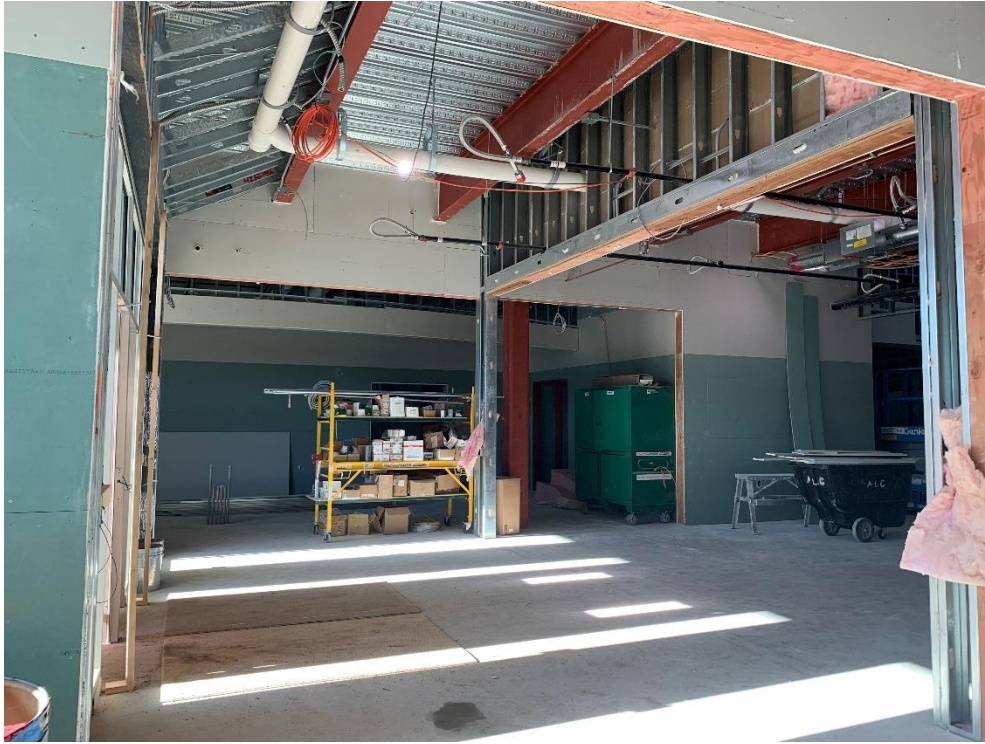
47. Area 1A – Gyp board install at south entry vestibule in progress.

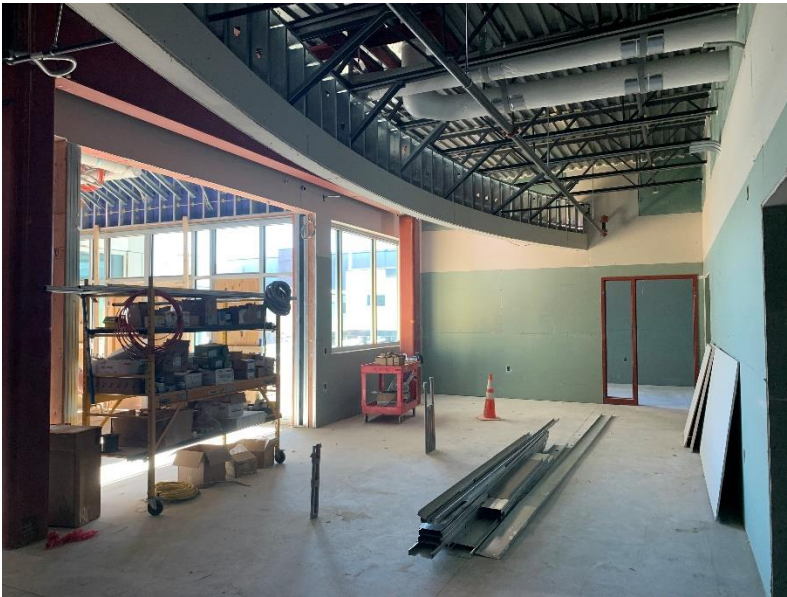
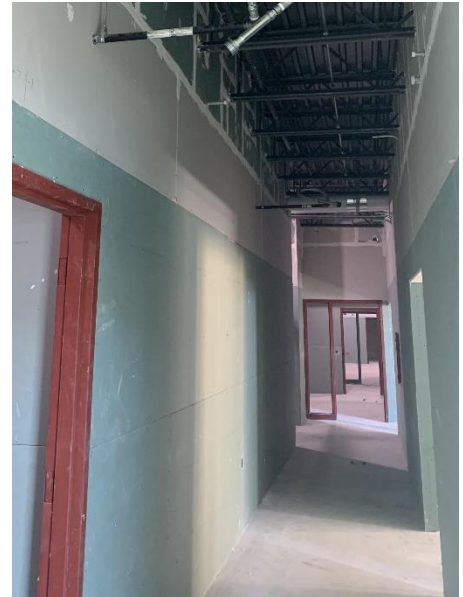
48. Area 1A – Gyp board install, taping, mudding, and above ceiling MEP work in progress at 5/6 front office.

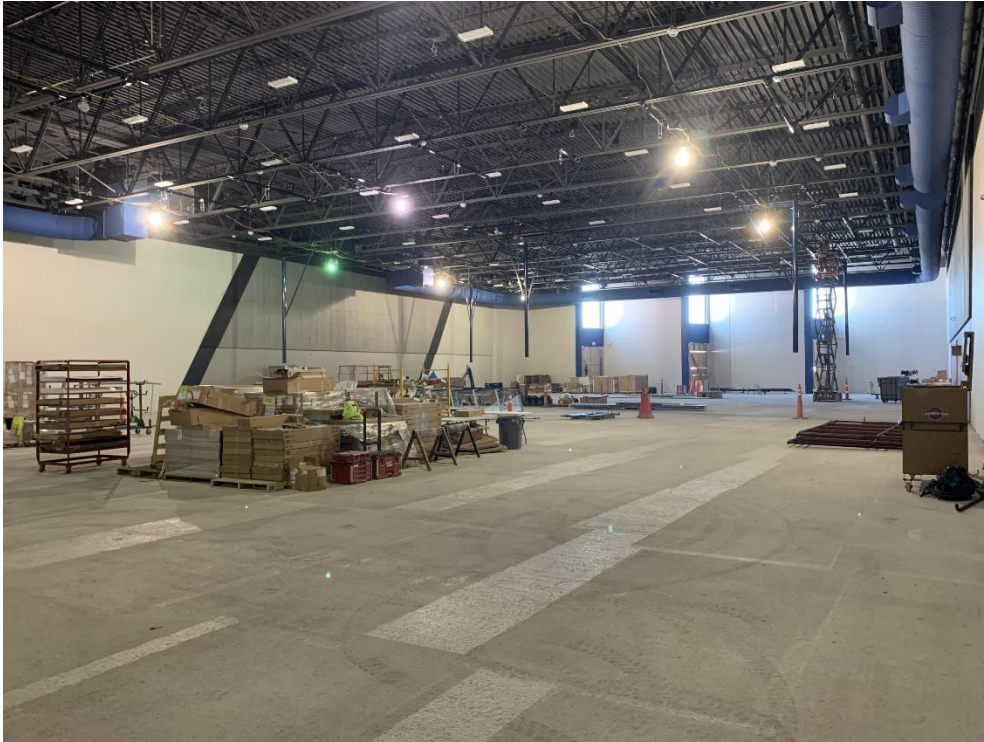
49. Area 6 – Painting in gym near completion. Lighting fixtures and gym equipment install in progress.

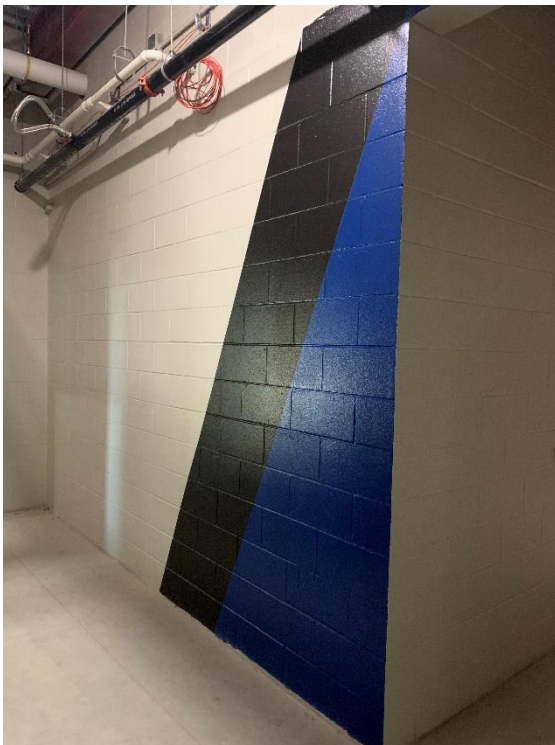
50. Area 1A – Accent painting at locker rooms in progress.

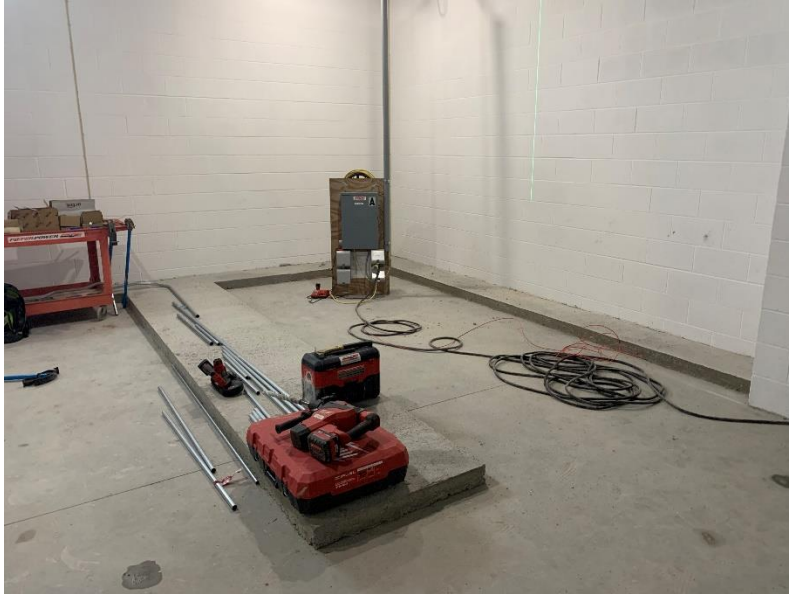
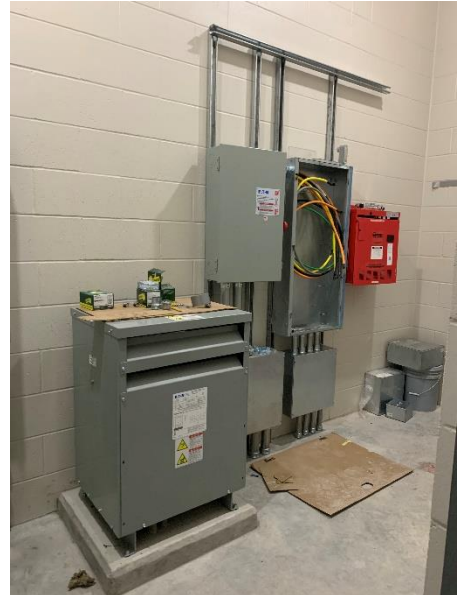
51. MEP work in locker room building in progress. Locker curbs are poured.

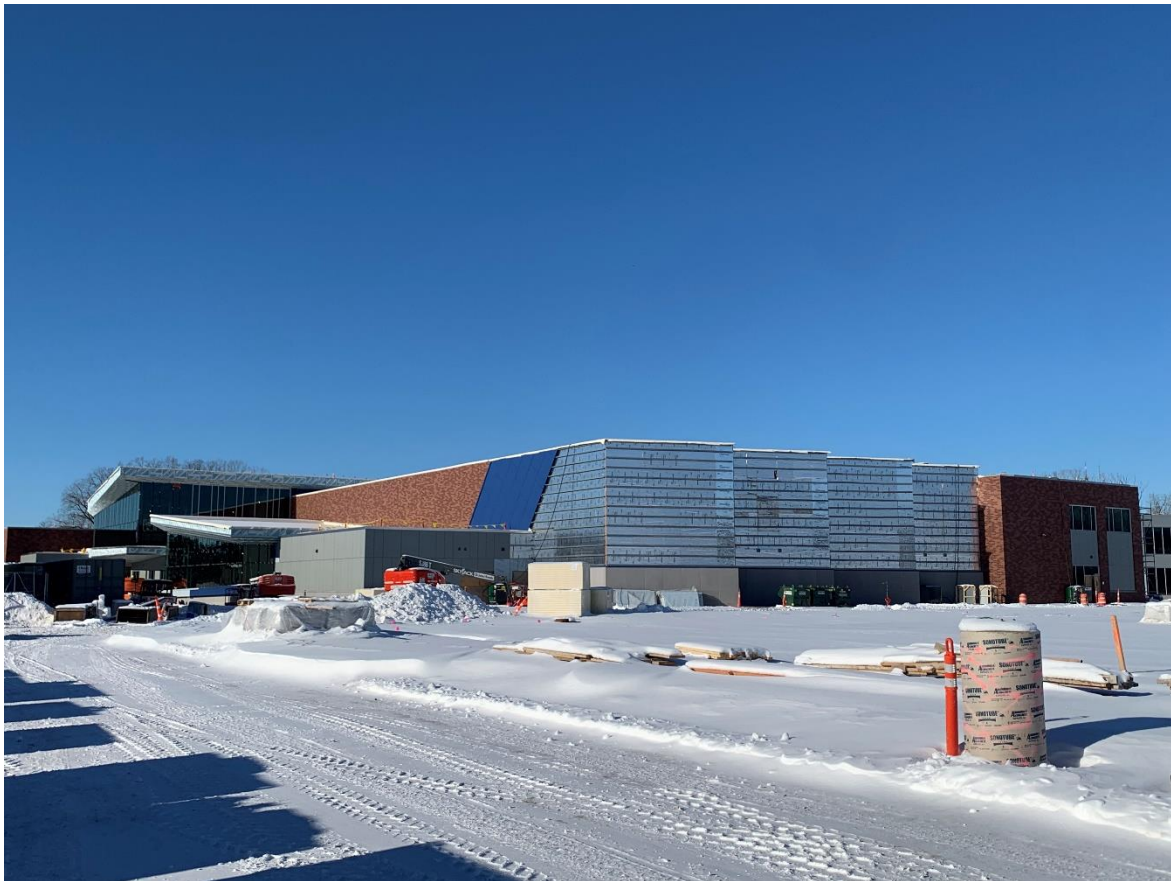
52. Overall progress image of southeast exterior.
