# Construction Observation Report 009 – July 26, 2024

Maplewood School

PROJECT NUMBER: 321169-01

OWNER:	MENASHA JOINT SCHOOL DISTRICT
From ARCHITECT/ENGINEER:	EUA
To CONTRACTOR	MIRON CONSTRUCTION CO, INC
SITE OBSERVATION TYPE	ARCHITECTURAL
DATE OF ISSUANCE:	August 1, 2024

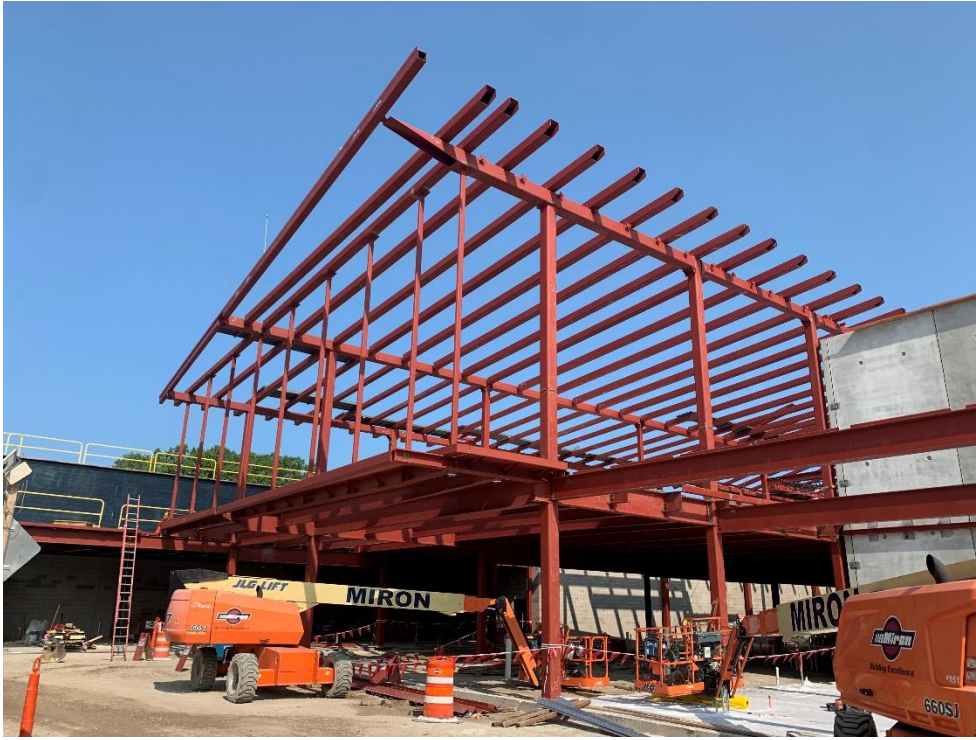
### 1. Area 1A – Structural steel framing and detailing in progress.

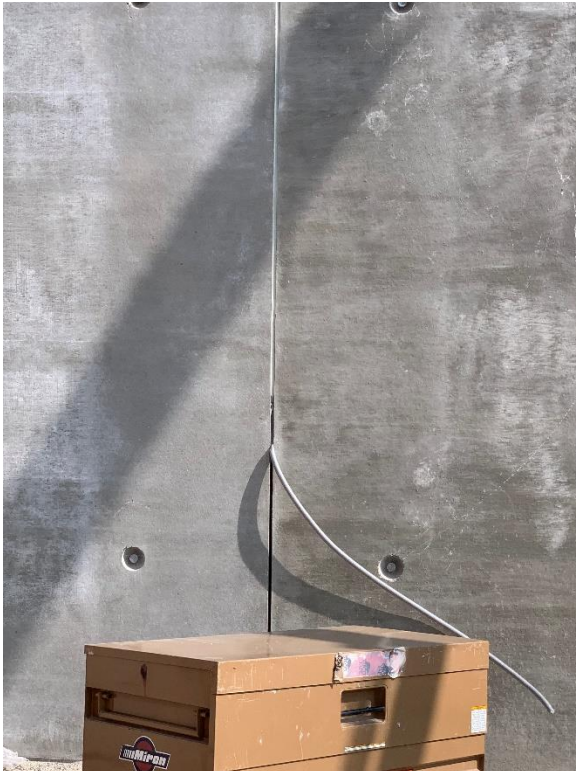
### 2. Area 2B – Structural precast panel joints receiving backer rod and sealant.

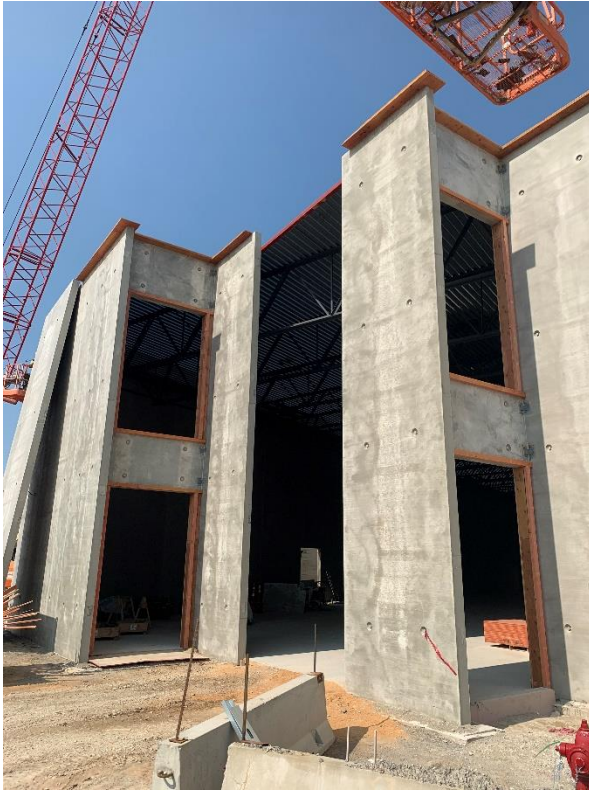
3. Area 6 – Window and coping blocking installation in progress.

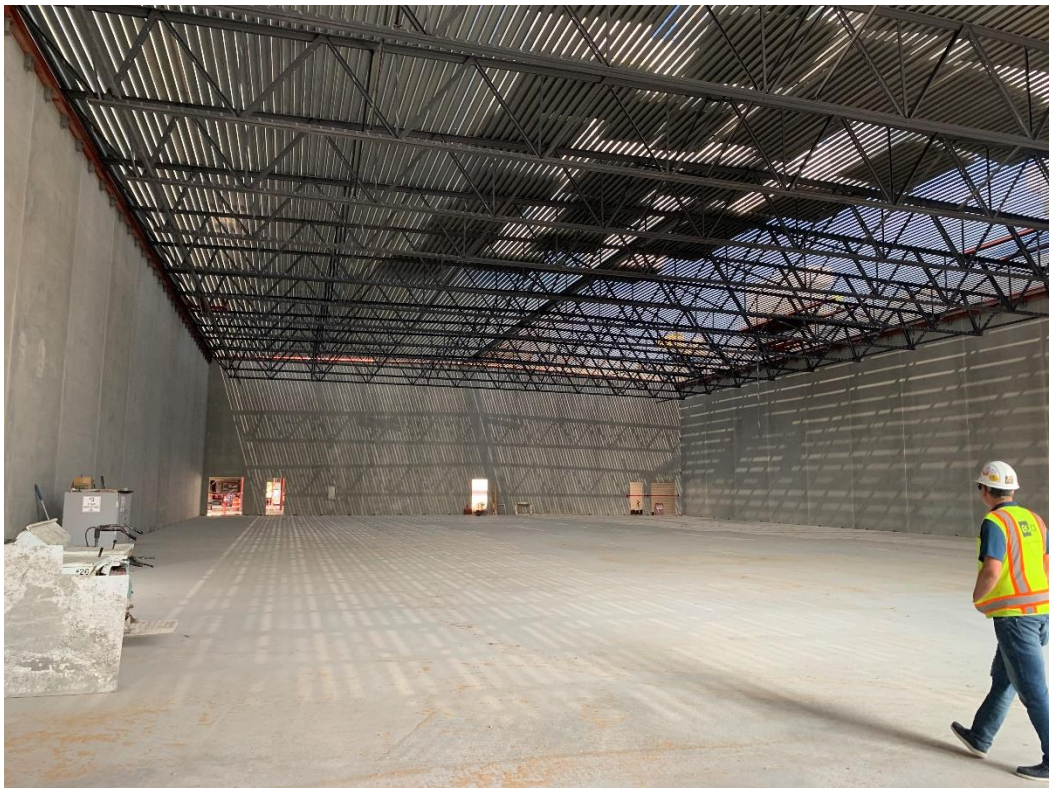
4. Area 6 – Concrete floor slab at Gym. Roof penetrations and insulation installation in progress.

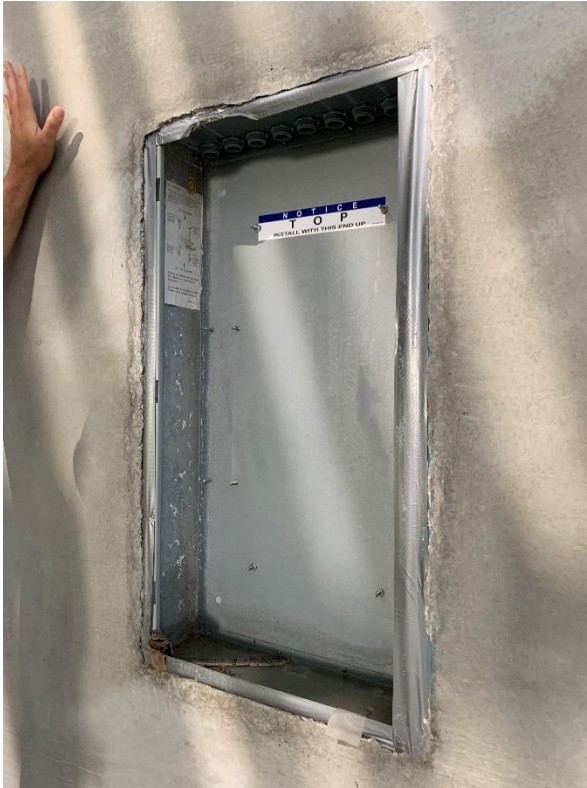
5. Area 6 – Equipment embedded in gym precast panels beginning installation.

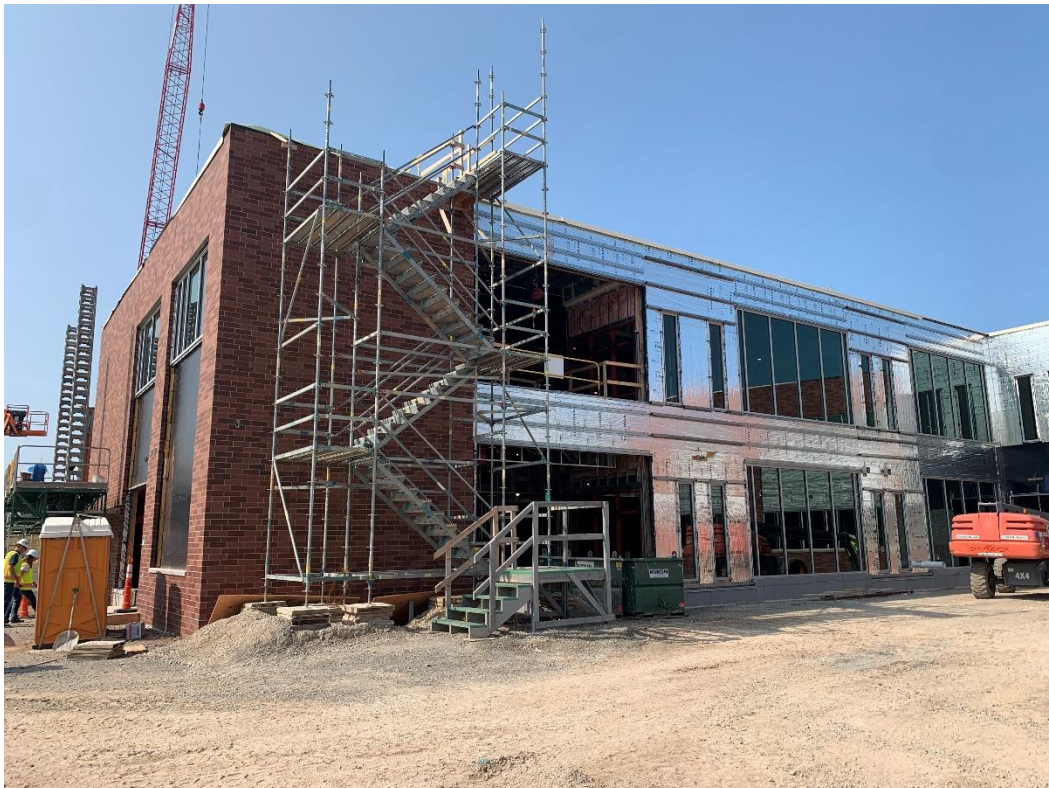
6. Area 6 – Exterior brick and cast stone installed. Exterior board insulation and girt system installation in progress.

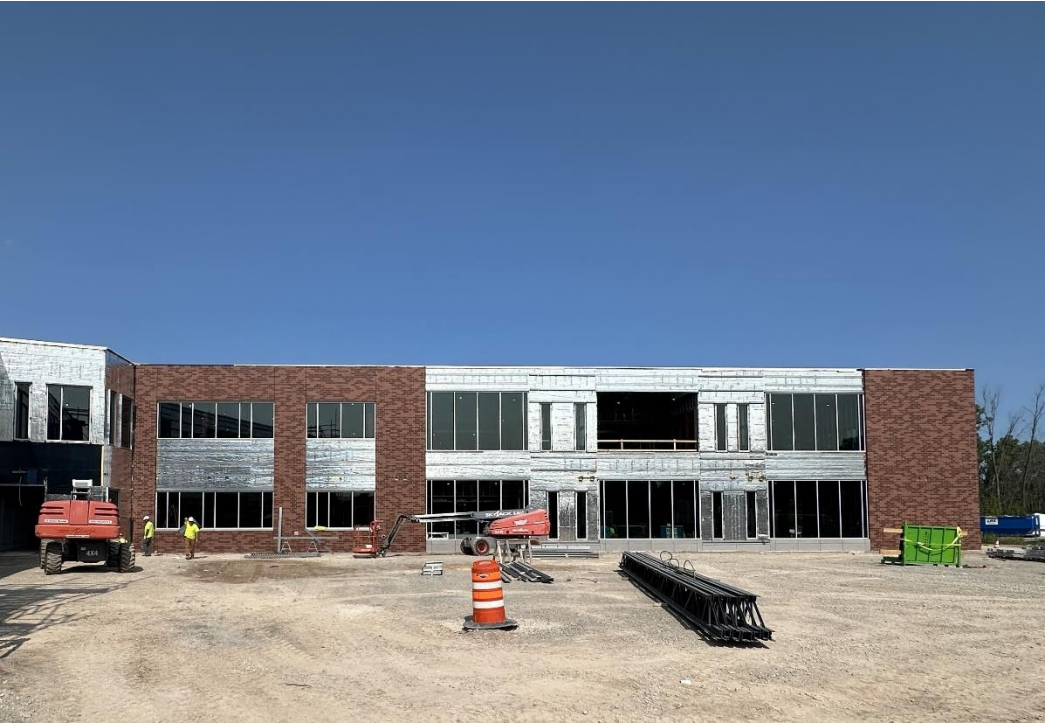
7. Area 5 – Exterior brick and cast stone installed. Exterior board insulation and girt system installation in progress.

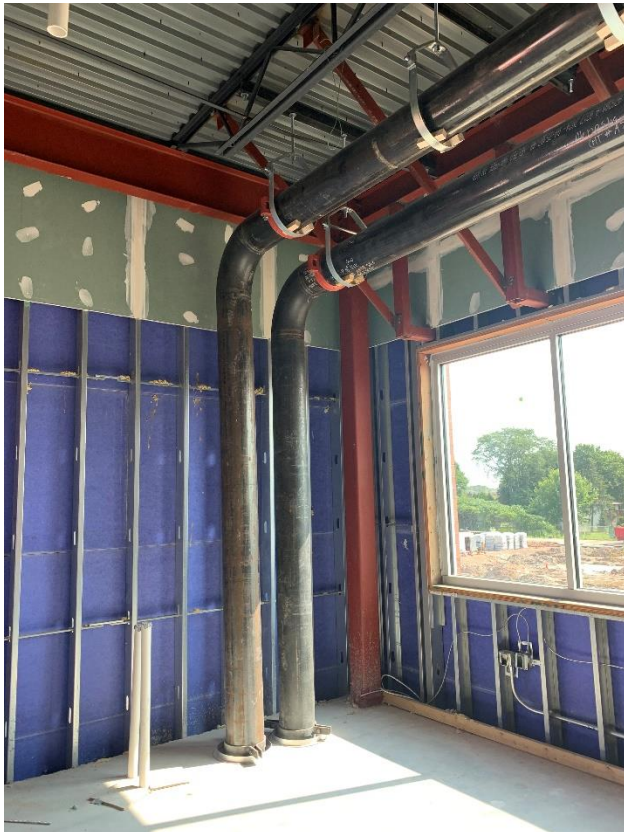
8. Area 6 – Geothermal piping from Manifold room to second floor ceiling.

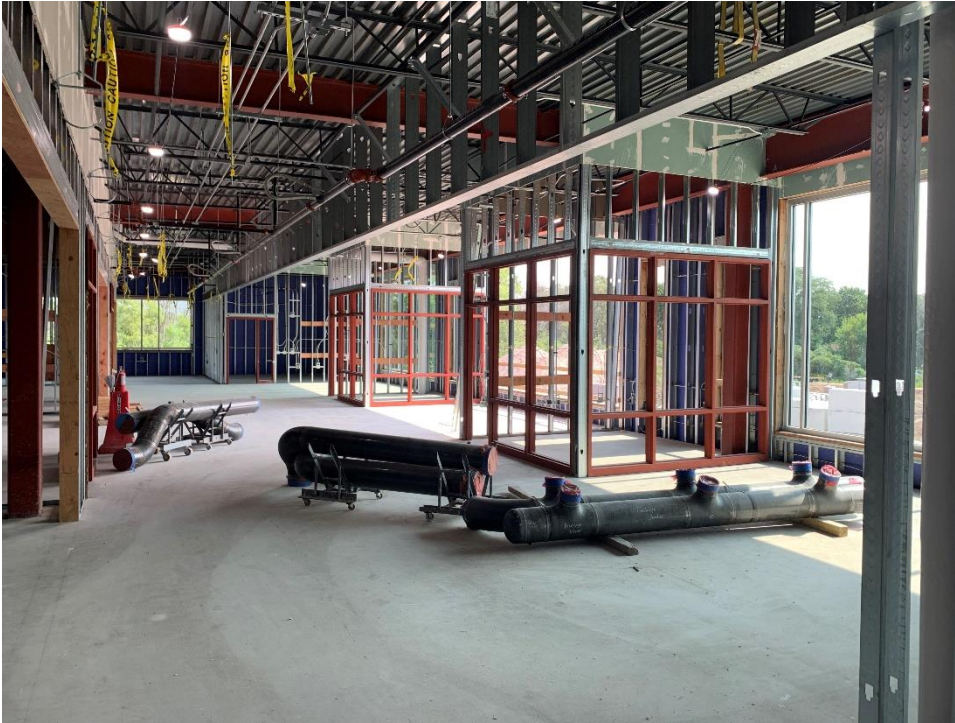
9. Area 5 – Geothermal piping, hangers, and gyp board installation in progress.

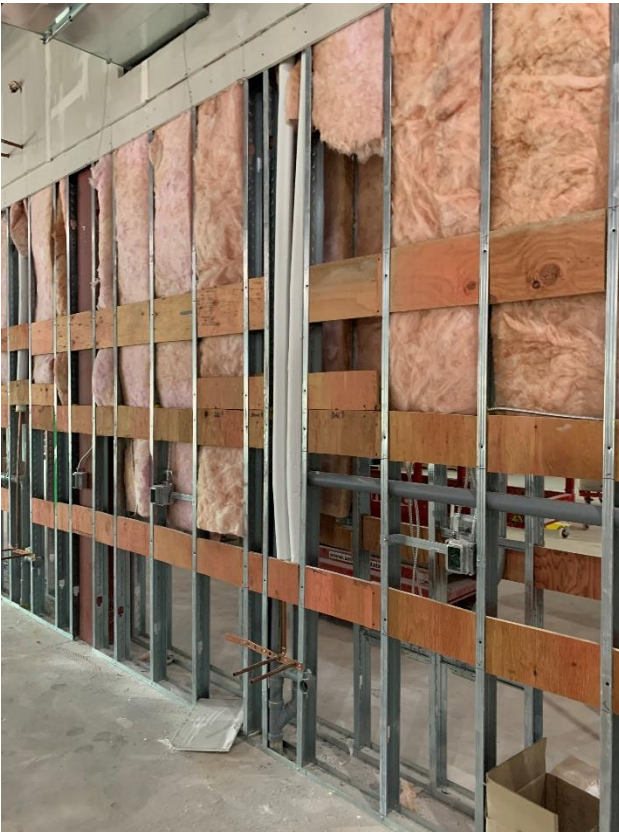
10. Area 5 –In wall plumbing, blocking, and insulation installation in progress.

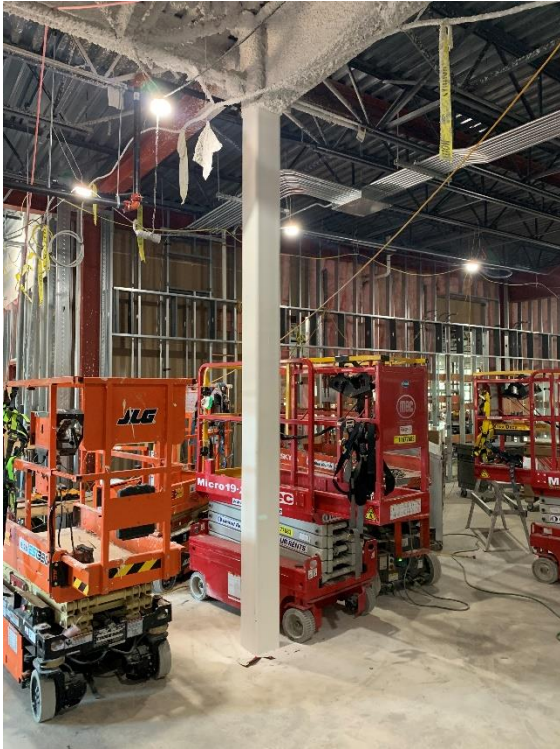
11. Area 5/6 – Intumescent painted structural column.

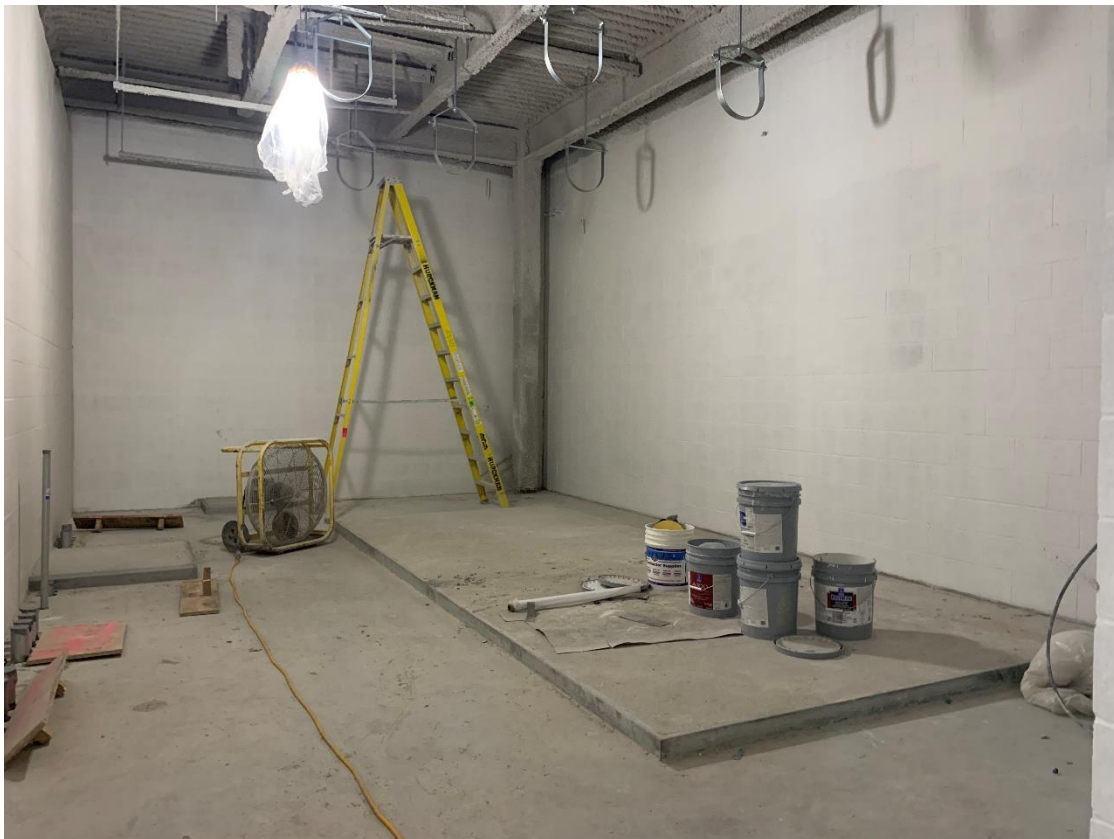
12. Area 6 – Second floor pump room wall primer in progress.

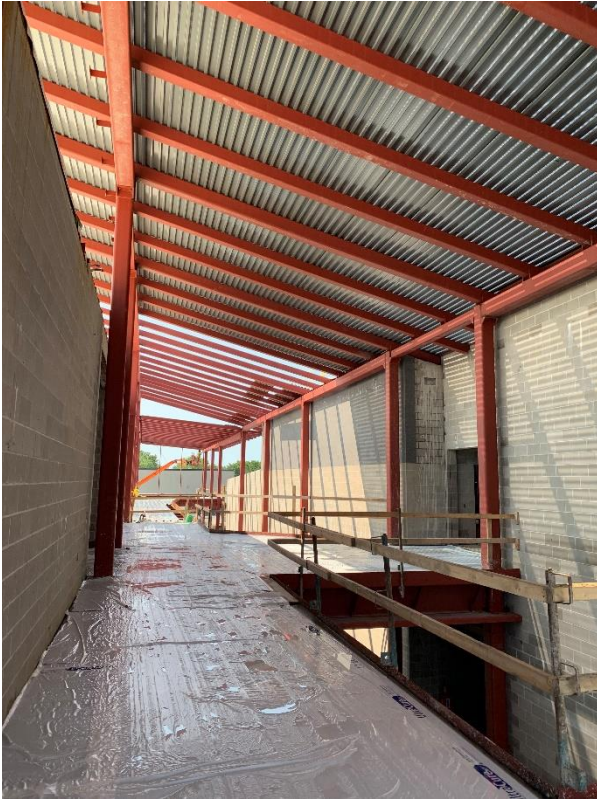
13. Area 1A/1B – Center Spine structural framing, acoustic decking, concrete floor slab installation in progress.

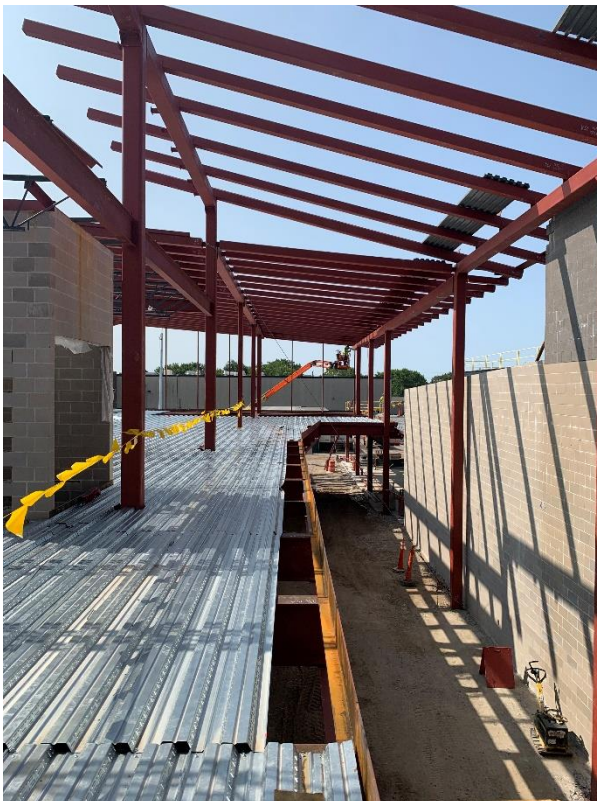
14. Area 1A – Center Spine structural framing and floor deck installation in progress.

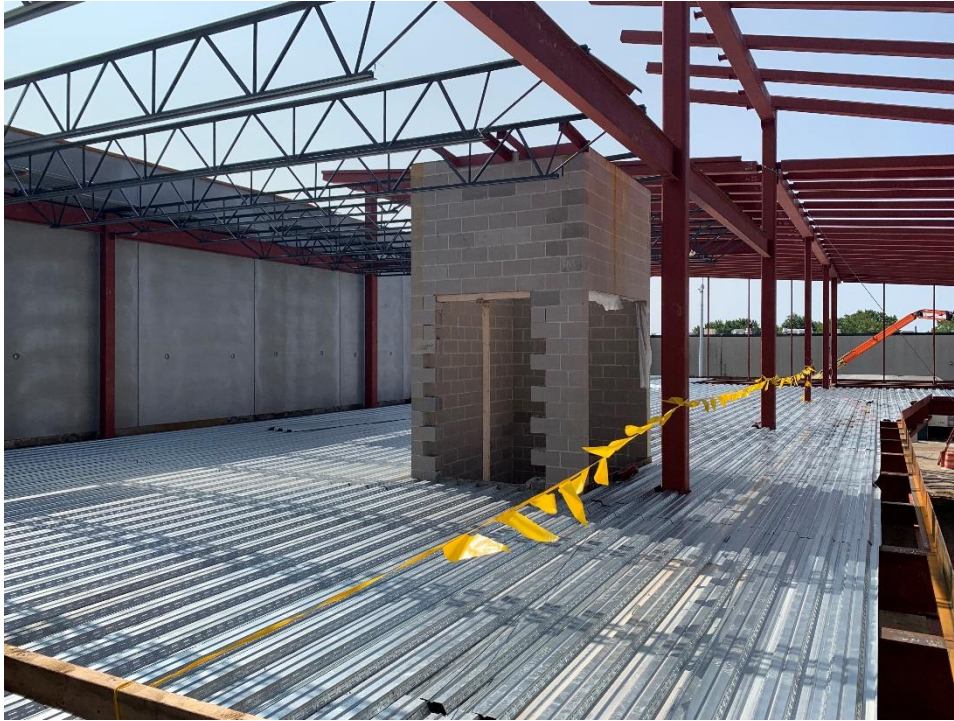
15. Area 1A – Structural framing and floor deck installation in progress.

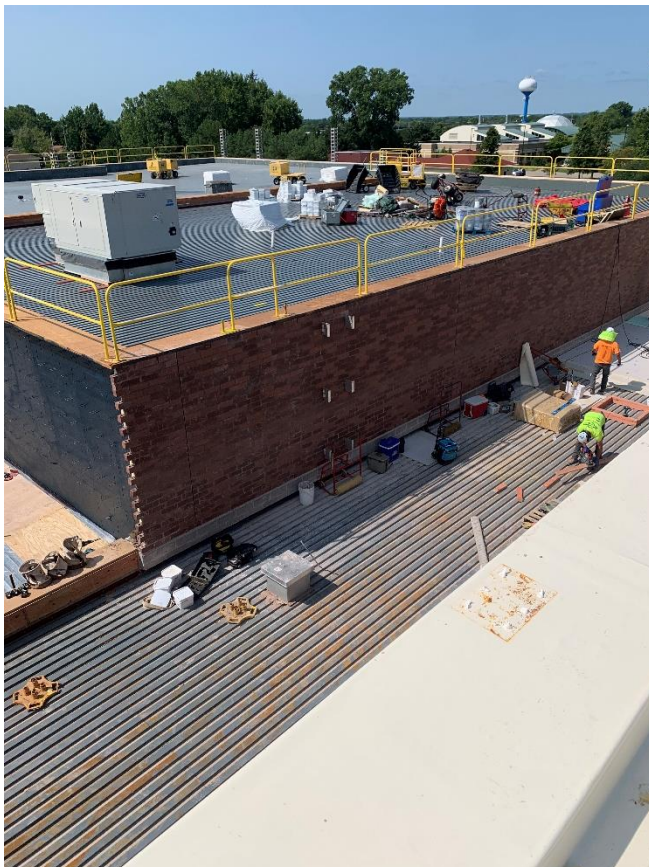
16. Area 3 – Upper wall brick and roof installation in progress.

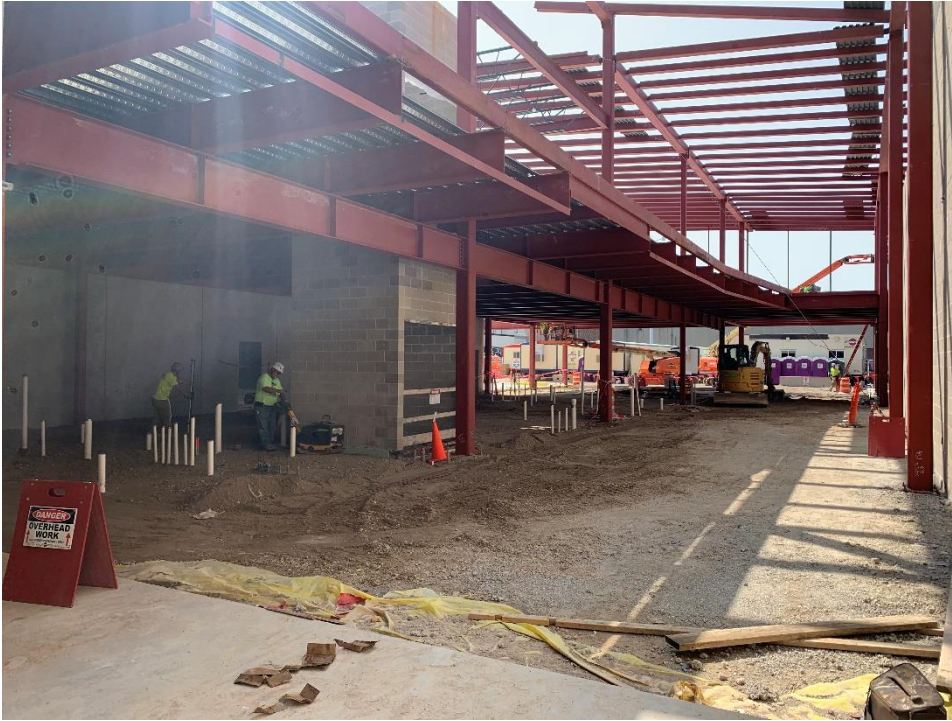
17. Area 1A – Under slab preparation in progress.

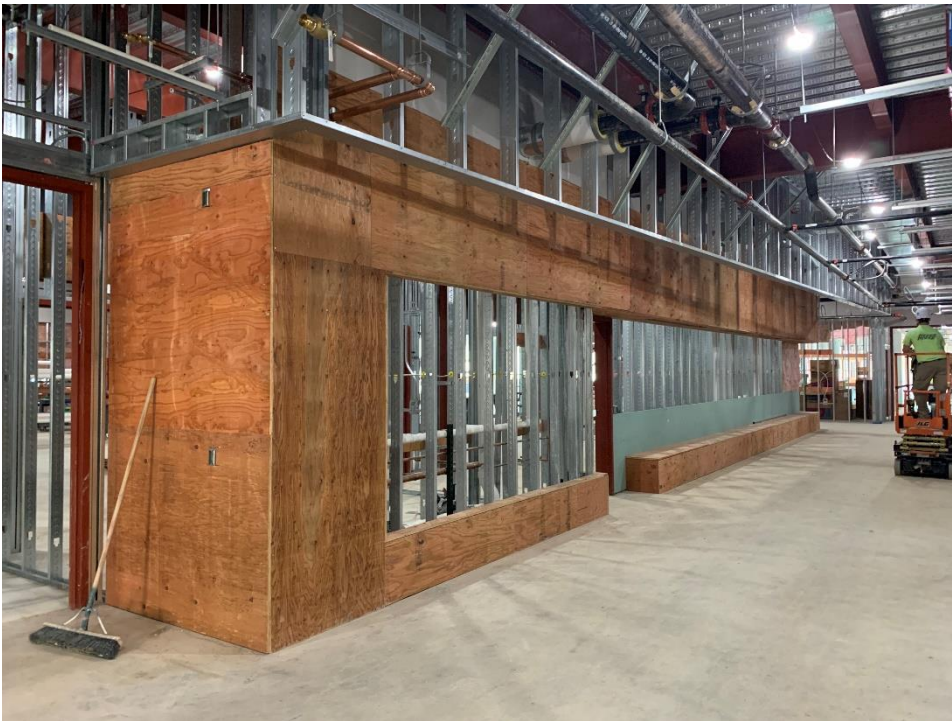
18. Area 6 – Survey entry feature plywood and gyp board installation in progress.

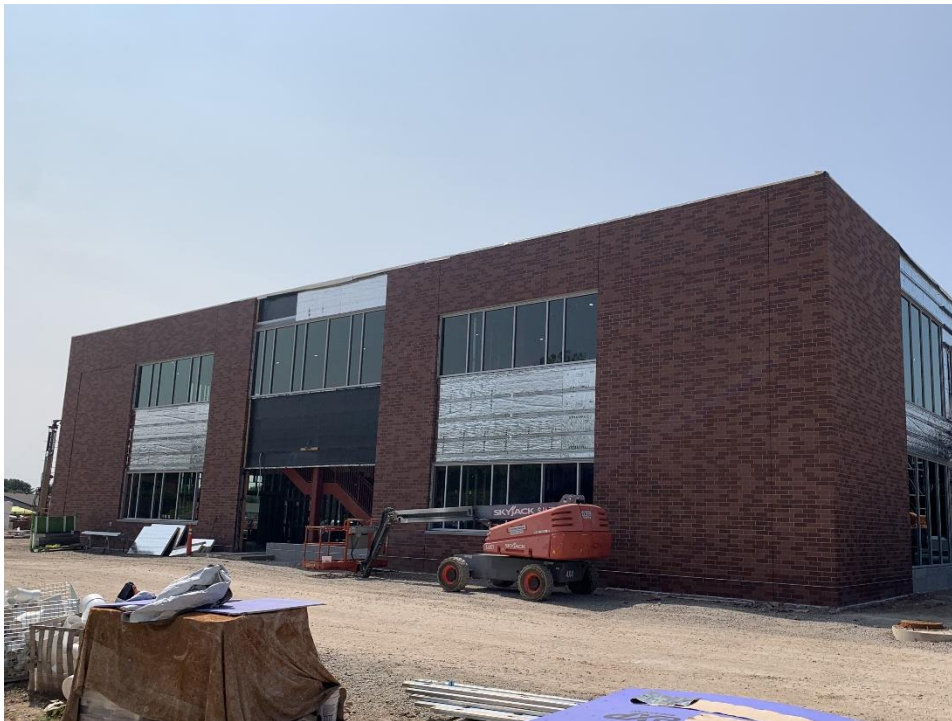
20. Area 5 – Exterior brick and cast stone installed. Exterior board insulation and girt system installation in progress.

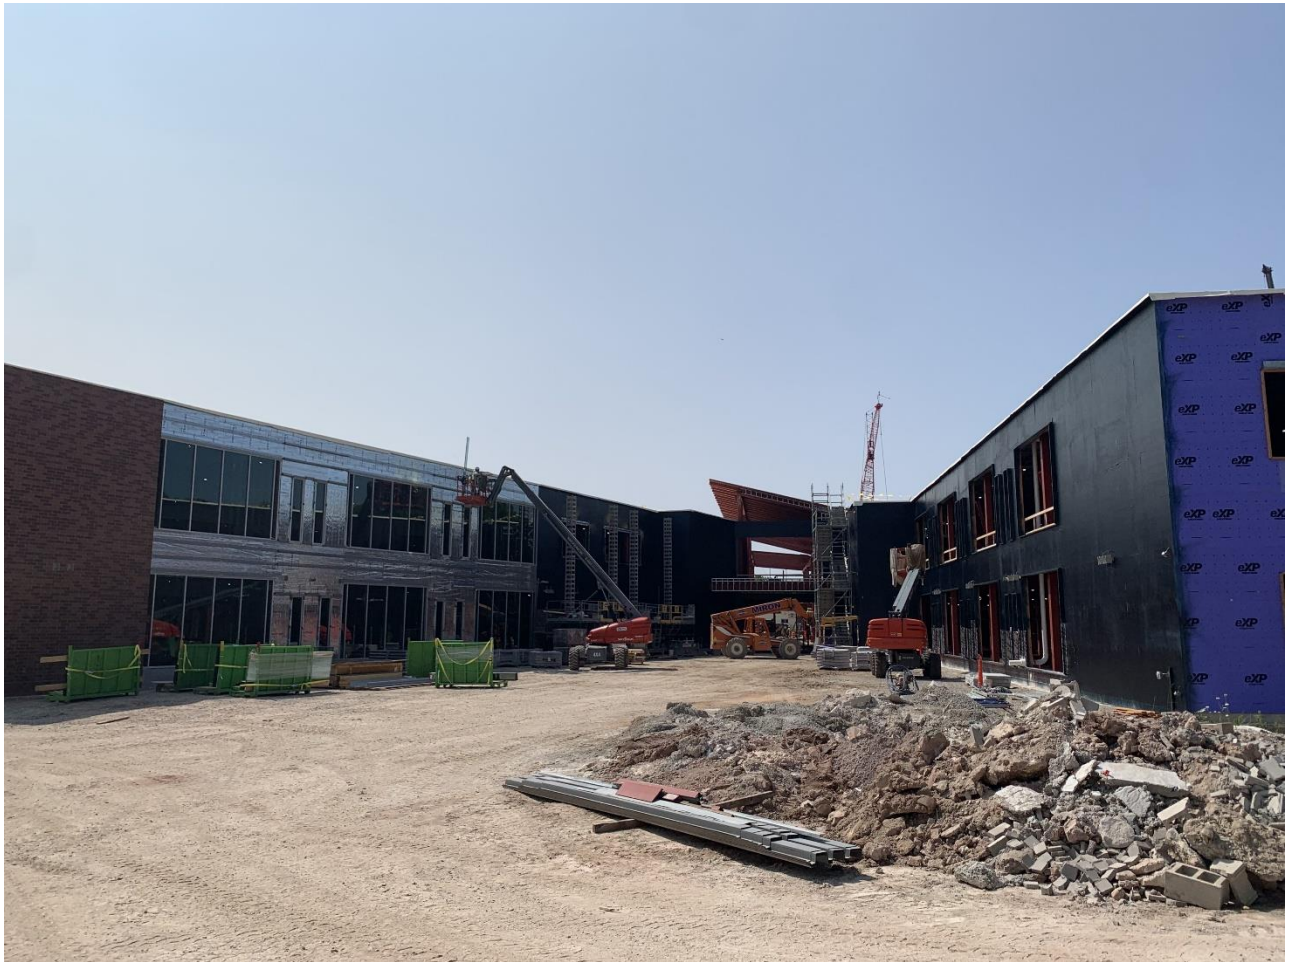
21. Area 5 – Exterior brick and cast stone installed. Exterior board insulation and girt system installation in progress.

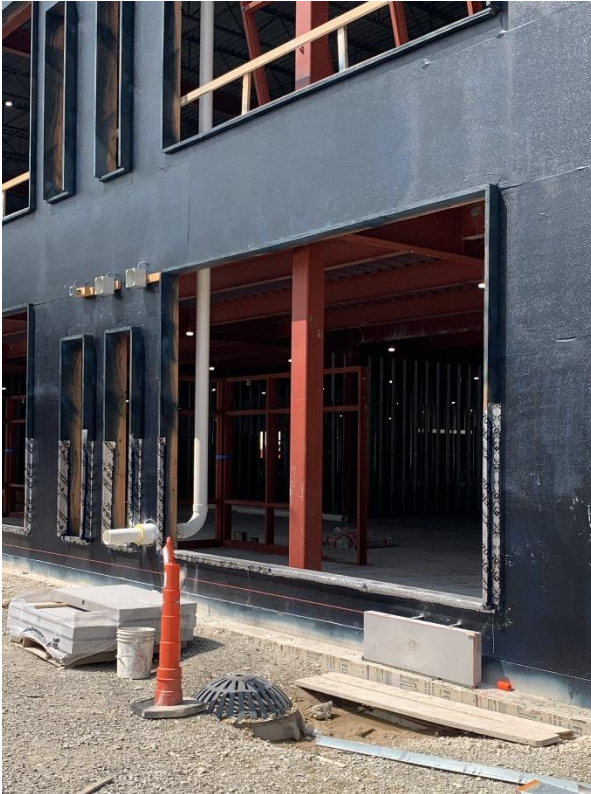
22. Area 4 – Window weather proofing membrane and masonry installation in progress.

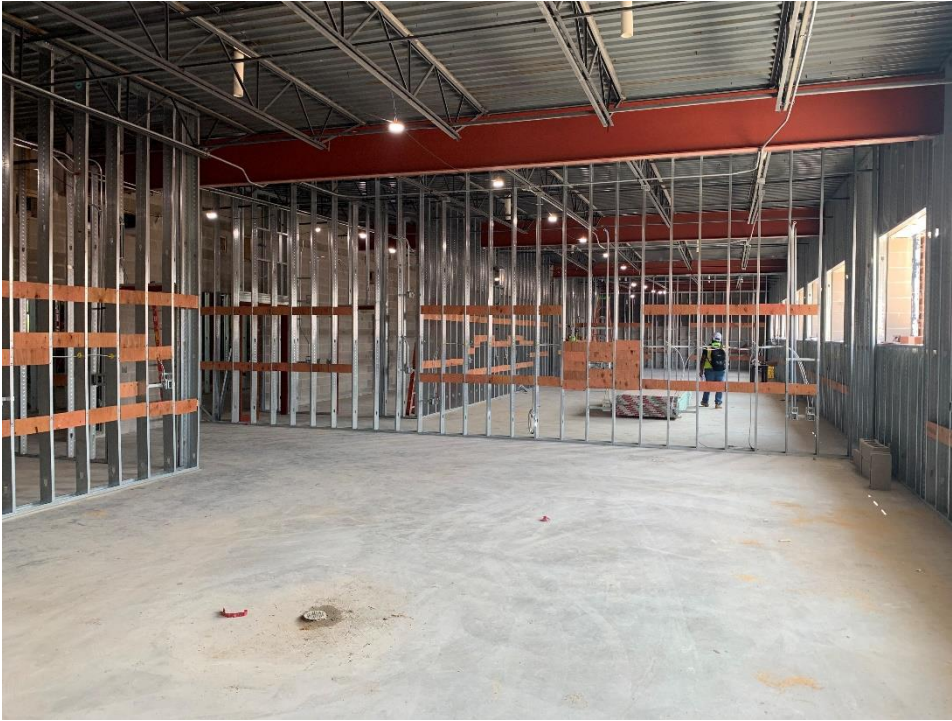
24. Area 3 – Art rooms interior stud, blocking, and in wall electrical/ plumbing installation in progress.

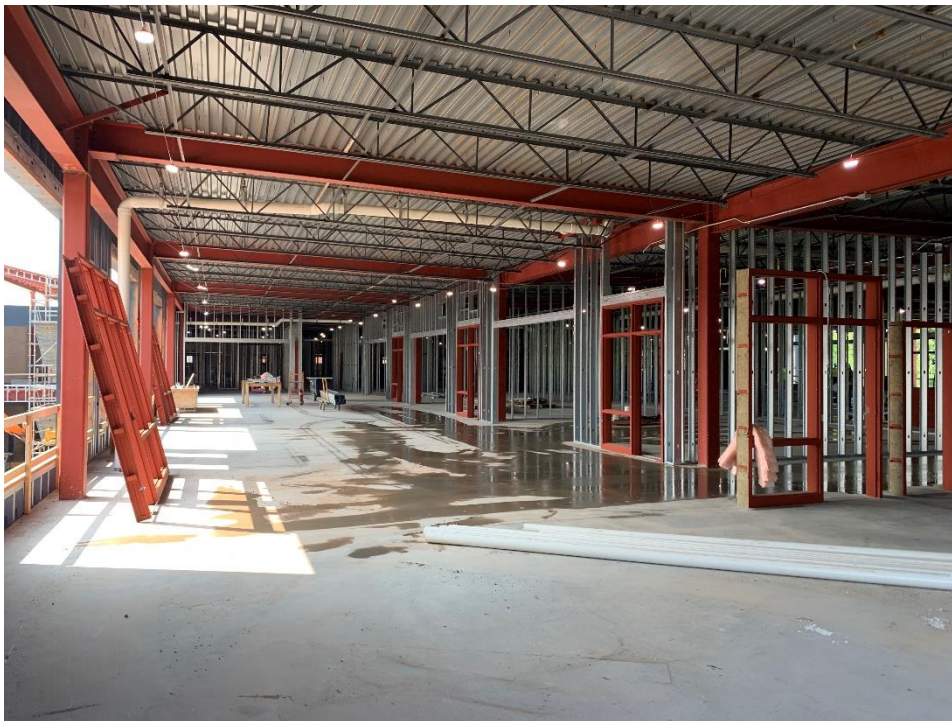
25. Area 4 – Interior metal stud and hollow metal framing installation in progress.

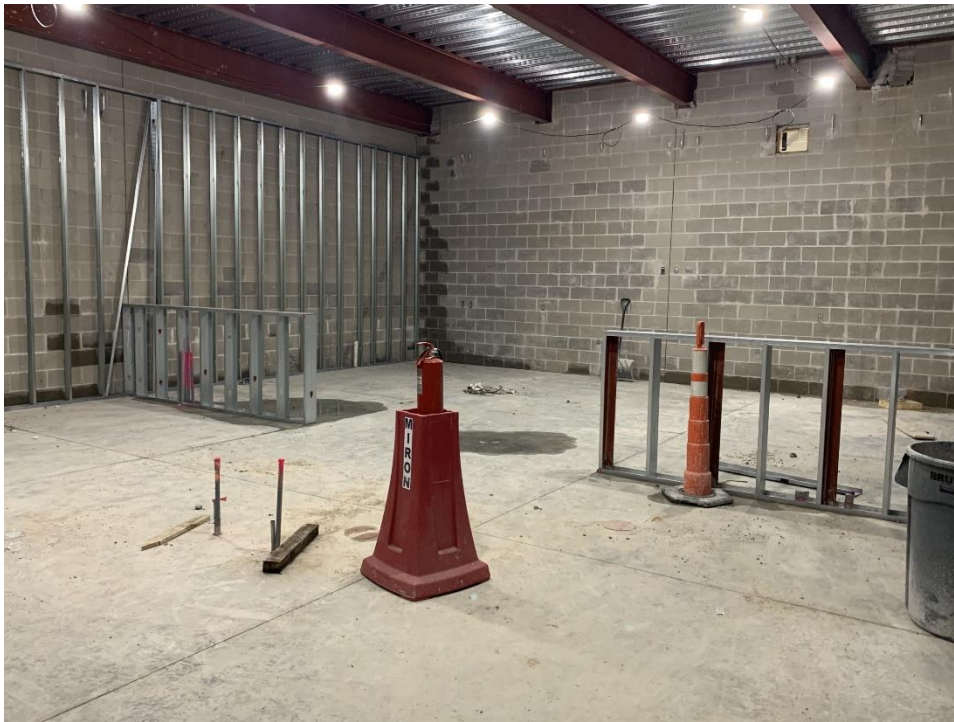
26. Area 3 – Culinary room metal stud installation in progress.

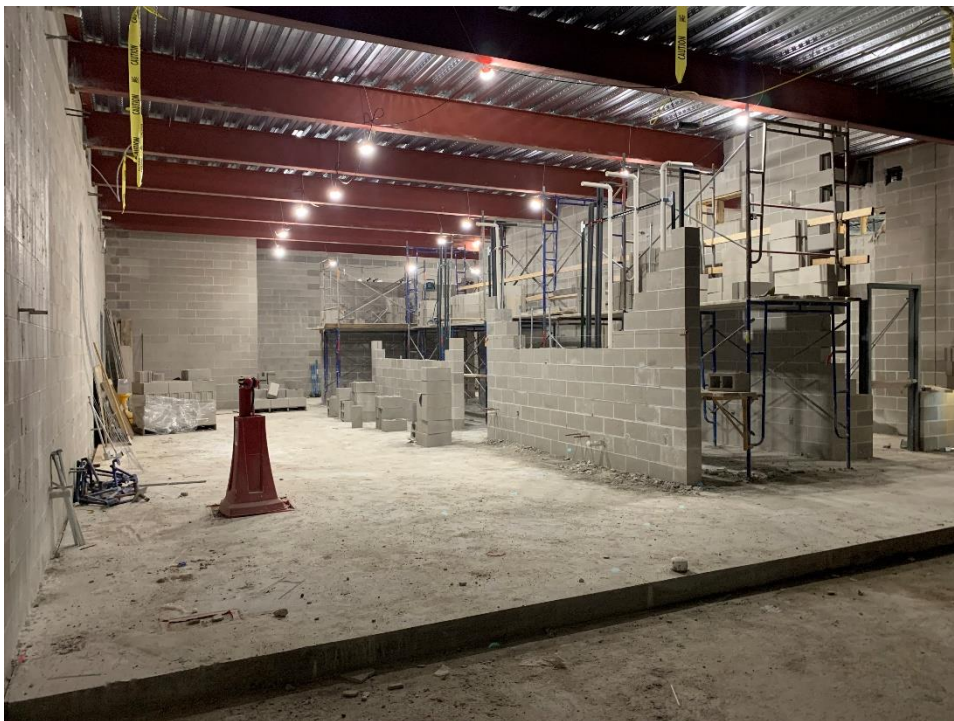
27. Area 3 – Kitchen interior CMU wall installation in progress.

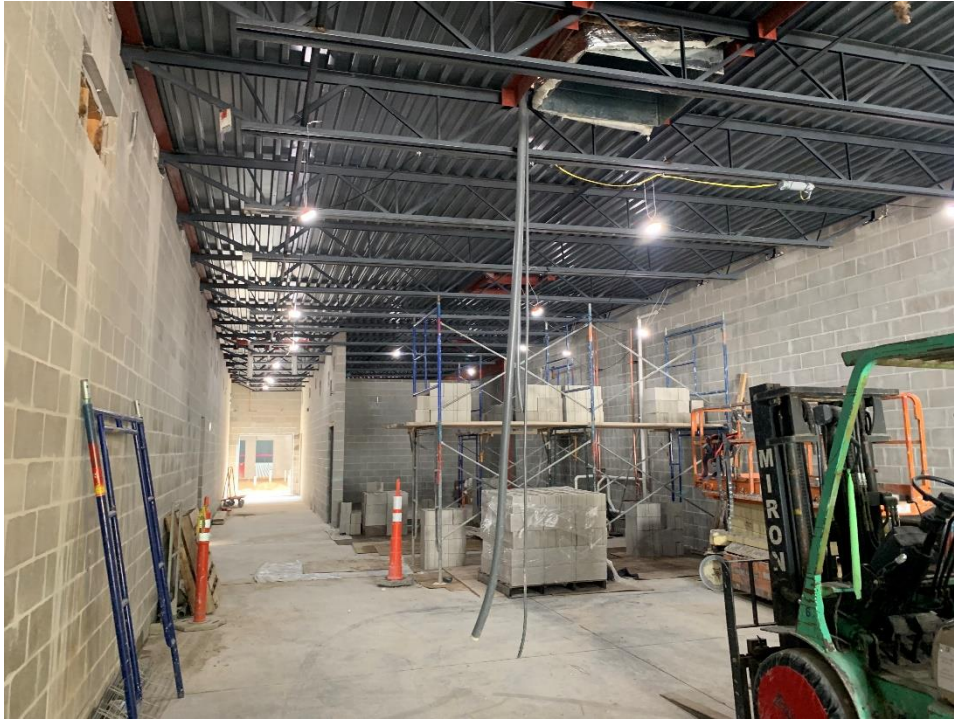
28. Area 3 – Interior CMU wall installation at receiving in progress.

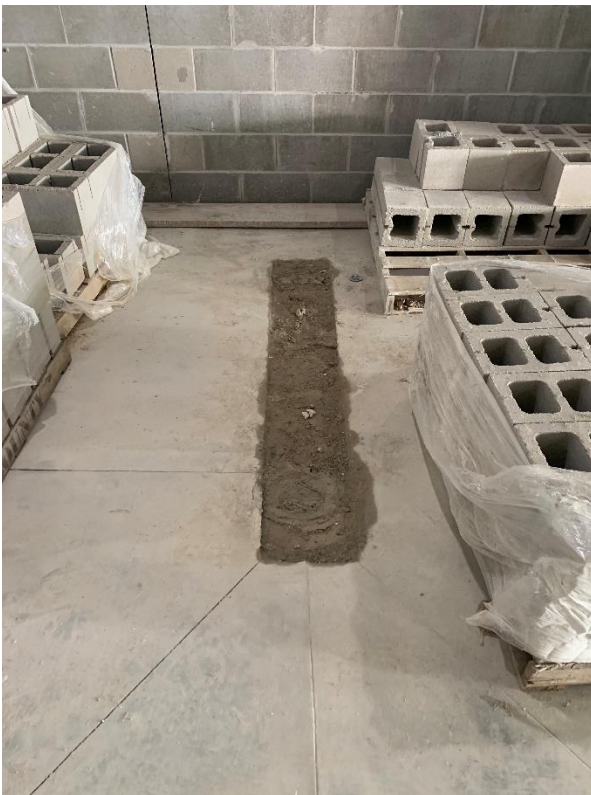
29. Area 3 – Recessed slot drain rough opening at receiving.

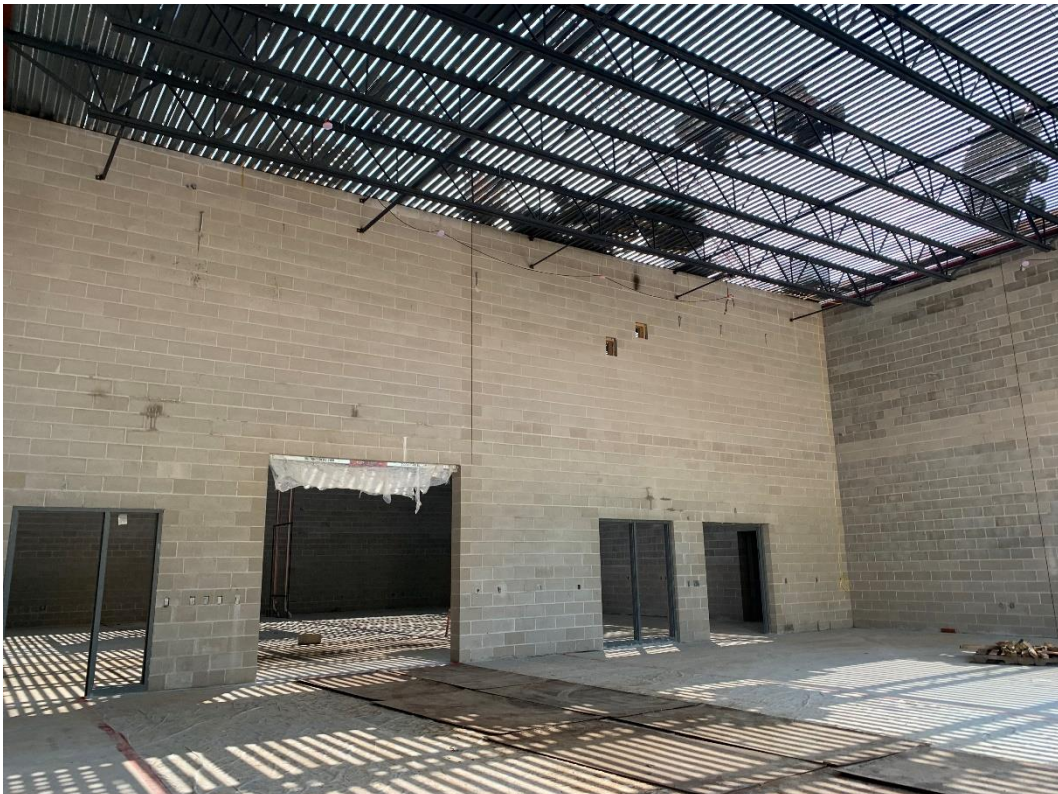
31. Area 3 – Acoustic decking in tech ed. Roof insulation, hollow metal frames, and plumbing installation in progress.

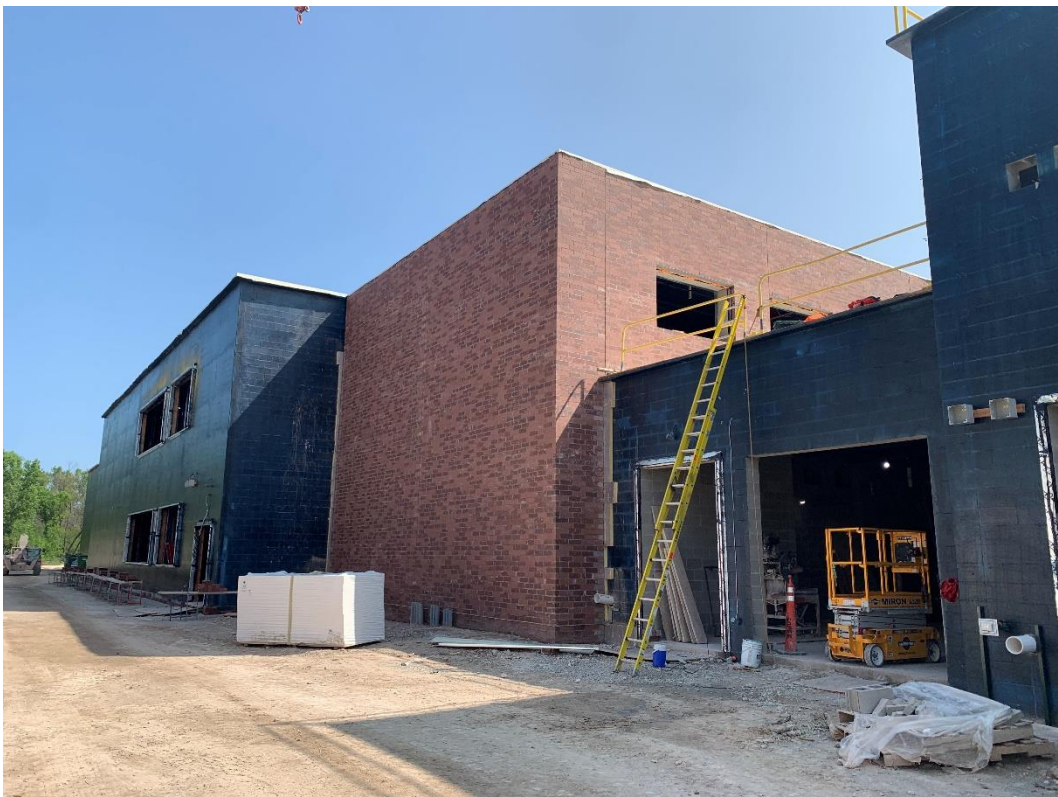
33. Area 3/4 – Exterior brick, AVB, and Window weather proofing membrane installation in progress.

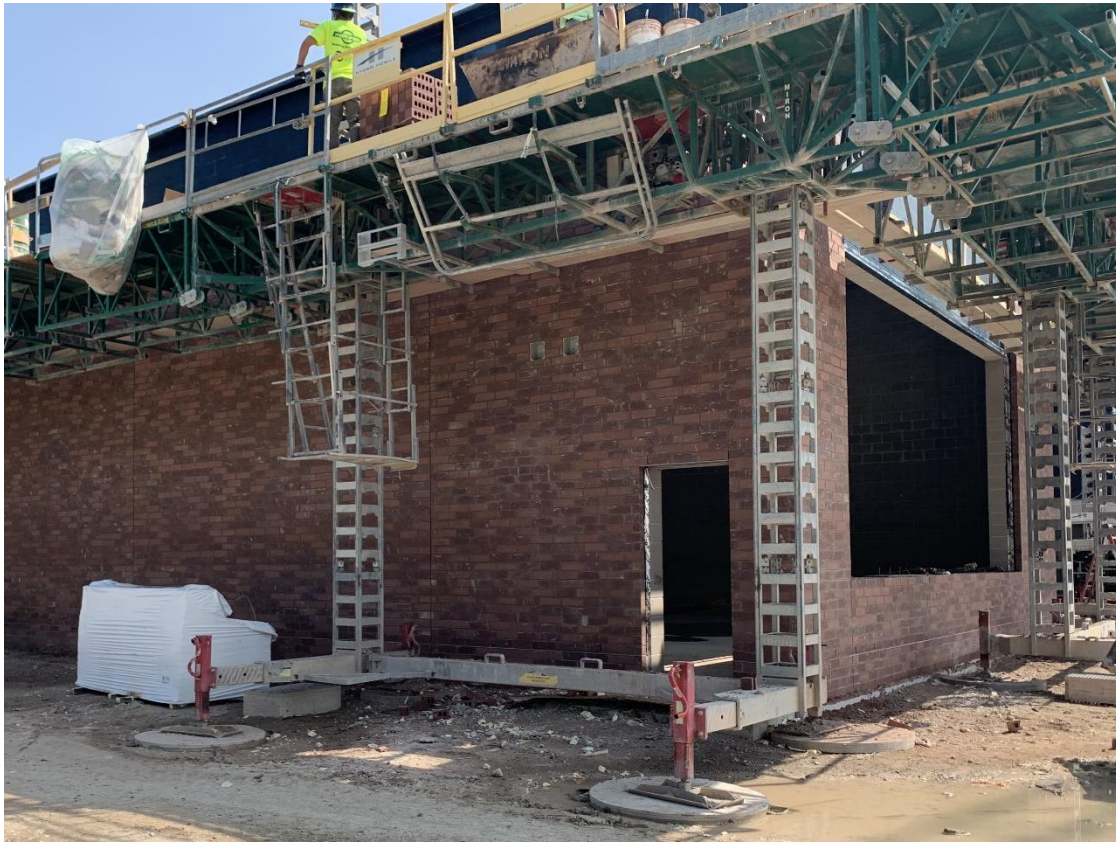
26. Area 2A – Exterior brick and board insulation installation in progress.
