Construction Observation Report 010 – August 8, 2024

Maplewood School

PROJECT NUMBER: 321169-01

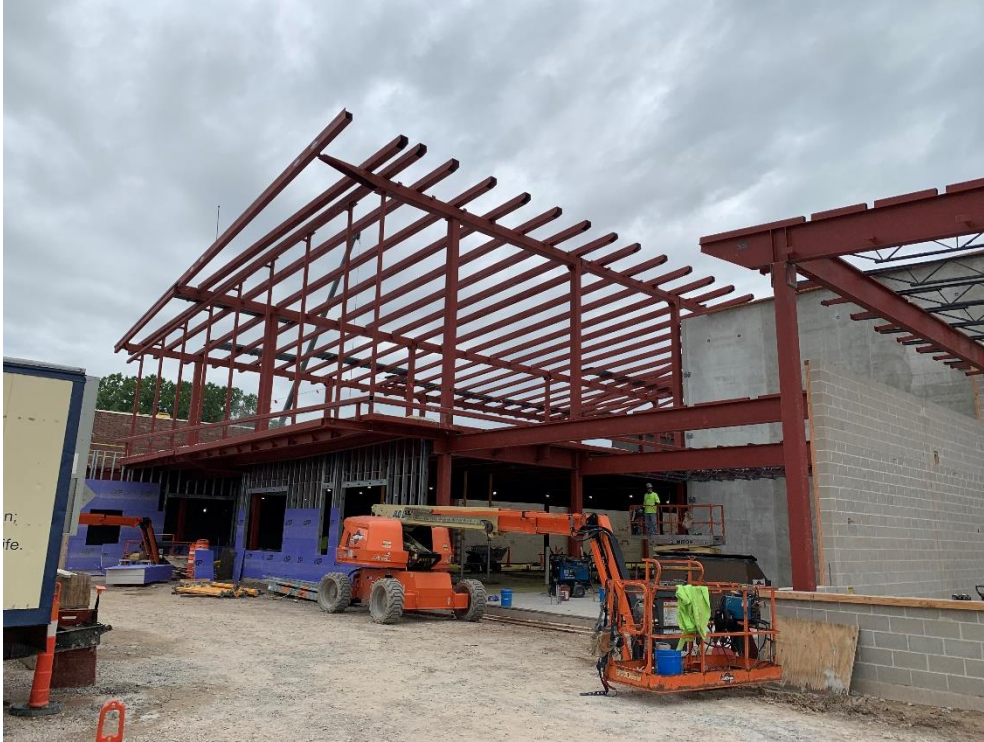
1. Area 1A – Structural steel framing and detailing in progress. Exterior metal stud framing and sheathing installation in progress.

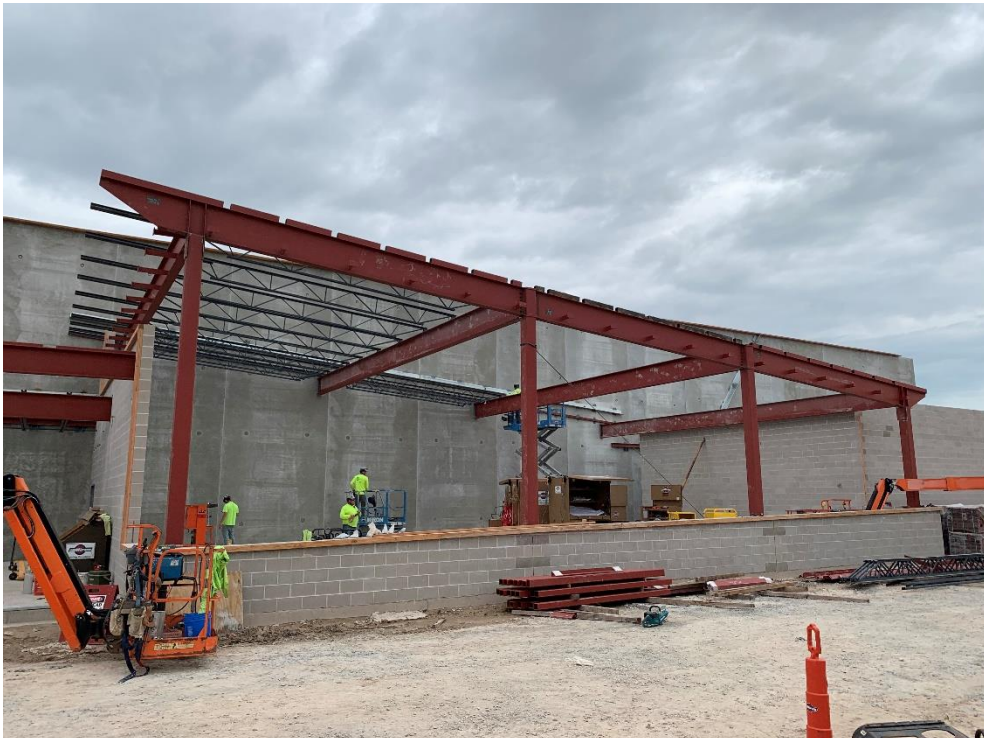
2. Area 2B – Structural steel framing, detailing and wood blocking installation in progress.

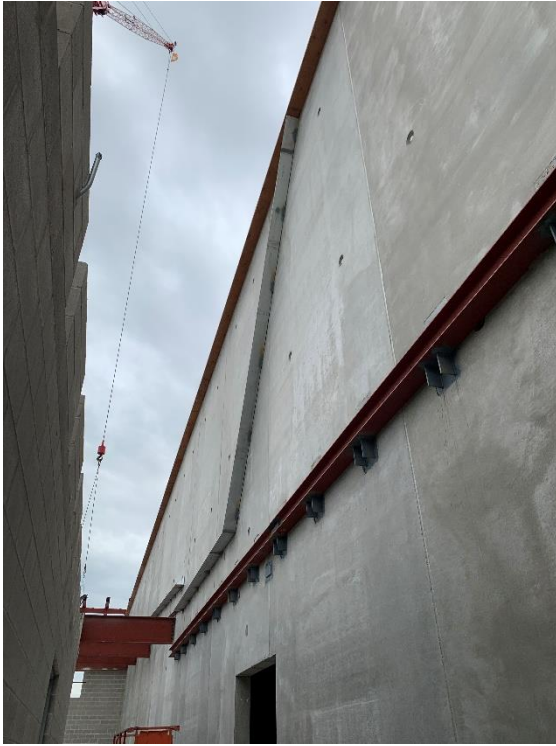
3. Area 2B & 6 – Structural steel framing installation in progress. Sloped brick ledge installed.

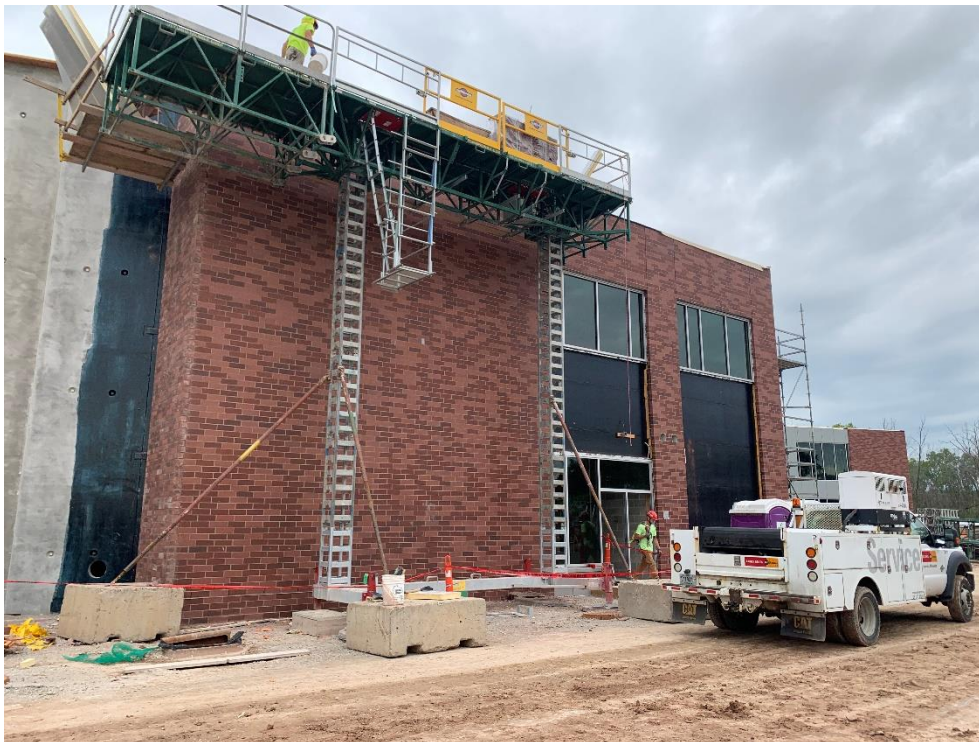
4. Area 6 – Brick veneer installation and cleaning in progress. Exterior storefront frame installation in progress.

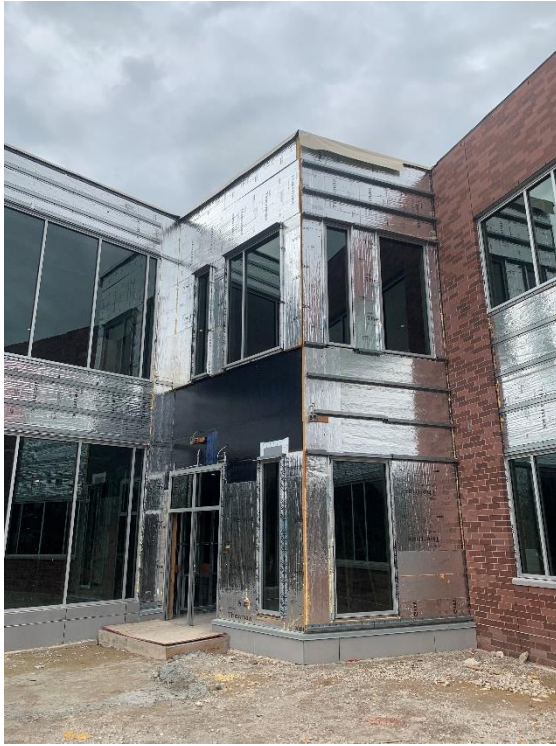
5. Area 5 & 6 – Board insulation, metal panel girt system, and storefront glazing installation in progress.

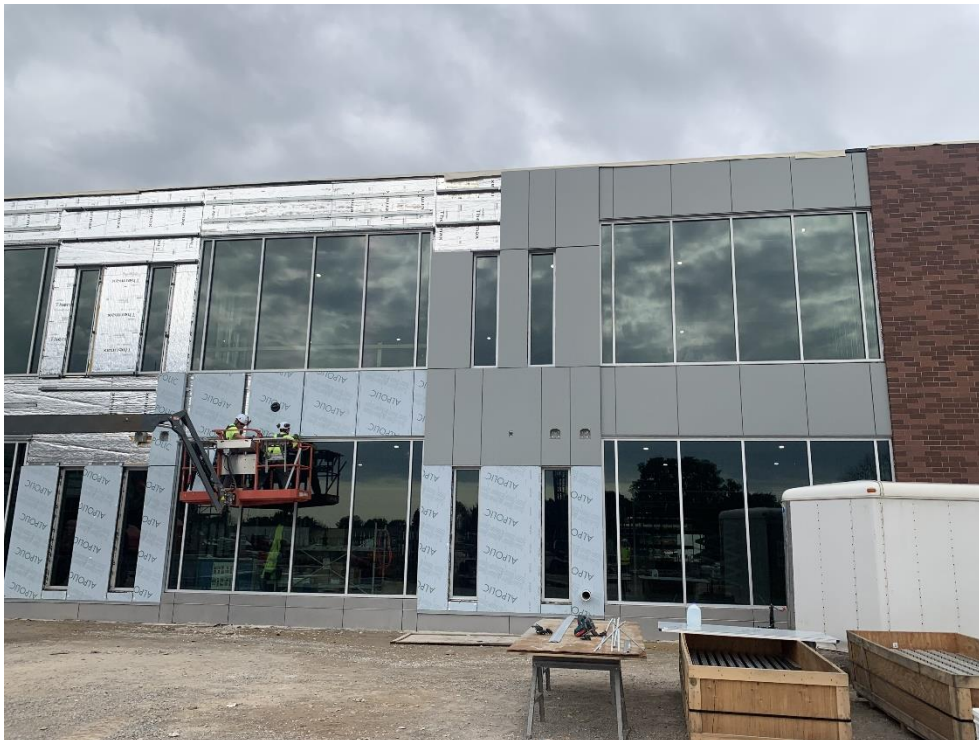
6. Area 5 – Composite metal panel and storefront glazing installation in progress.

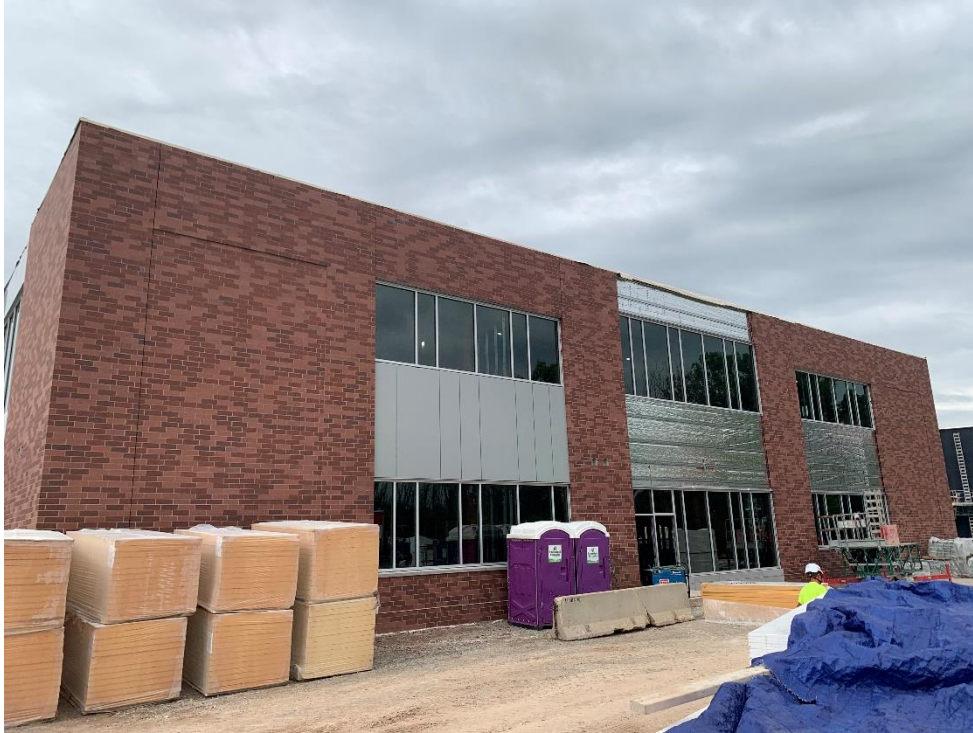
7. Area 5 – Composite metal panel and storefront glazing installation in progress.

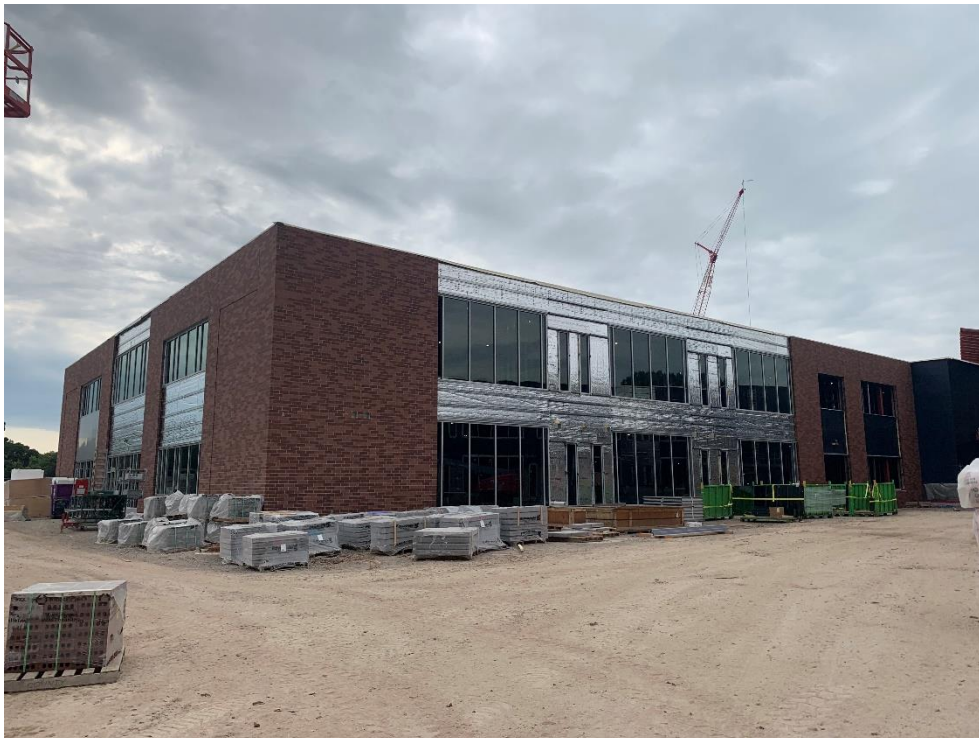
8. Area 5 – Metal panel girt system and storefront glazing installation in progress.

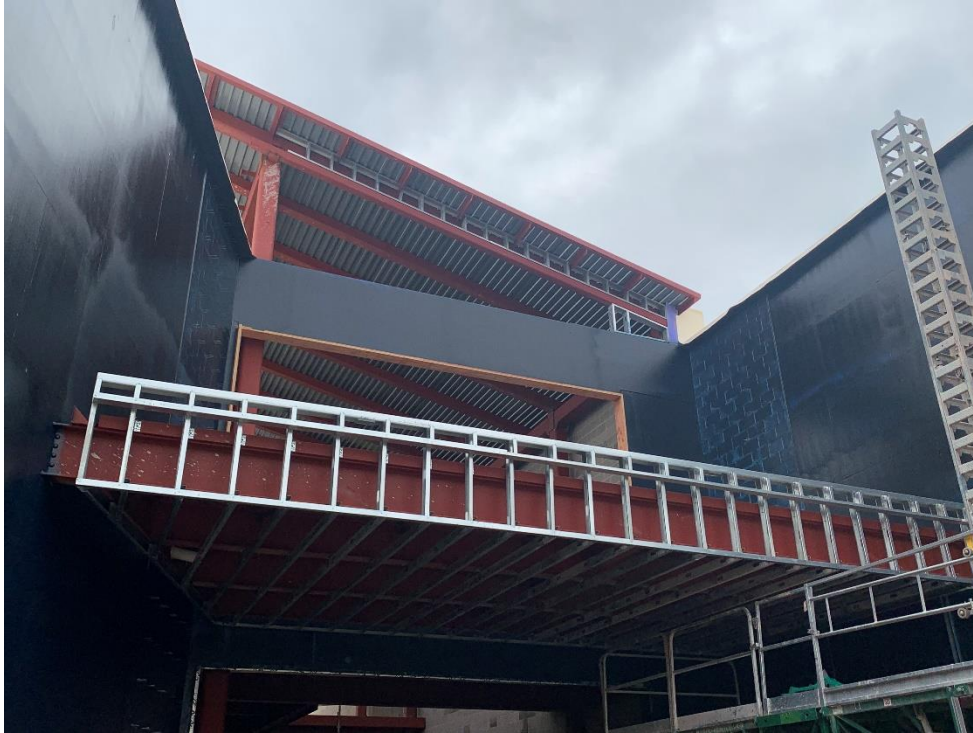
9. Area 1B – Spray applied AVB and cold form framing installation in progress.

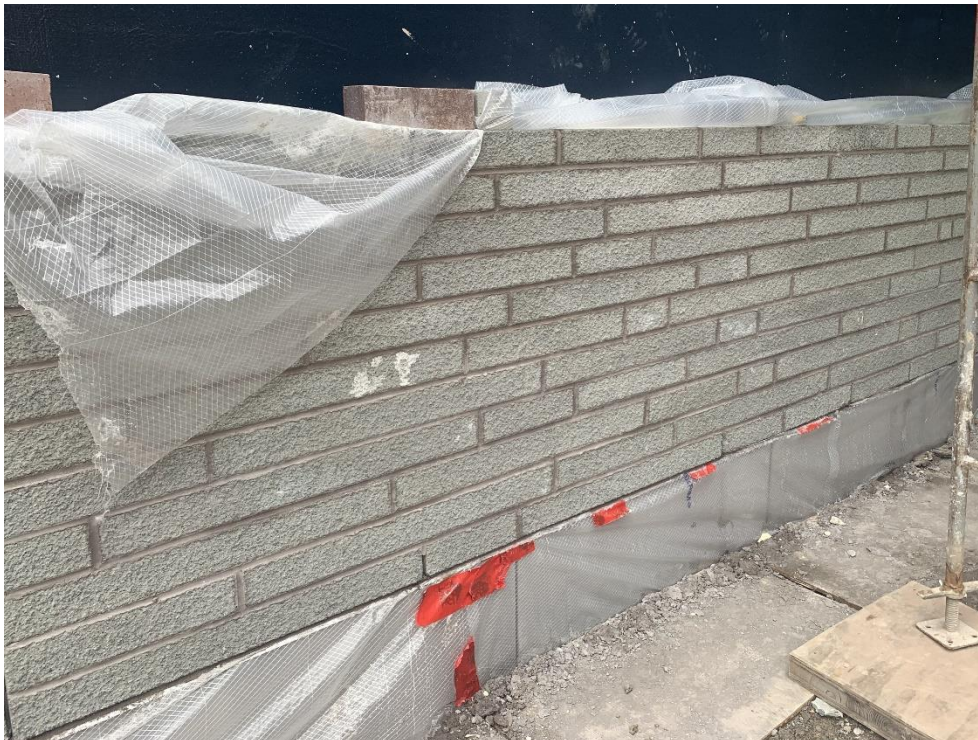
10. Area 5 – FB-2 random bond pattern installation in progress.

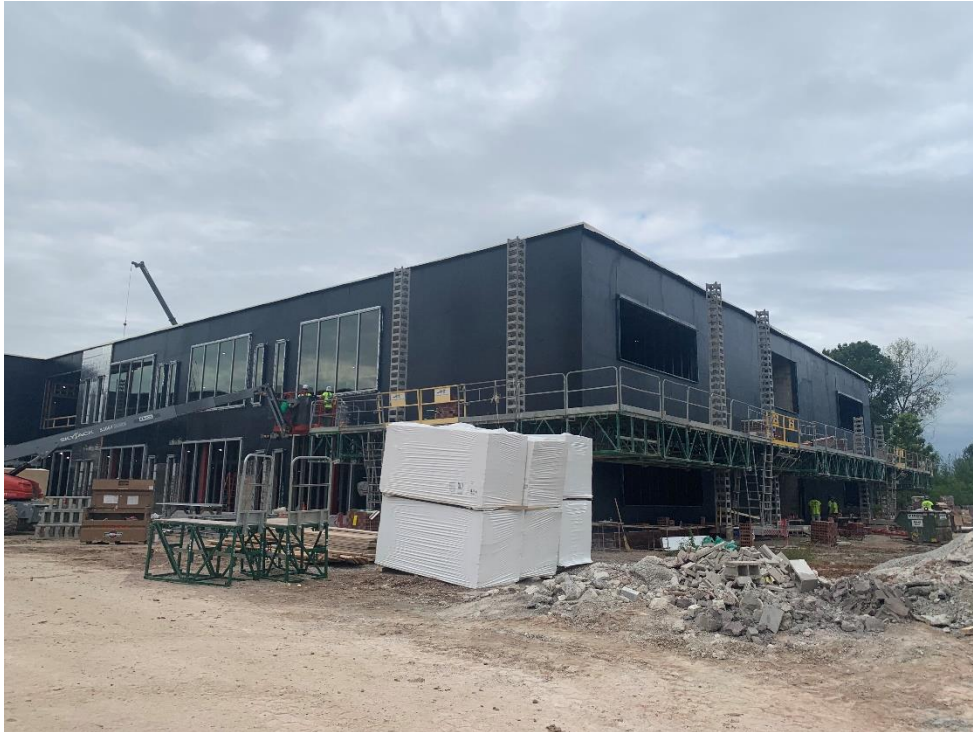
11. Area 4 – Exterior storefront framing and glazing installation in progress. Exterior cast stone and face brick installation in progress.

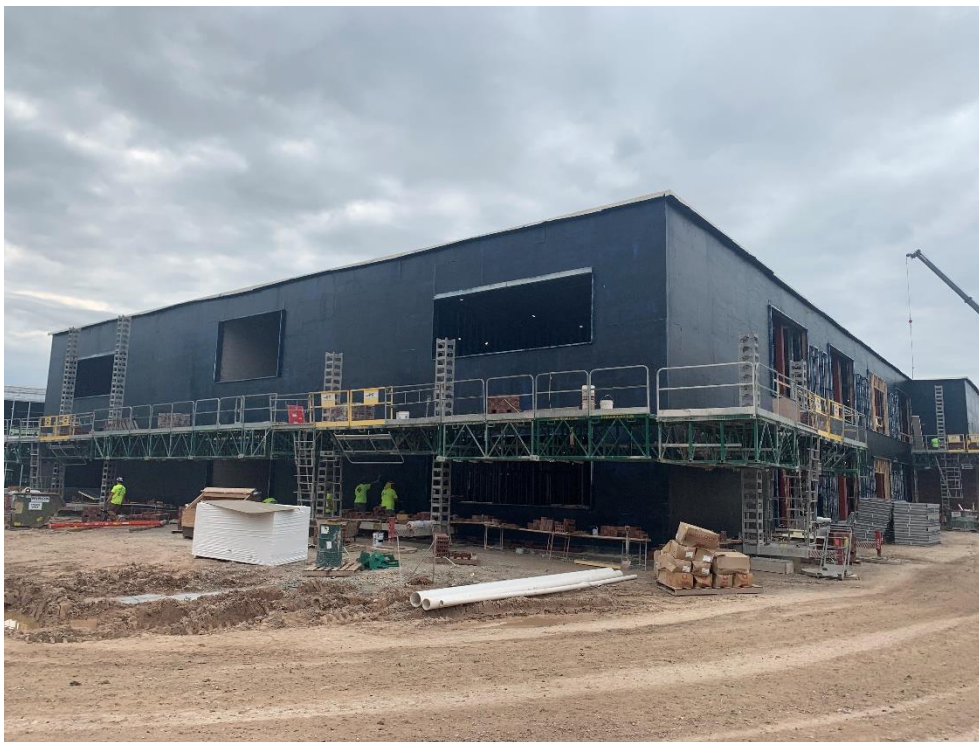
12. Area 4 – Exterior face brick installation in progress.

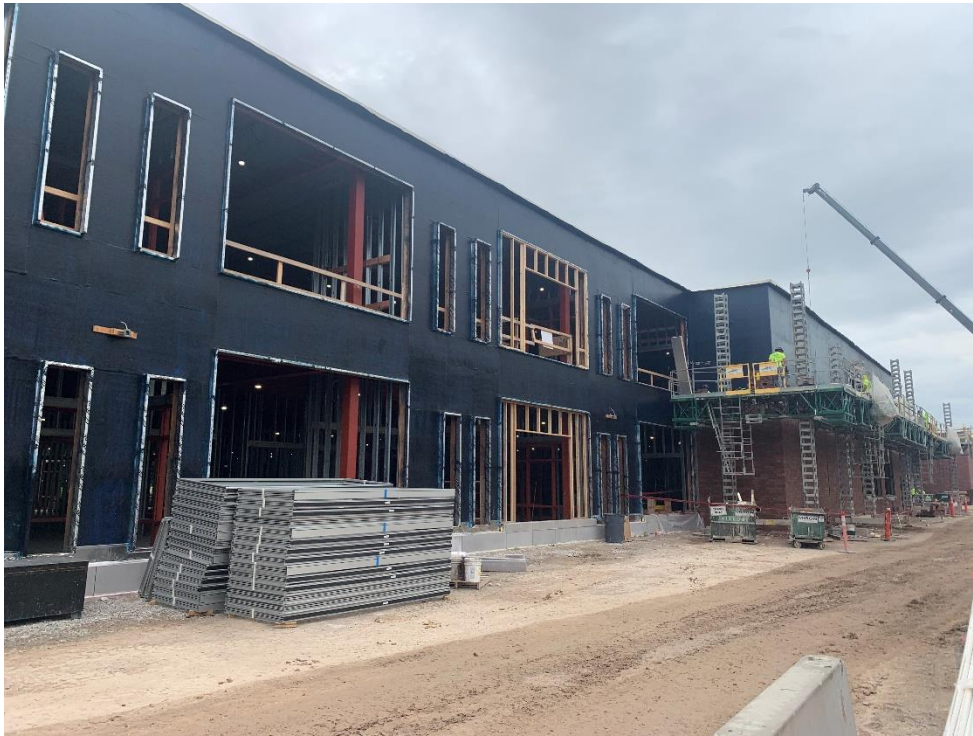
13. Area 3 & 4 –Exterior cast stone and face brick installation in progress.

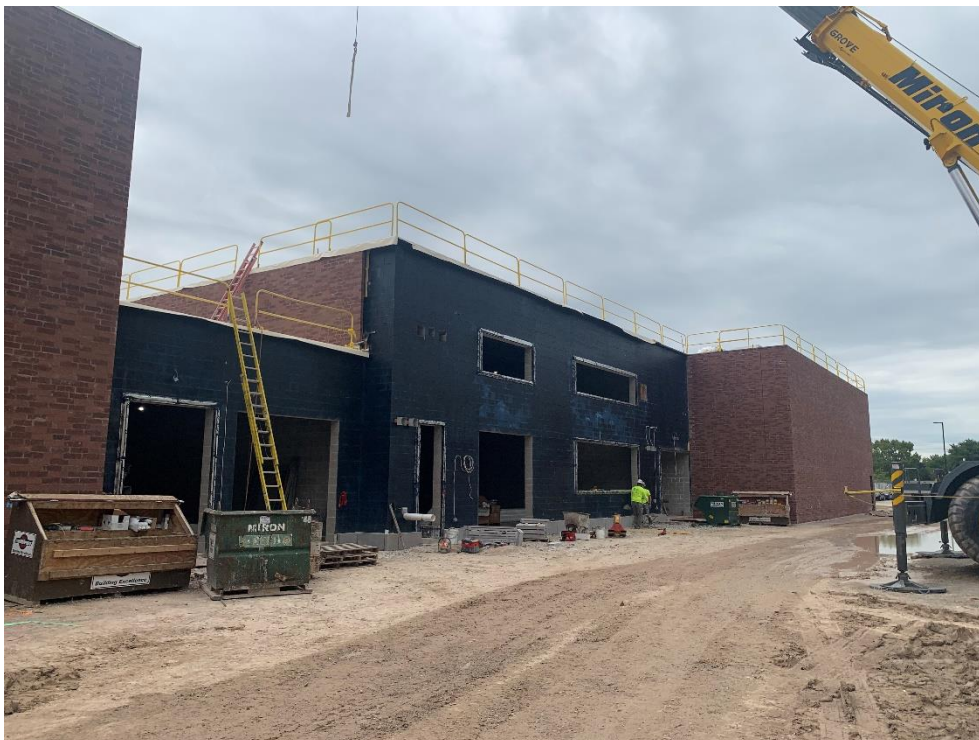
14. Area 3 – Exterior cast stone and window/door weather proofing membrane installation in progress.

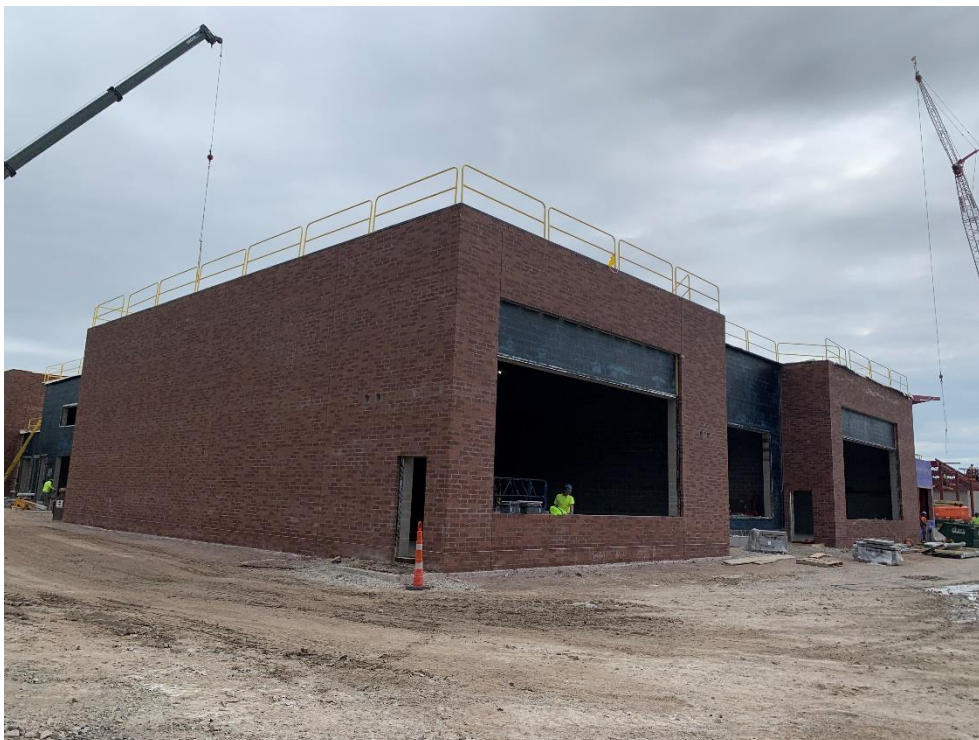
16. Area 2A – Exterior face brick veneer installed

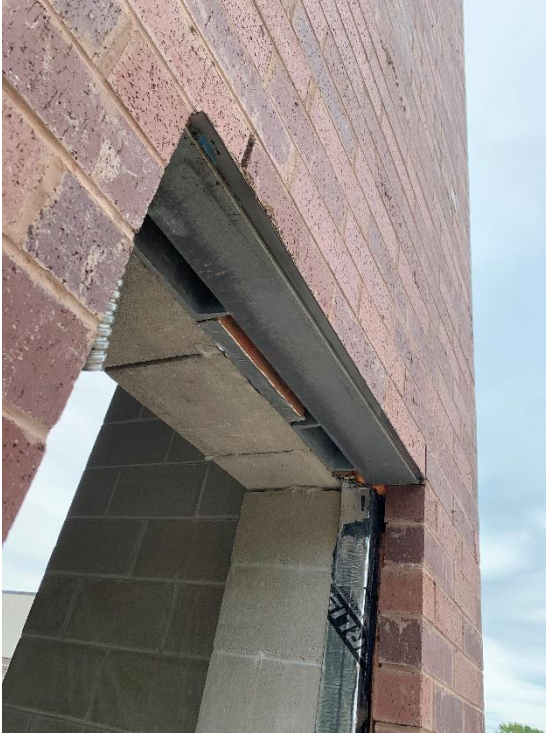
17. Area 2A – Insulation at door head in progress

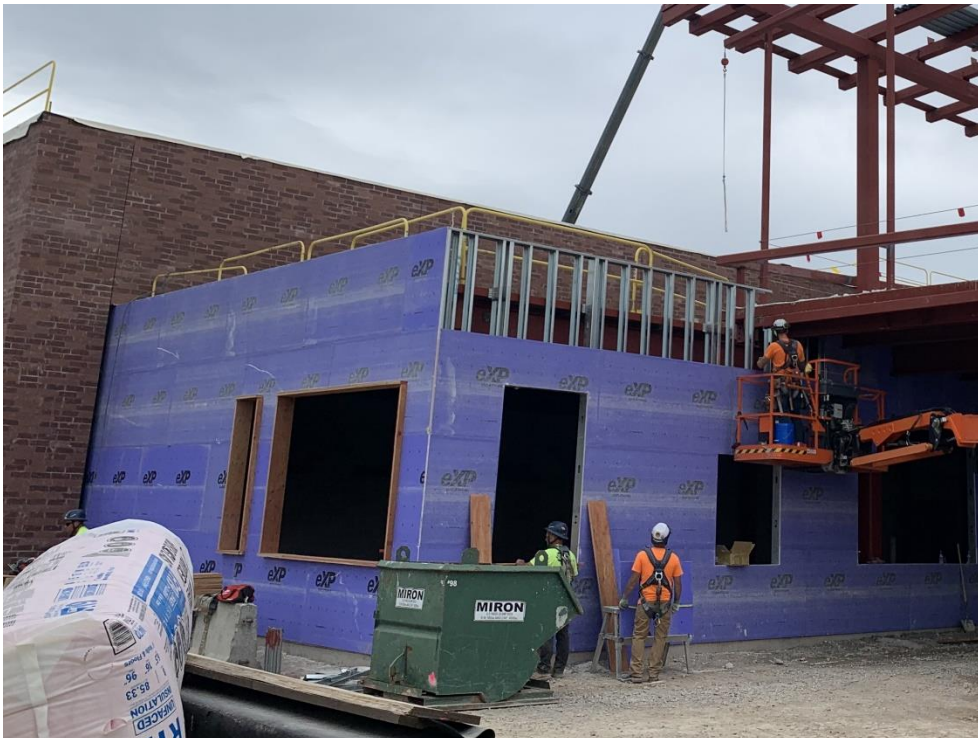
18. Area 1A – Exterior metal stud framing, sheathing, and window blocking installation in progress.

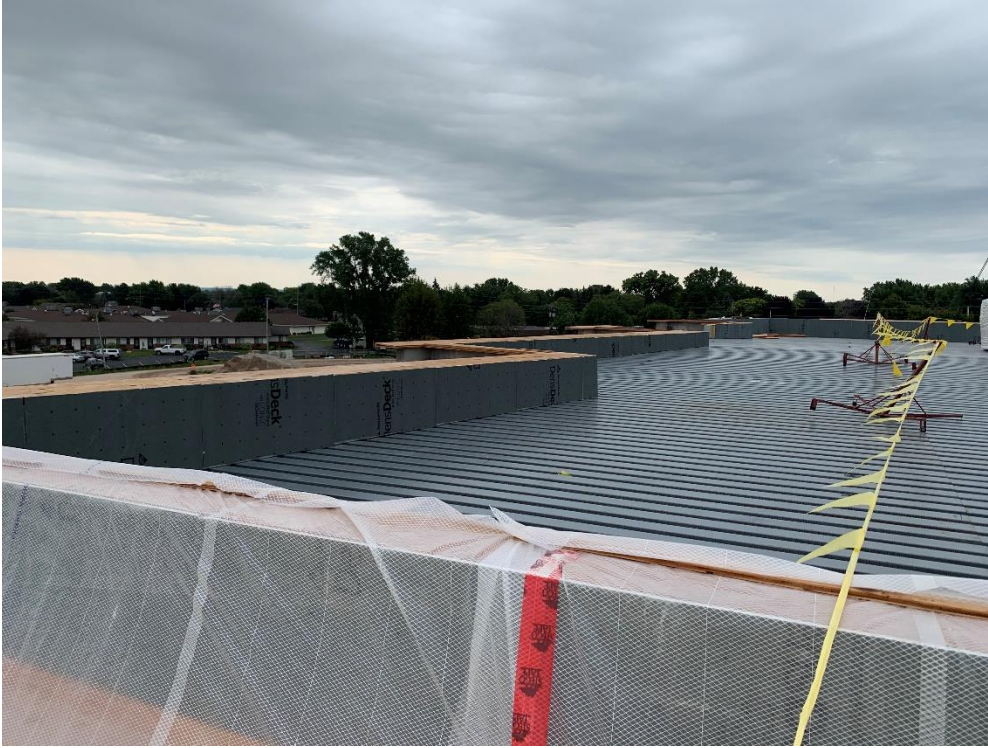
19. Area 6 – Parapet wall sheathing installation in progress.

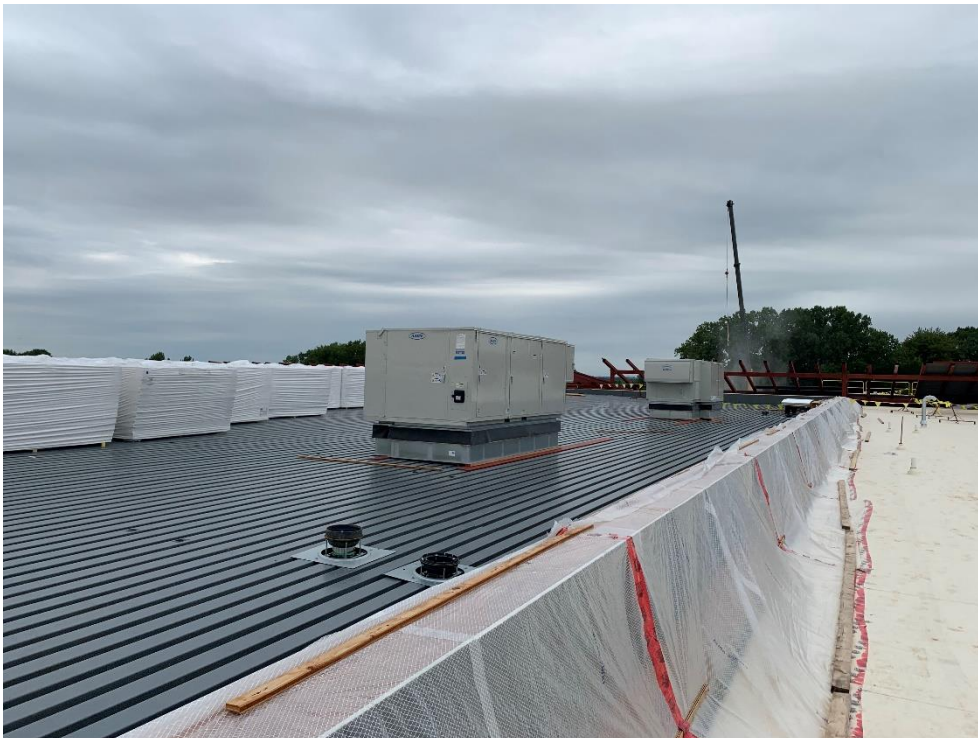
20. Area 6 – RTU and roof drain installation in progress.

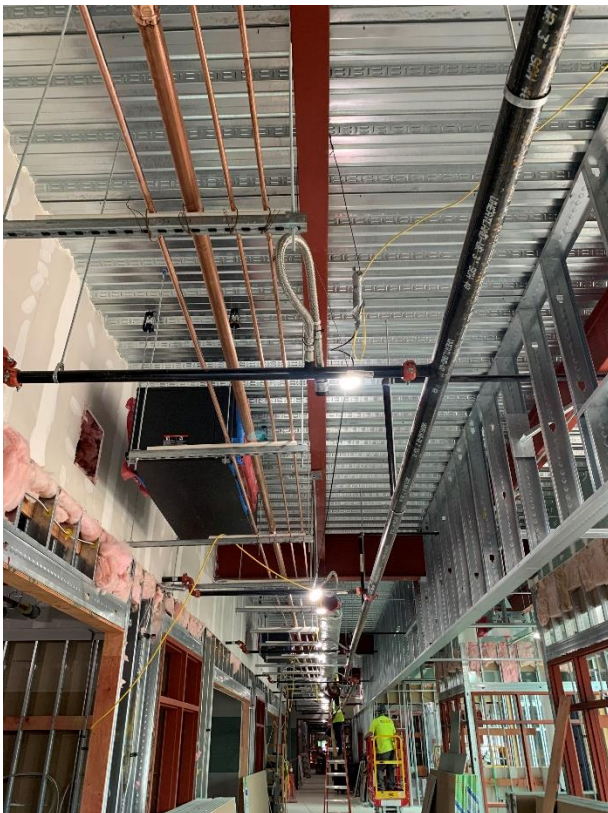
24. Area 6 – Above ceiling plumbing, fire protection piping, and geothermal pipes & heat pump installation in progress.

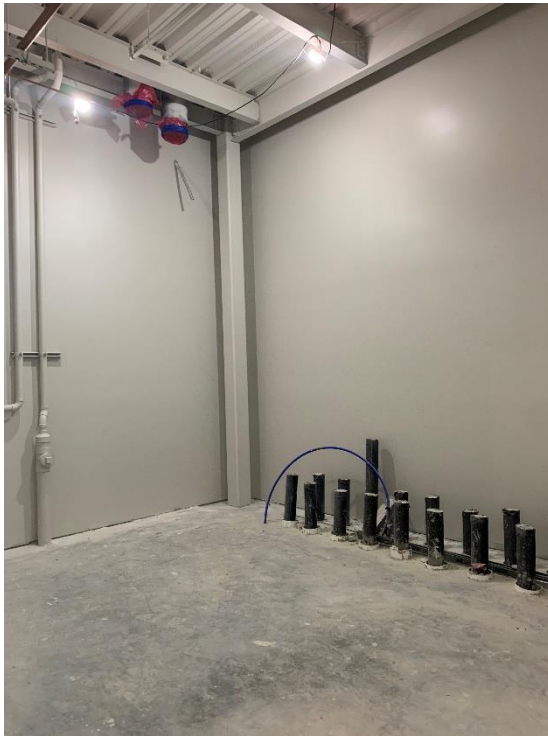
25. Area 6 – Manifold room painting in progress.

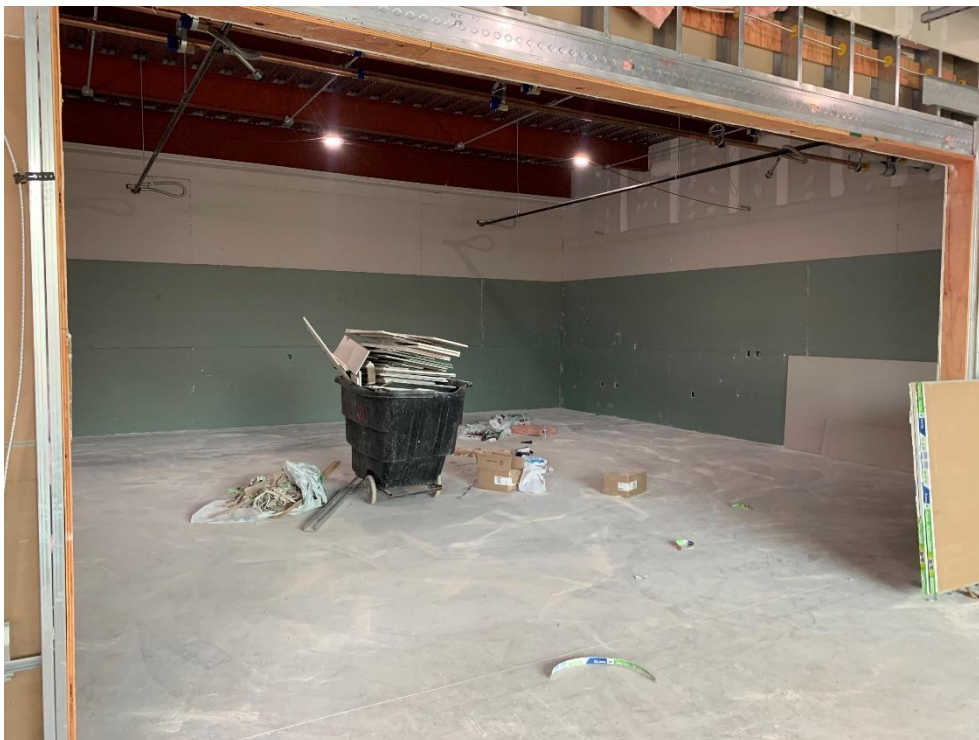
26. Area 6 – gyp board installation in progress.

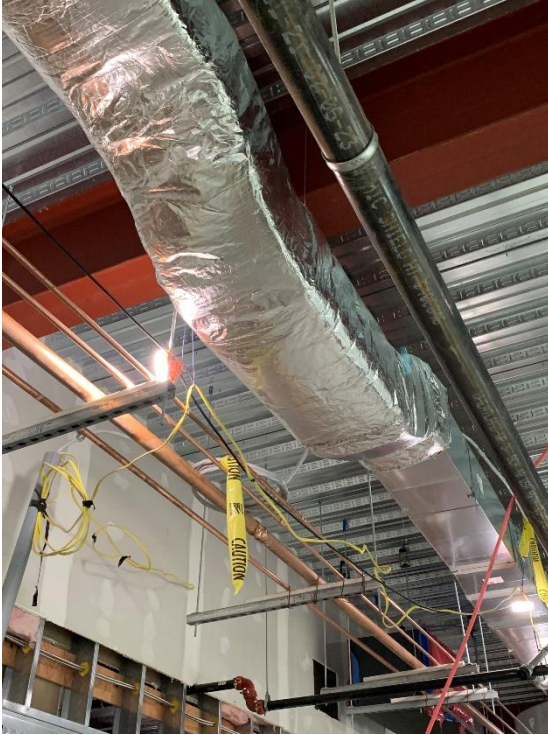
27. Area 6 – sheet metal duct insulation installation in progress.

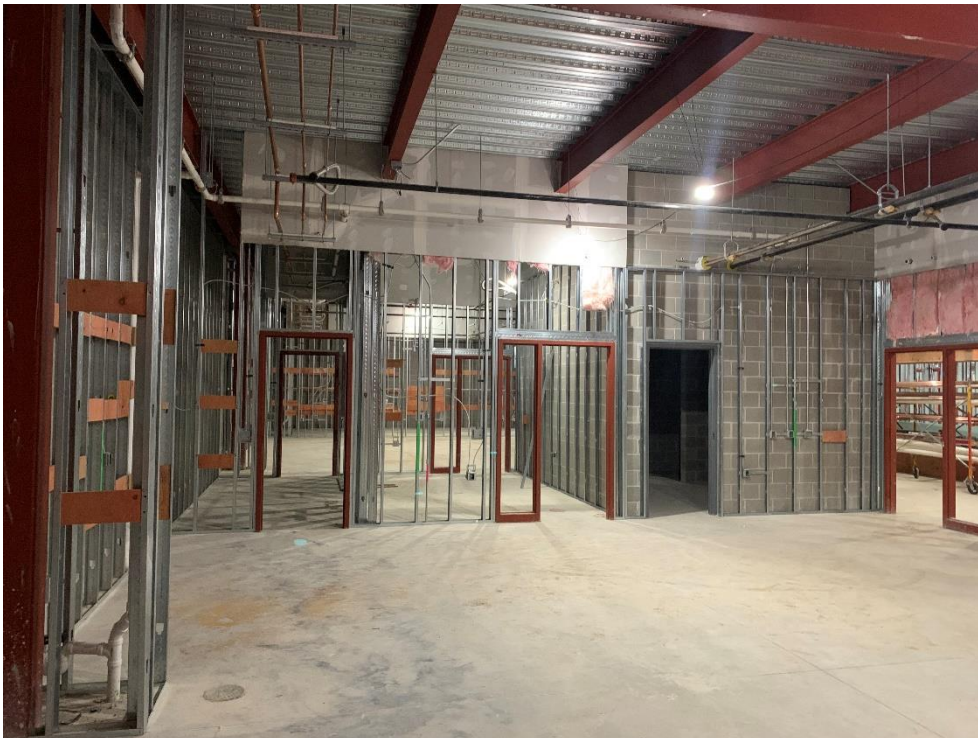
28. Area 6 – IDS gyp board installation in progress.

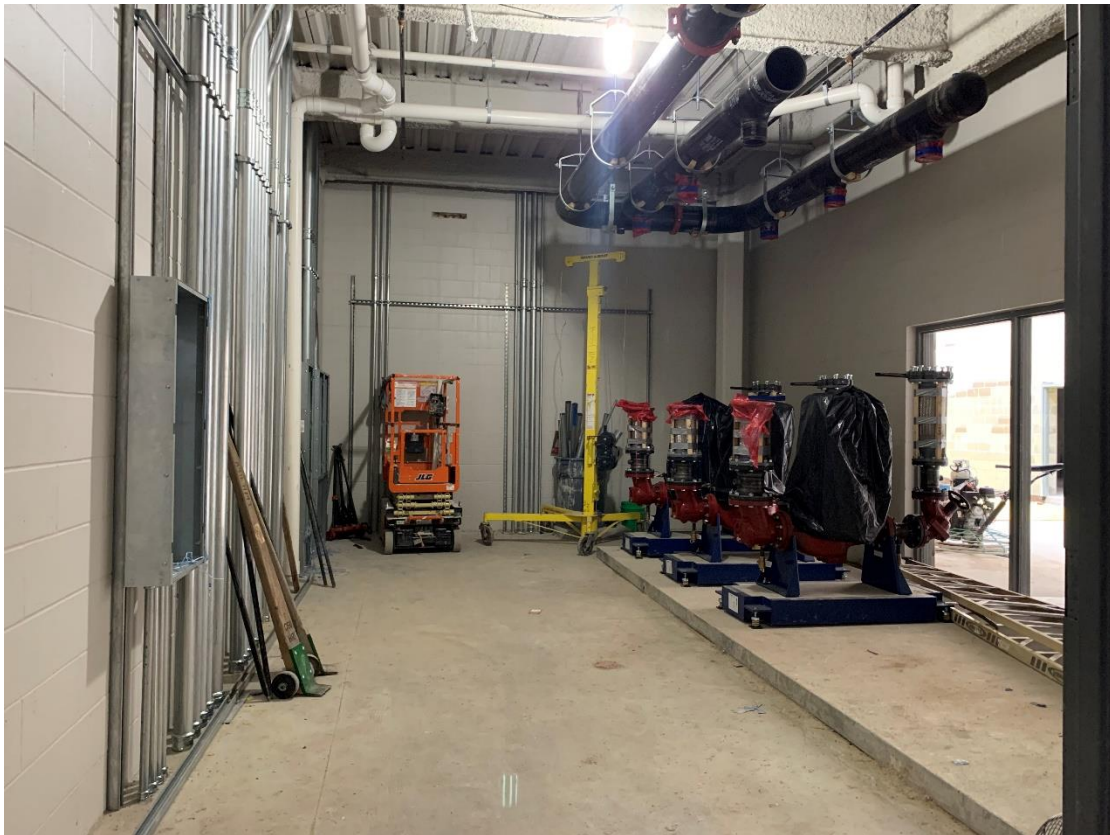
30. Area 6 – First floor pump room geothermal pumps, piping, and electrical conduit installation in progress.

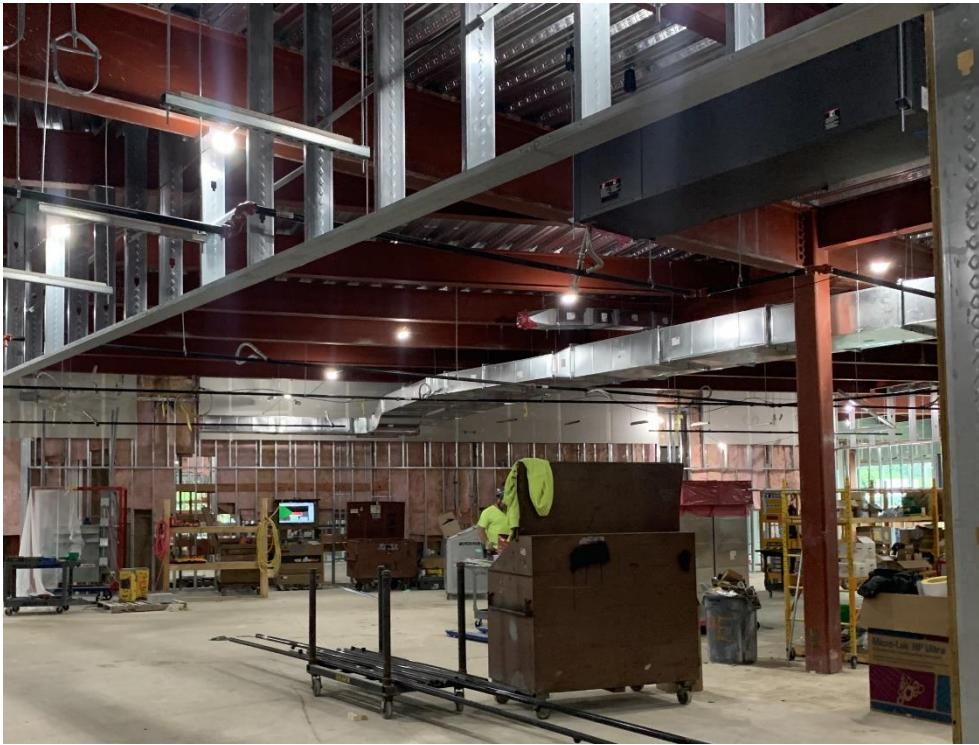
31. Area 5 – HVAC hangars and ducts, geothermal piping, and gyp board installation in progress.

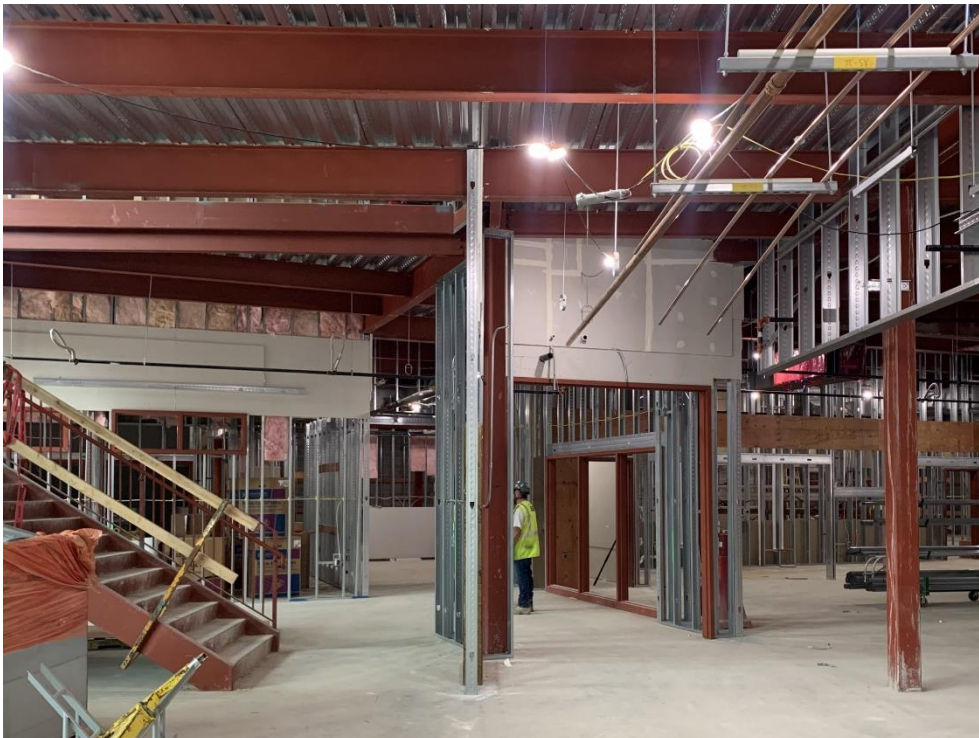
32. Area 5 – metal stud framing, above ceiling plumbing, and gyp board installation in progress.

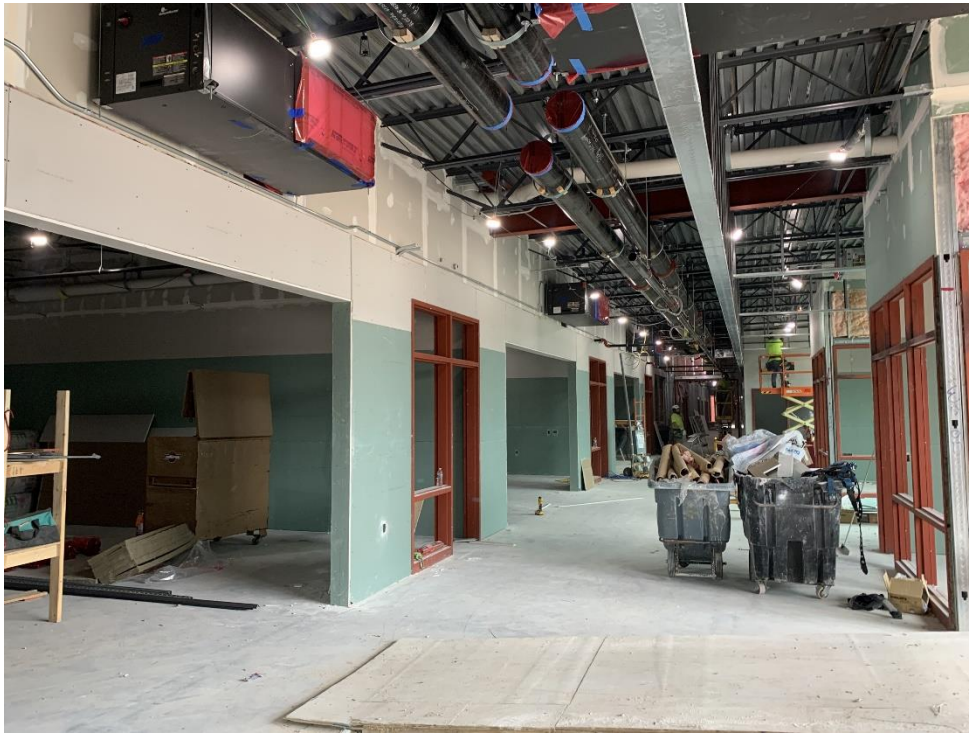
33. Area 6 – Second floor gyp board, geothermal piping, and heat pump installation in progress.

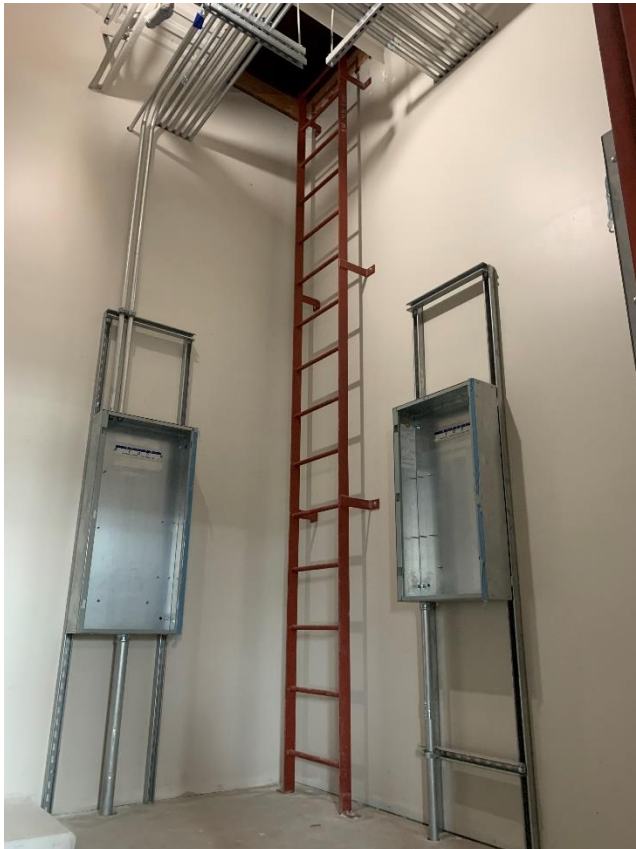
34. Area 5 – roof ladder and hatch. Electrical conduit installation in progress.

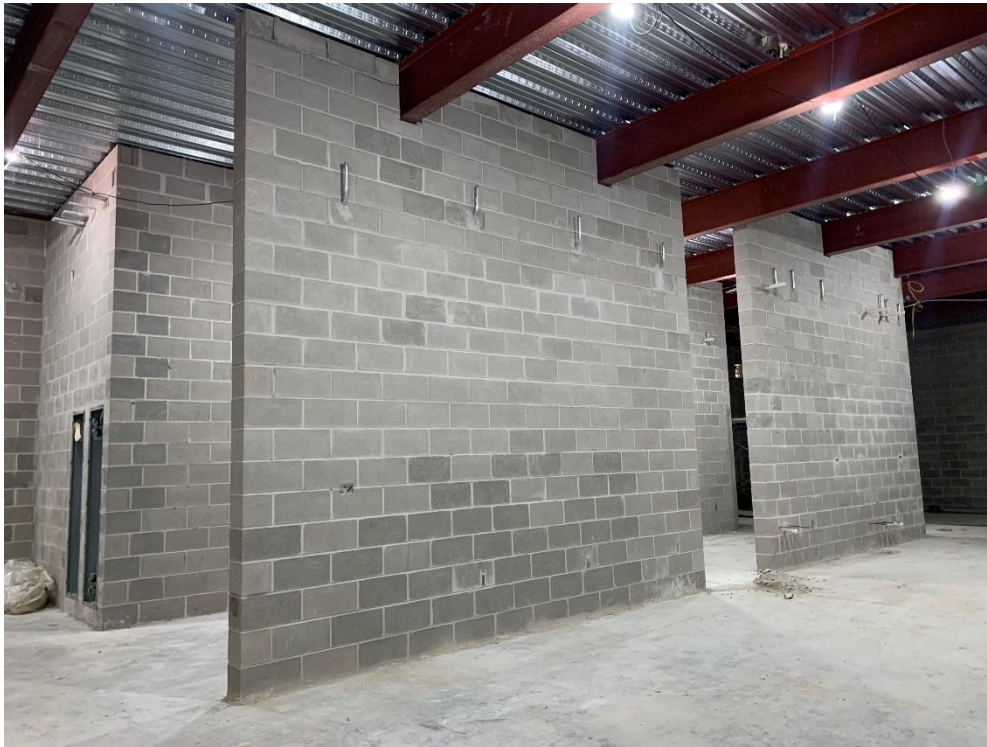
35. Area 3 – CMU walls in the kitchen are installed.

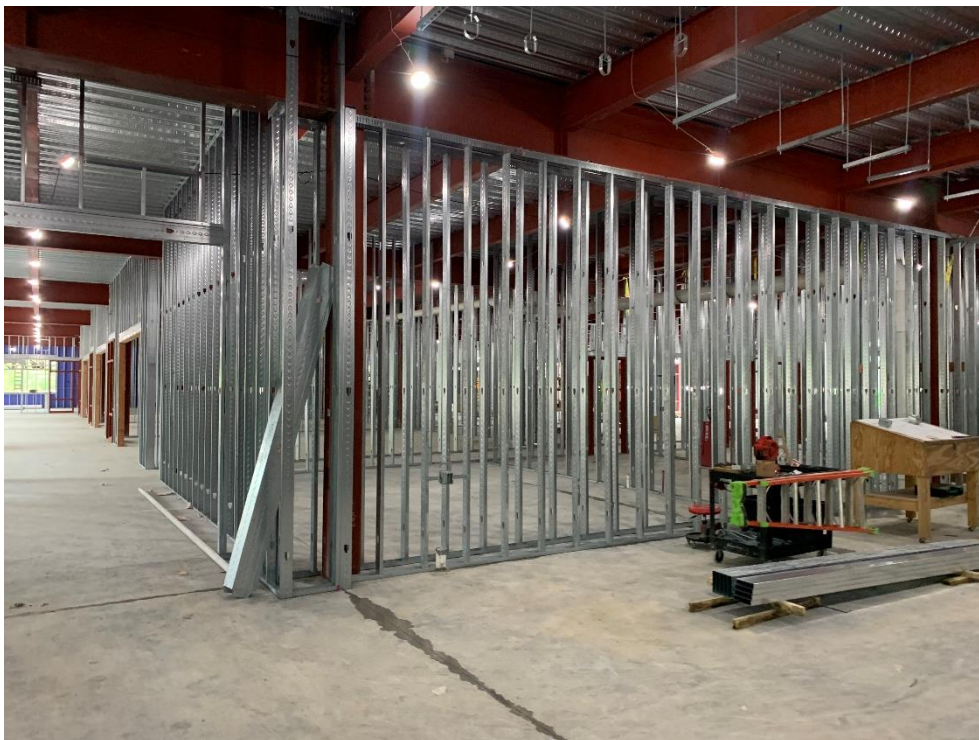
36. Area 4 – Interior metal stud framing and blocking in progress.

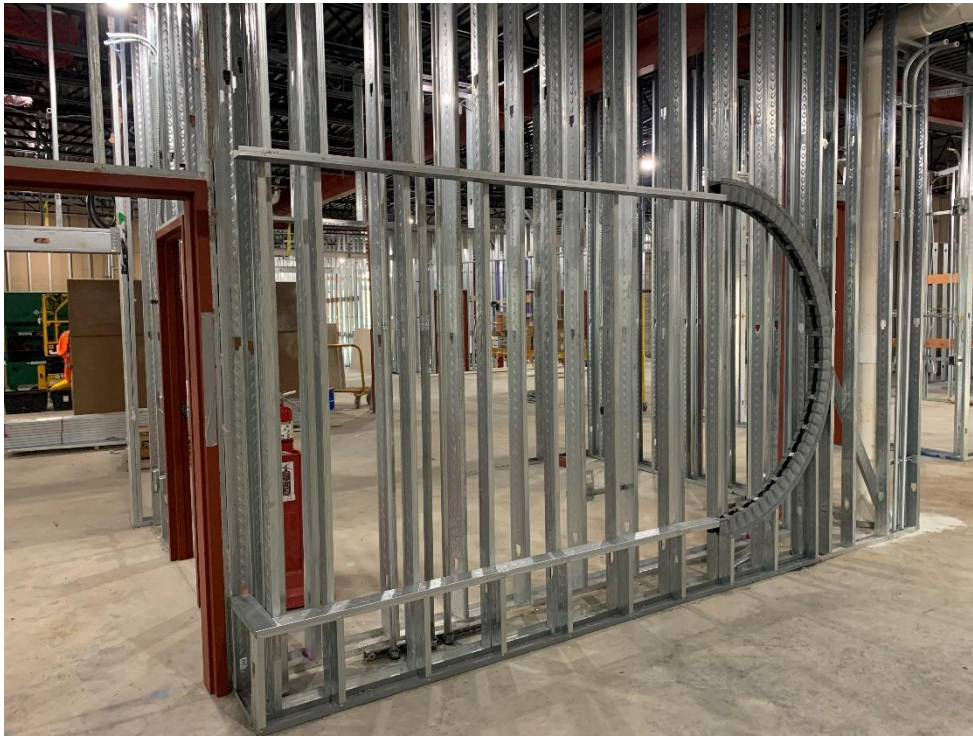
37. Area 3 – Grade wing entry feature metal framing in progress.

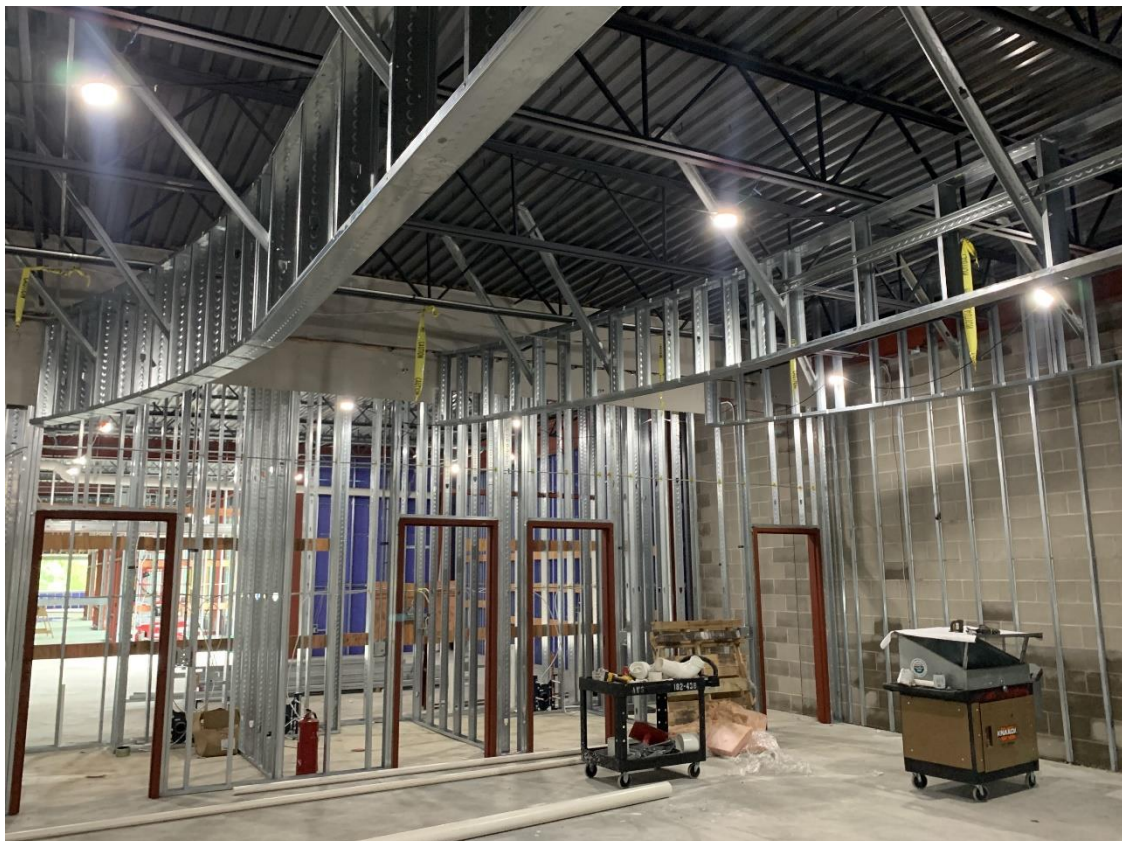
38. Area 3 – Interior metal stud framing and blocking in progress.
