Construction Observation Report 010 – August 8, 2024

Maplewood School

PROJECT NUMBER: 321169-01

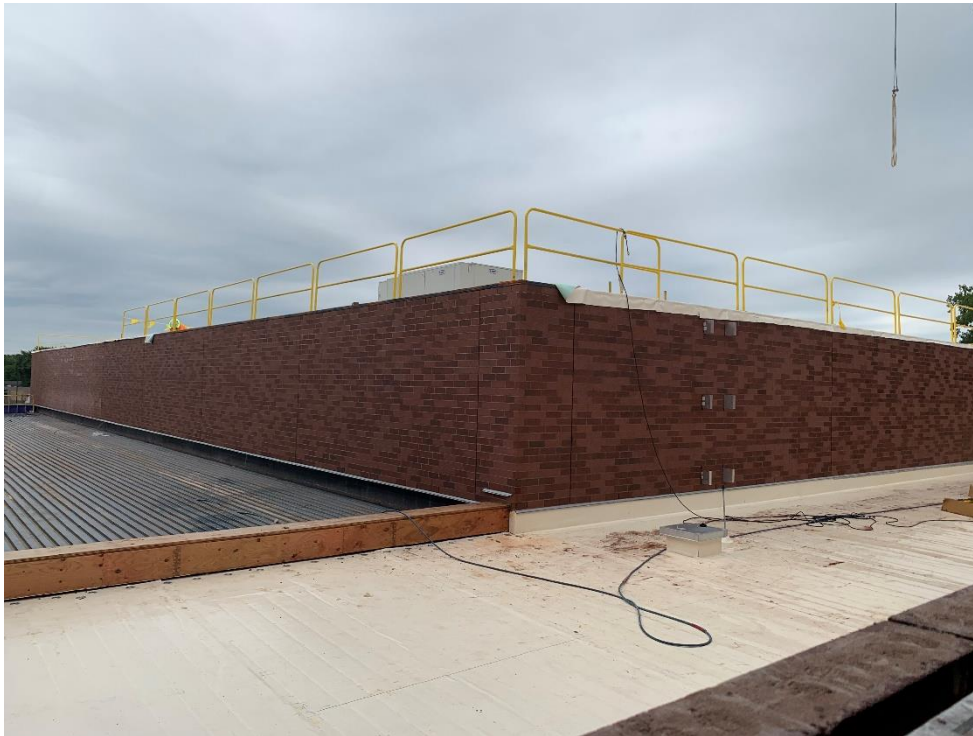
39. Area 3 – Above roof face brick veneer installed. Roofing installation in progress.

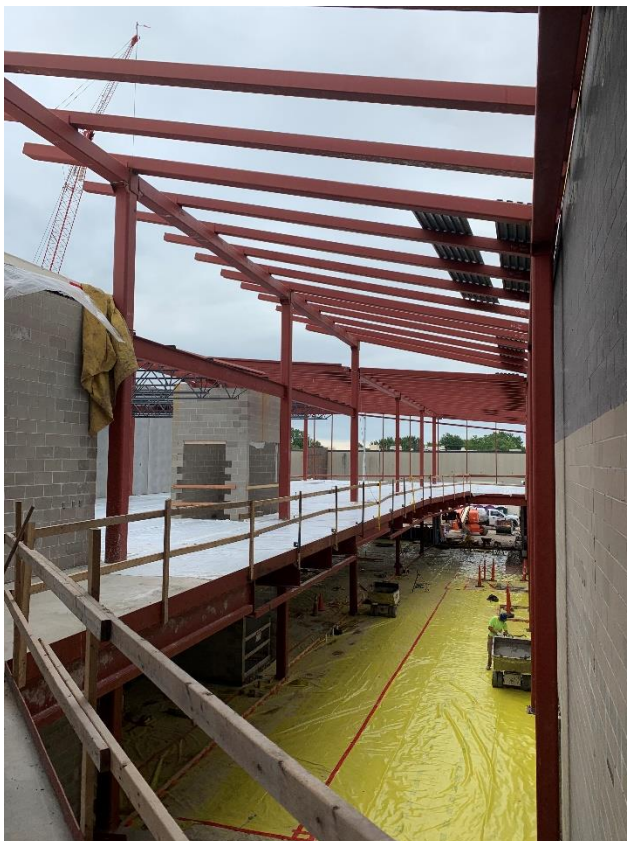
40. Area 1B – Roof decking installation in progress.

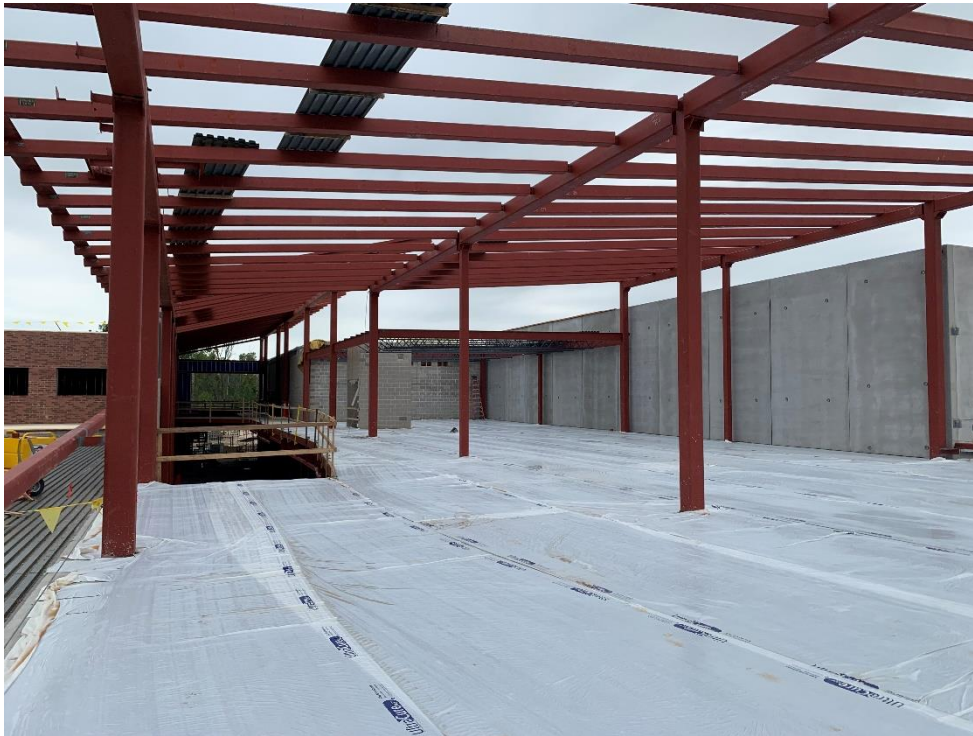
41. Area 1A – Second floor concrete slab poured. Structural steel detailing and deck installation in progress.

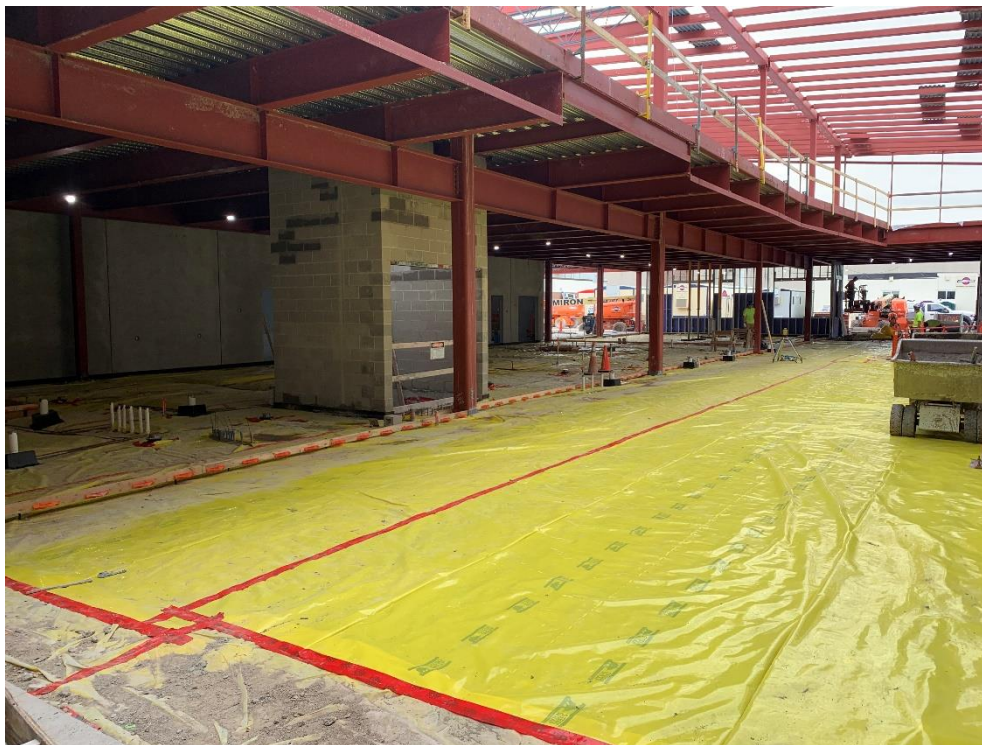
42. Area 1A – prep for slab on grade pour in progress.

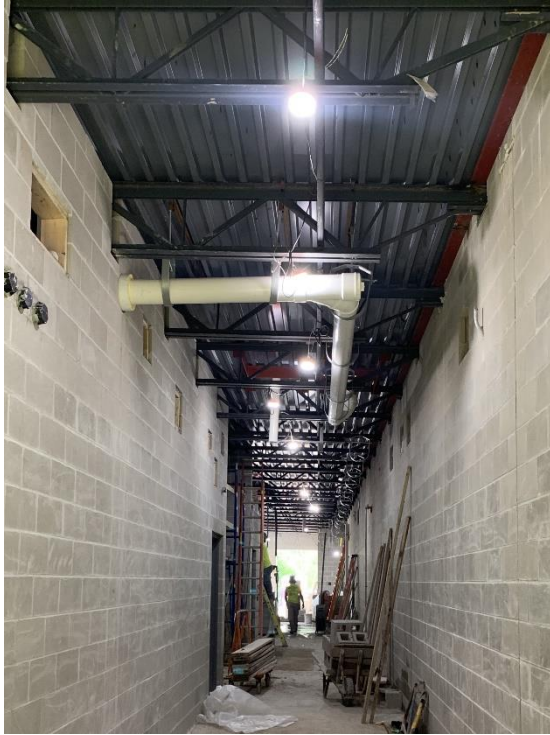
43. Area 3 – Roof drain piping in receiving in progress.

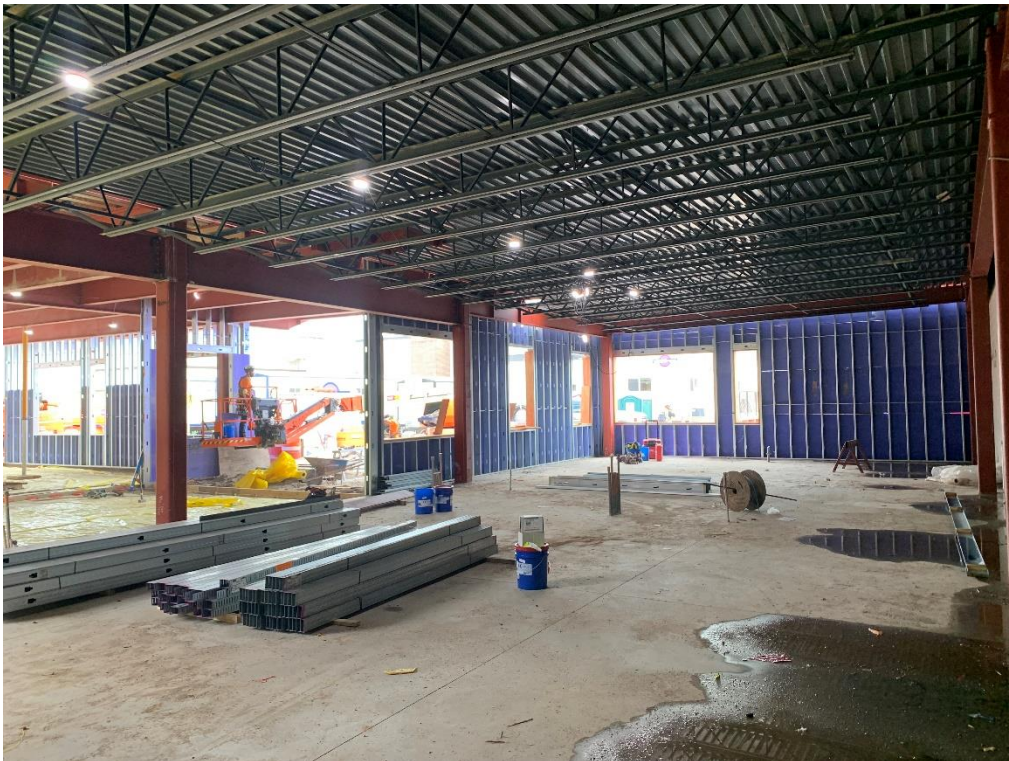
44. Area 1A – Interior metal stud framing in progress.
