Construction Observation Report 026 – March 21st, 2025

Maplewood School

PROJECT NUMBER: 321169-01

OWNER:	MENASHA JOINT SCHOOL DISTRICT
From ARCHITECT/ENGINEER:	EUA
To CONTRACTOR	MIRON CONSTRUCTION CO, INC
SITE OBSERVATION TYPE	ARCHITECTURAL
DATE OF ISSUANCE:	April 2 nd , 2025

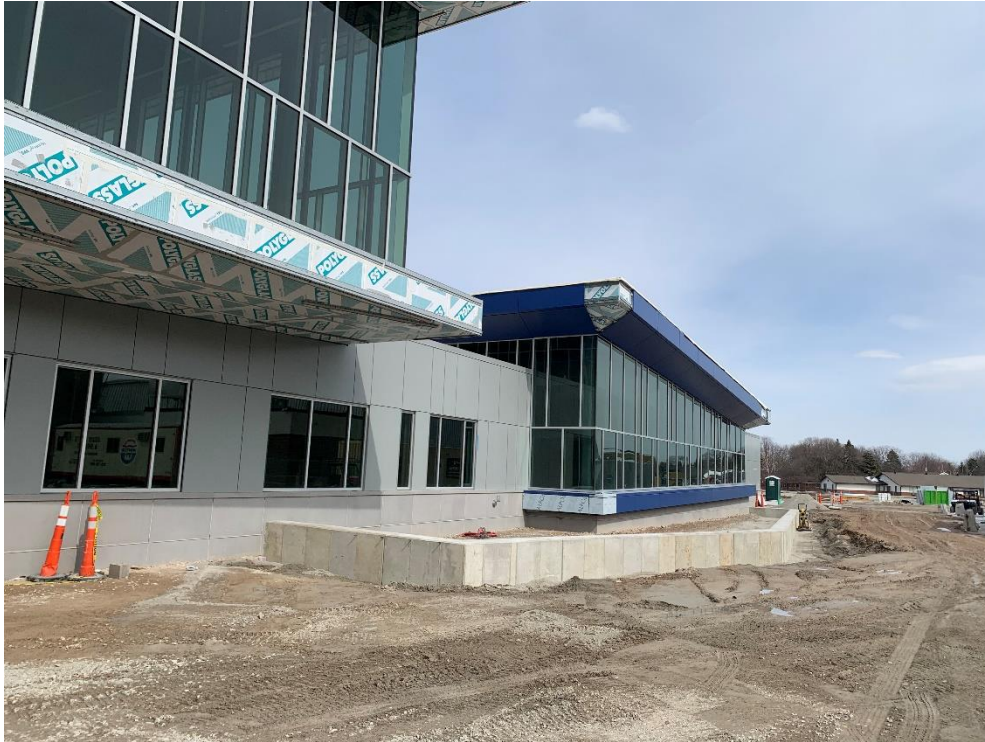
1. Area 2B South – Composite wall panel install continues at upper soffits. Concrete seat wall near building has been poured.

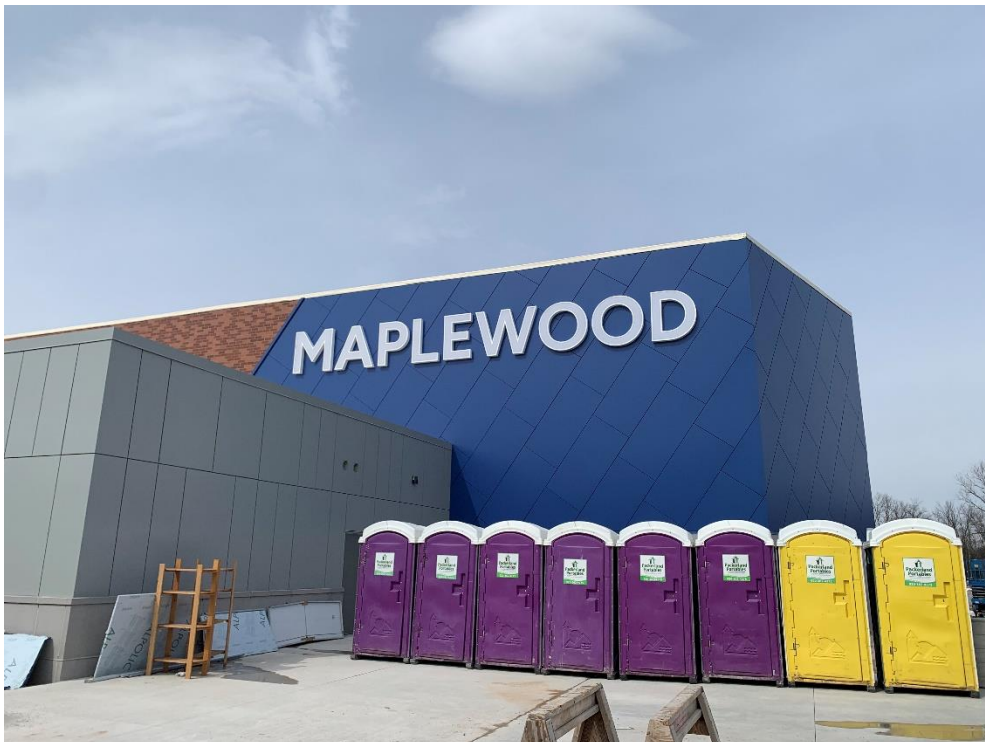
2. Area 6 – Building sign appears to be installed.

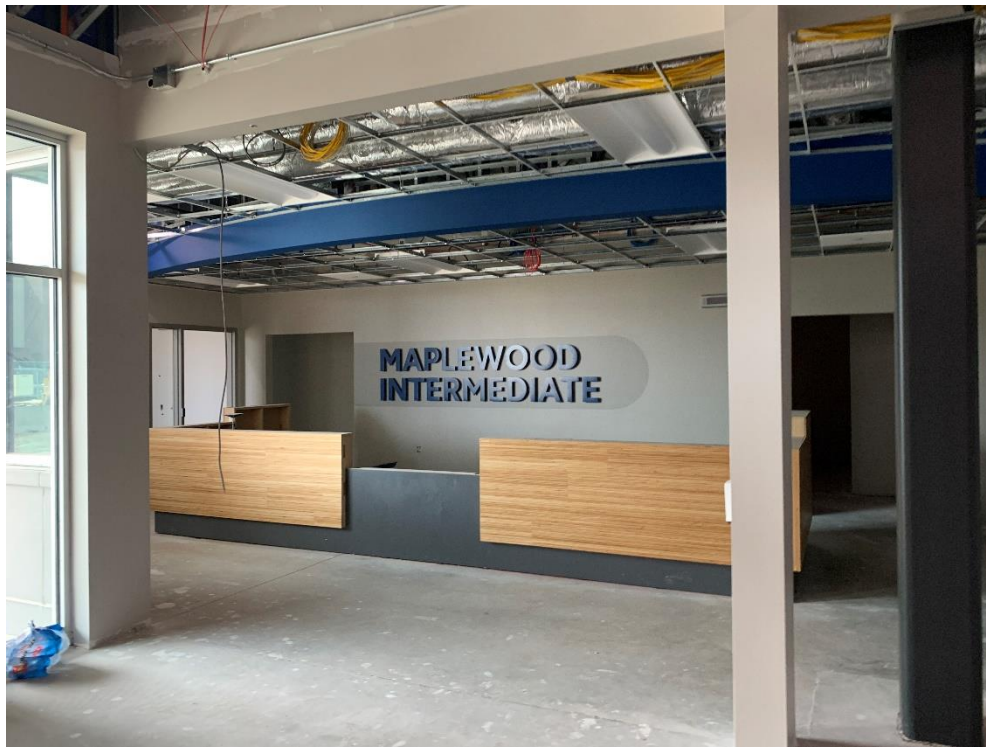
3. Area 1A – Reception desk millwork install continues. Dimensional lettering at 5/6 office appears to be installed.

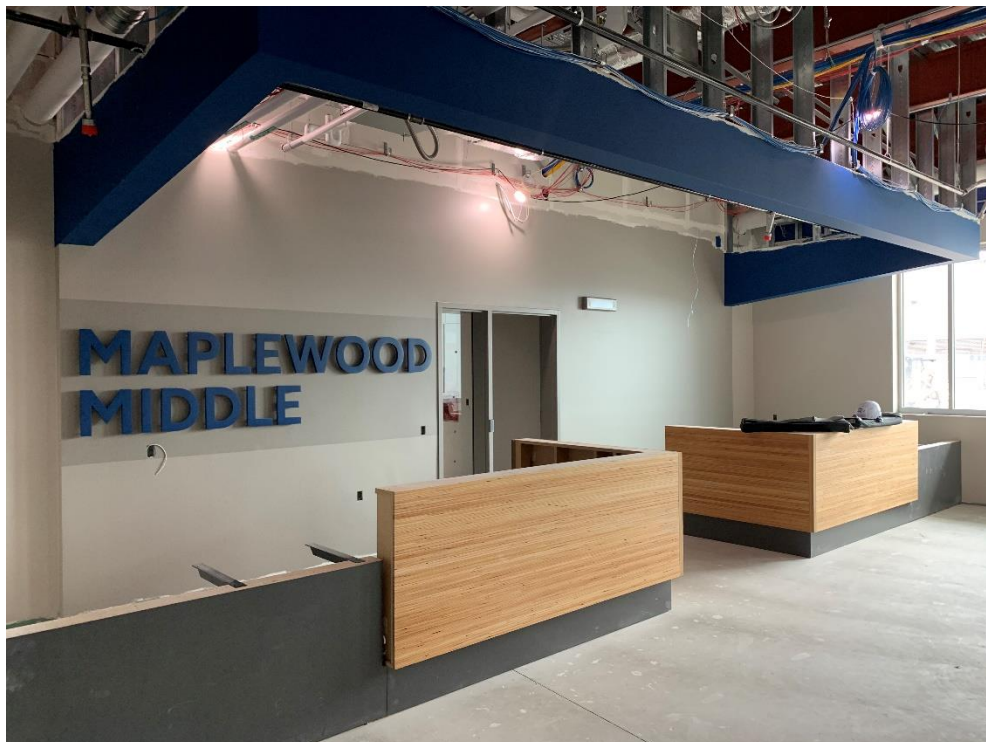
4. Area 1A – Reception desk millwork install continues. Dimensional lettering at 7/8 office appears to be installed..

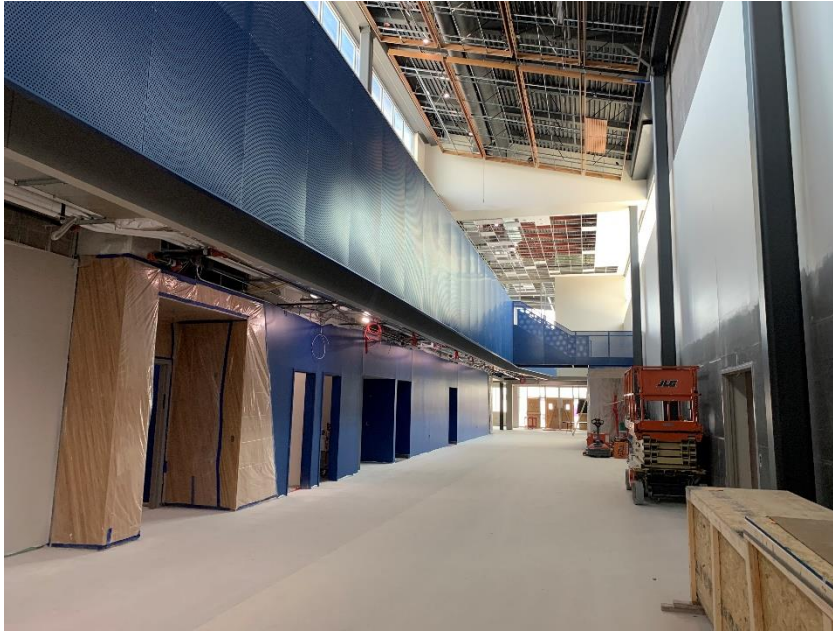
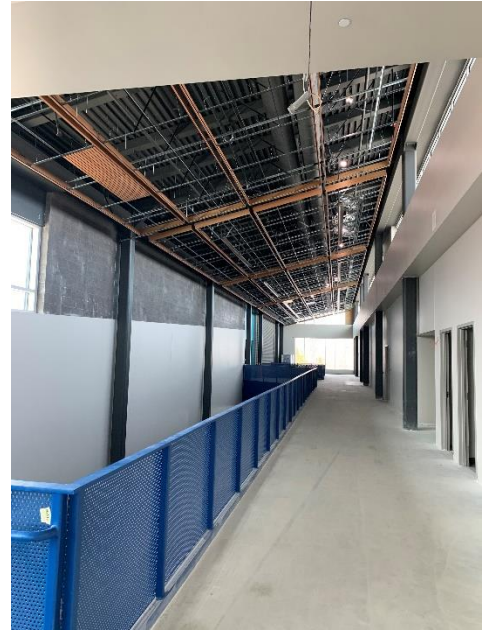
5. Area 1A – Terrazzo flooring on second floor appears to be in progress. Wood look ceiling system install in progress.

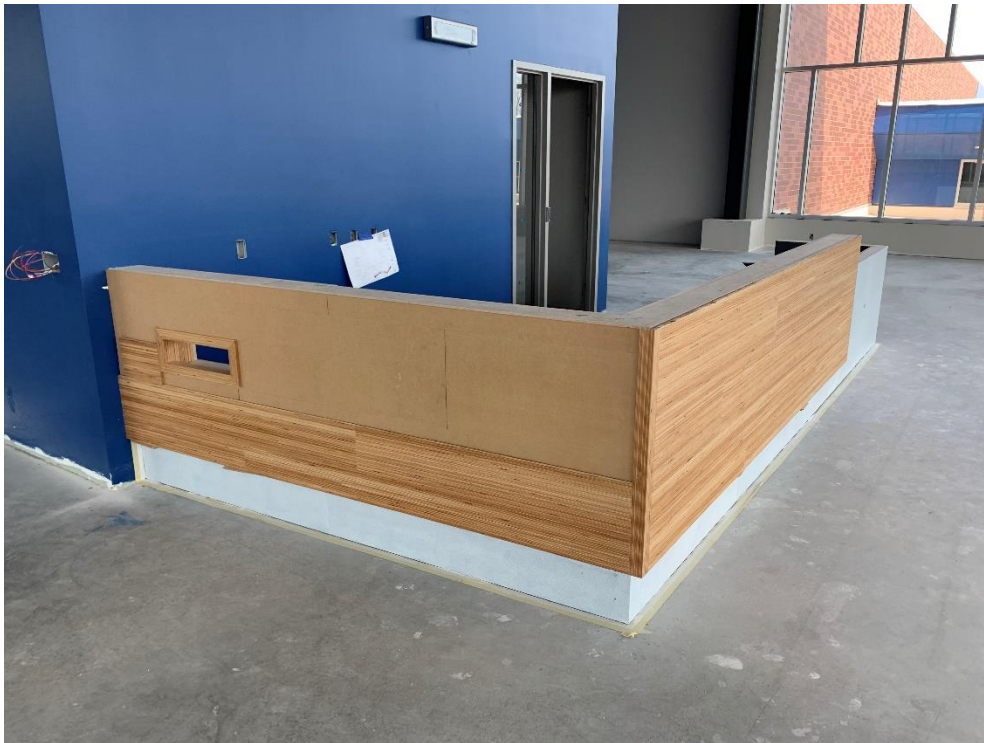
6. Area 1A – LMC circulation desk millwork install continues.

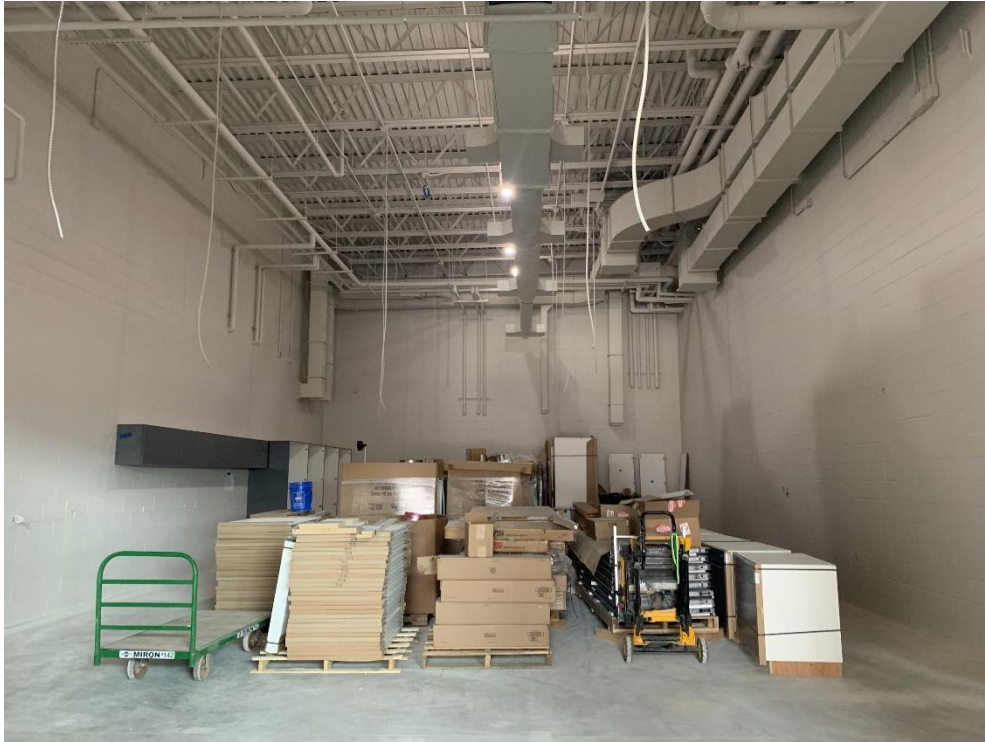
7. Area 3 – Casework install in tech-ed suite in progress.

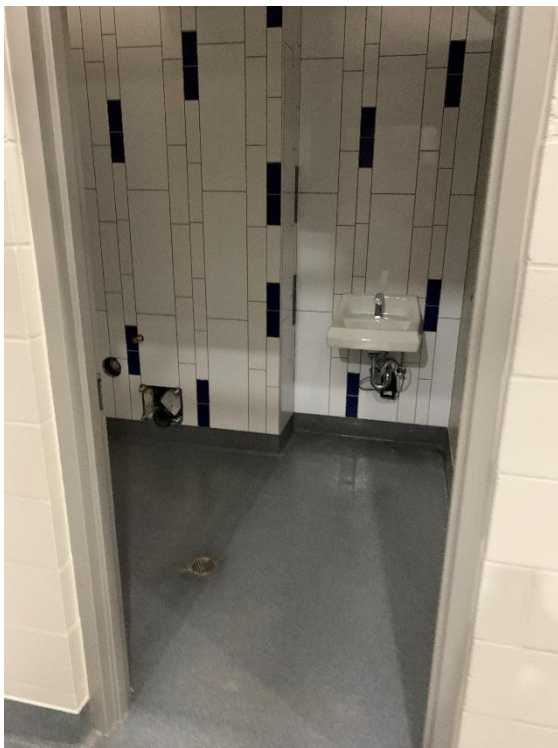
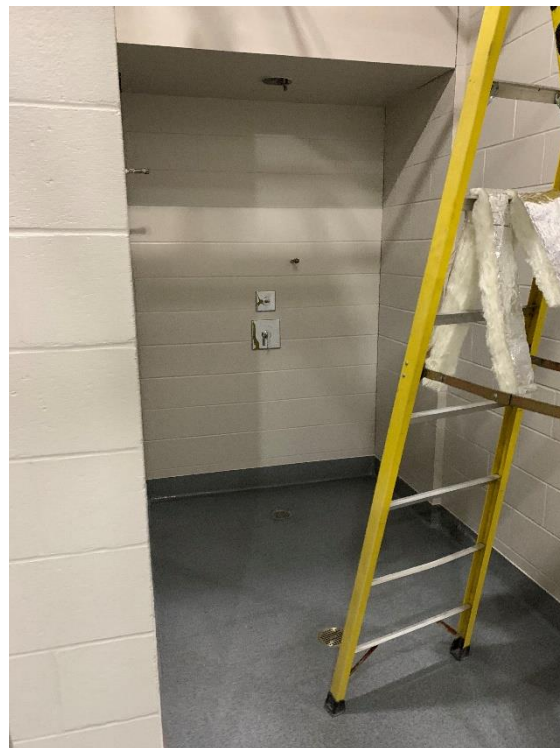
8. Area 1A – Plumbing fixture install in the locker rooms in progress.

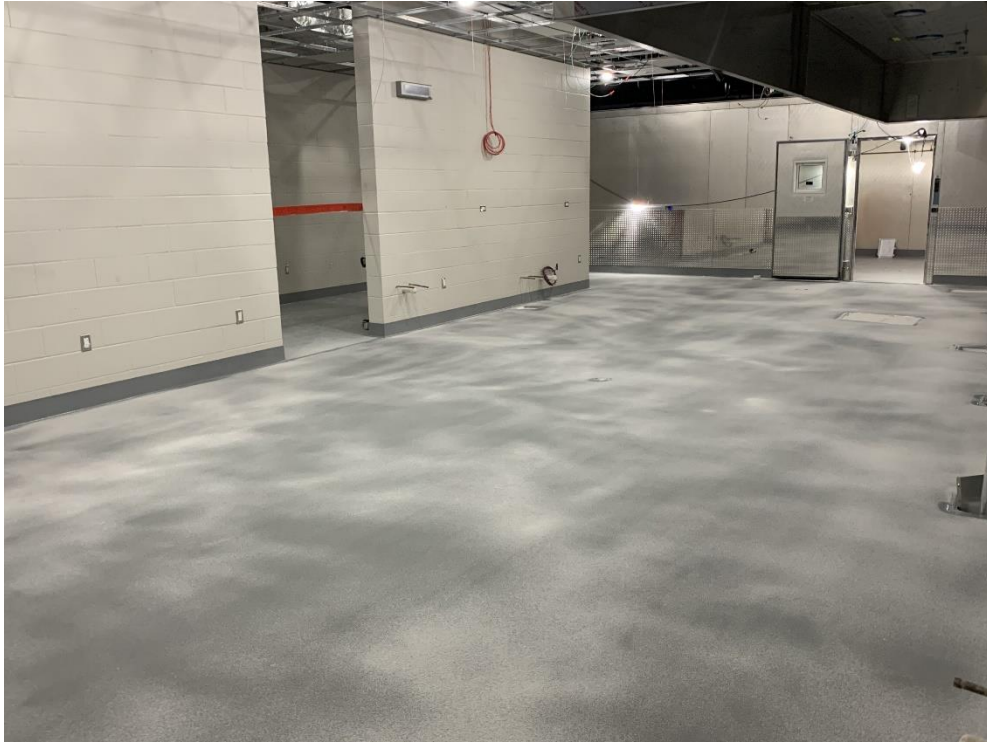
9. Area 3 – Epoxy flooring install in the kitchen in progress.

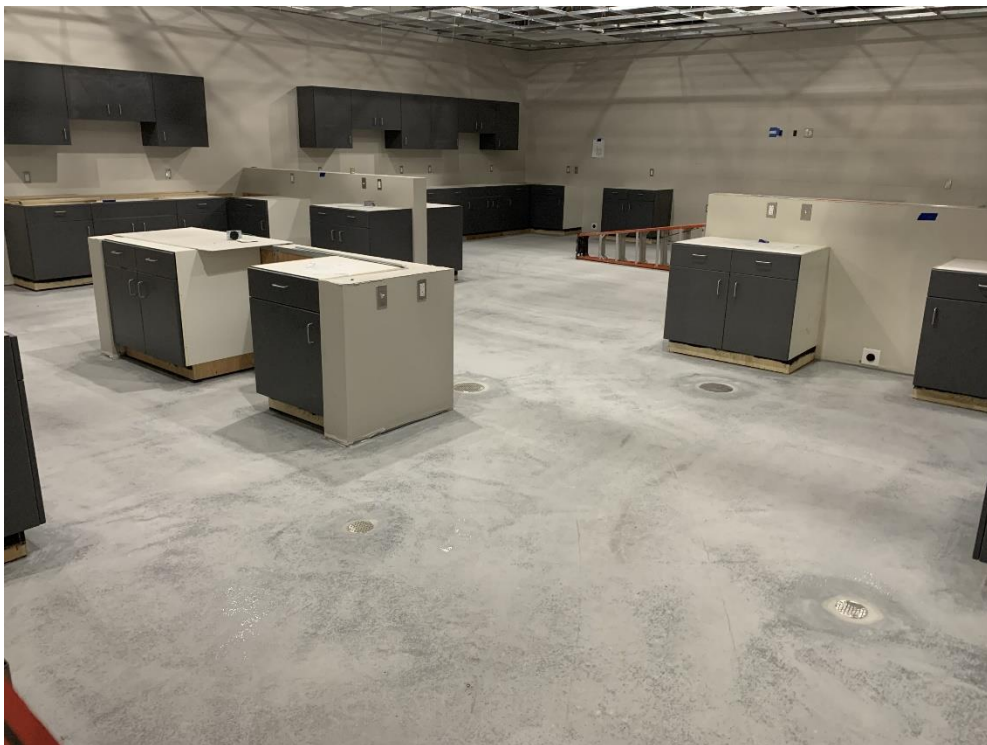
10. Area 3 - Epoxy flooring install in the culinary lab in progress.

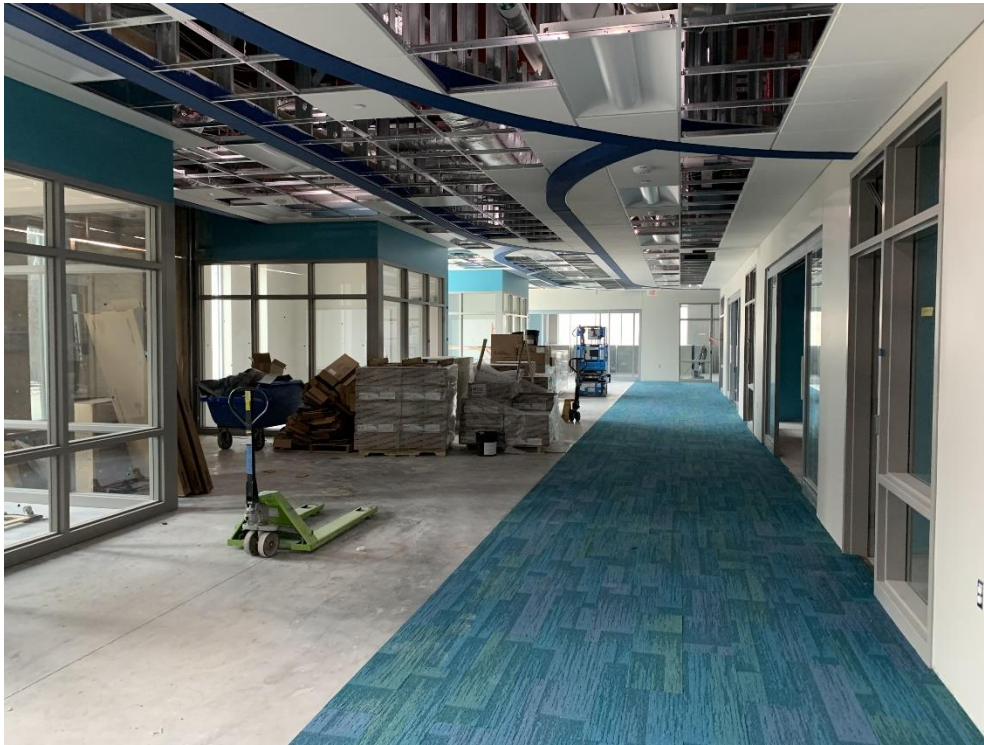
11. Area 4 – Carpet install in progress throughout gradewing area.

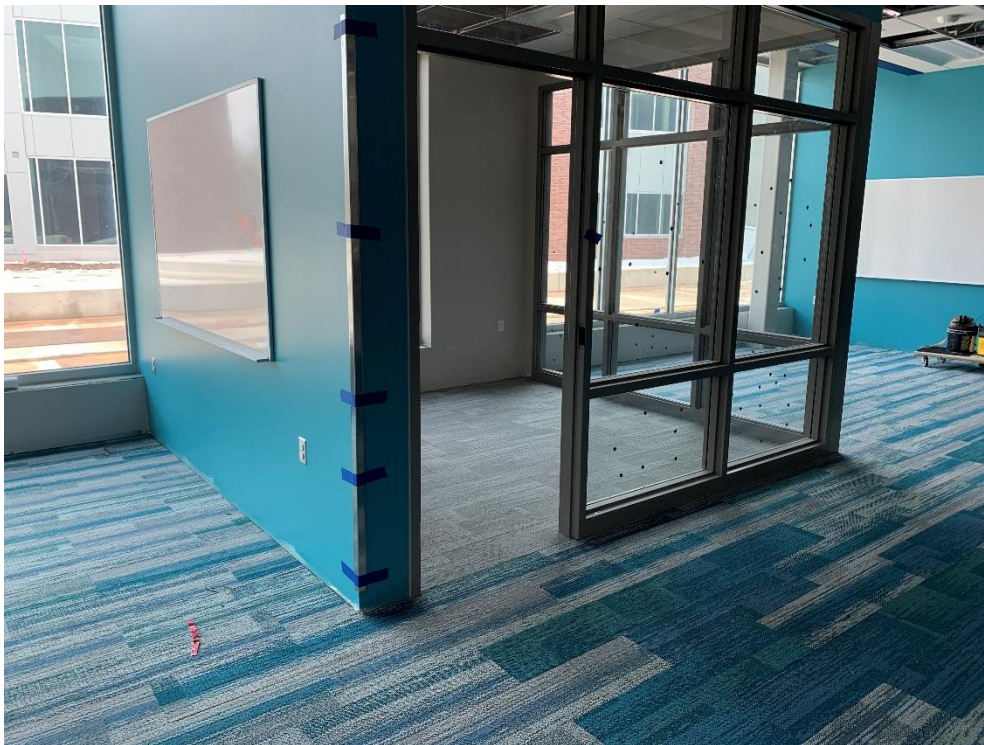
12. Area 4 – Corner guard and window sill install in progress throughout gradewing area.

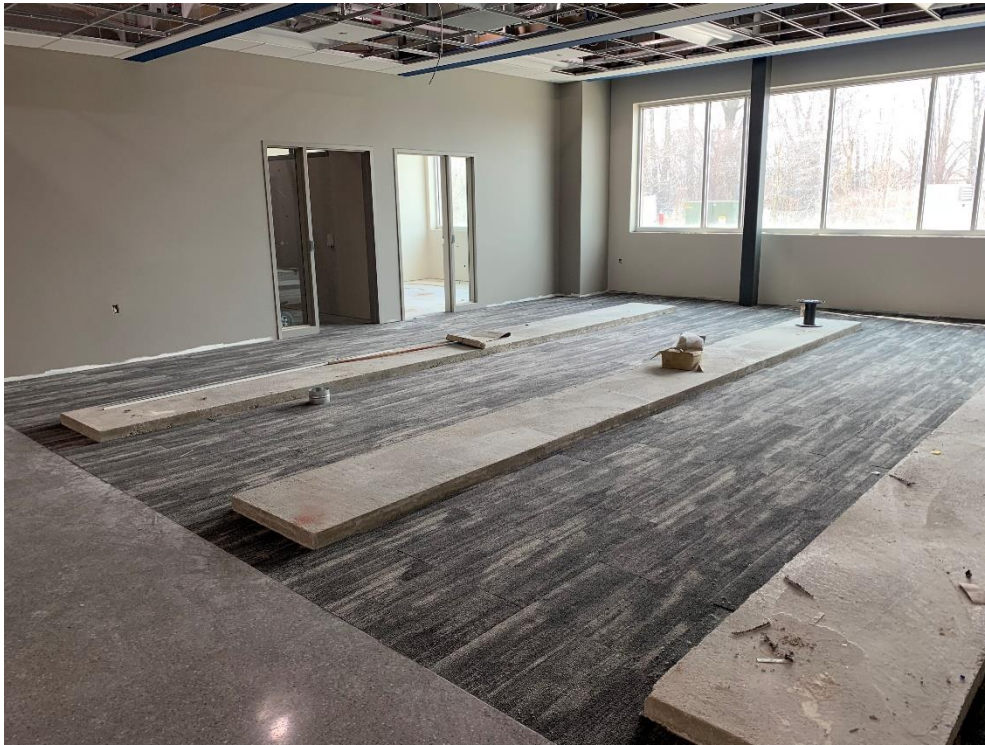
13. Area 3 – Carpet install in locker alcoves in progress.

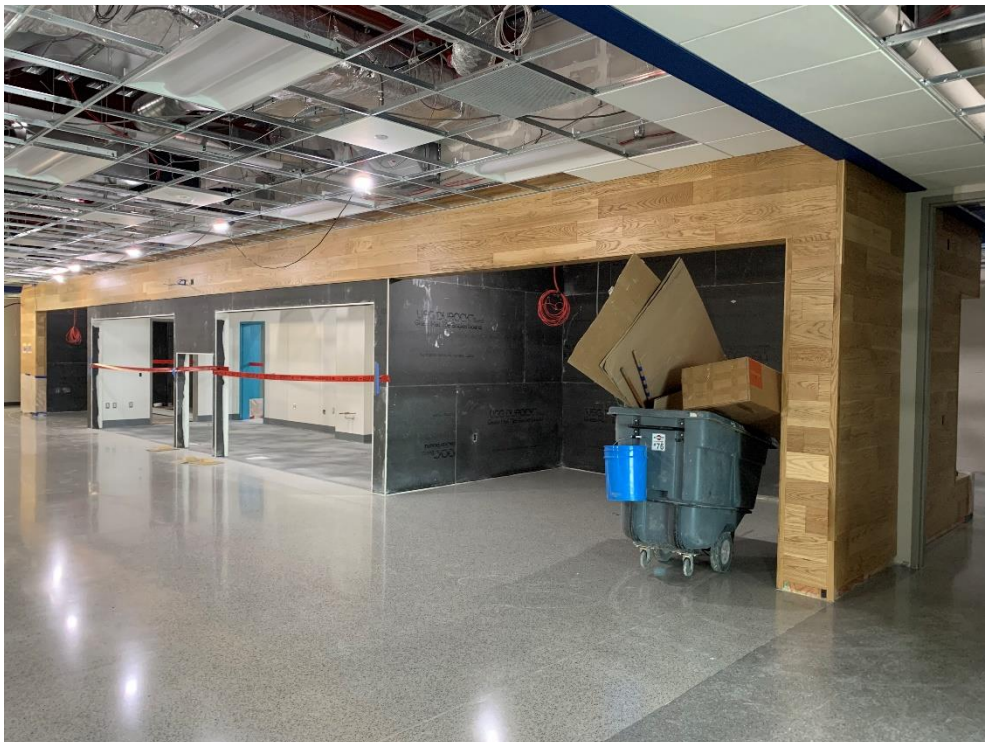
14. Area 3 – Progress photo of first floor server. Epoxy flooring install in progress.

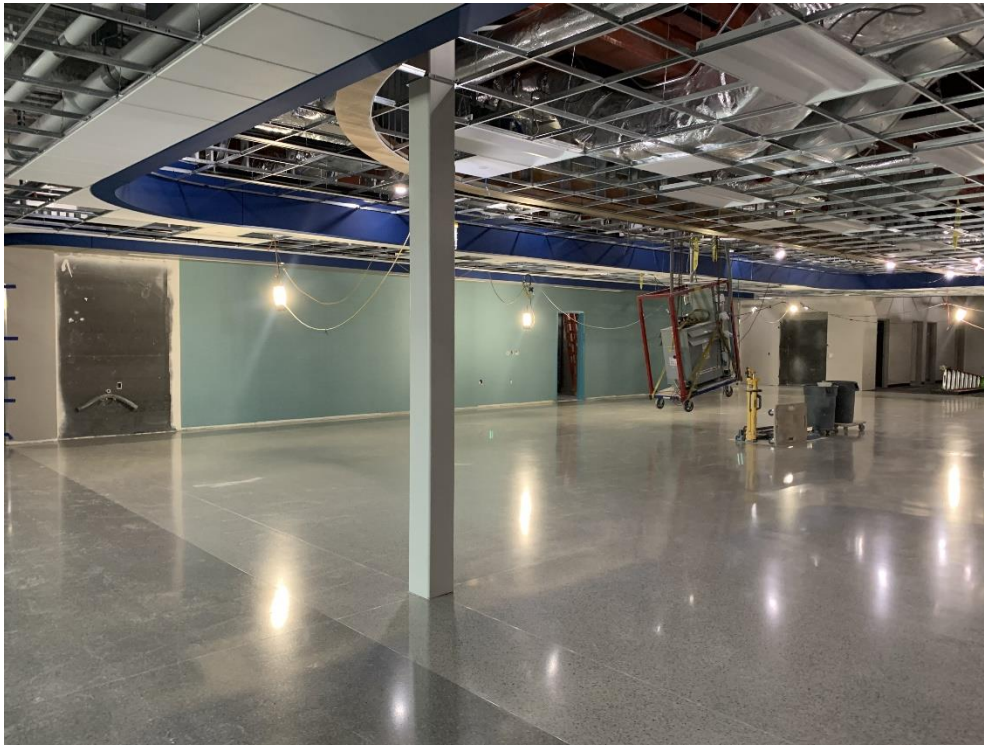
15. Area 3 – Progress photo of first floor flex café. Terrazzo flooring appears to be installed.

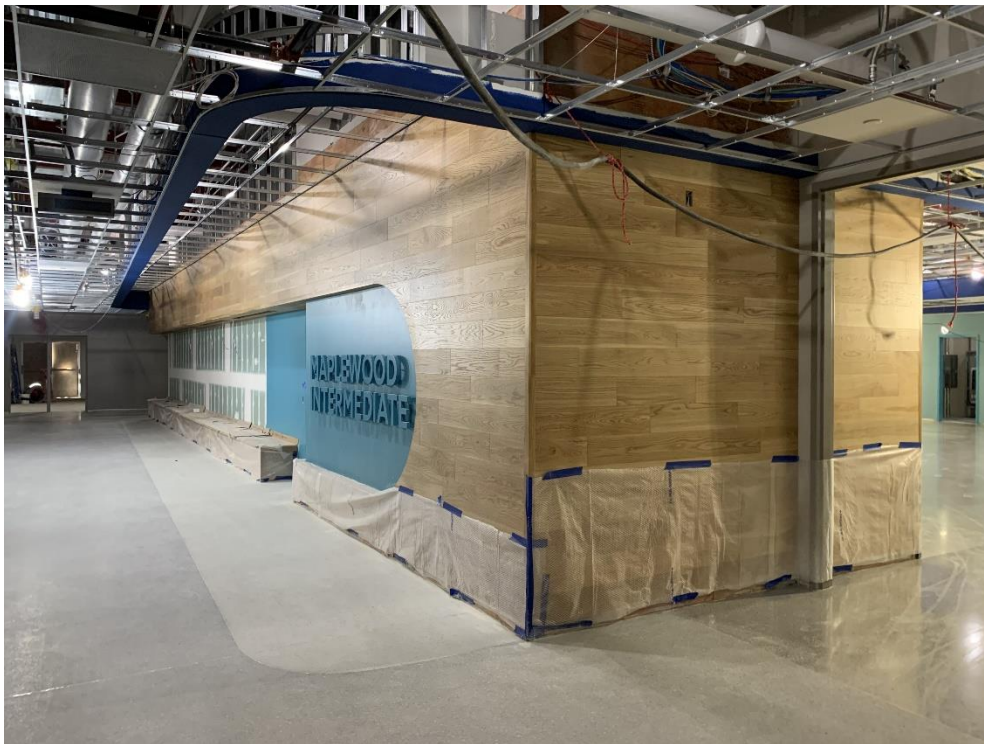
16. Area 3 – Terrazzo flooring in corridor appears to be installed. Dimensional letters at feature wall appear to be installed.

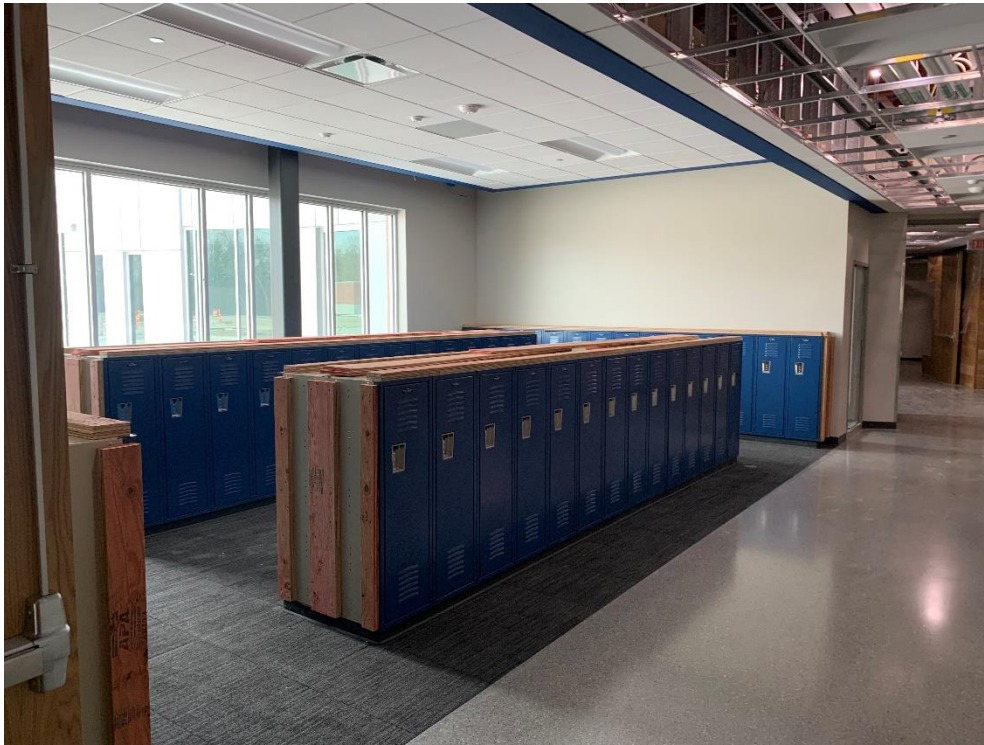
17. Area 5 – Wood blocking for solid surface locker surrounds appear to be installed.

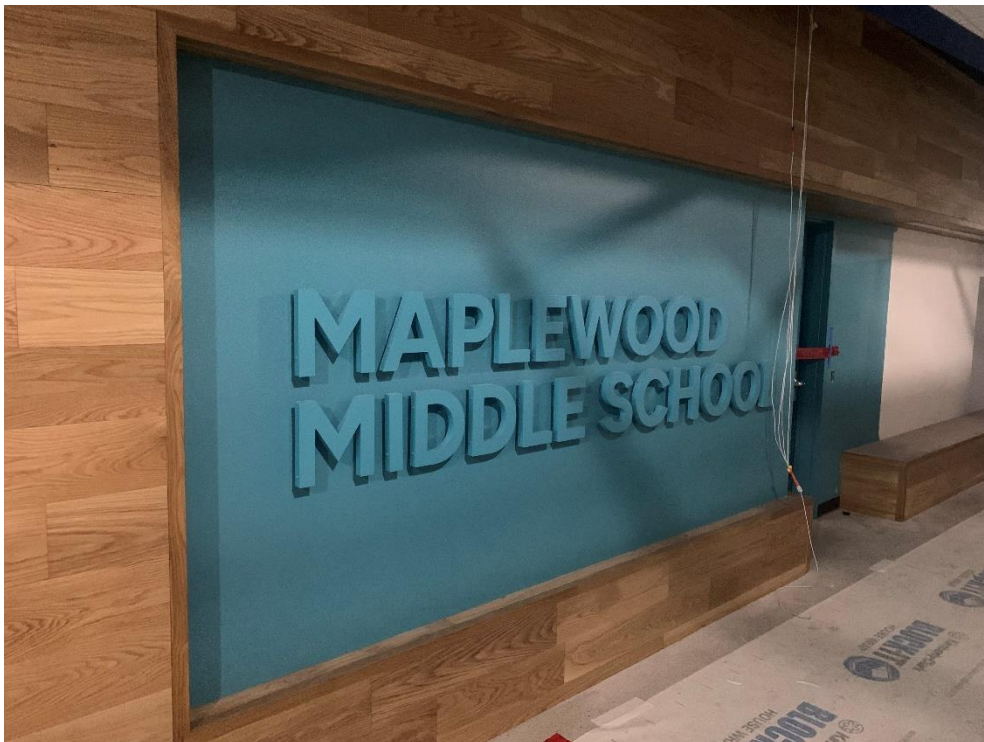
18. Area 6 – Dimensional letters at feature wall appear to be installed.

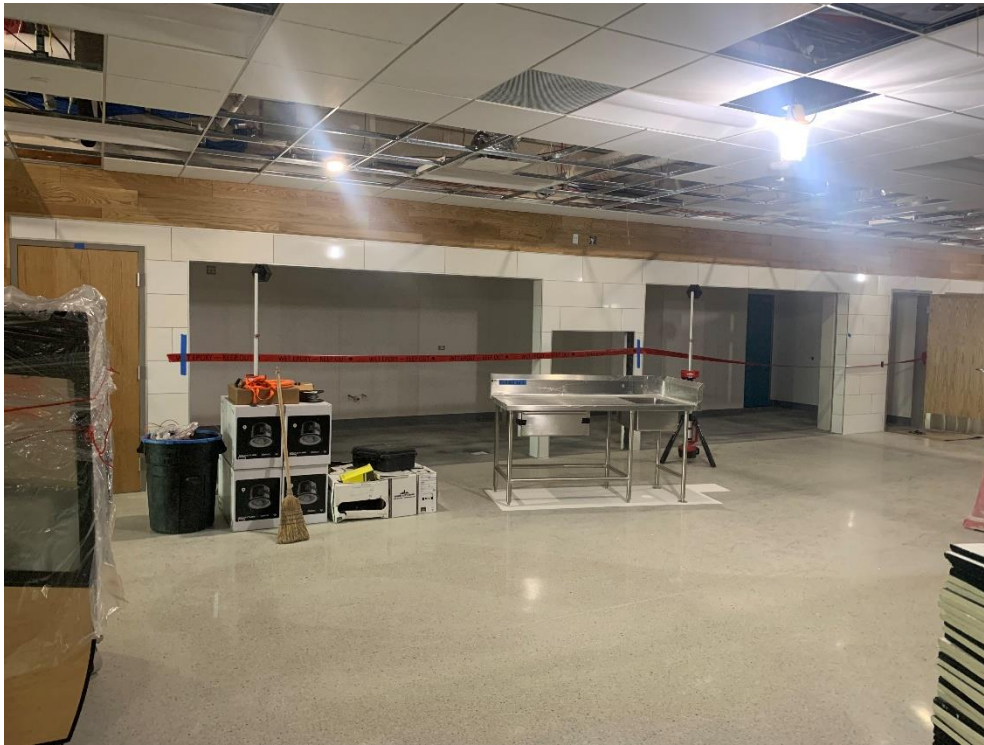
19. Area 5 – Epoxy flooring install in servery in progress.

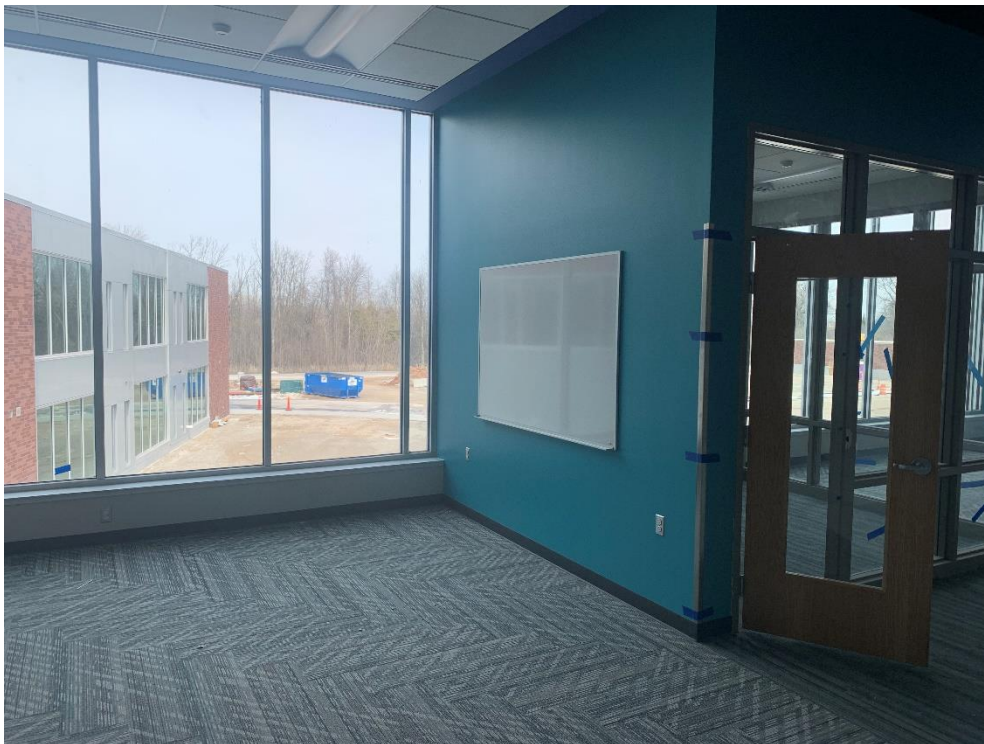
20. Area 5/6 – Corner guard and window sill install in progress throughout areas.

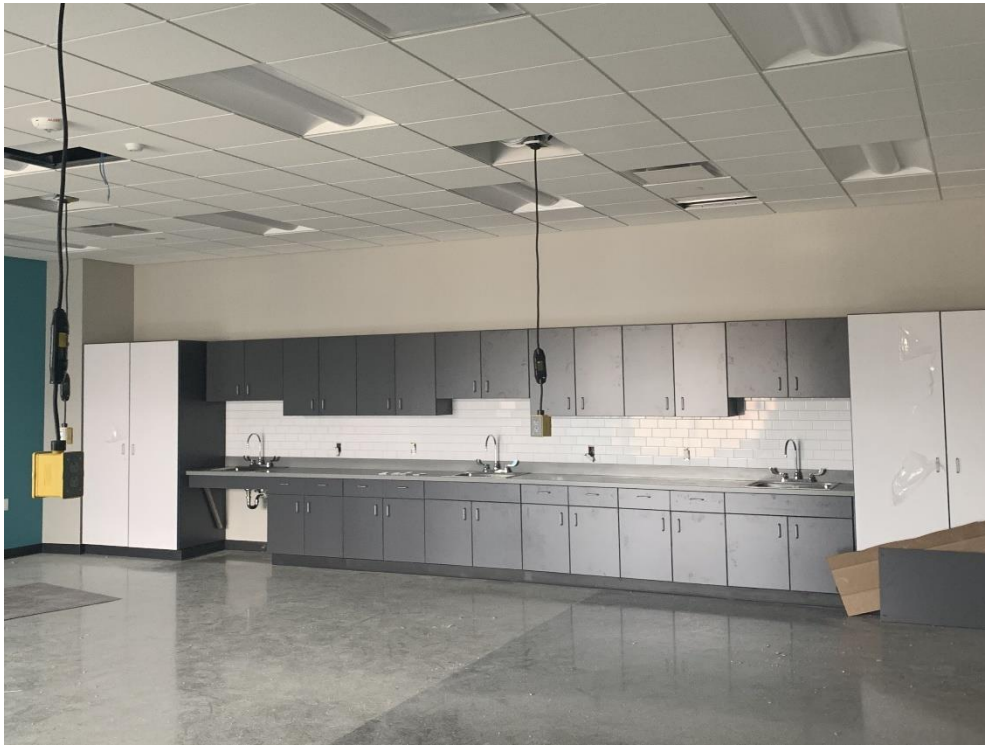
21. Area 6 – Tile backsplash at first and second floor science classrooms appears to be installed.
