Construction Observation Report 022 – January 23RD, 2025

Maplewood School

PROJECT NUMBER: 321169-01

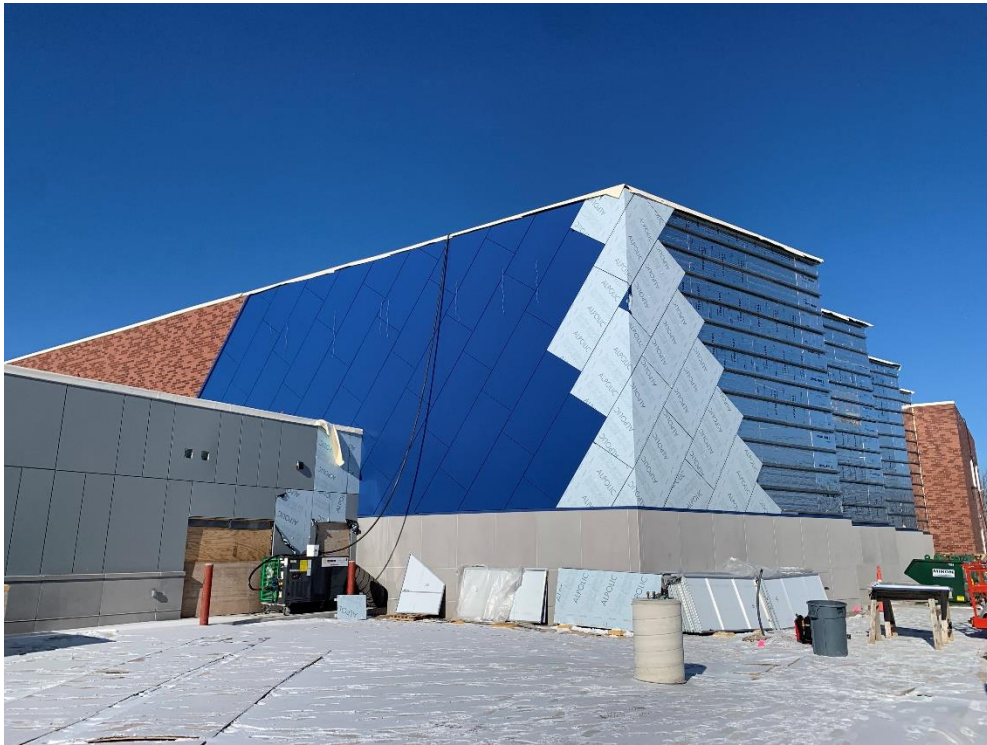
1. Area 6 South – Composite wall panel install continues.

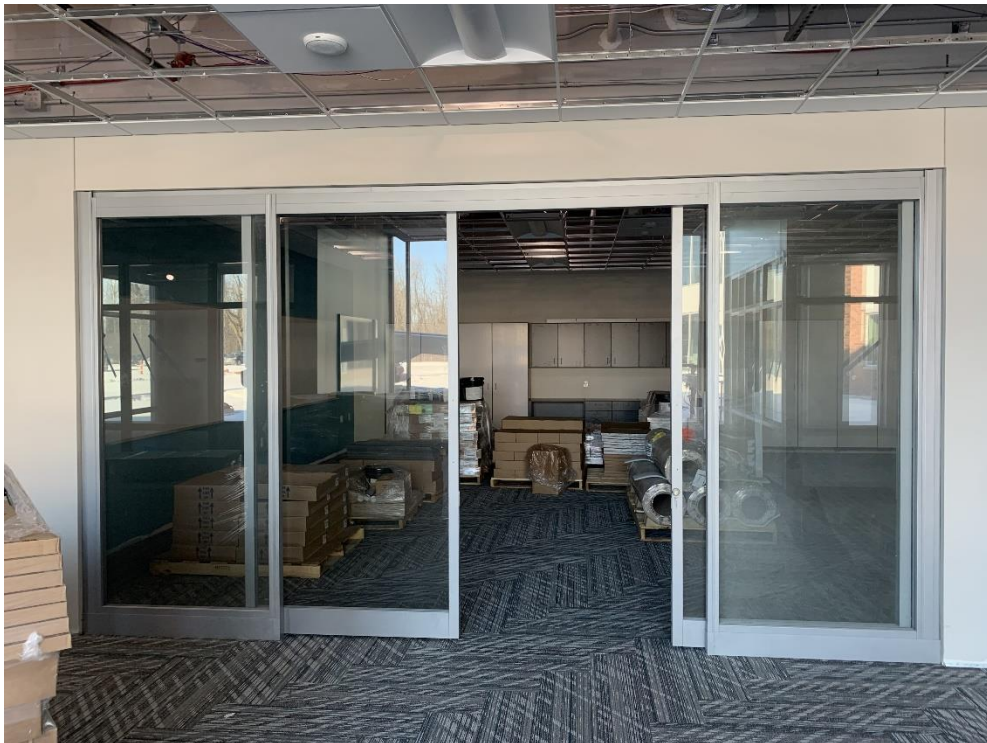
2. Area 6 – Classroom sliding door install in progress on both first and second floors.

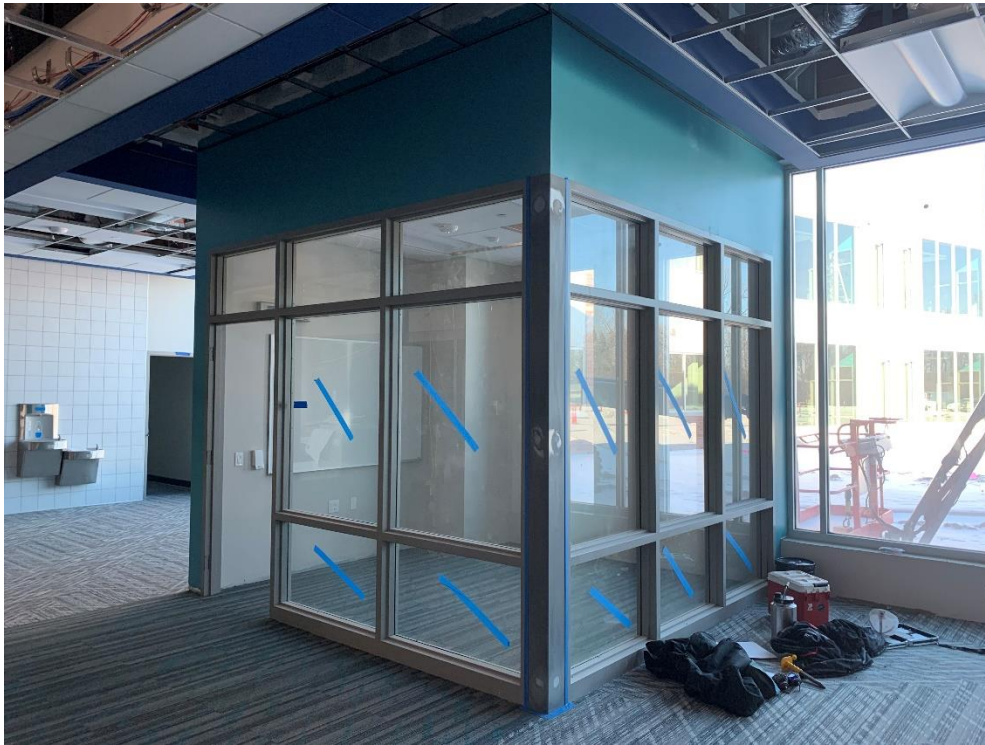
3. Area 6 – Metal closure piece install at SGI's in progress throughout grade wings.

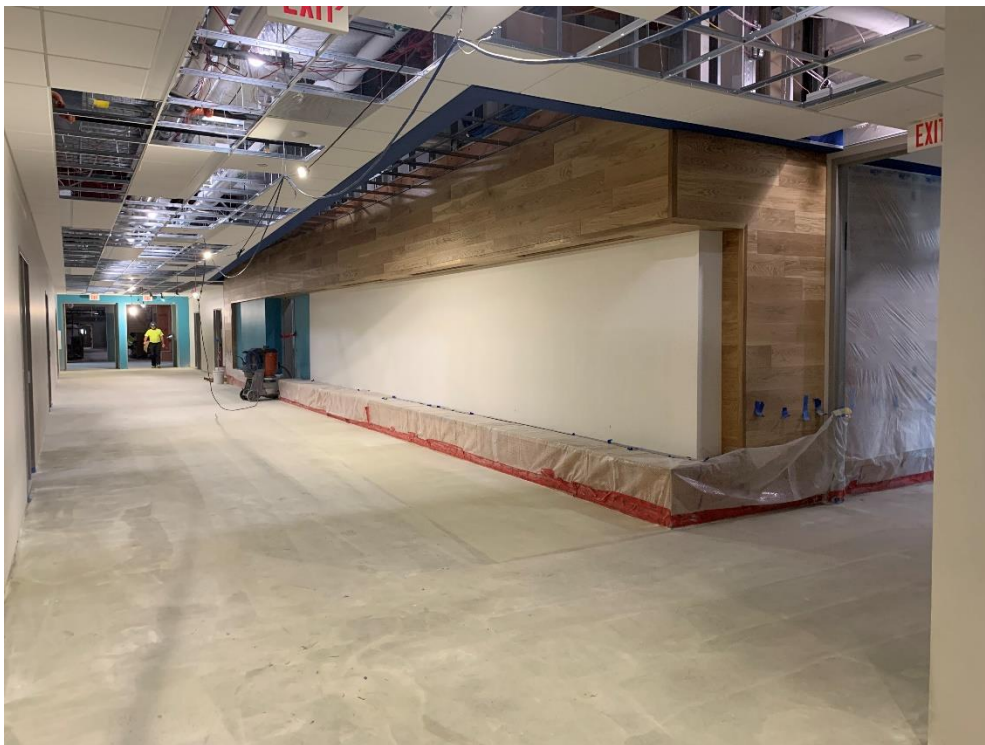
4. Area 6 – Terrazzo floor grinding in progress in first floor grade wing entry.

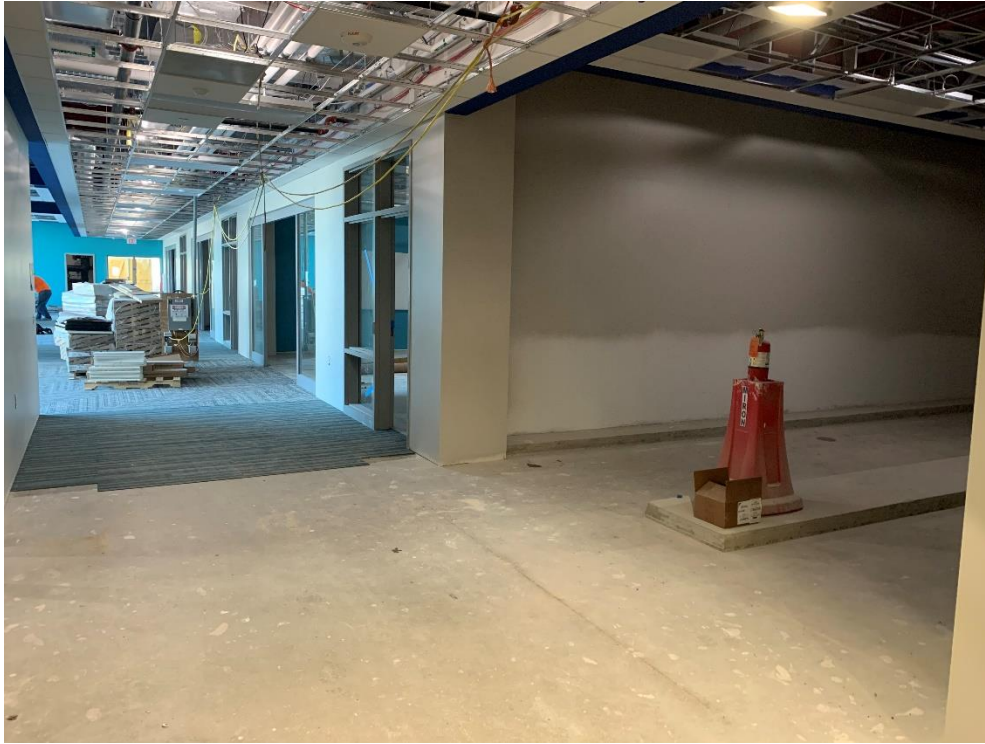
5. Area 6 – Carpet install in first floor corridor and locker alcove in progress.

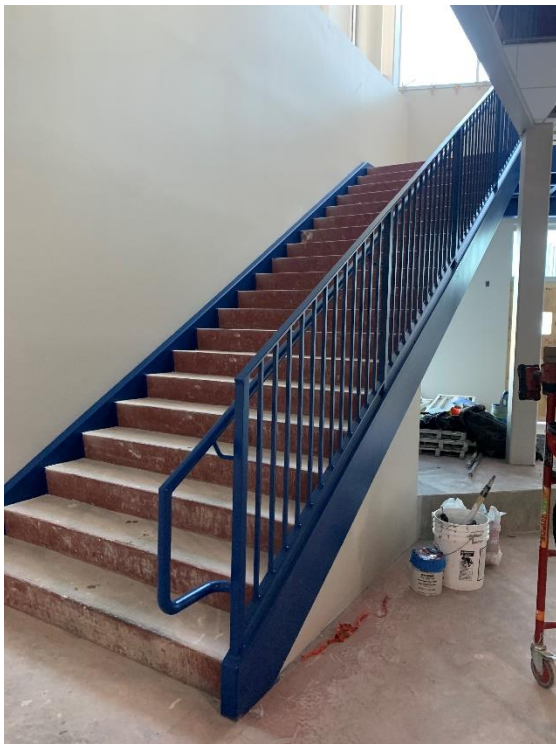
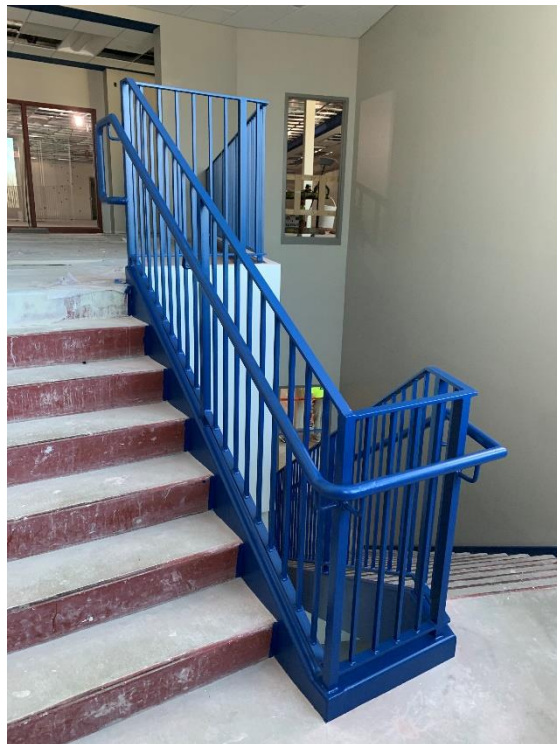
6. Area 5 – Walls and railings in knuckle stair appear to be painted.

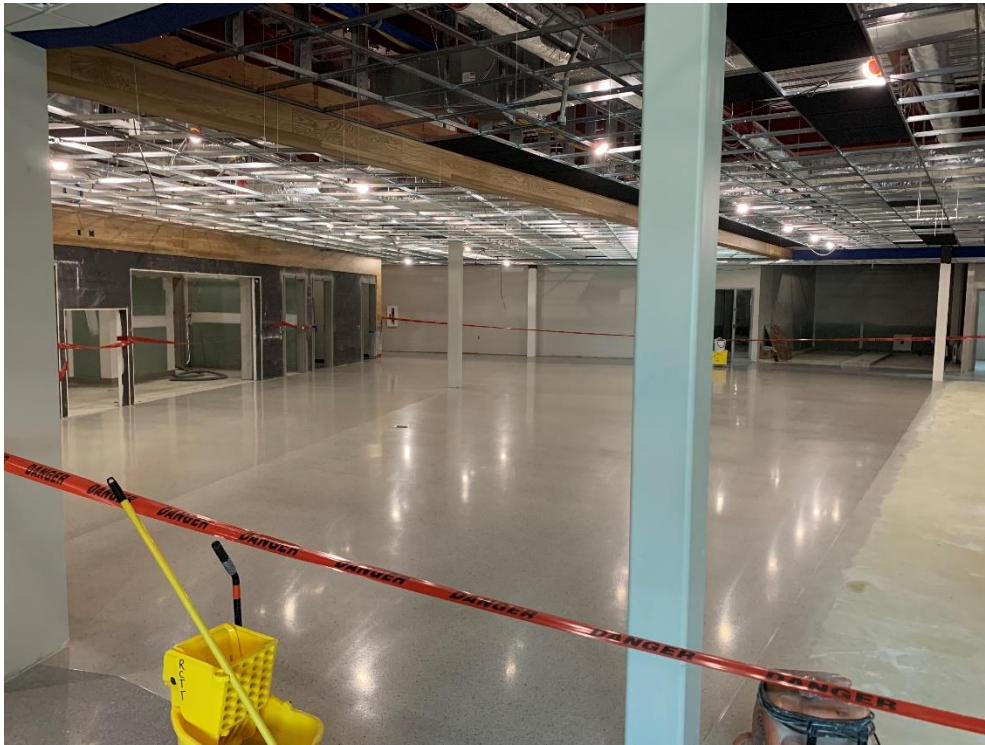
7. Area 5 –Terrazzo flooring in first floor flex café is getting sealed.

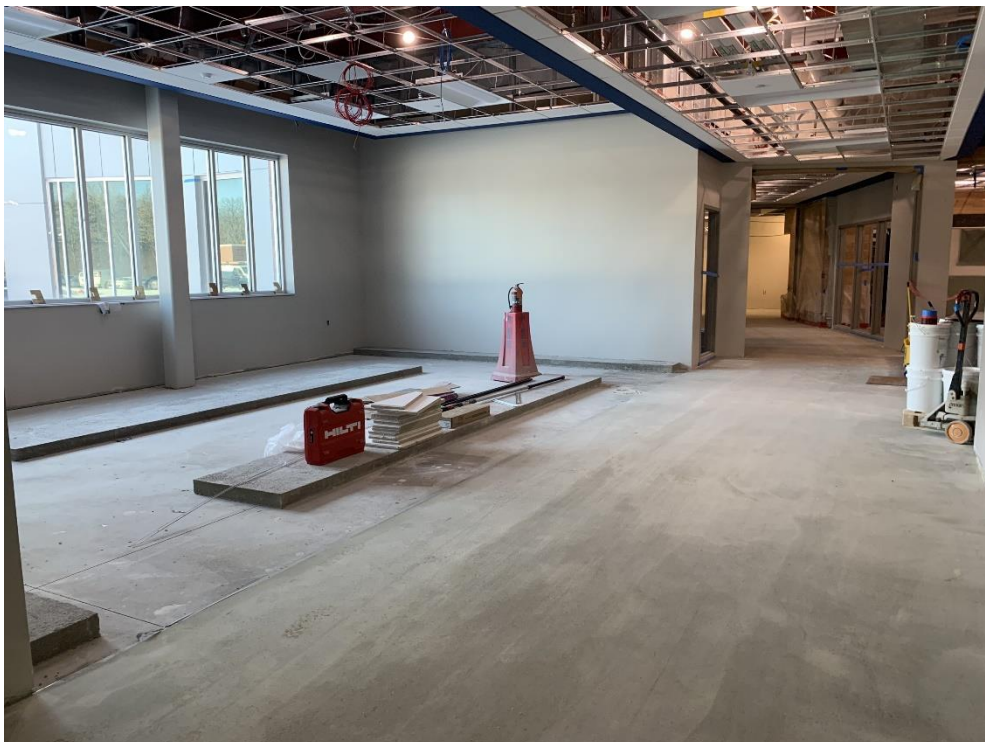
8. Area 5 – Terrazzo floor grinding in progress in first floor corridors.

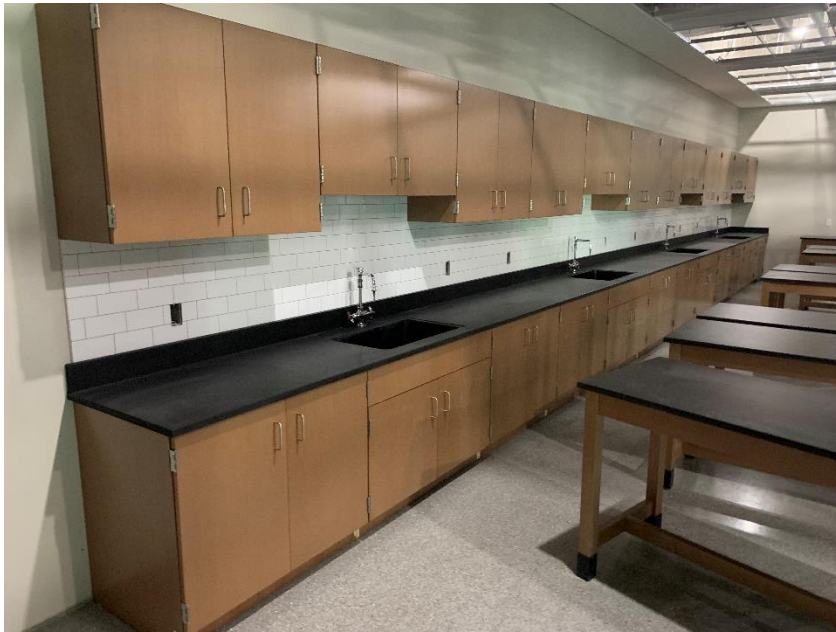
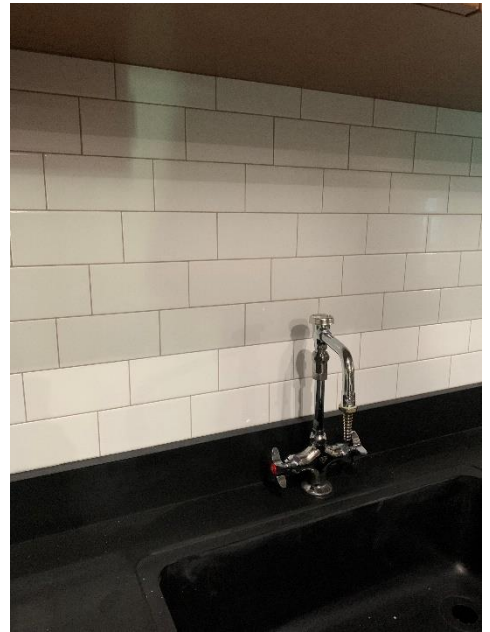
9. Area 5 – Tile backsplash in first floor science lab appears to be installed.

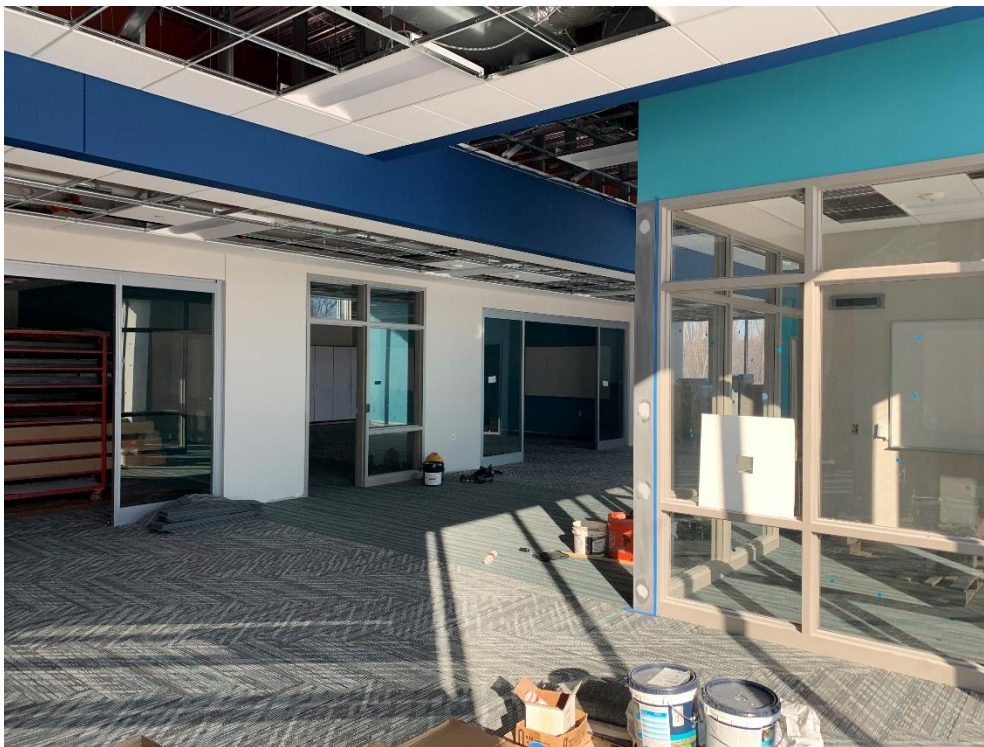
10. Area 5 – Carpet install throughout first floor grade neighborhood in progress.

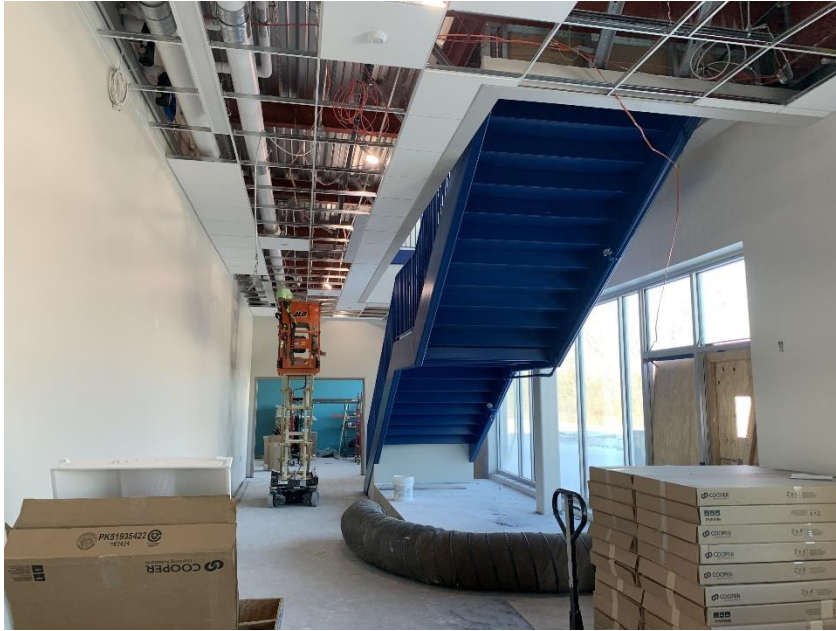
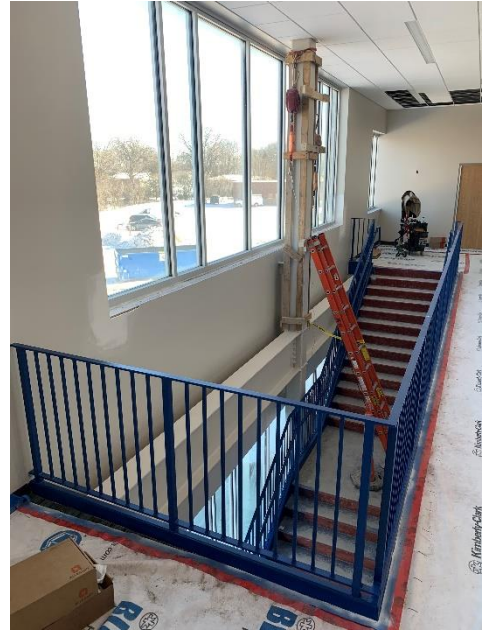
11. Area 5 – Stair, rail, and wall painting in north stair in progress.

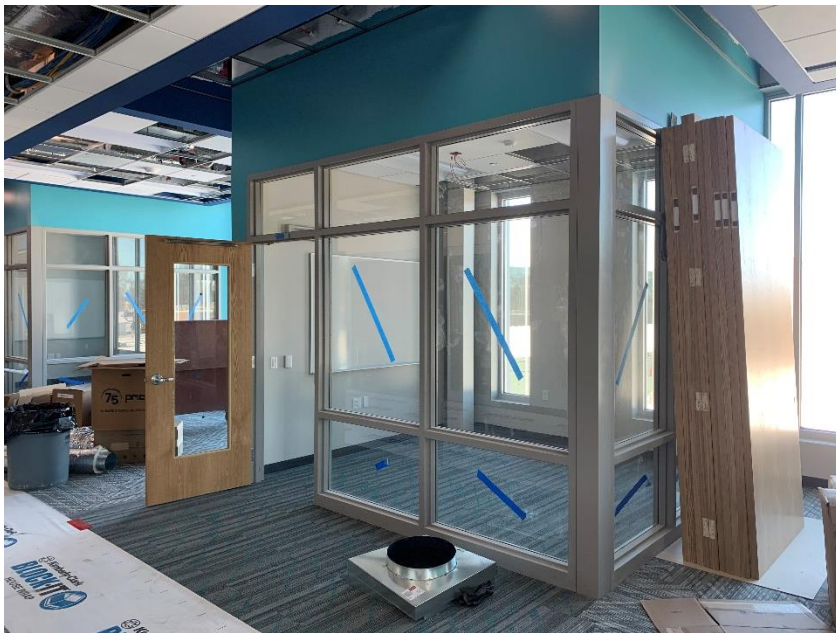
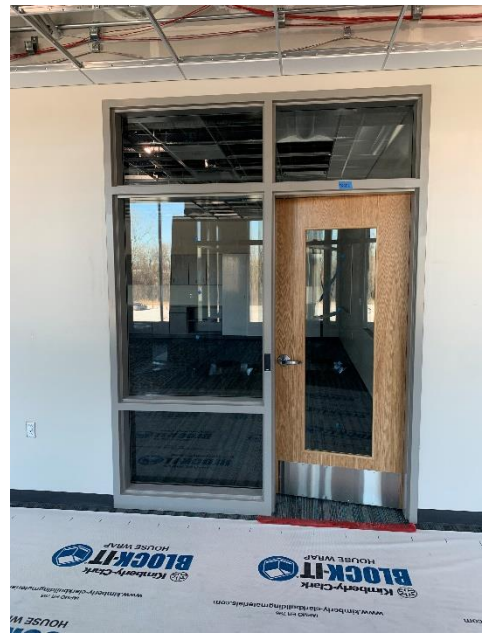
12. Area 6 – Door lite install in second floor classrooms and collab area in progress.

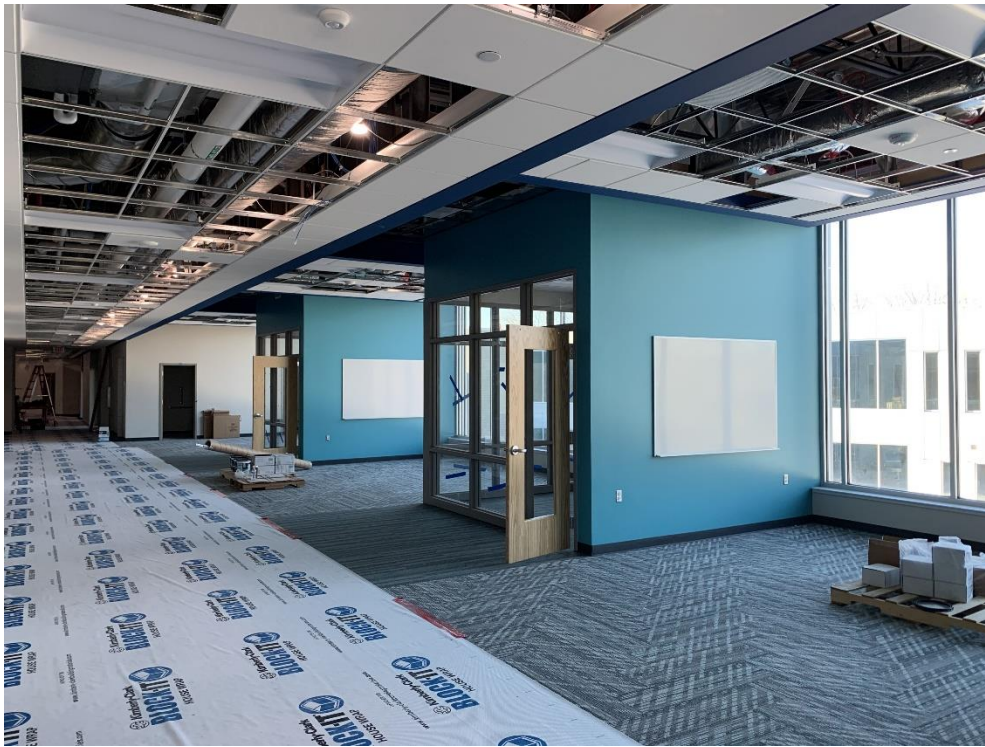
13. Area 5 – Door install in second floor grade neighborhood in progress.

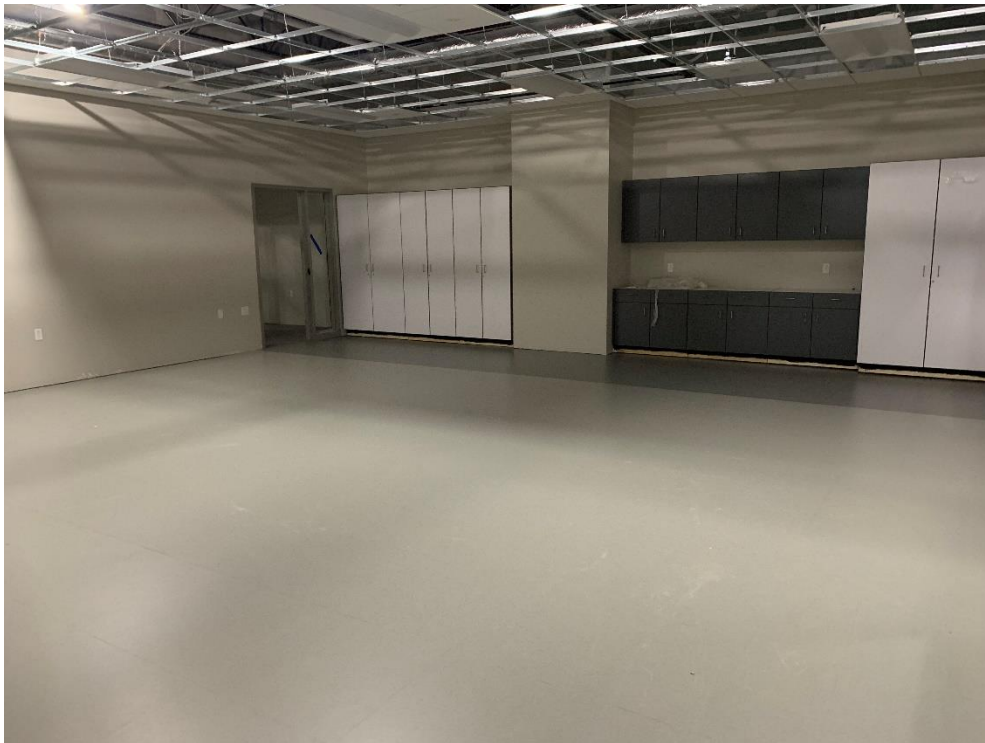
14. Area 6 – Resilient flooring in second floor EBD rooms appear to be installed.

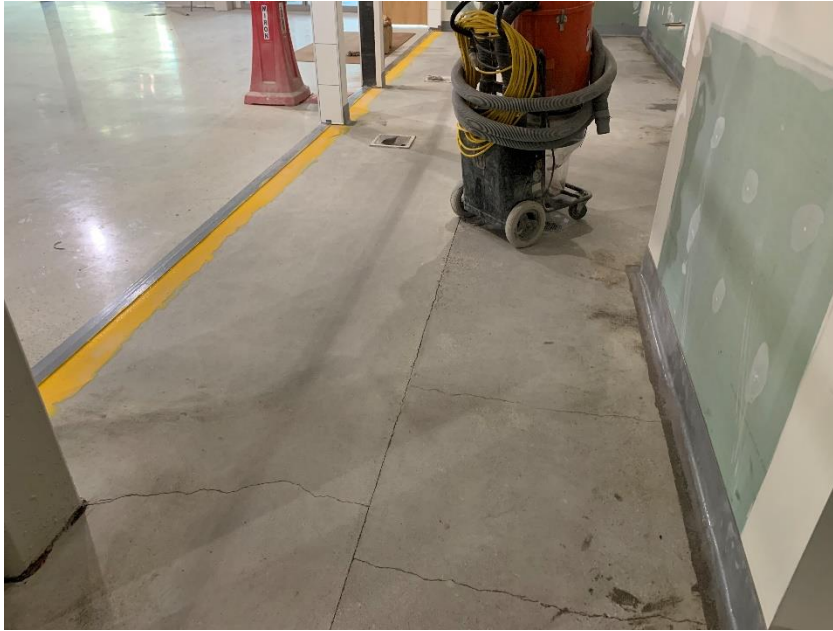
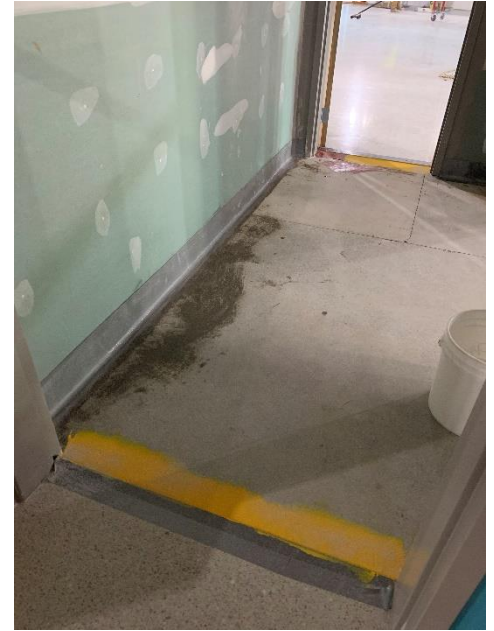
15. Area 5 – Epoxy floor install in second floor servery in progress.

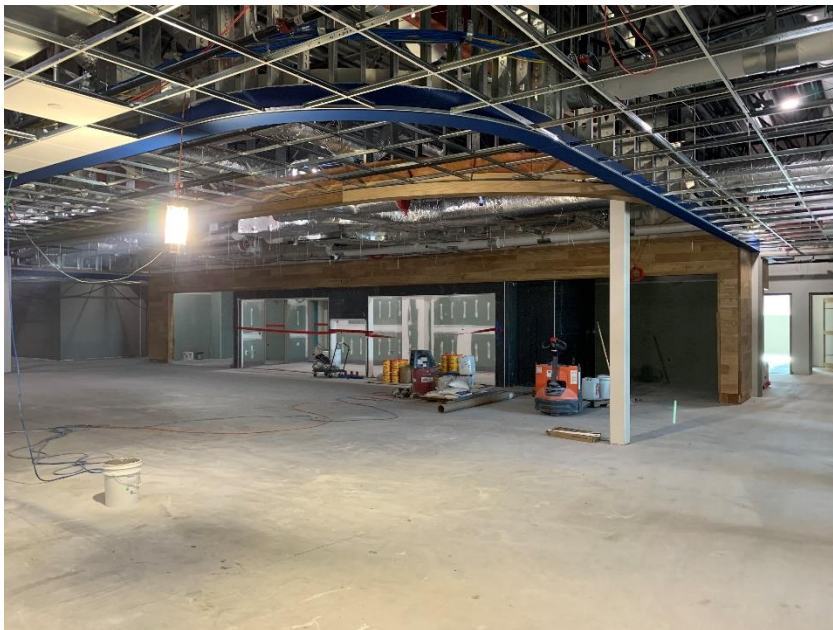
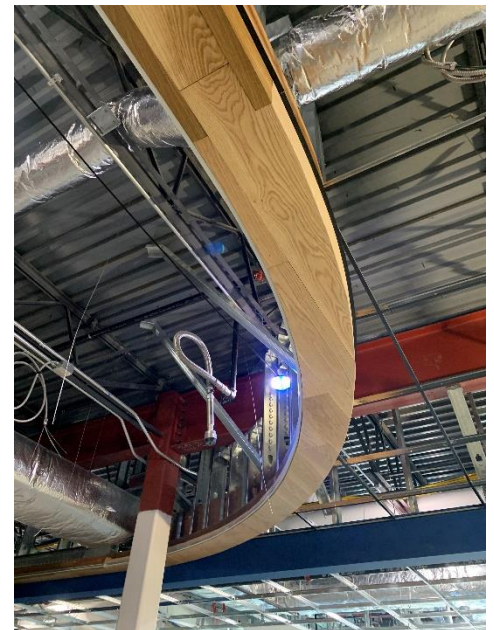
16. Area 3 – Wood plank install in second floor flex café in progress.

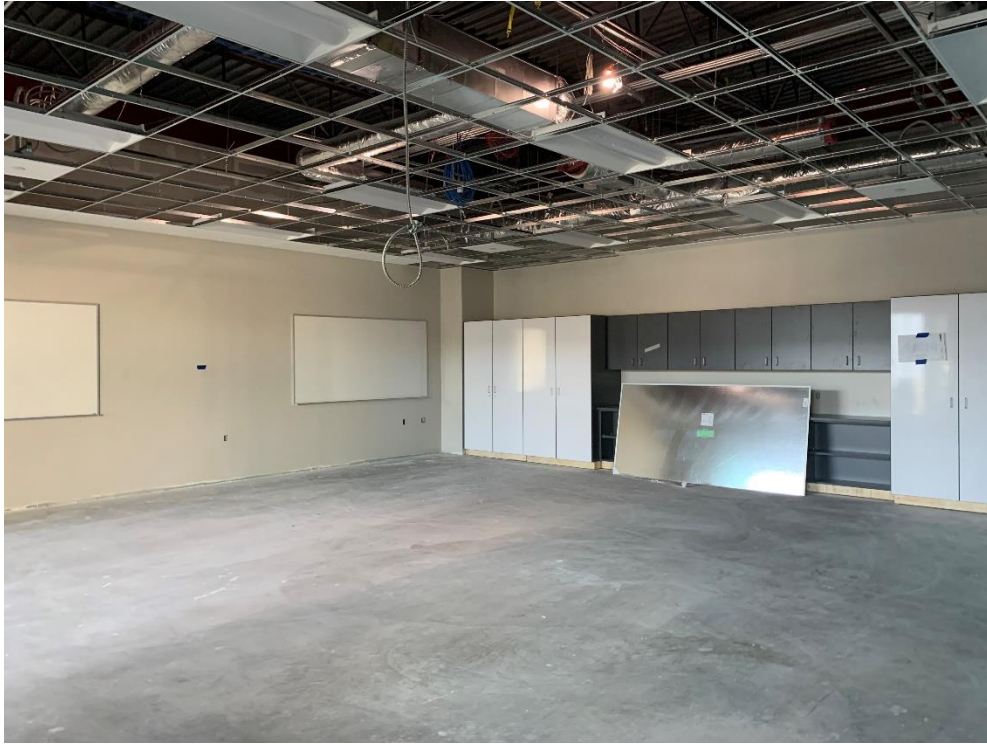
17. Area 4 – Marker board install in second floor classrooms in progress.

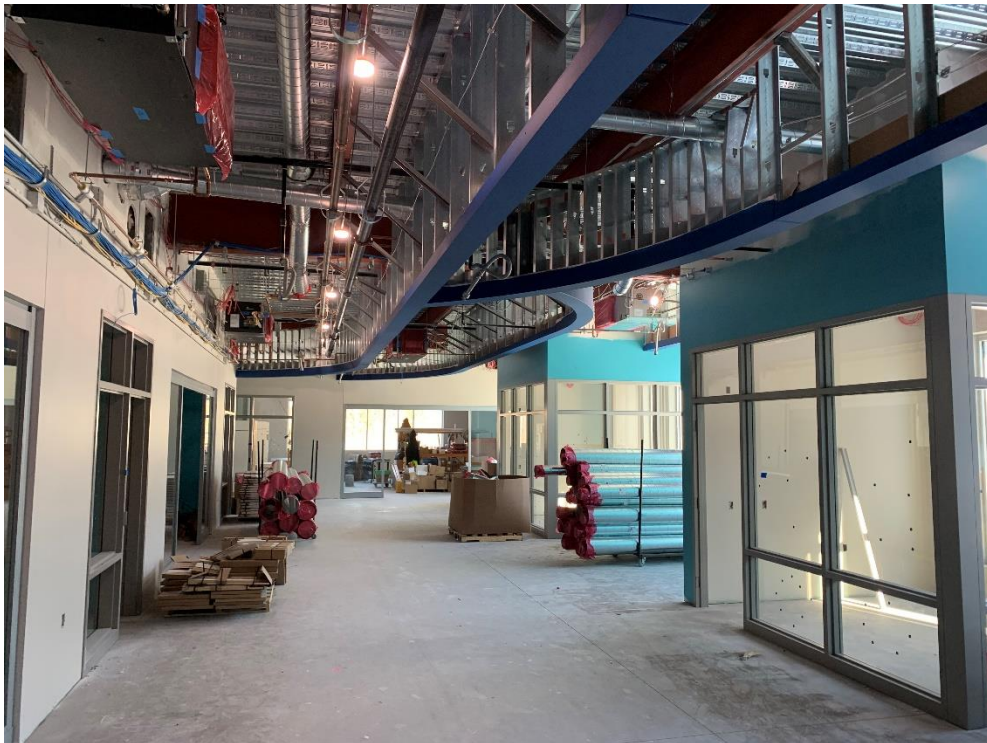
18. Area 4 – First floor grade neighborhood is painted.

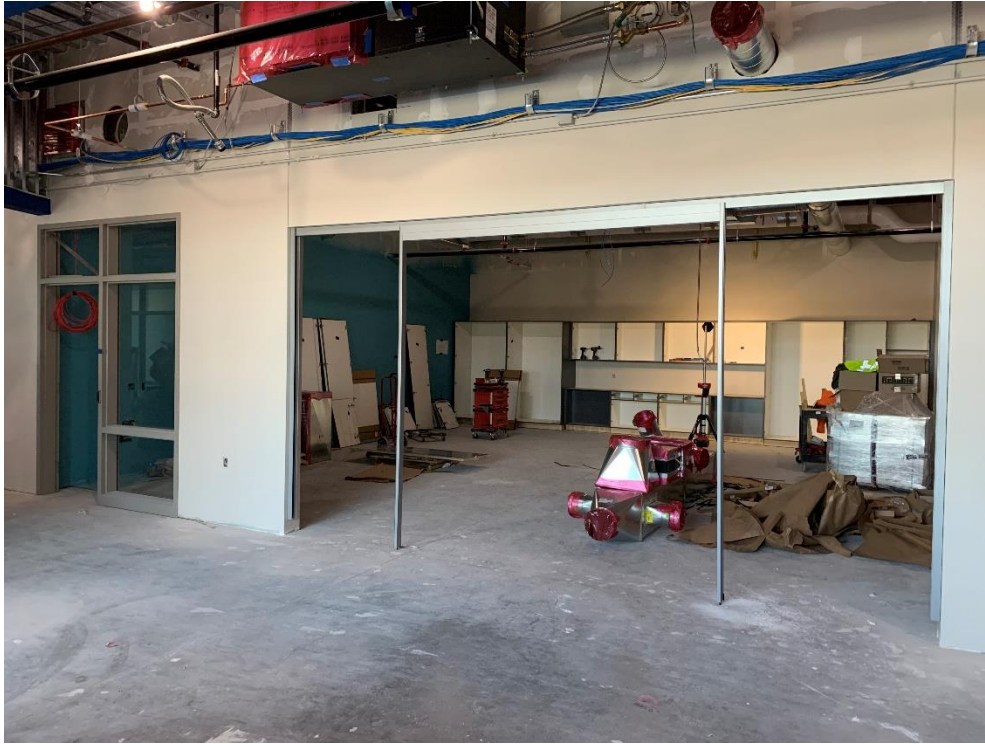
19. Area 4 – Casework and sliding door system install in first floor grade neighborhood in progress.

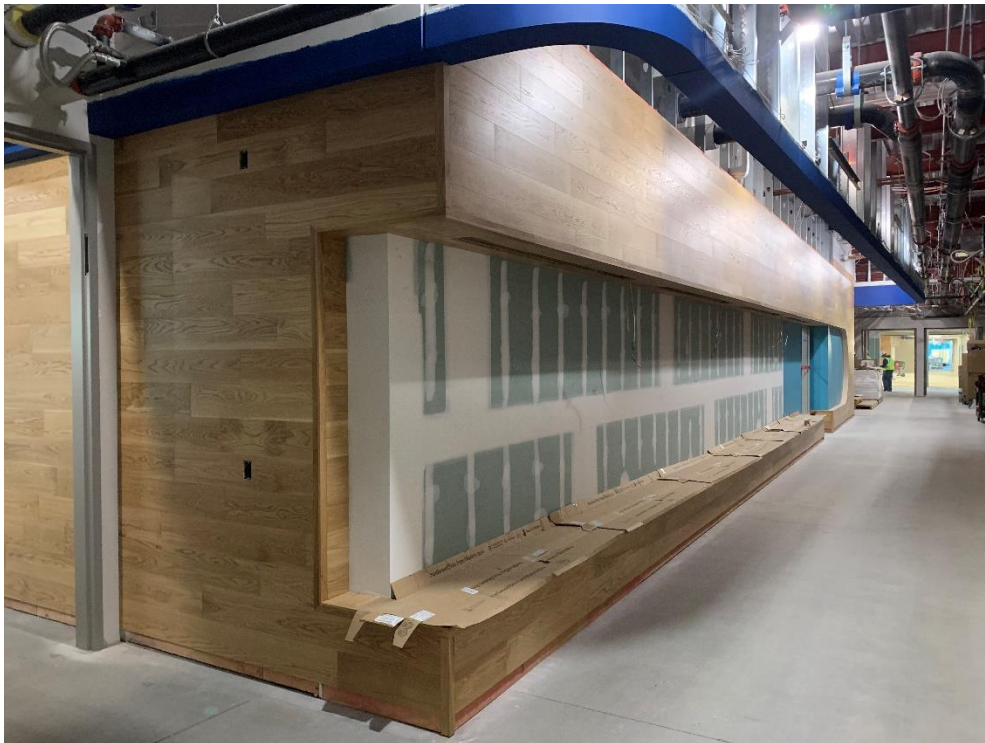
20. Area 3 – Wood plank on first floor grade wing entry appears to be installed.

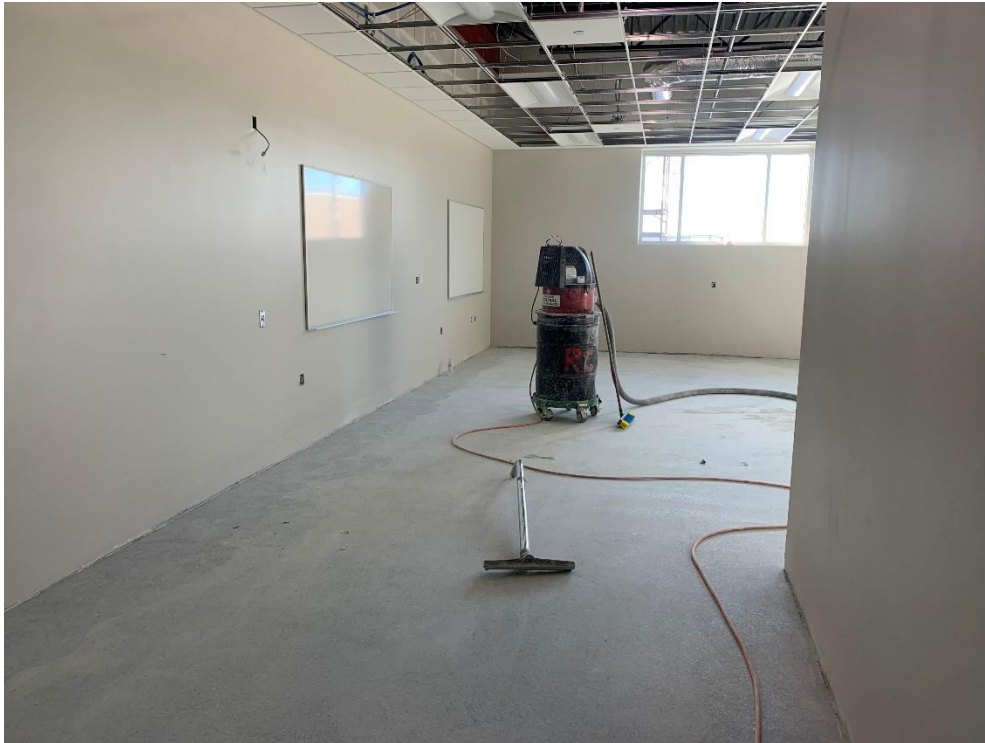
21. Area 3 – Terrazzo floor install in second floor art rooms in progress.

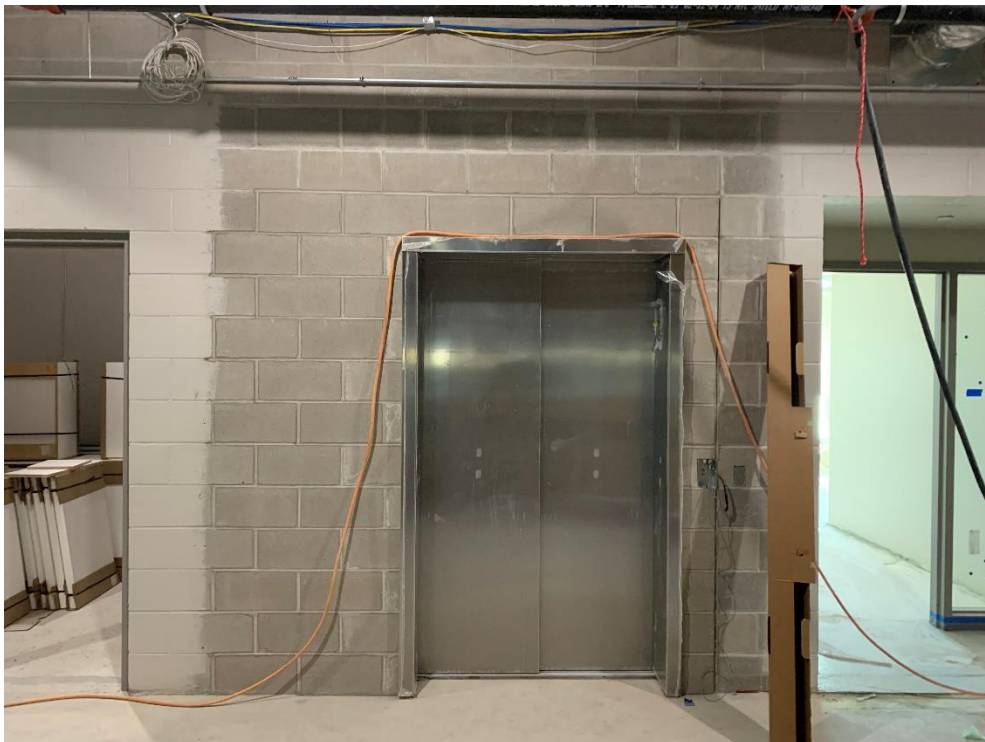
22. Area 3 – Elevator doors in first and second floor corridors appear to be installed.

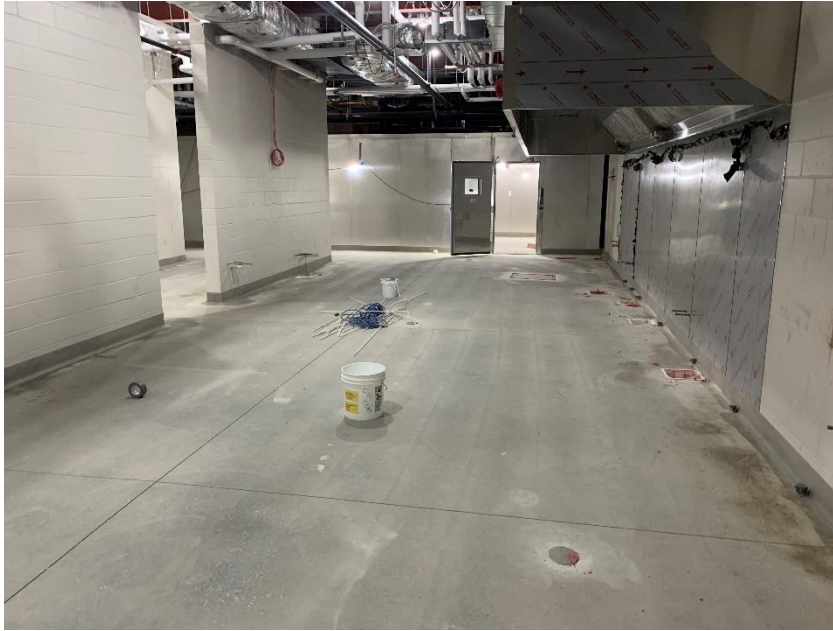
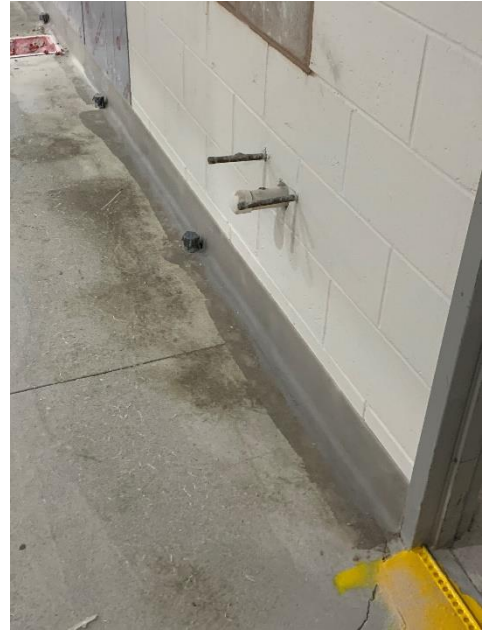
23. Area 3 – Epoxy flooring in kitchen in progress.

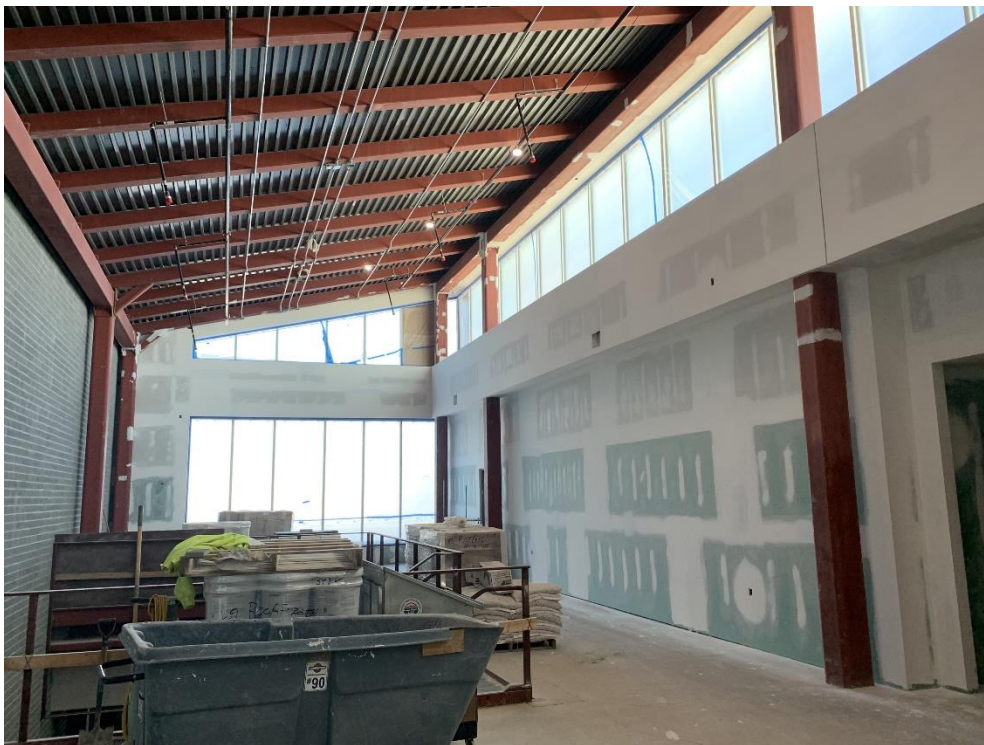
24. Area 1B – Painting in second floor center spine beginning.

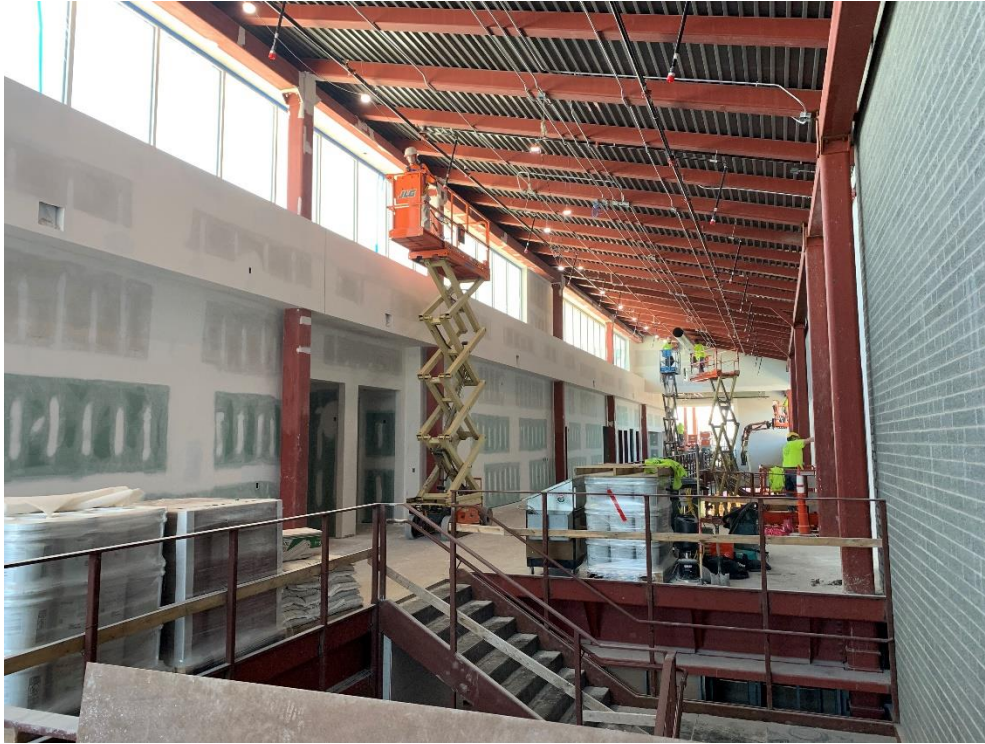
25. Area 1A – Painting in second floor center spine beginning.

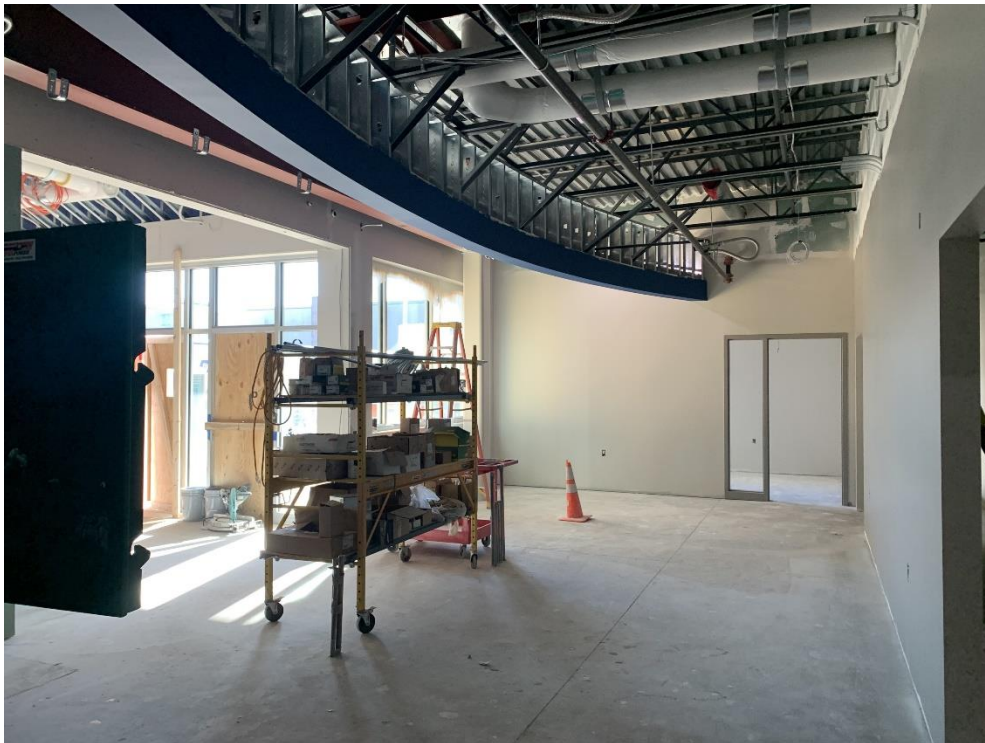
26. Area 1A – Painting in front offices in progress.

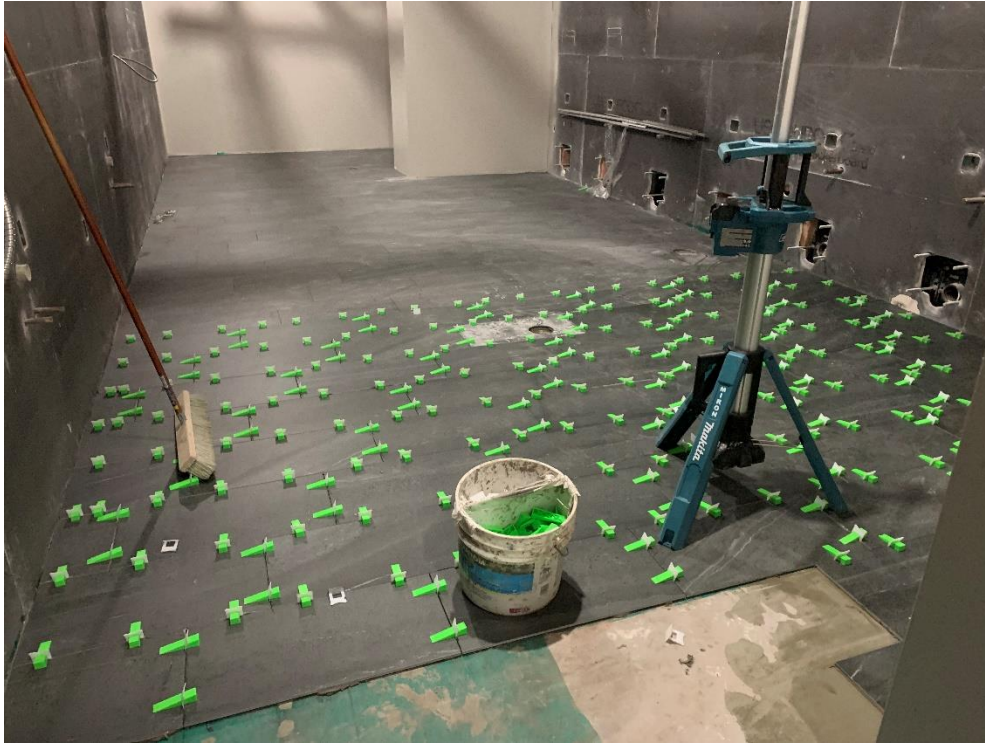
27. Area 1A – Tile flooring in toilet rooms in progress.

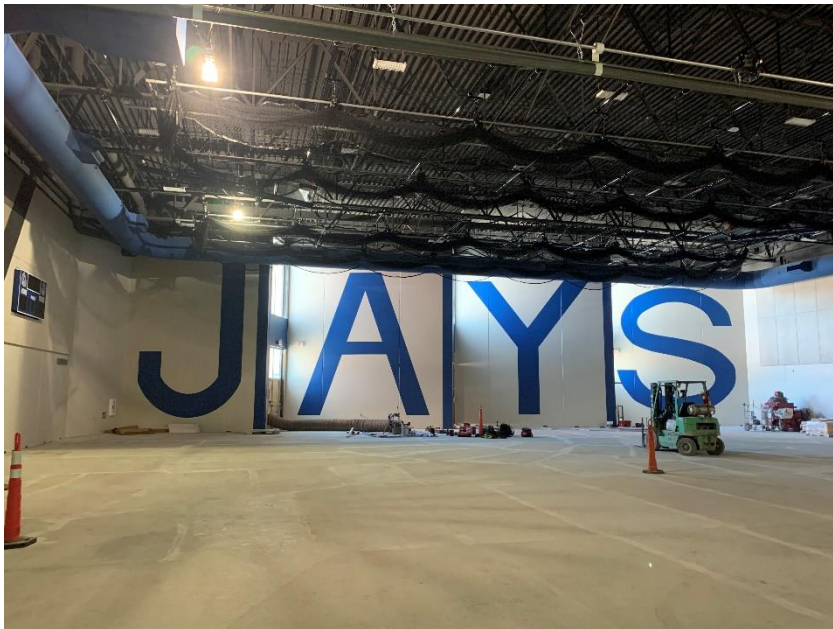
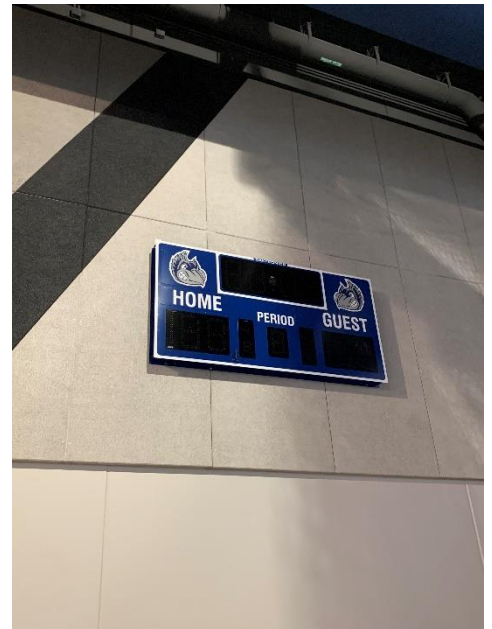
28. Area 6 – Painted letters in progress. Score boards appear to be installed.

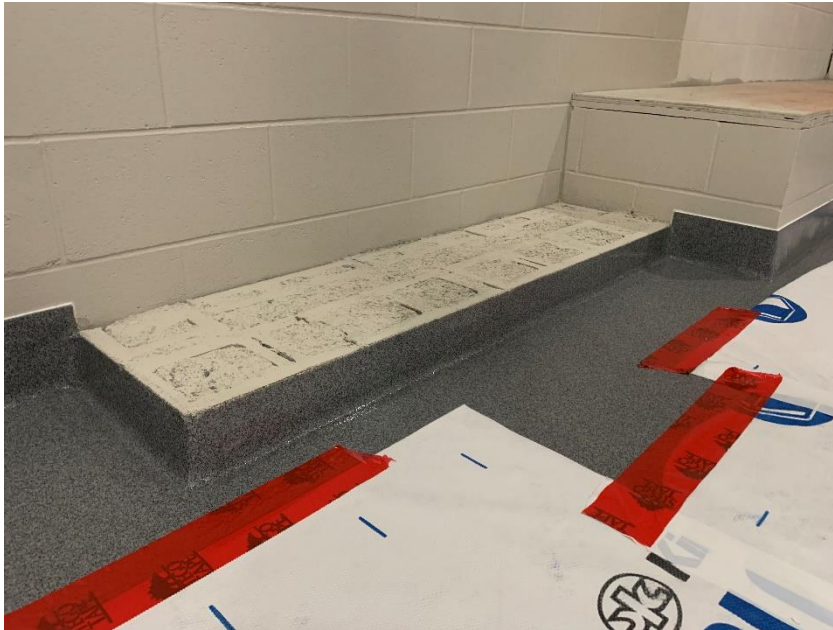
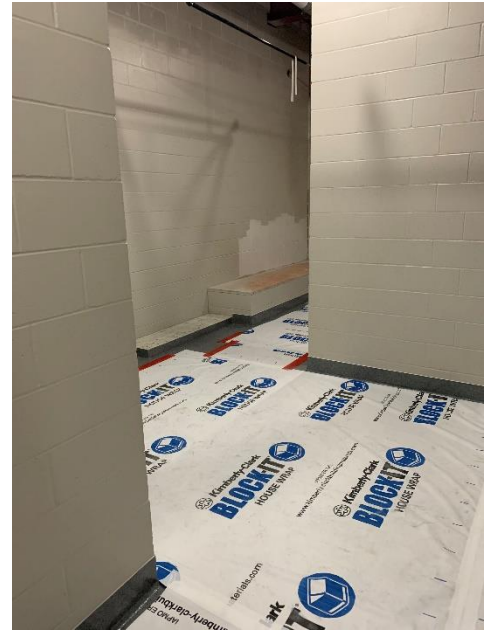
29. Area 6 – Epoxy floor appears to be installed in locker rooms.
