Construction Observation Report 022 – January 23RD, 2025

Maplewood School

PROJECT NUMBER: 321169-01

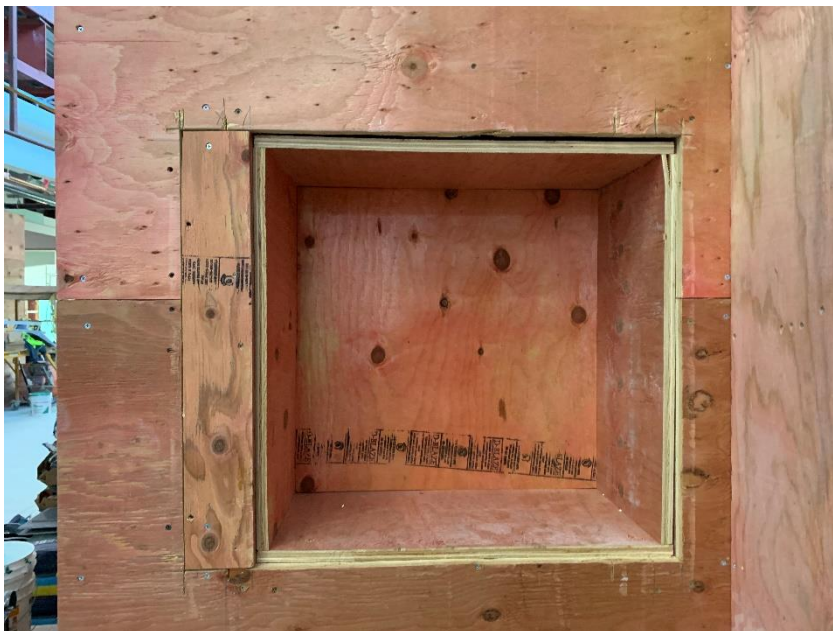
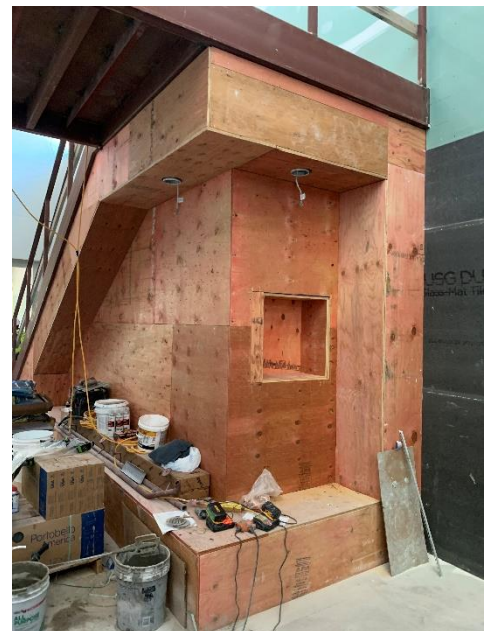
30. Area 1A – Recess for time capsule has been framed out.
