Construction Observation Report 023 – February 5th, 2025

Maplewood School

PROJECT NUMBER: 321169-01

OWNER:	MENASHA JOINT SCHOOL DISTRICT
From ARCHITECT/ENGINEER:	EUA
To CONTRACTOR	MIRON CONSTRUCTION CO, INC
SITE OBSERVATION TYPE	ARCHITECTURAL
DATE OF ISSUANCE:	February 18, 2025

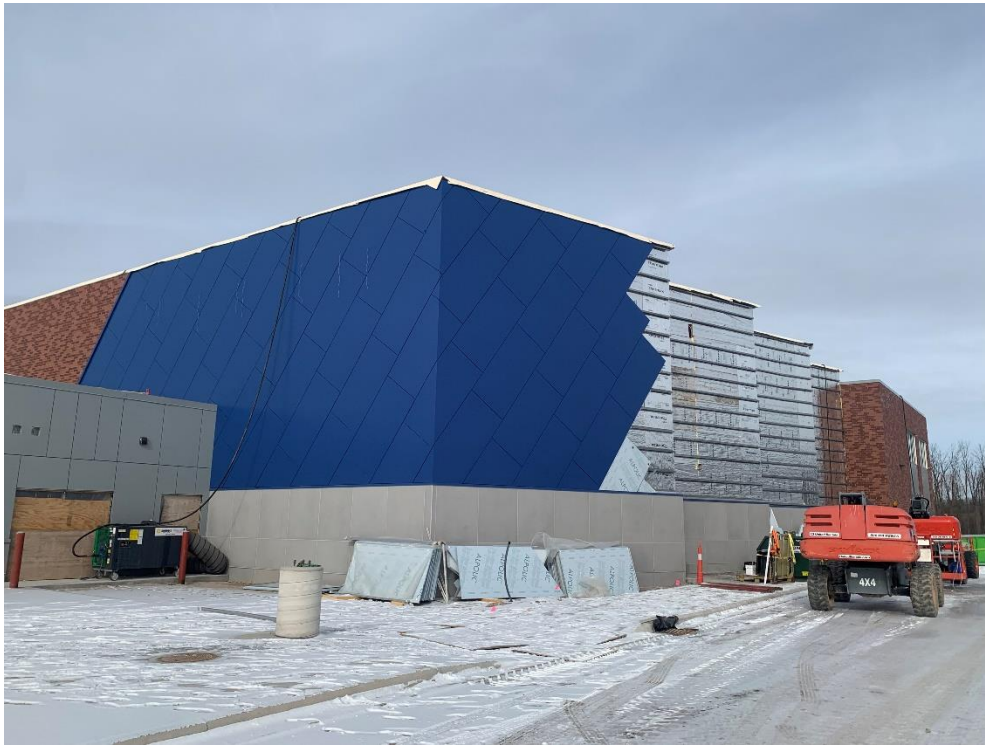
1. Area 6 South – Composite wall panel install continues.

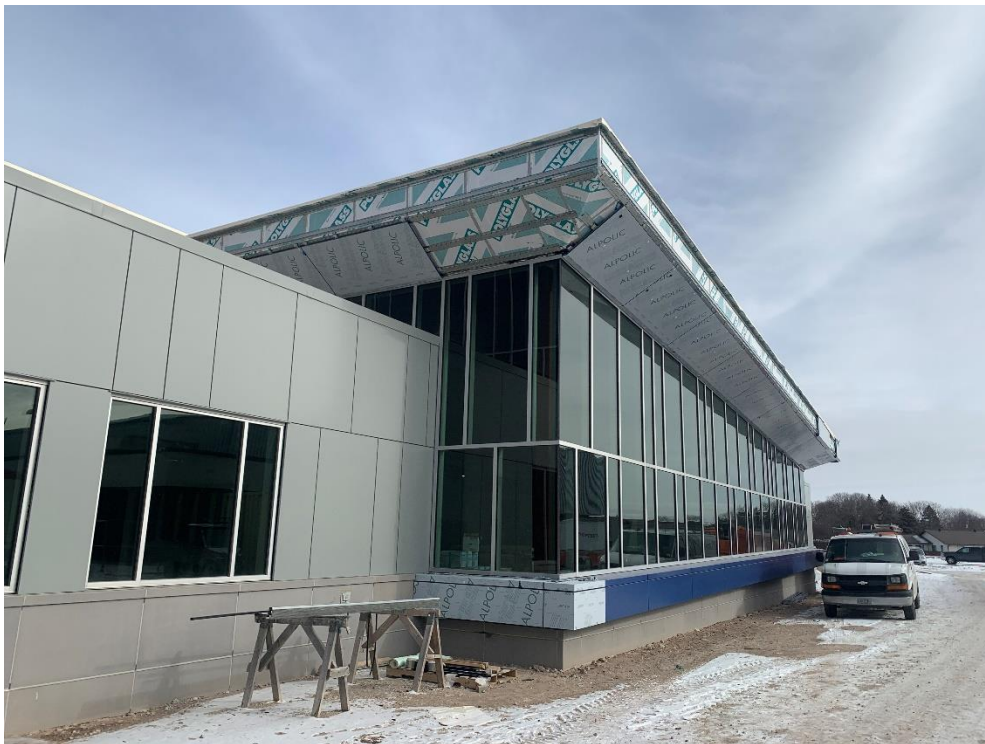
2. Area 2B – Composite wall panel install on upper soffit at Fitness Room continues.

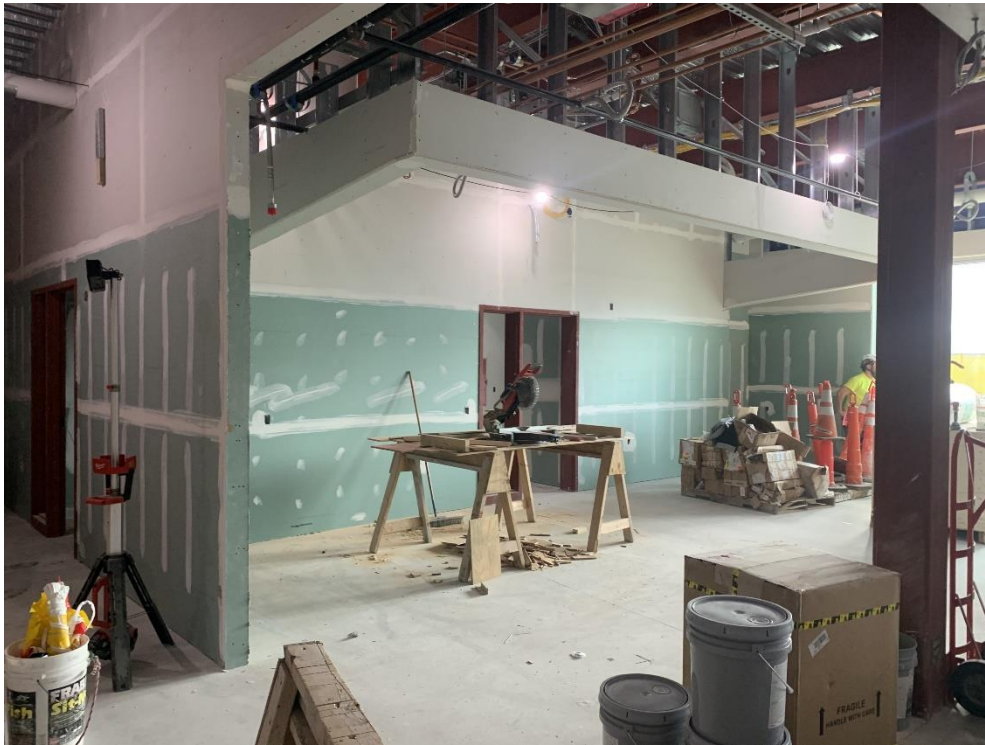
3. Area 2B – Taping and mudding in the 7/8 front office continues.

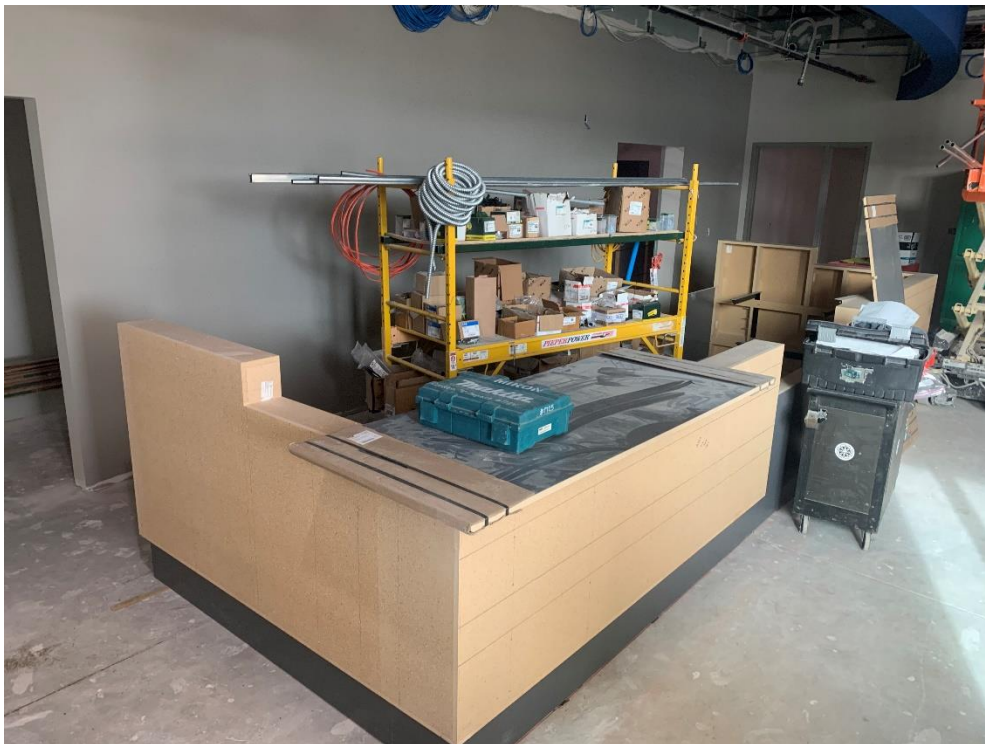
4. Area 1A – Casework and reception desk install in progress.

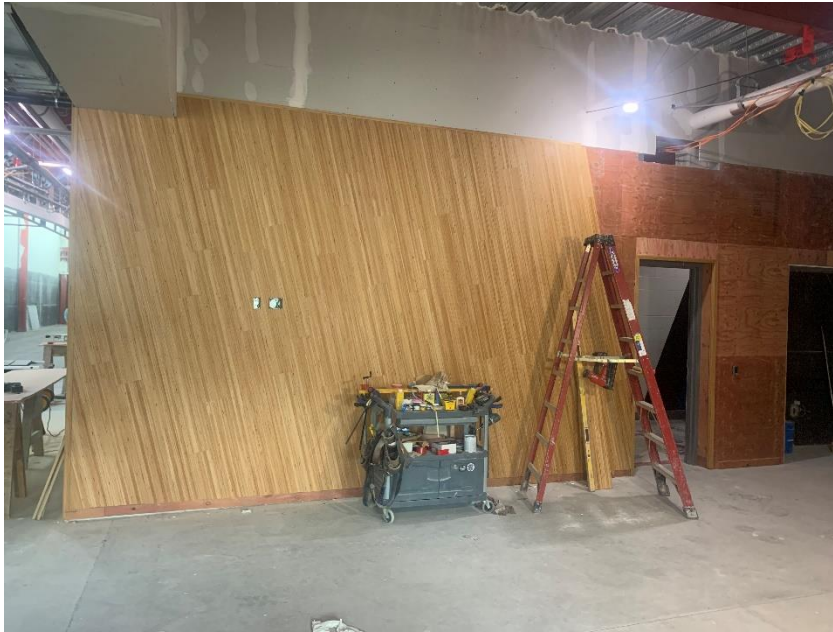
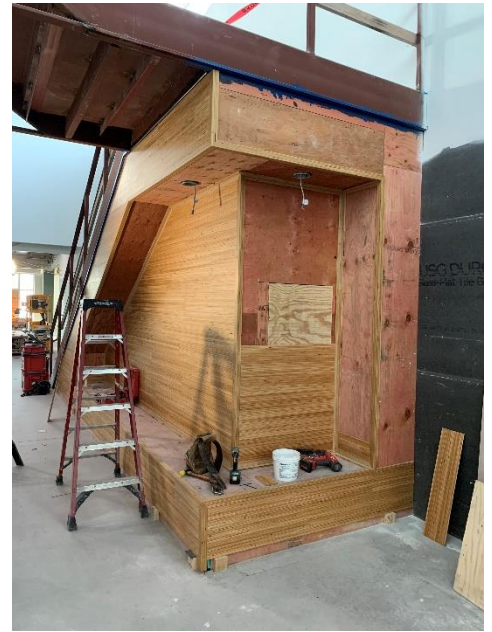
5. Area 1A – Wood plank install in center spine in progress.

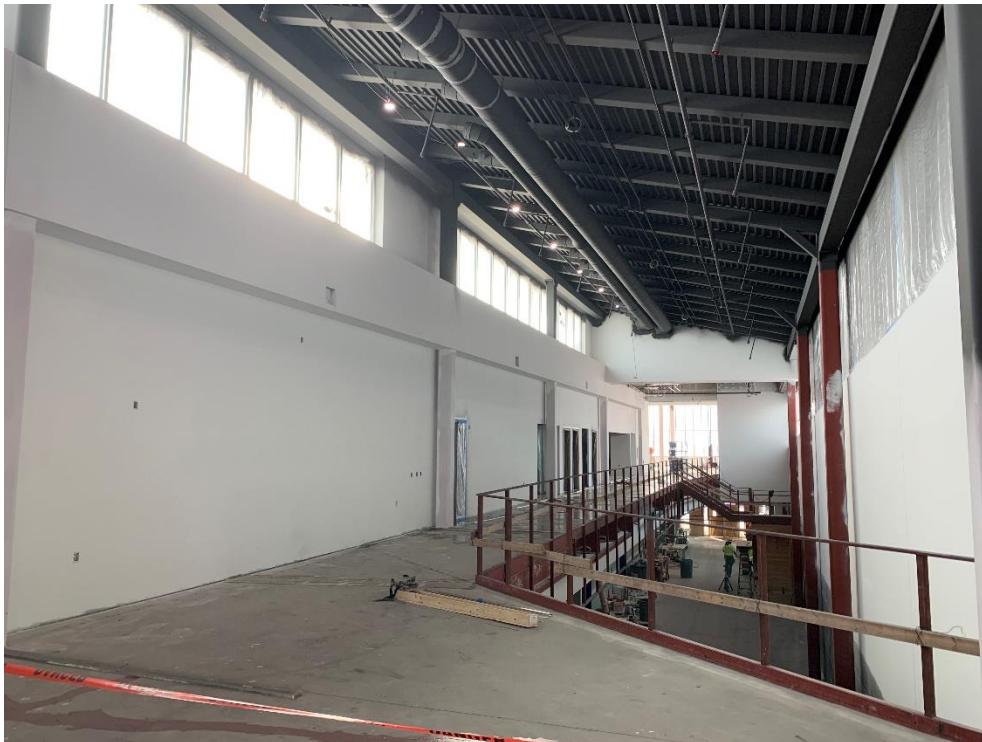
6. Area 1A/1B – Painting in center spine in progress. Terrazzo flooring install is beginning.

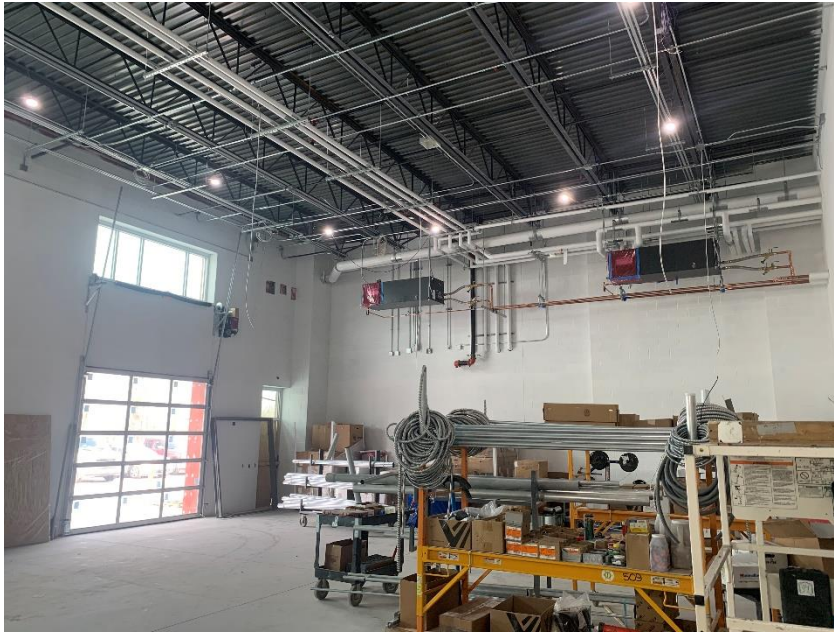
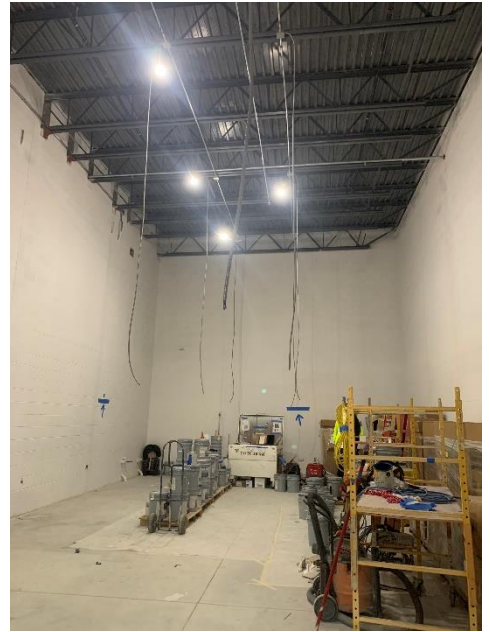
7. Area 3 – MEP work in tech ed area in progress.

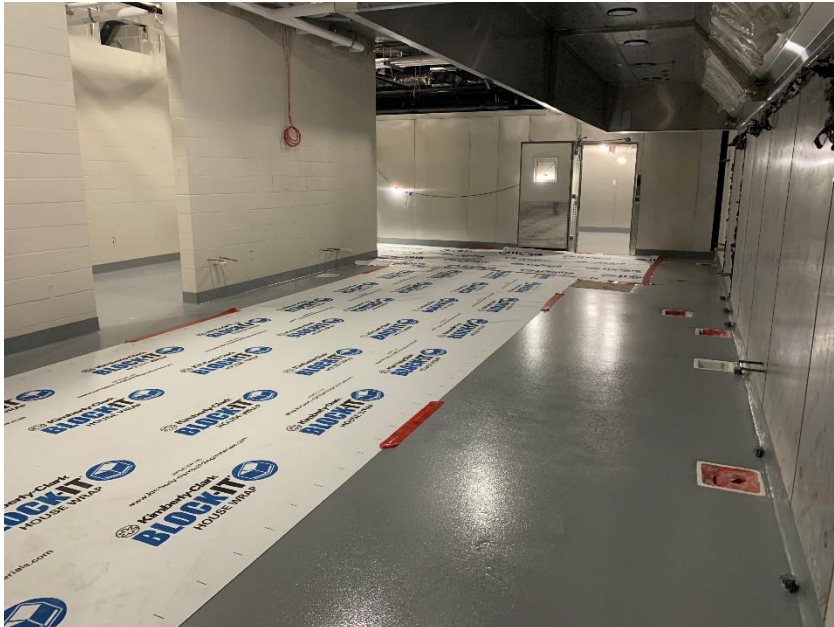
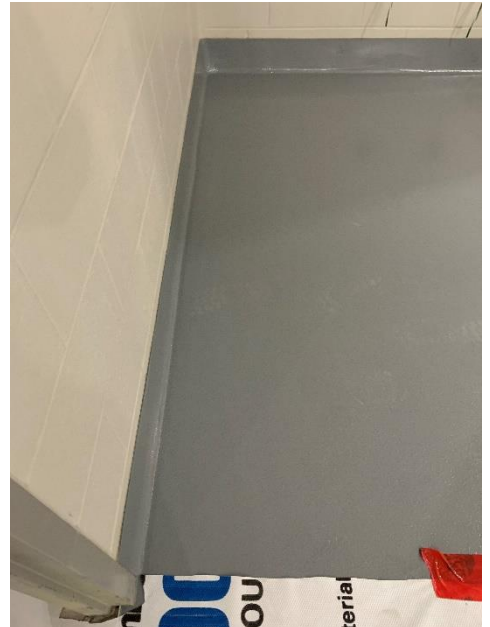
8. Area 3 – Epoxy flooring throughout the kitchen area, cooler, and freezer appear to be installed.

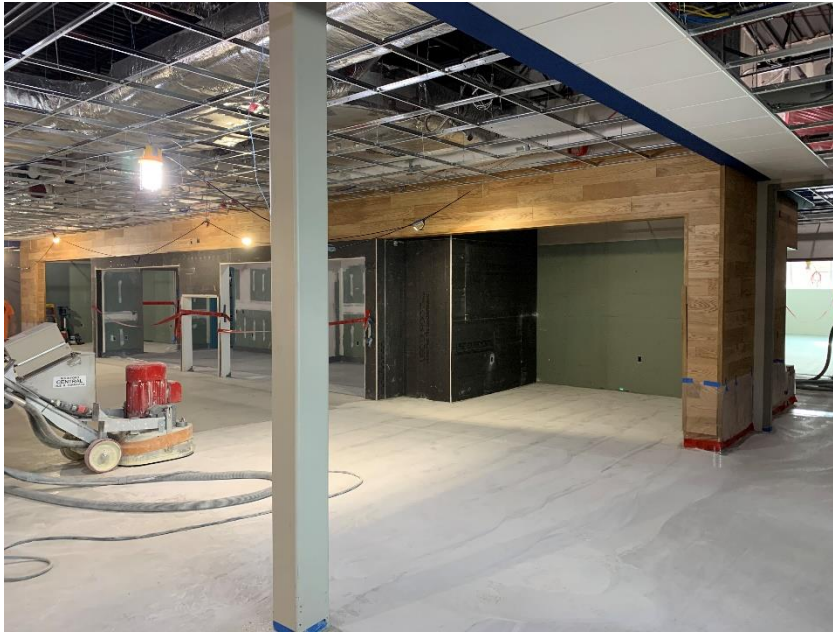
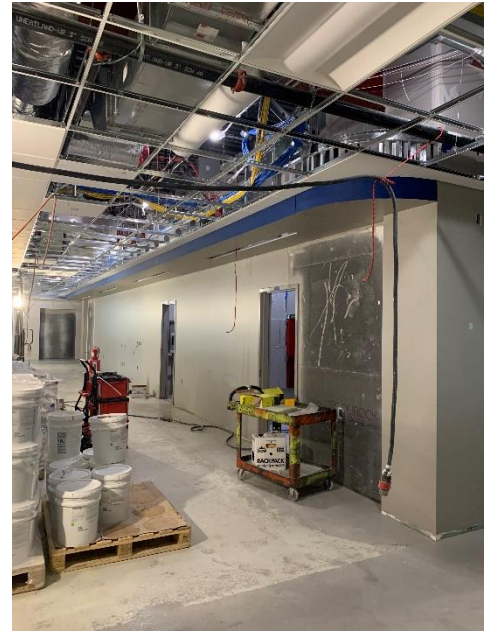
9. Area 4 – Painting and terrazzo flooring install in the second floor flex café in progress.

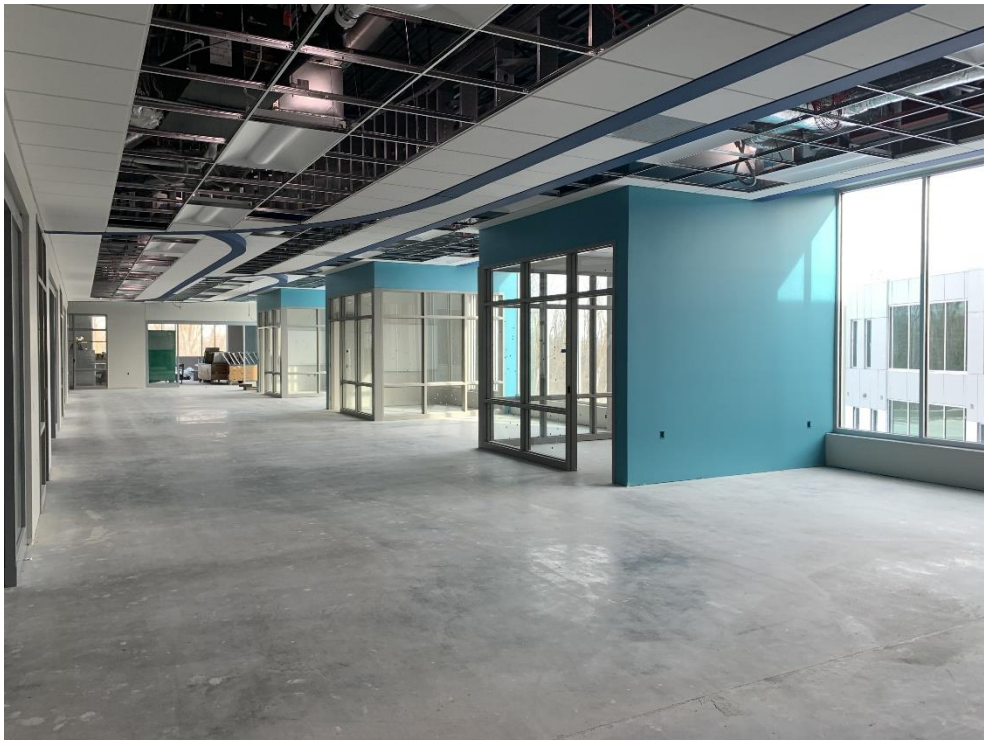
10. Area 4 – Painting in second floor grade neighborhood appears to be finished.

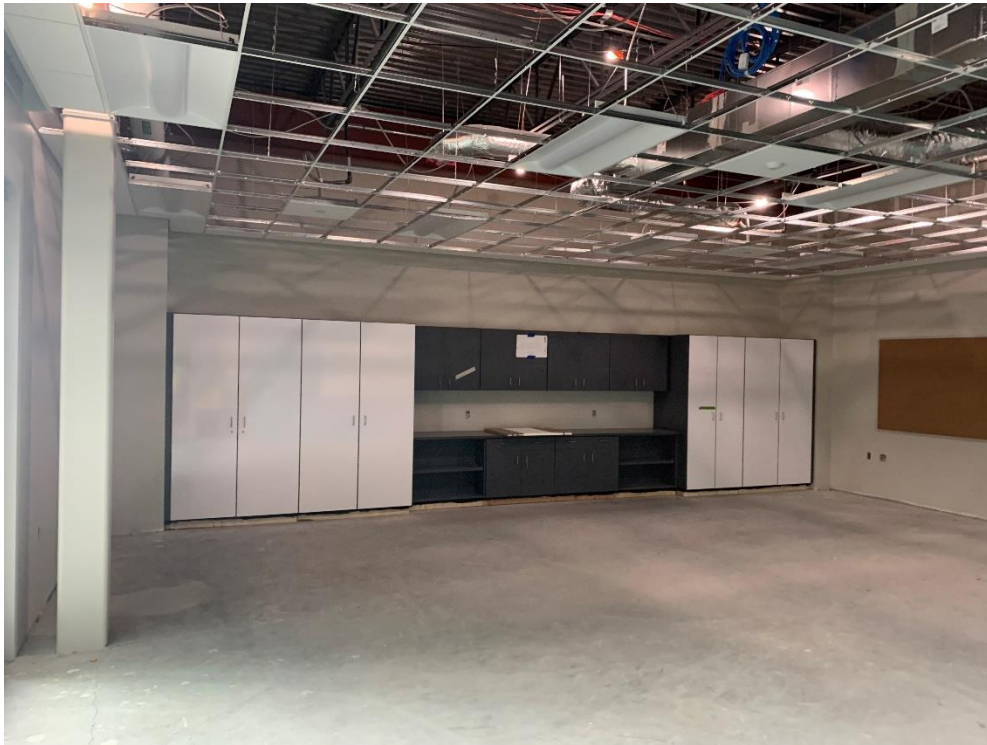
11. Area 4 – Casework install continues in second floor classrooms and offices

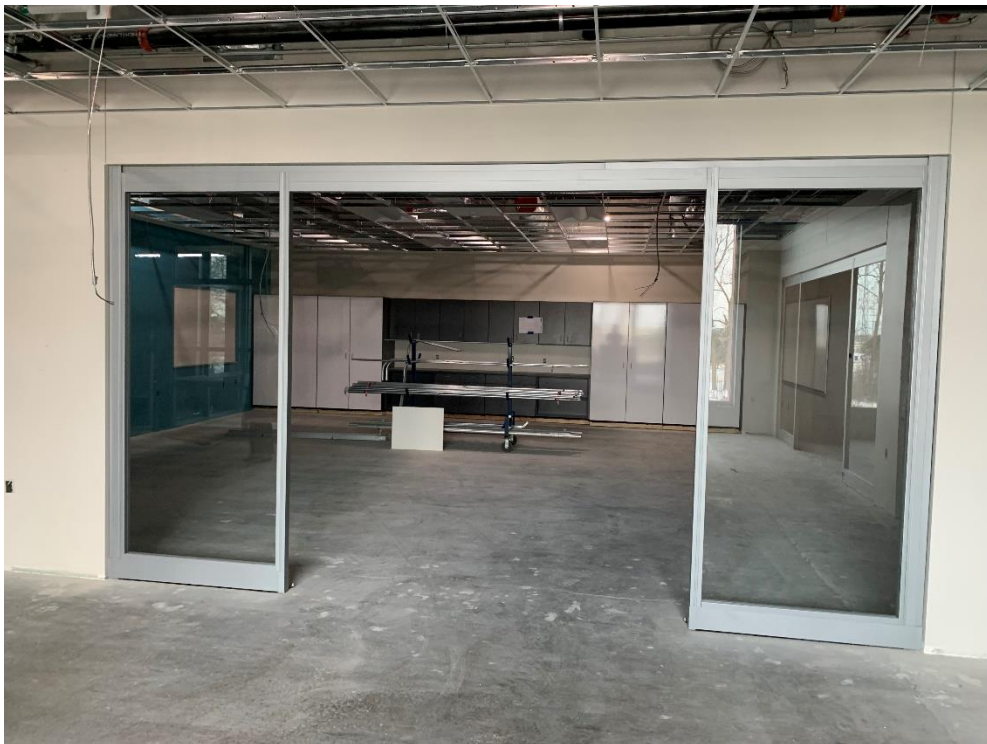
12. Area 4 – Sliding door system install in second floor classrooms in progress.

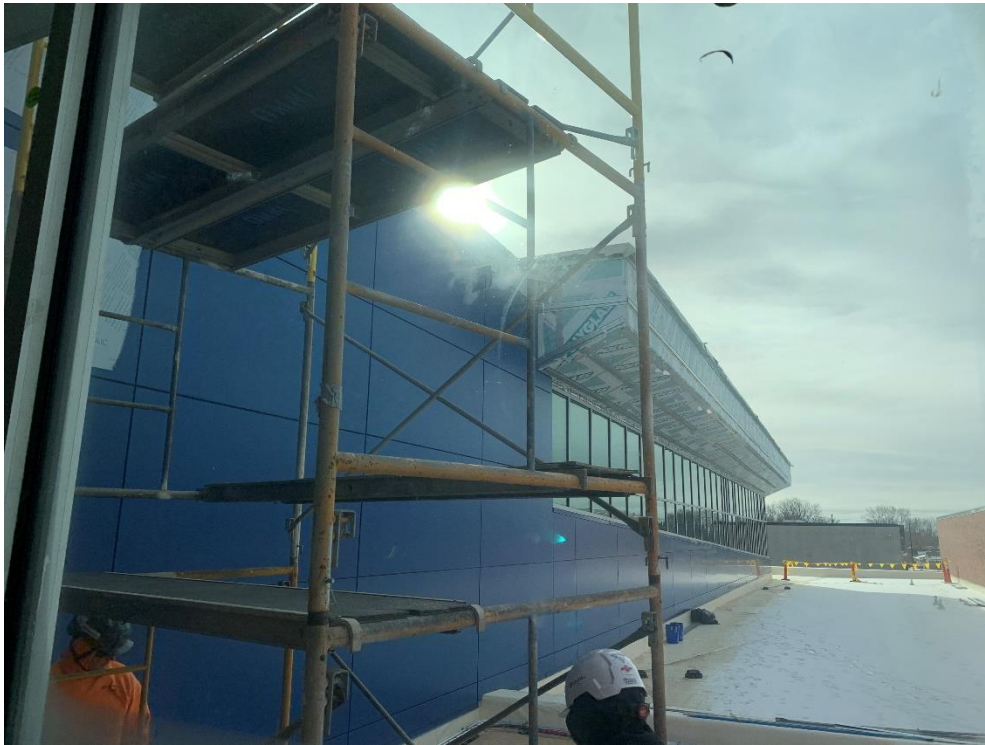
13. Area 1A – Composite wall panel install at clerestory areas in progress.

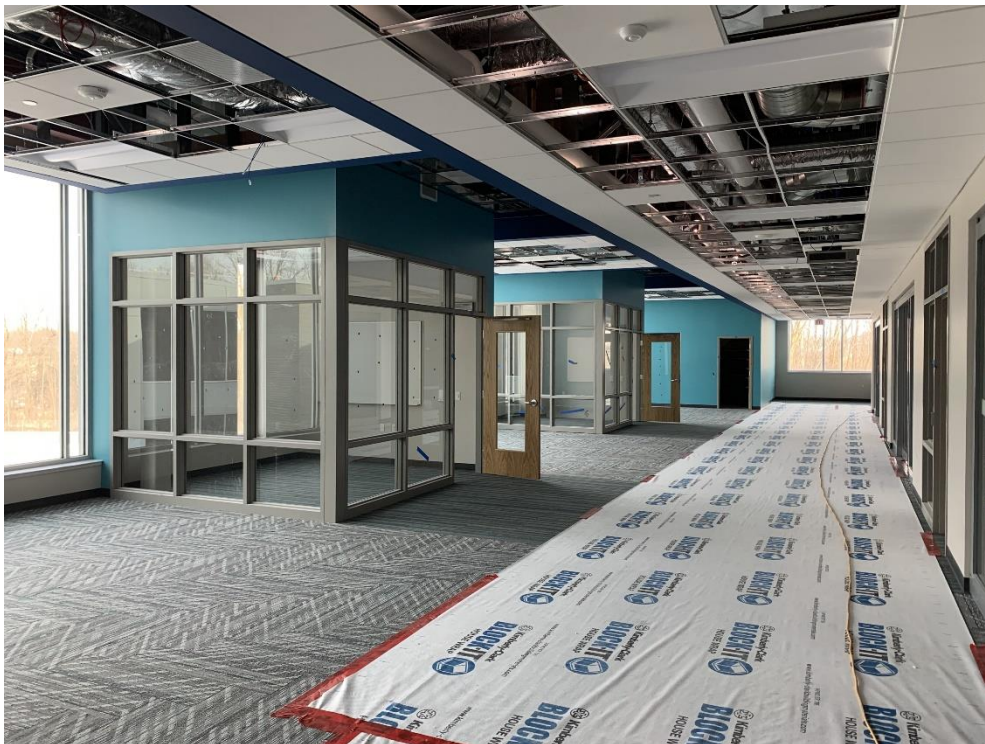
14. Area 5 – Door and lite install in grade neighborhoods continues.

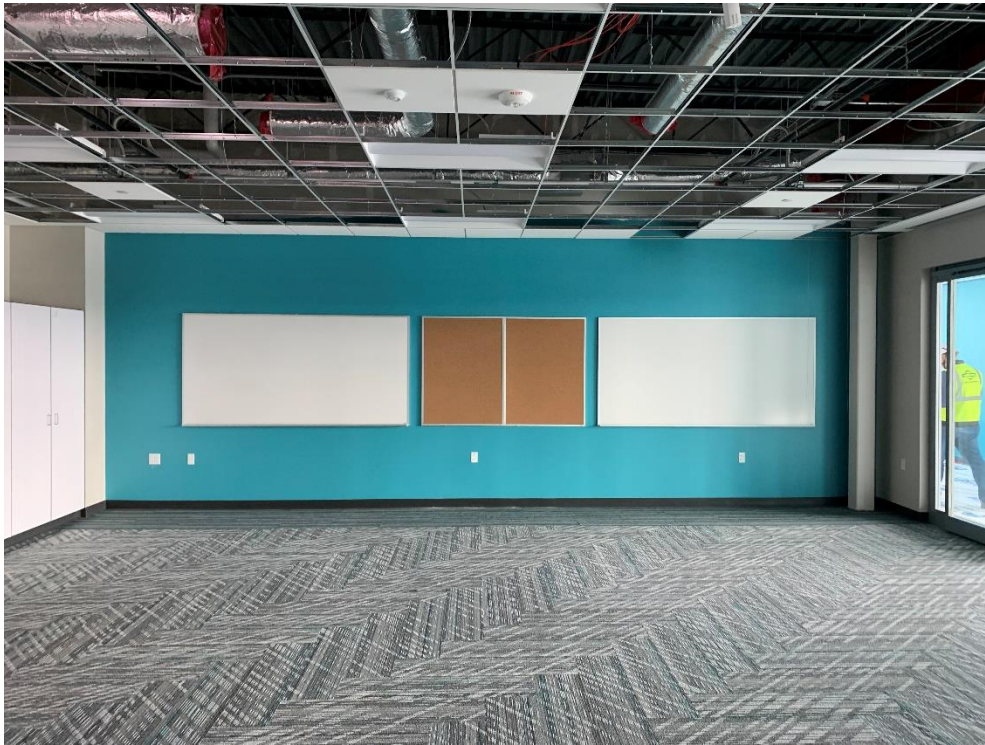
15. Area 5 – Markerboard, tackboard, and wall mounted equipment appear to be installed.

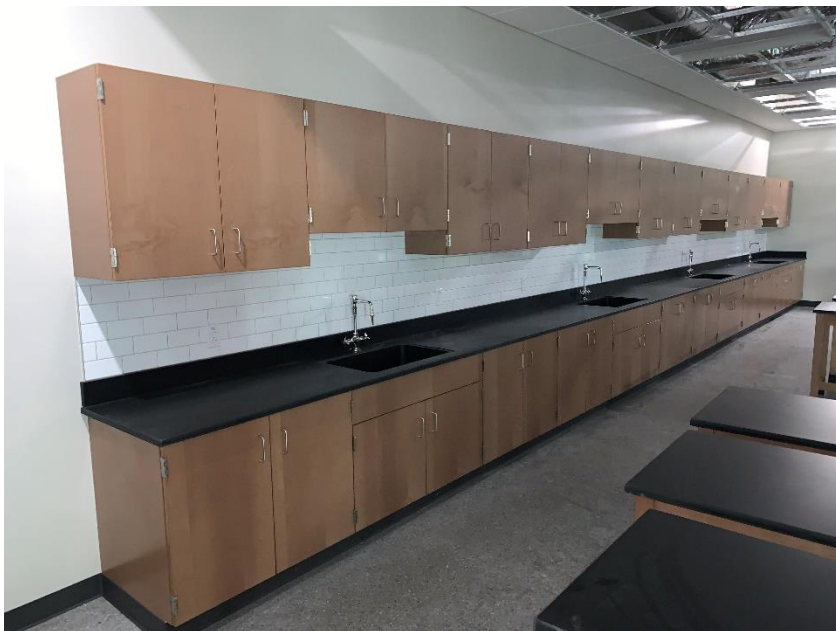
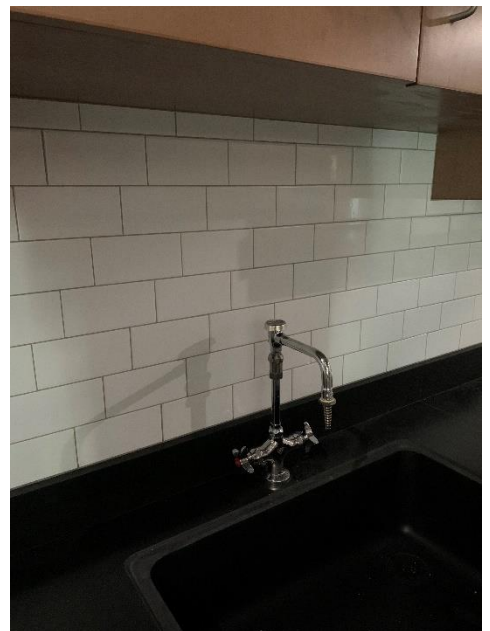
16. Area 5 – Tile backsplash in science labs appear to be installed.

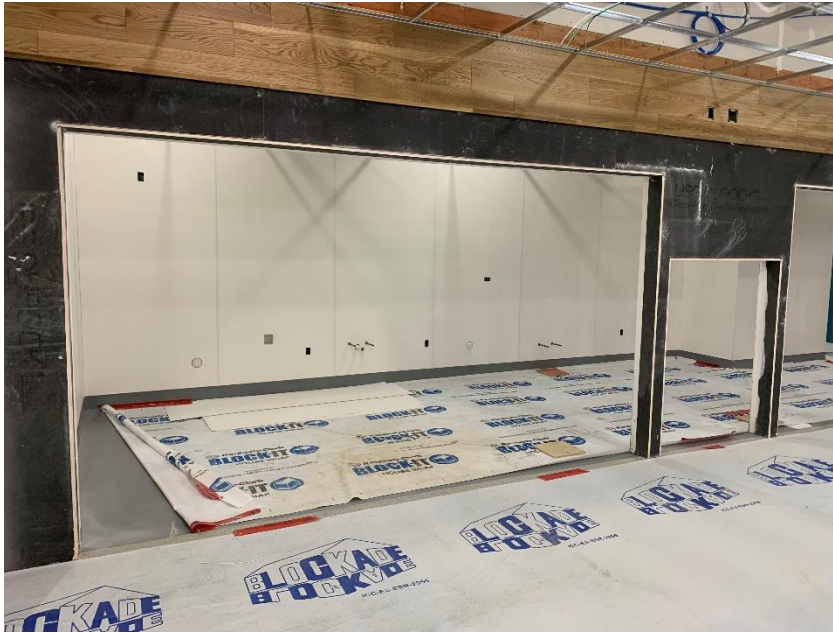
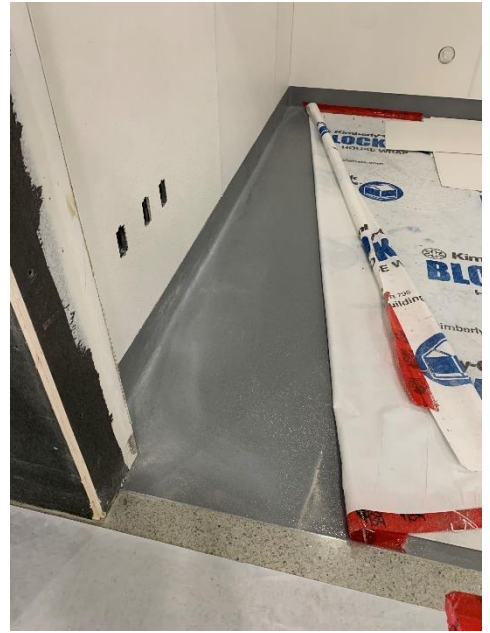
17. Area 5 – Epoxy flooring in flex café serverys appear to be installed.

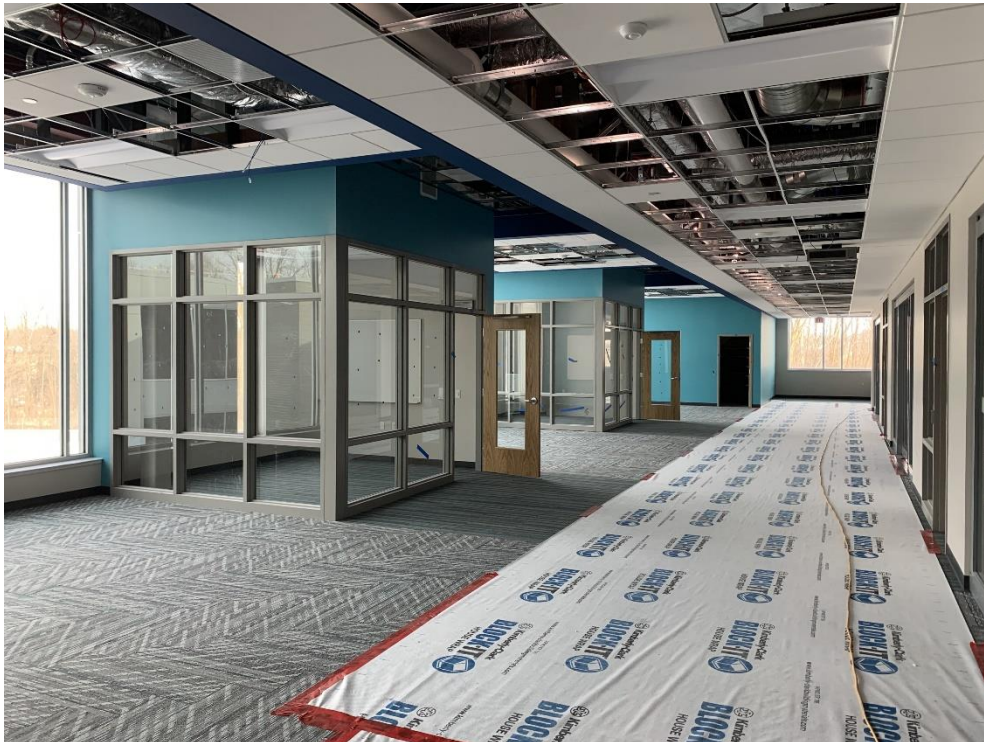
18. Area 5 – Door and lite install in grade neighborhoods continues.

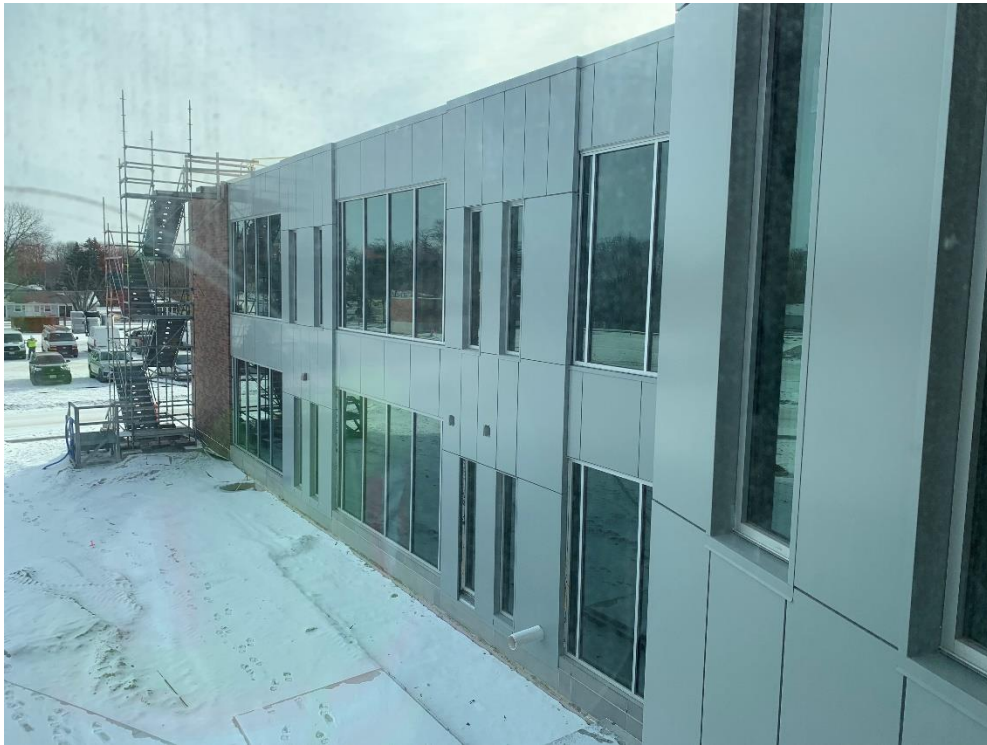
19. Window flashing install in progress around building exterior.

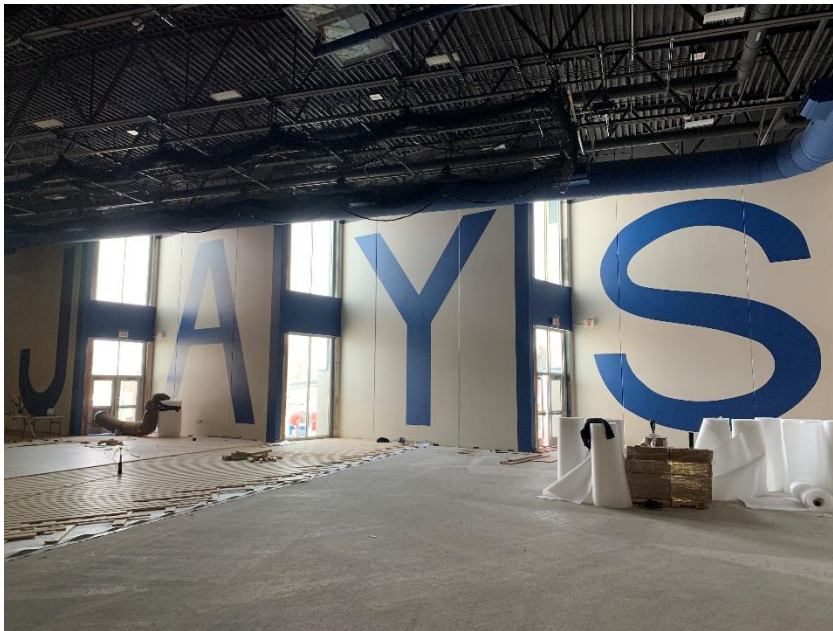
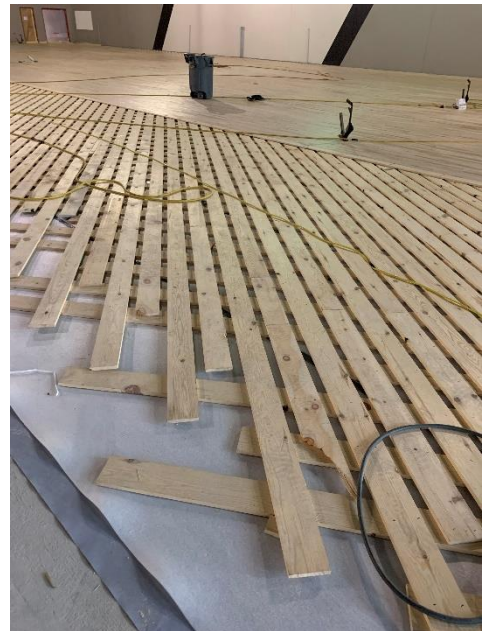
20. Area 6 – Painted letters in gym appear to be complete. Gym flooring install in progress.
