# Construction Observation Report 024 – March 7th, 2025

Maplewood School

PROJECT NUMBER: 321169-01

OWNER:	MENASHA JOINT SCHOOL DISTRICT
From ARCHITECT/ENGINEER:	EUA
To CONTRACTOR	MIRON CONSTRUCTION CO, INC
SITE OBSERVATION TYPE	ARCHITECTURAL
DATE OF ISSUANCE:	March 14 <sup>th</sup> , 2025

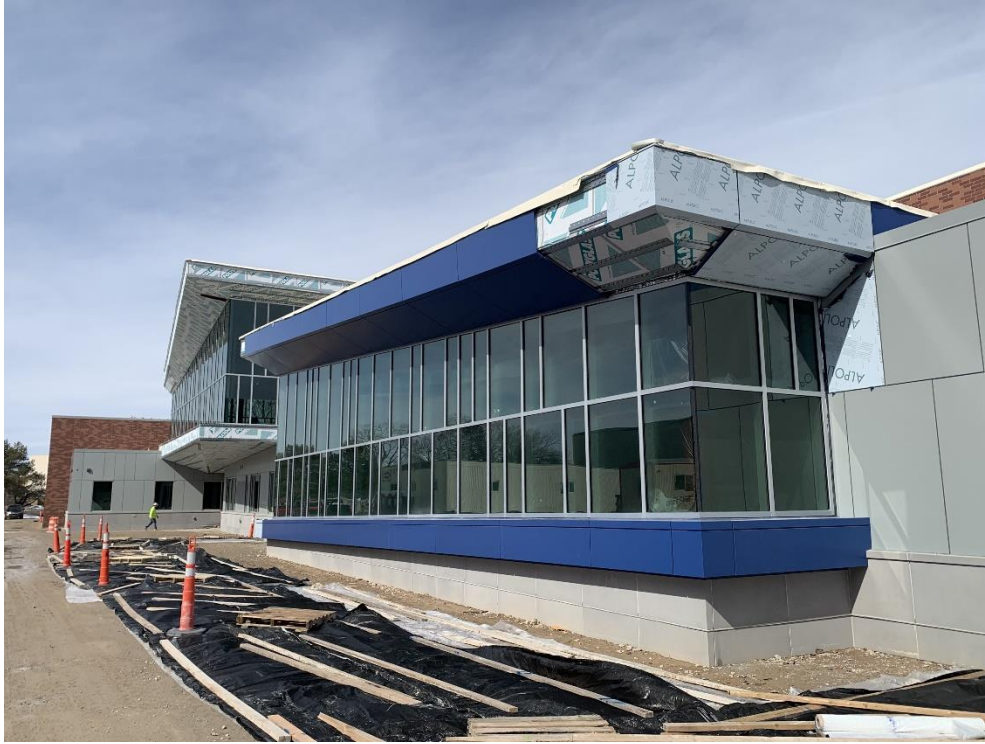
1. Area 2B South – Composite wall panel install continues at upper soffits. Prep for concrete seat wall in progress.

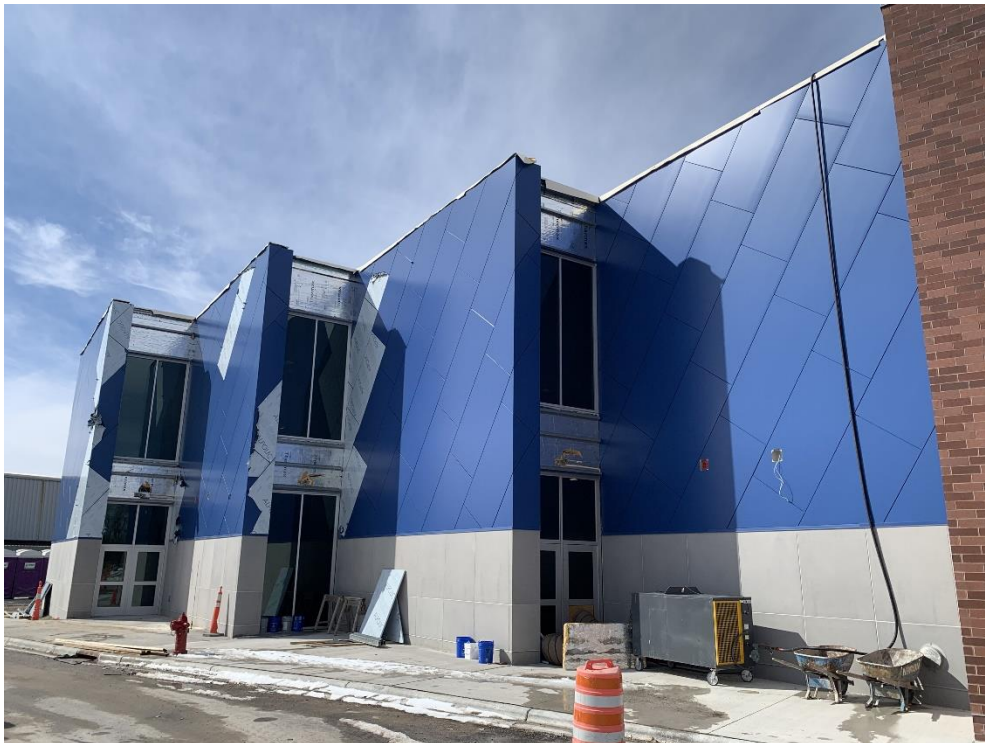
2. Area 6 – Composite wall panel install continues on east sawtooth walls.

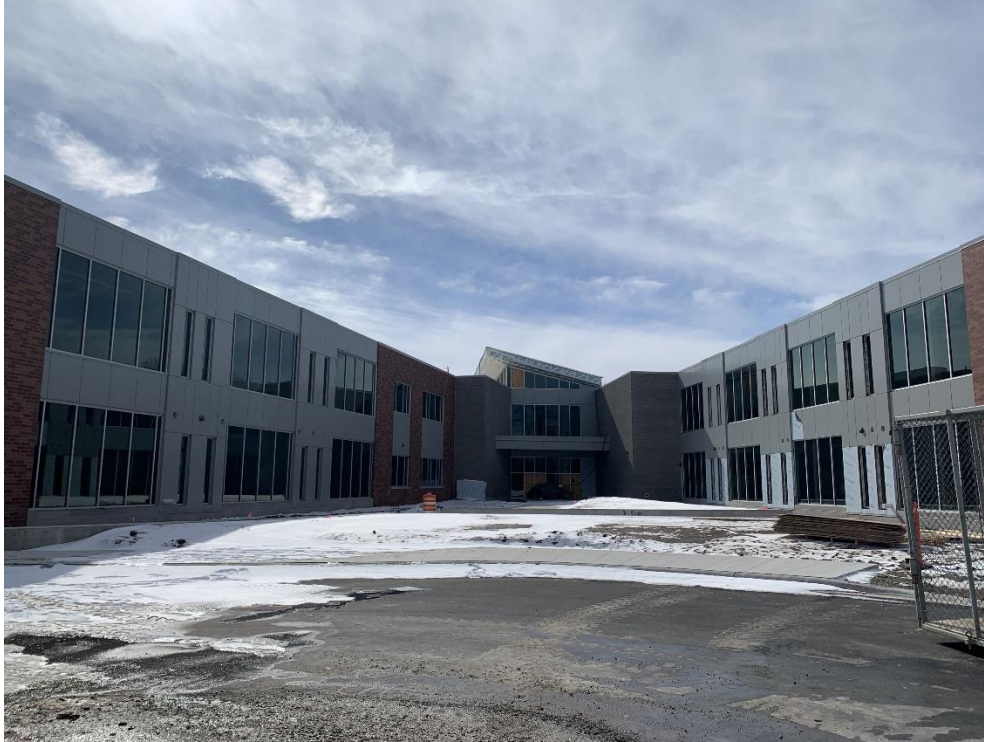
3. Exterior flashing and sealant install around the building continues.

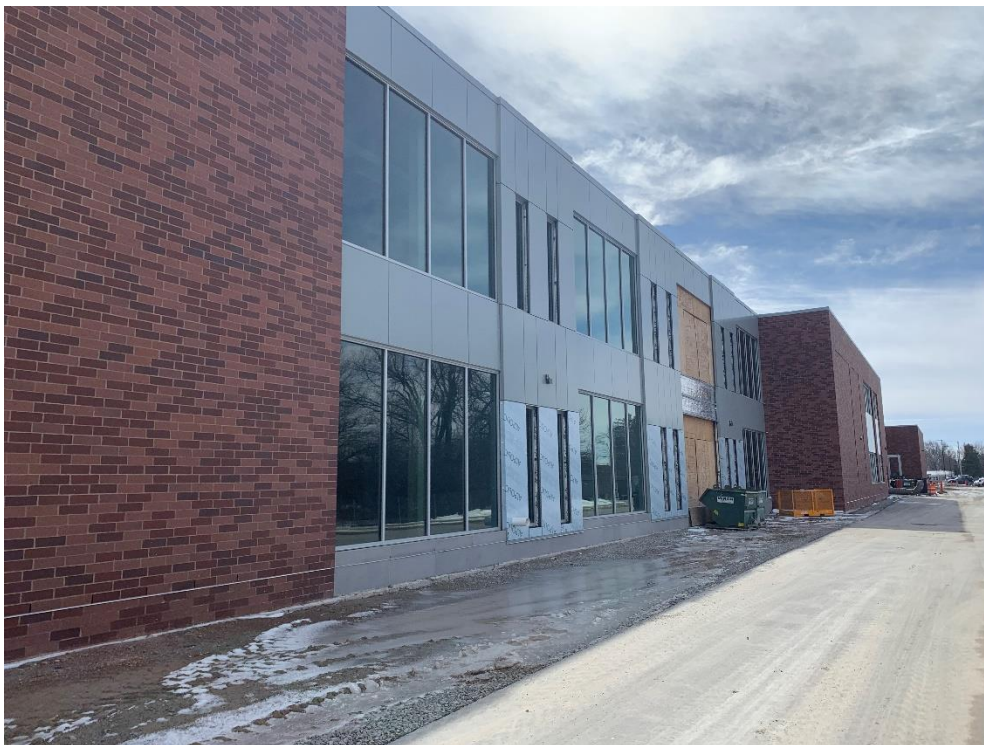
4. Area 4 – Composite metal wall panel and storefront system install on west elevation still in progress.

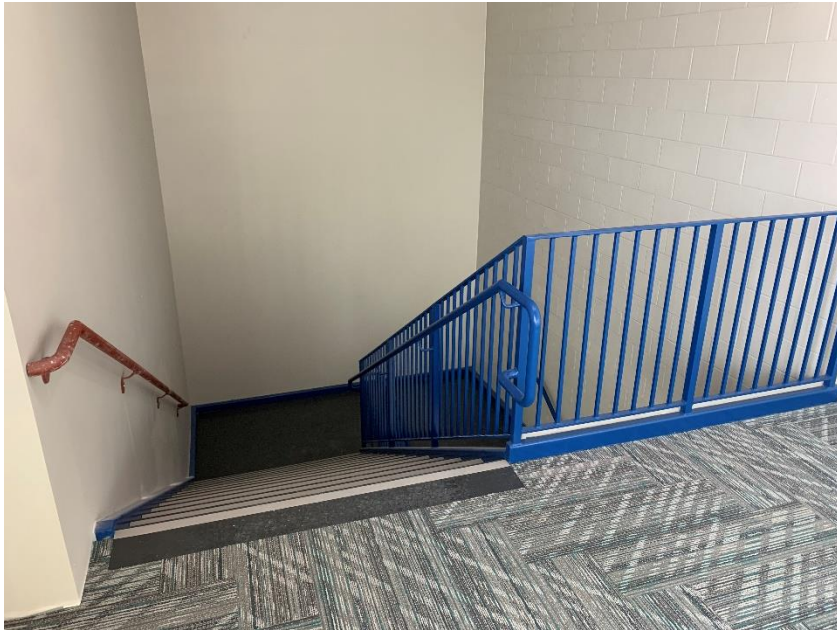
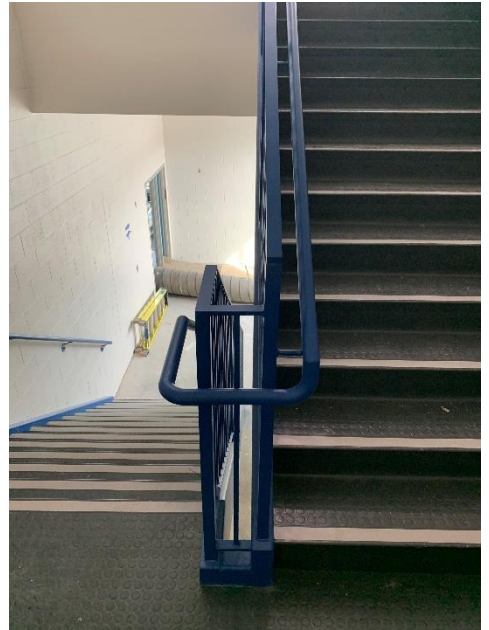
5. Area 6 – Stair tread and riser finish material appears to be installed. Painting in progress.

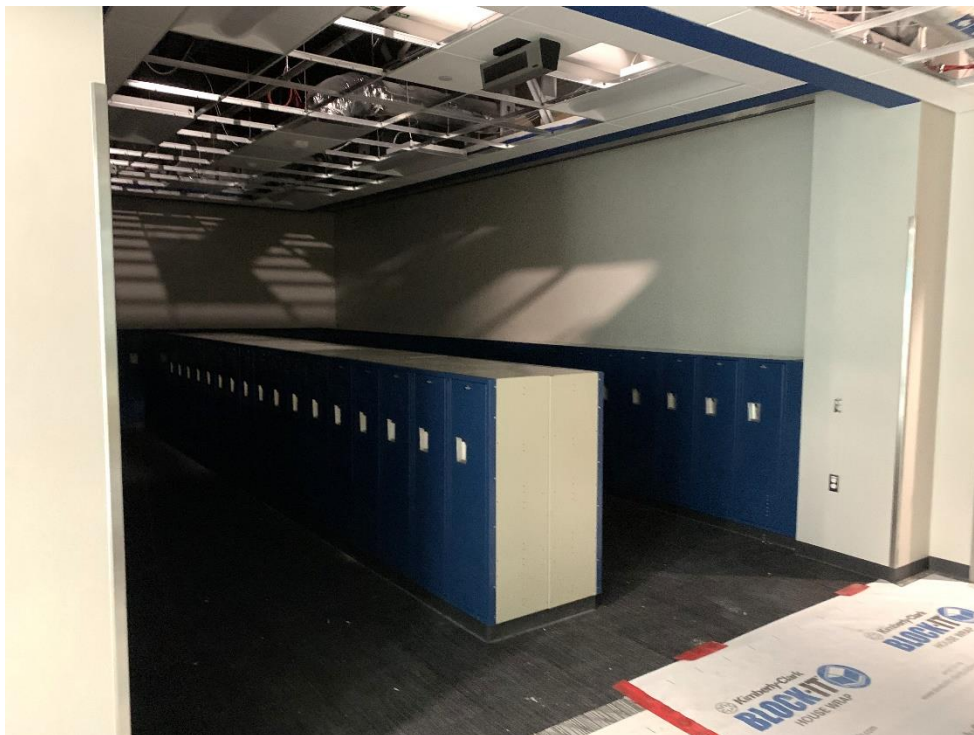
6. Area 6 – Second floor lockers installed.

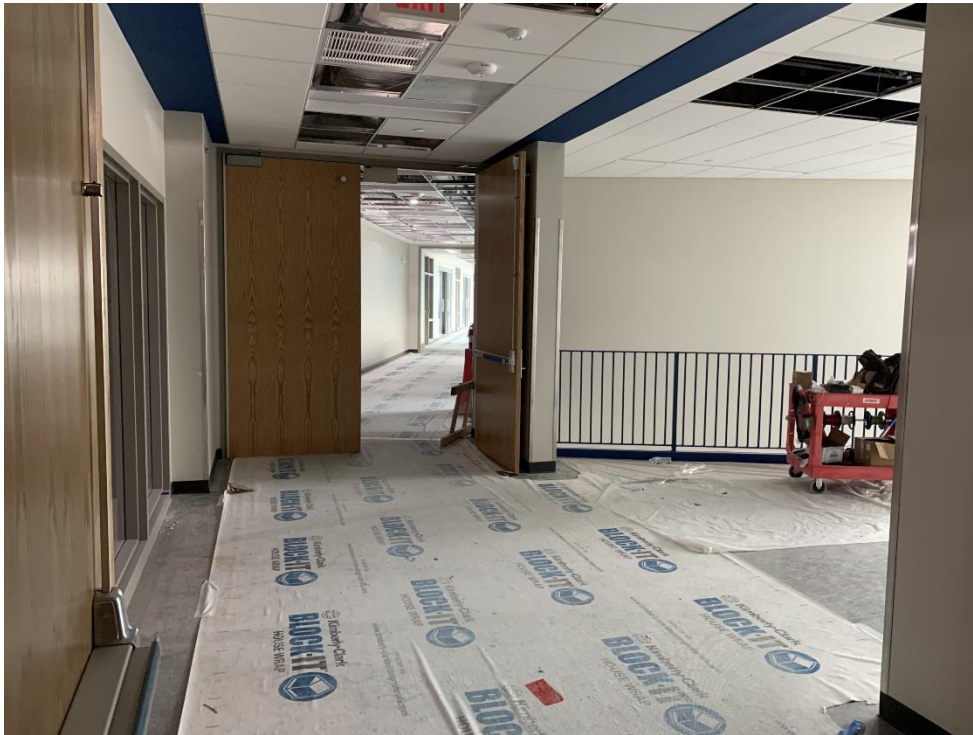
7. Area 5 – Terrazzo flooring and lock down doors appear to be installed in second floor corridor.

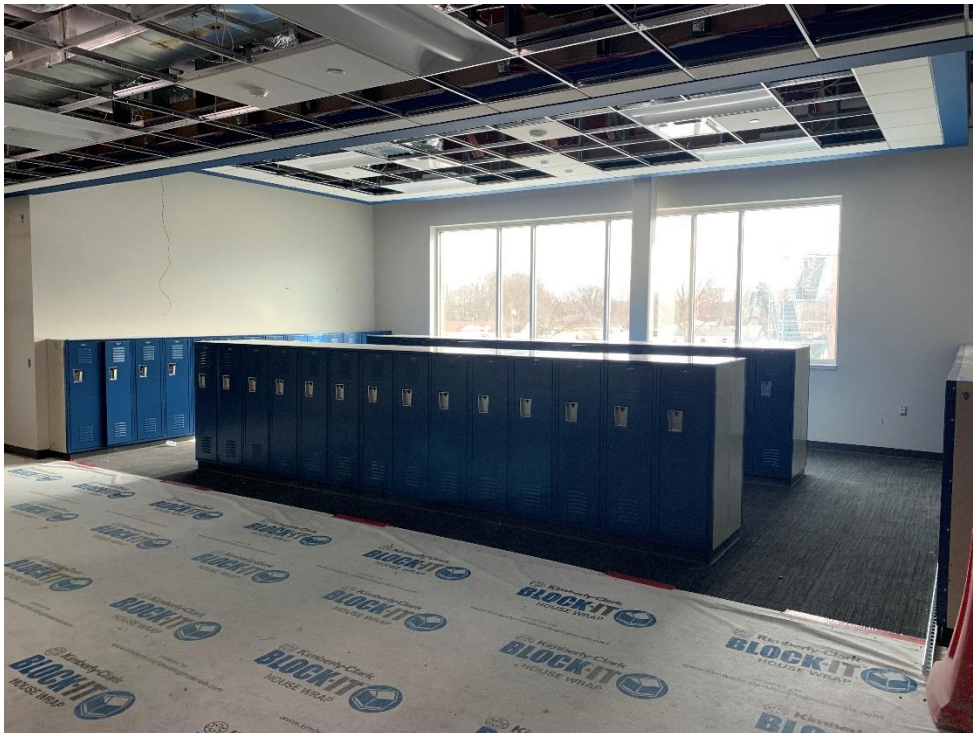
8. Area 5 – Second floor lockers appear to be installed.

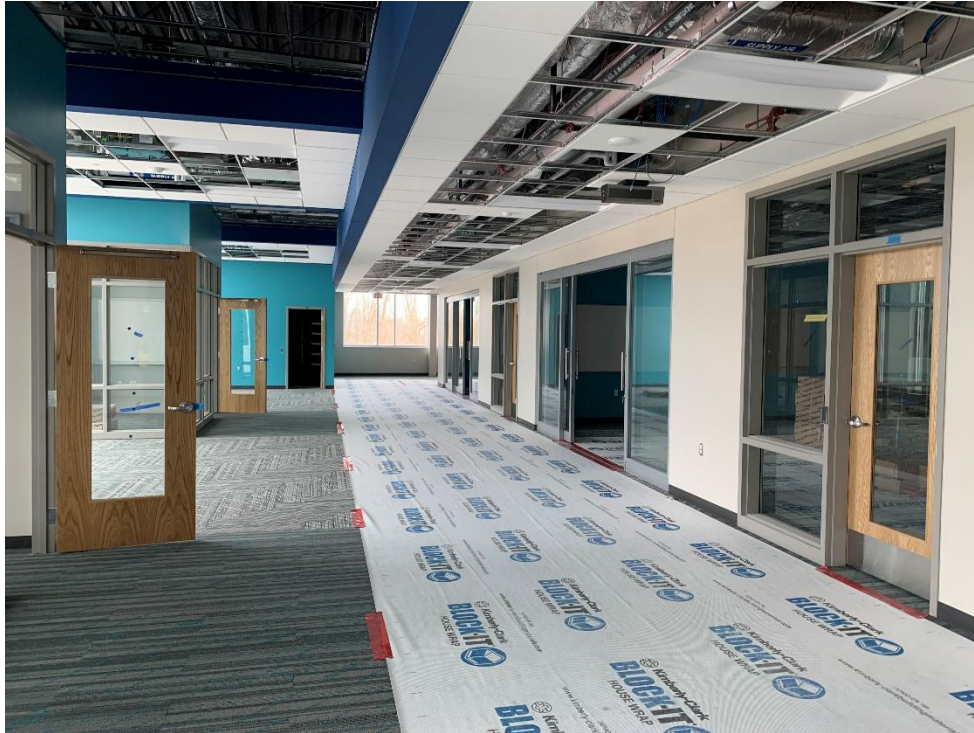
9. Area 5 – Doors and hardware appear to be installed in second floor grade neighborhoods.

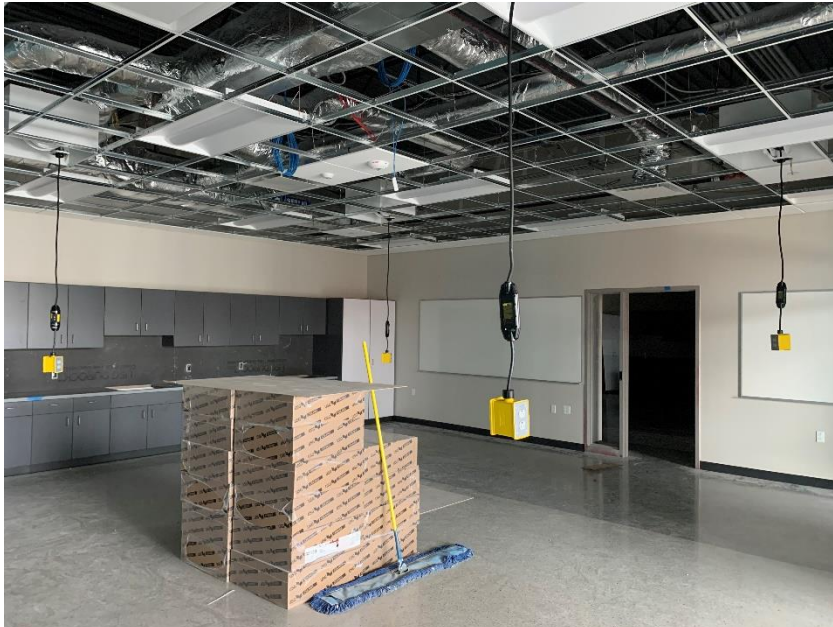
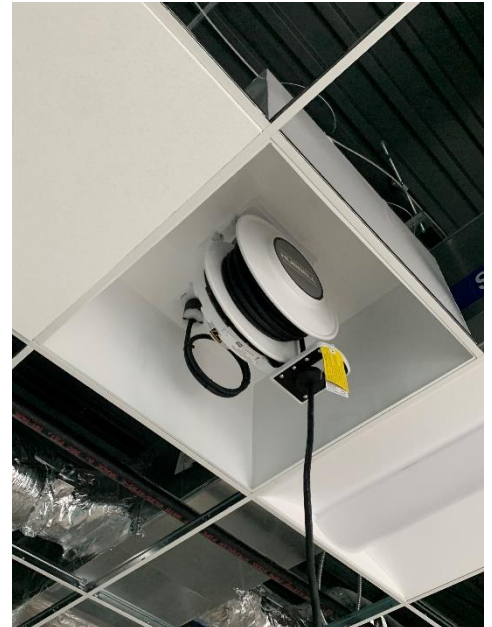
10. Area 5 – Ceiling mounted chord reels appear to be installed in second floor science classrooms.

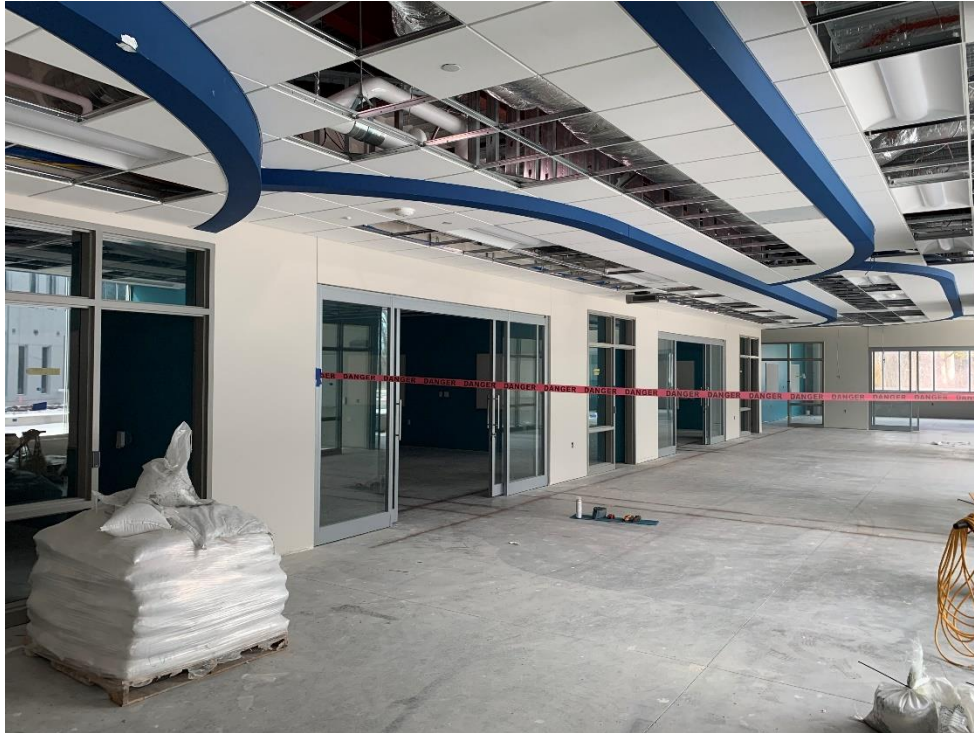
11. Area 4 – Glass sliding door system appears to be installed in first floor classrooms.

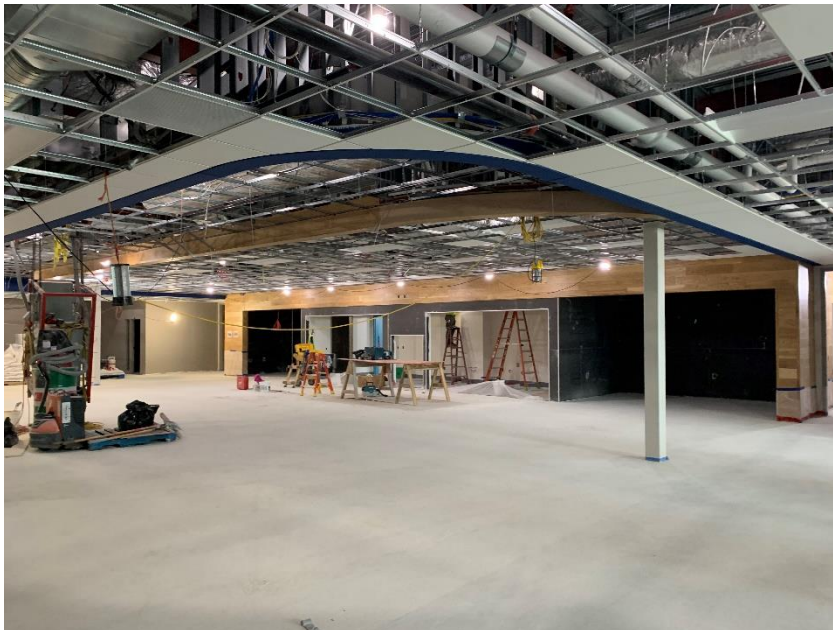
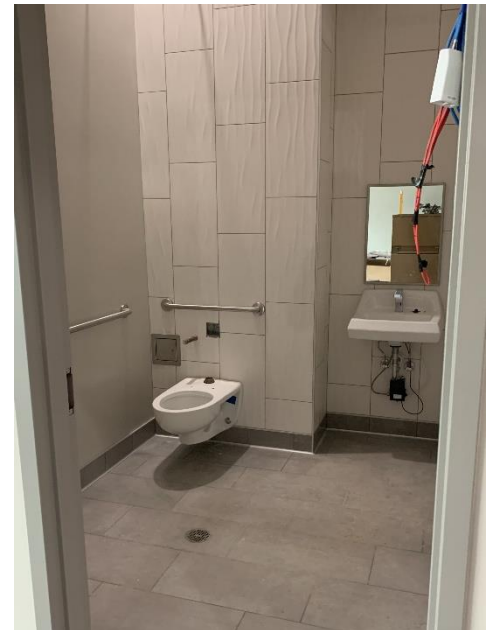
12. Area 3 – Terrazzo floor install in progress in first floor flex café. Plumbing fixture install in first floor toilet rooms in progress.

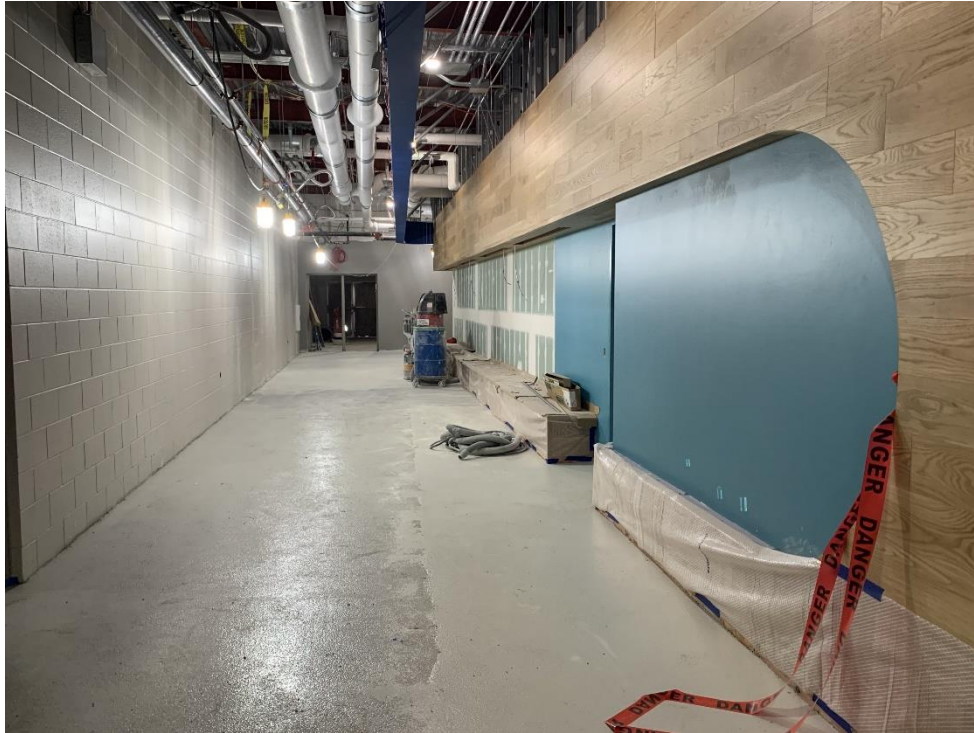
13. Area 3 – Terrazzo flooring install in first floor corridor in progress.

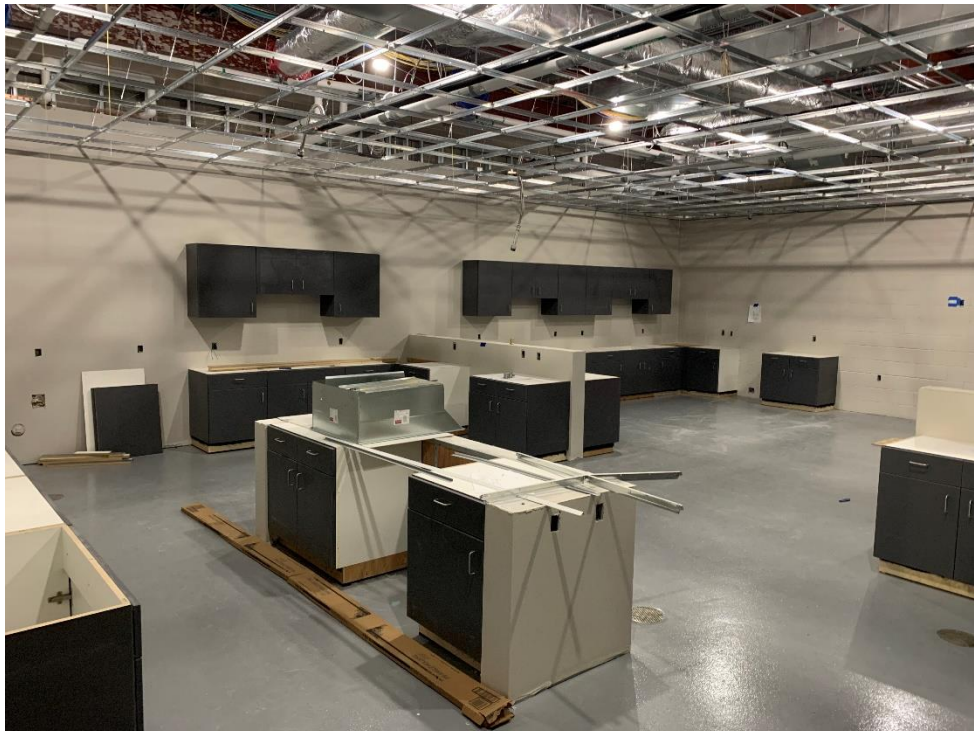
14. Area 3 – Casework install in culinary lab continues.

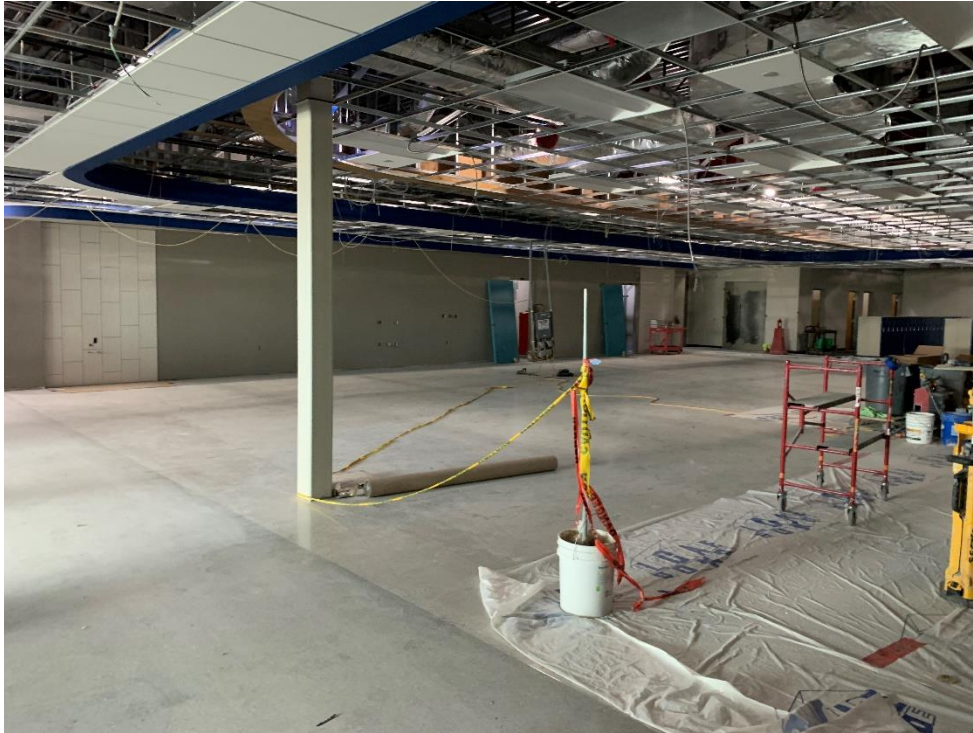
15. Area 3 – Terrazzo flooring appears to be installed and finished in second floor flex café.

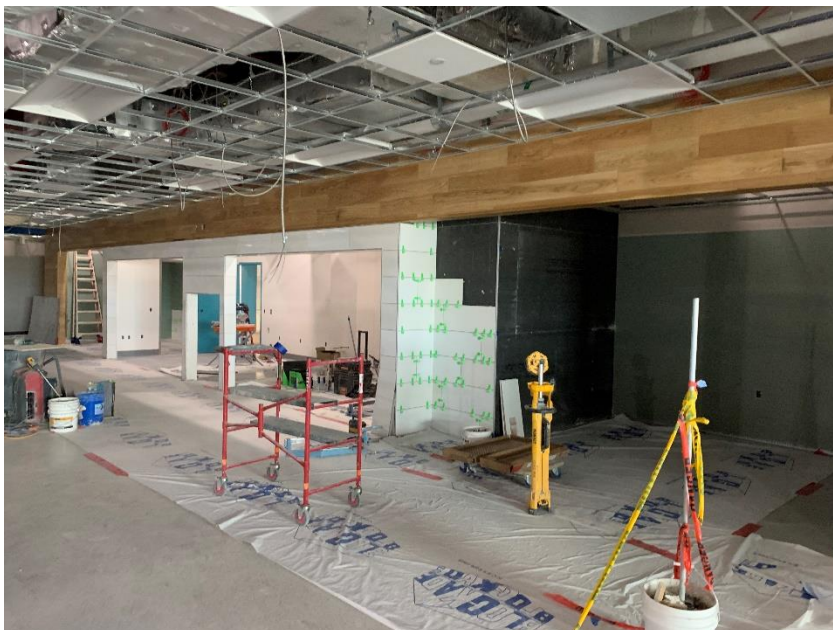
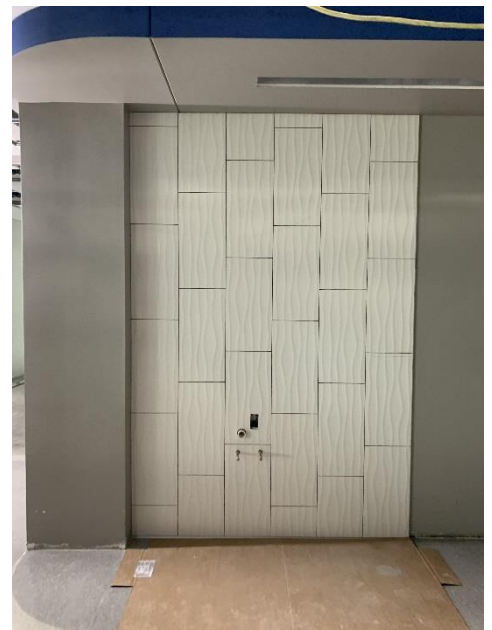
16. Area 3 – Tile install in second floor flex café continues.

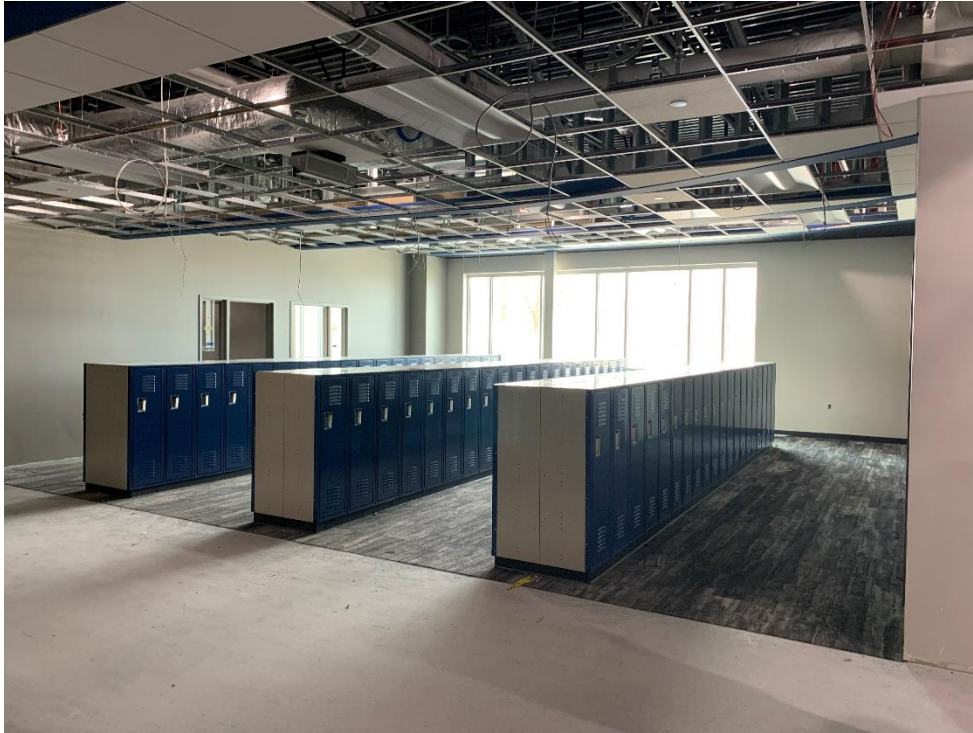
17. Area 3 – Second floor lockers appear to be installed.

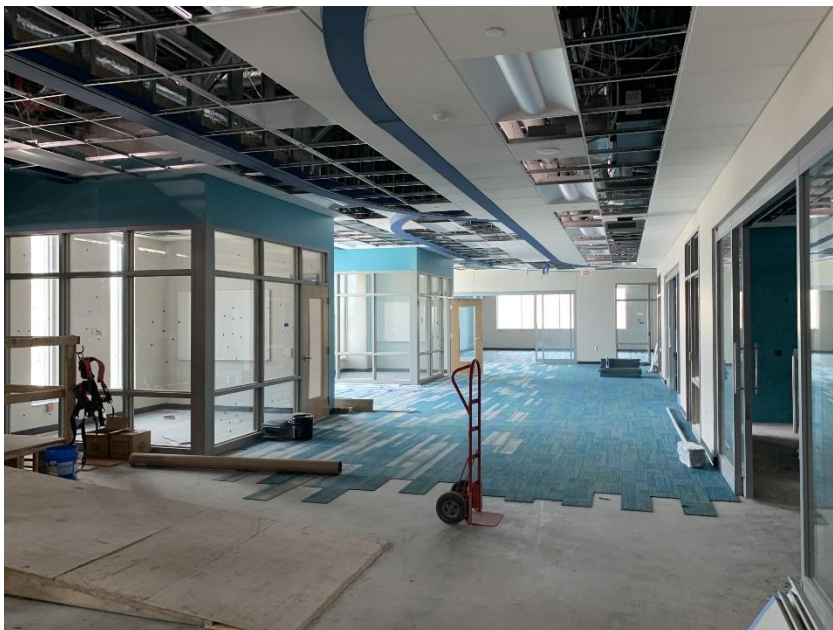
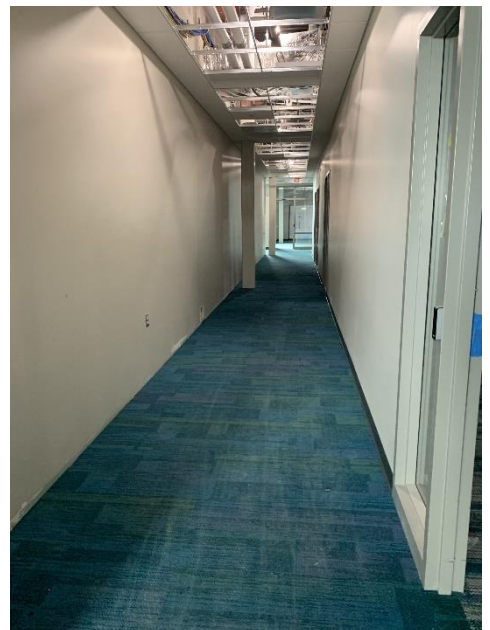
18. Area 4 – Carpet install in progress throughout first floor grade neighborhoods.

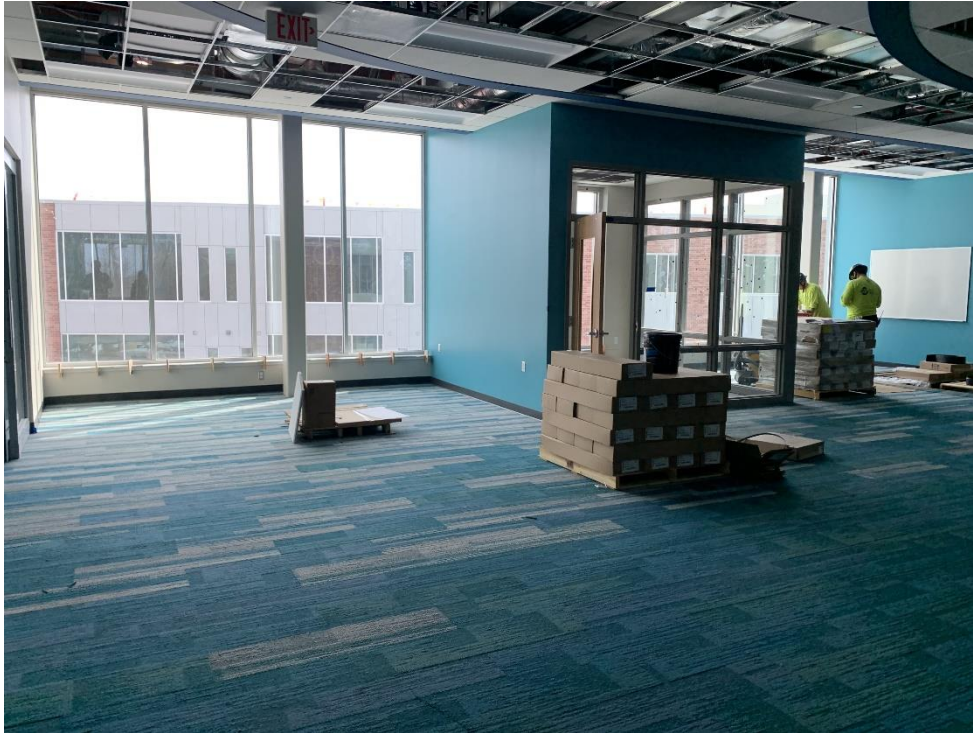
19. Area 4 – Solid surface window sill install continues.

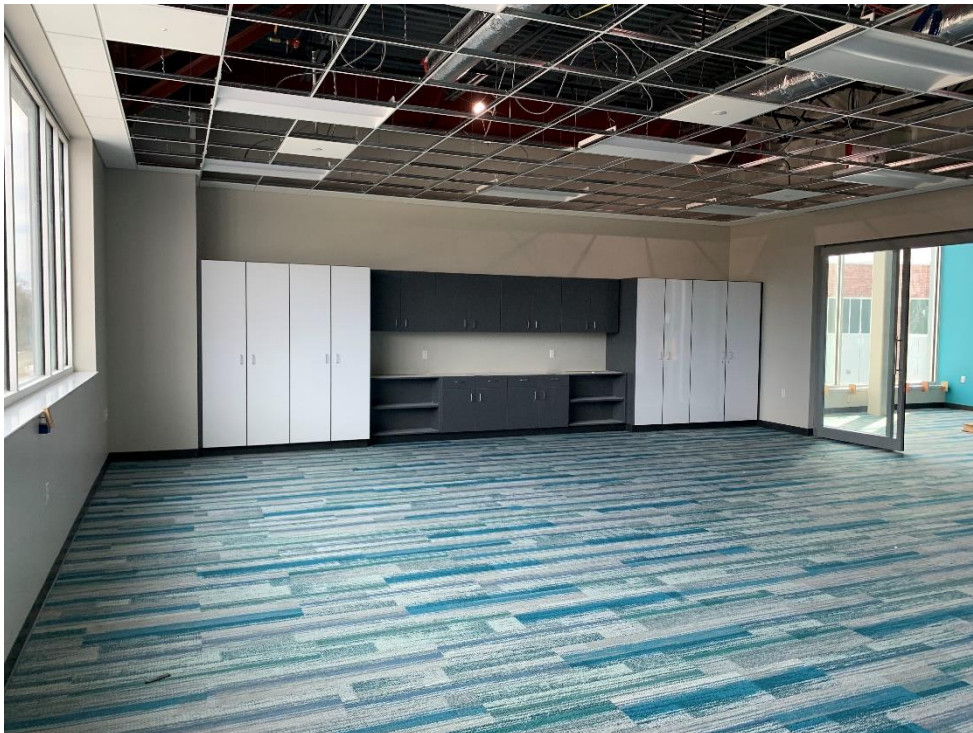
20. Area 4 – Casework install throughout area appears to be nearly complete.

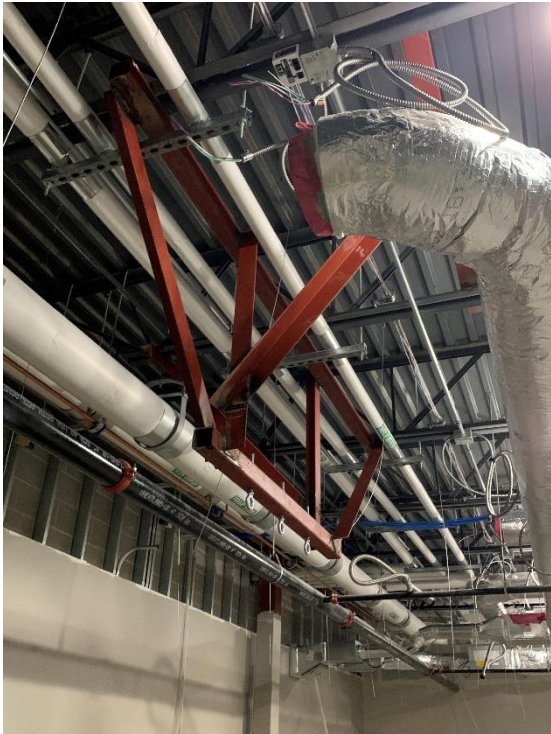
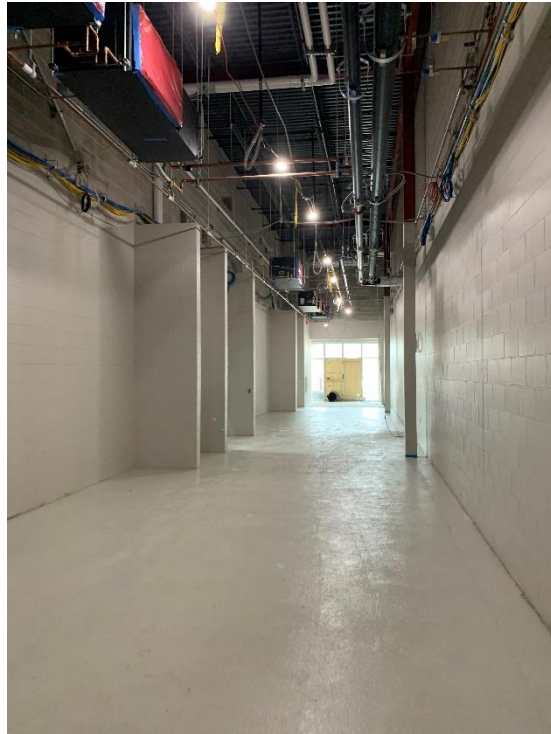
21. Area 3 – Structural support for therapy swing appears to be installed in OT/PT room. Terrazzo flooring has been poured in music/ tech ed corridor.

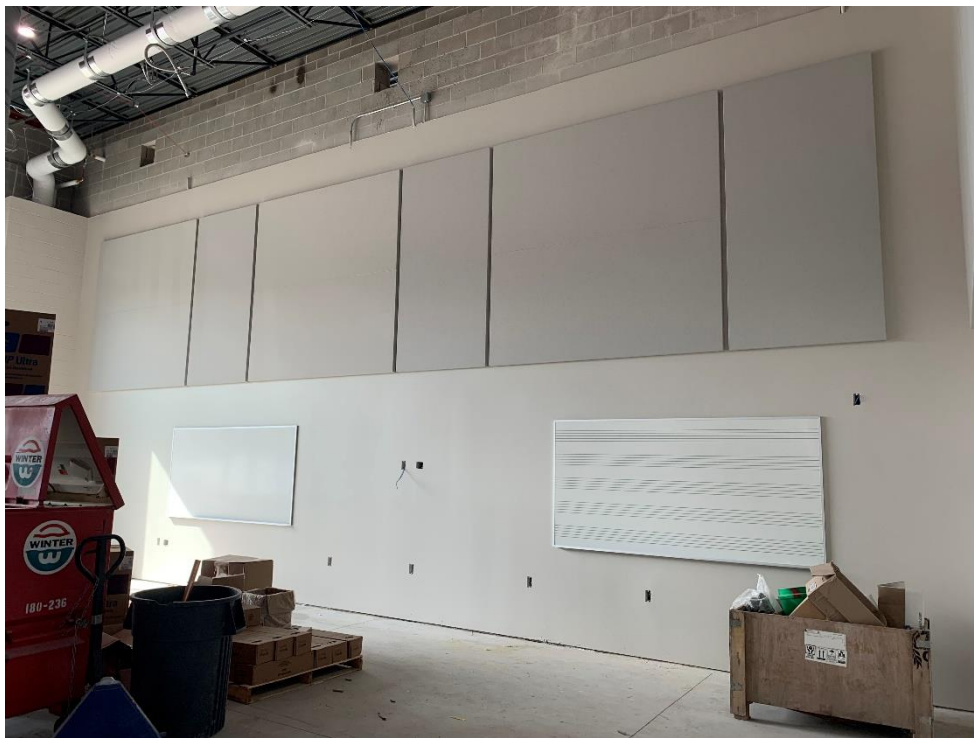
22. Area 3 – Marker board and acoustic wall panel install in progress throughout music suite.

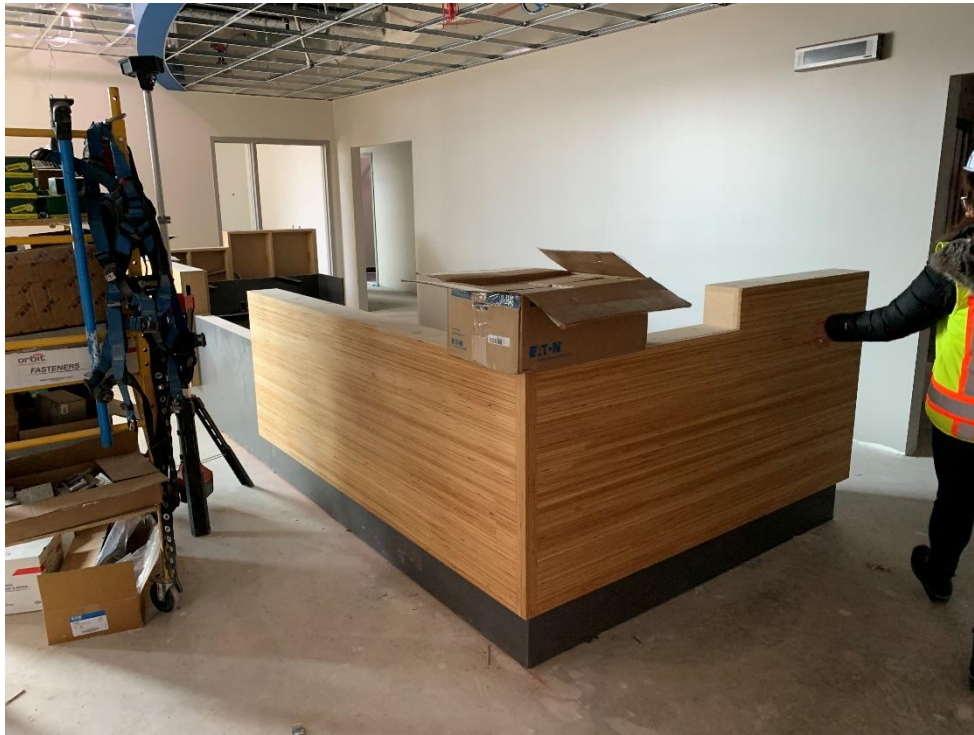
23. Area 1A – Reception desk millwork install continues in 5/6 office.

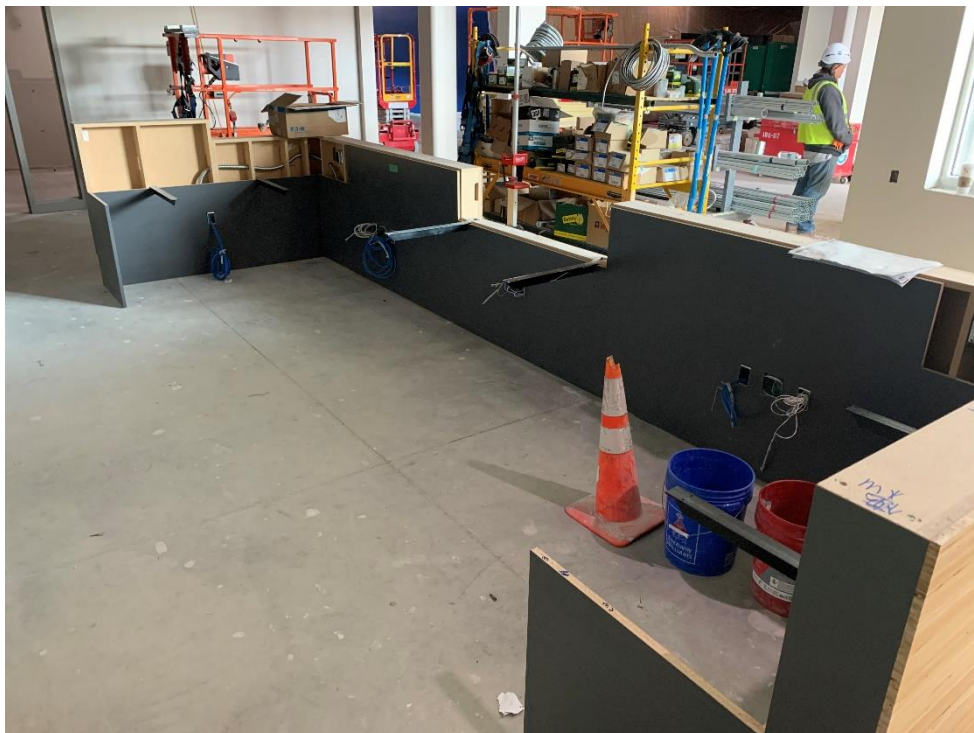
24. Area 1A – Reception desk millwork install continues in 5/6 office.

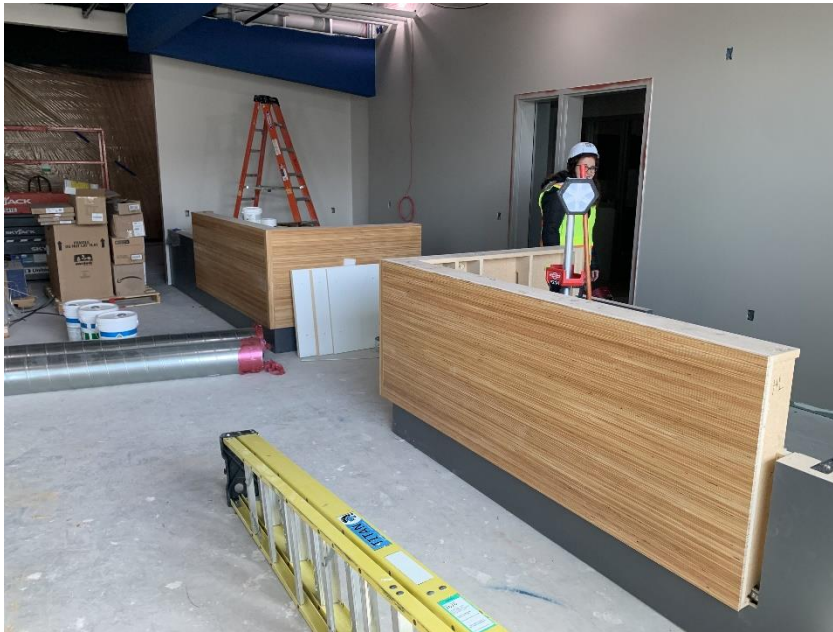
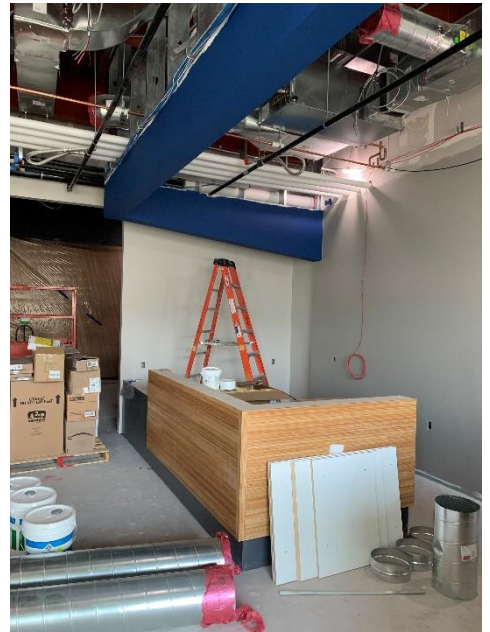
25. Area 1A - Reception desk millwork install continues in 7/8 office.

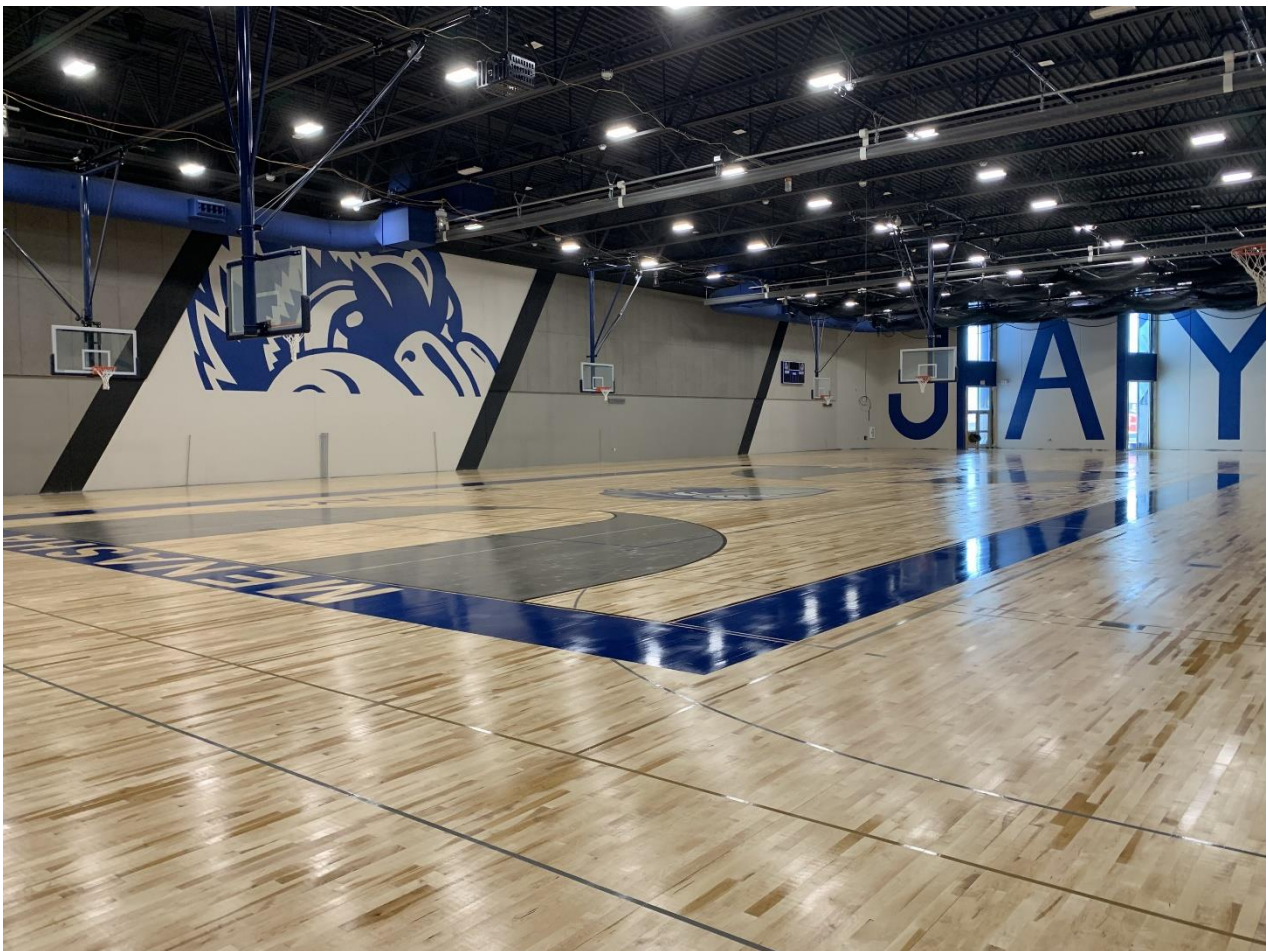
26. Area 6 - Gym floor appears to be installed, striped, painted, and sealed.

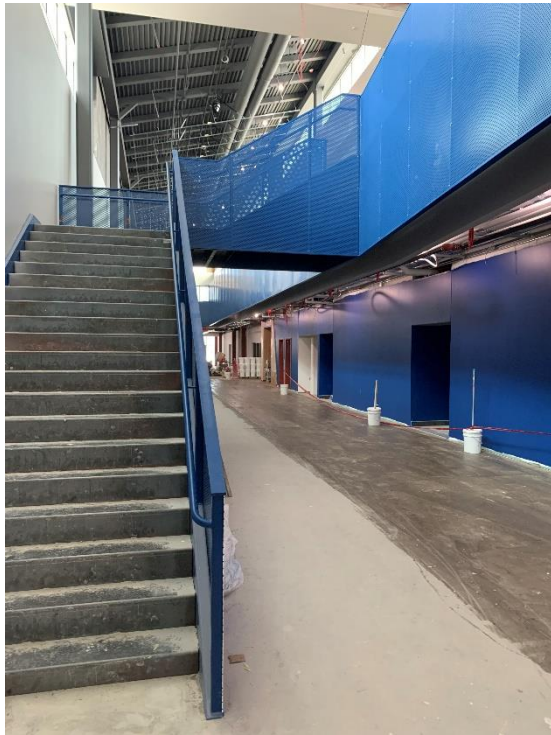
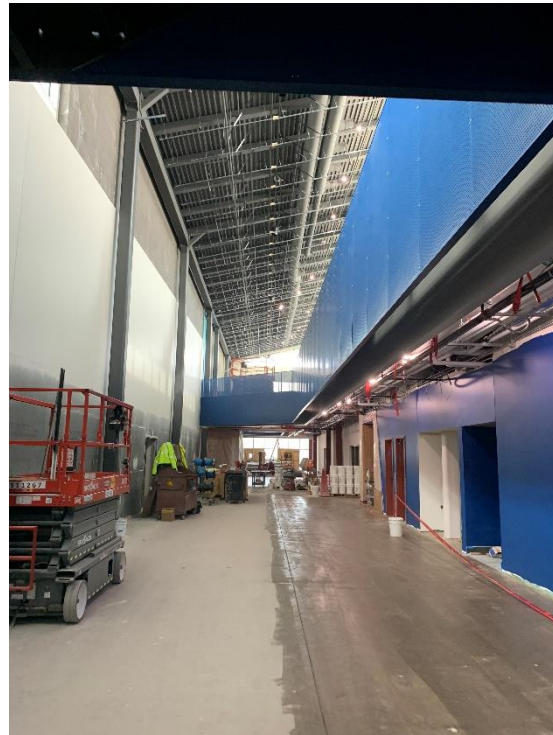
27. Area 1A/1B – Decorative infill panels appear to be installed in center spine. Terrazzo flooring prep in progress.

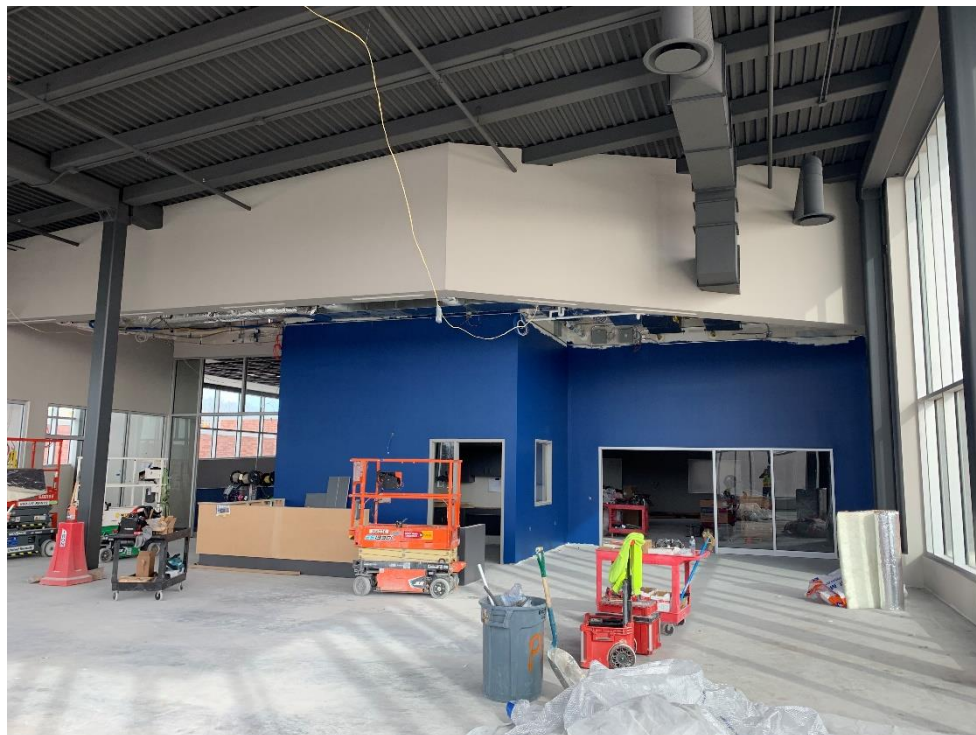
28. Area 1A – Door, borrowed light, interior storefront, and reception desk install in progress in LMC.

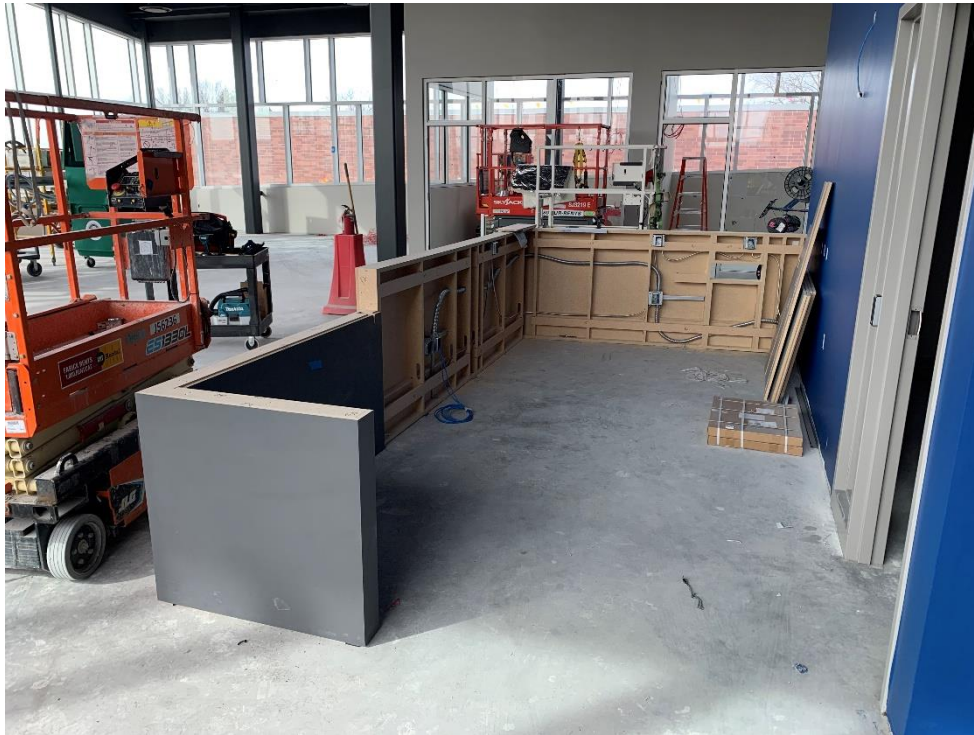
29. Area 1A – Door, borrowed light, interior storefront, and reception desk install in progress in LMC.
