# Construction Observation Report 024 – March 7th, 2025

Maplewood School

PROJECT NUMBER: 321169-01

OWNER:	MENASHA JOINT SCHOOL DISTRICT
From ARCHITECT/ENGINEER:	EUA
To CONTRACTOR	MIRON CONSTRUCTION CO, INC
SITE OBSERVATION TYPE	ARCHITECTURAL
DATE OF ISSUANCE:	March 14 <sup>th</sup> , 2025

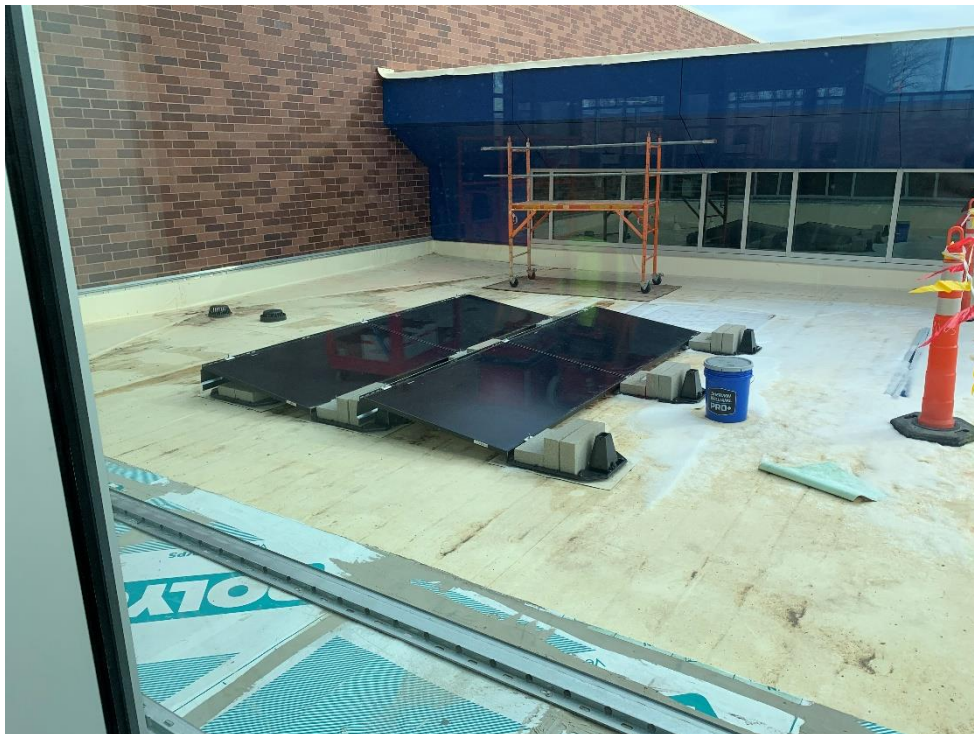
30. Area 1A – Educational solar panels have been located.

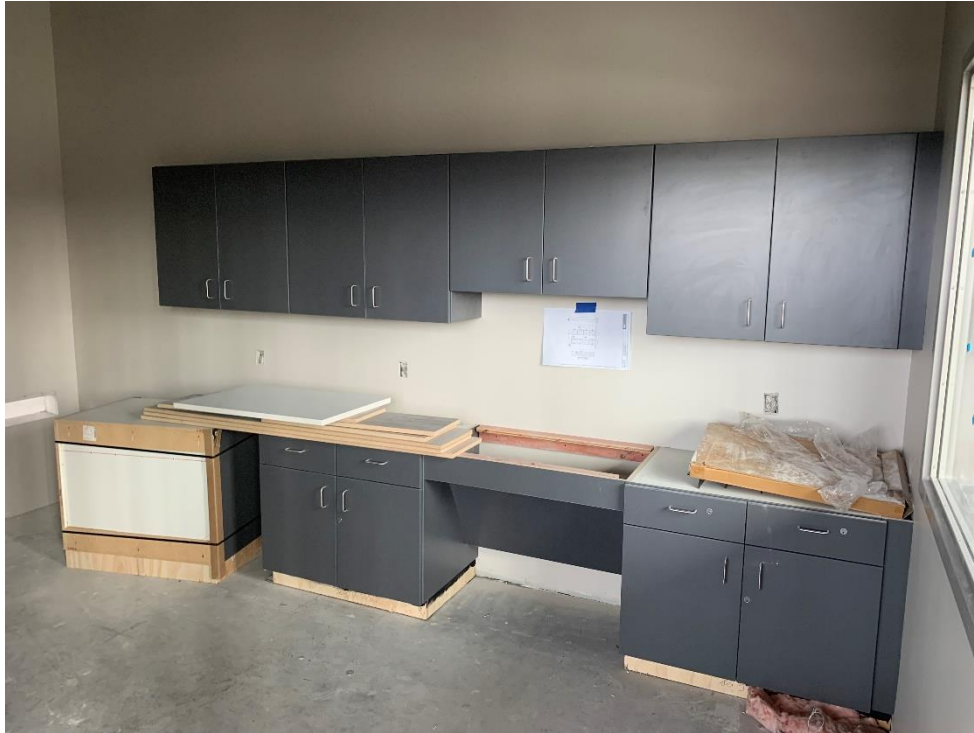
31. Area 1A – Casework install in LMC work room in progress.

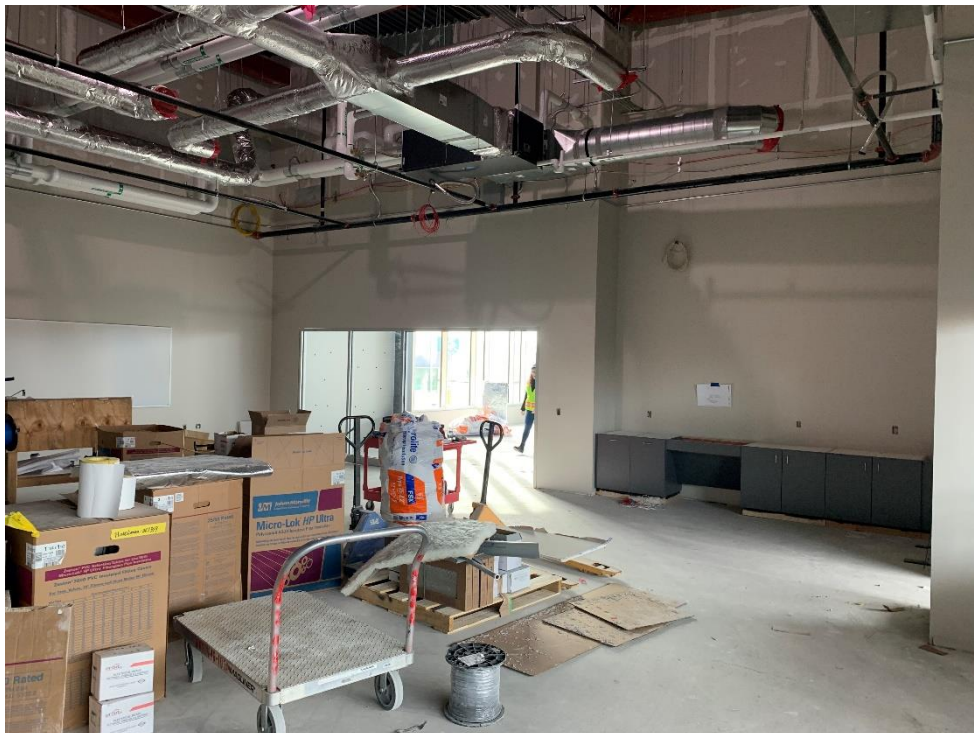
32. Area 1A – Casework install in LGI in progress
