# Construction Observation Report 024 – February 19<sup>th</sup>, 2025

Maplewood School

PROJECT NUMBER: 321169-01

| SITE OBSERVATION TYPE | ARCHITECTURAL |

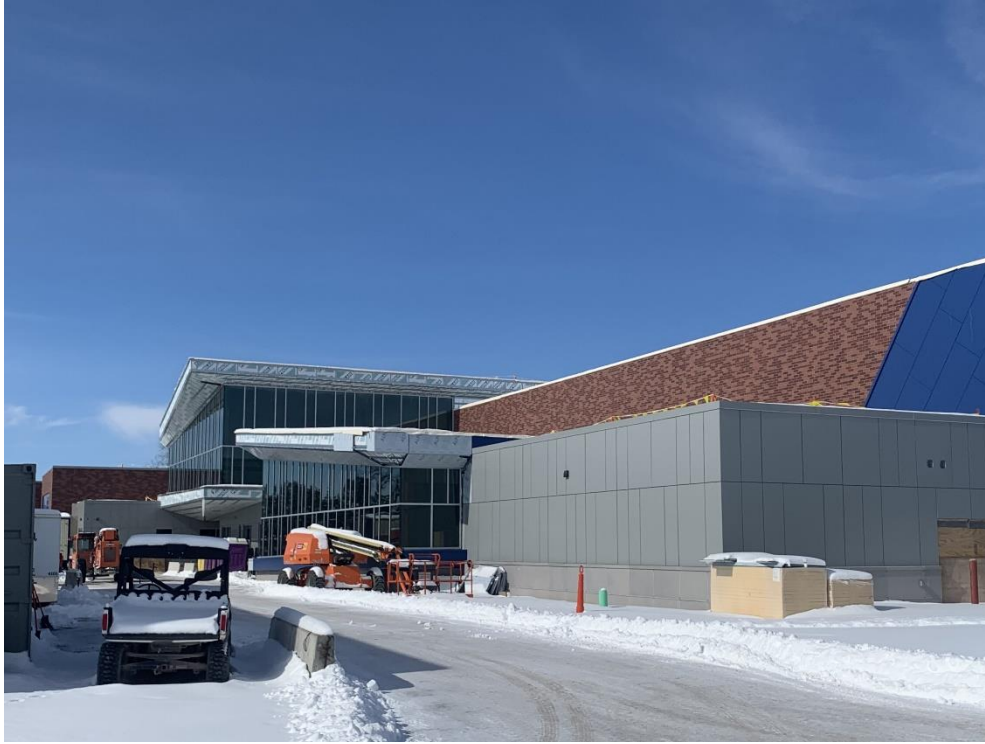
1. Area 1A & 2B South – Composite wall panel install continues at upper and lower soffits.

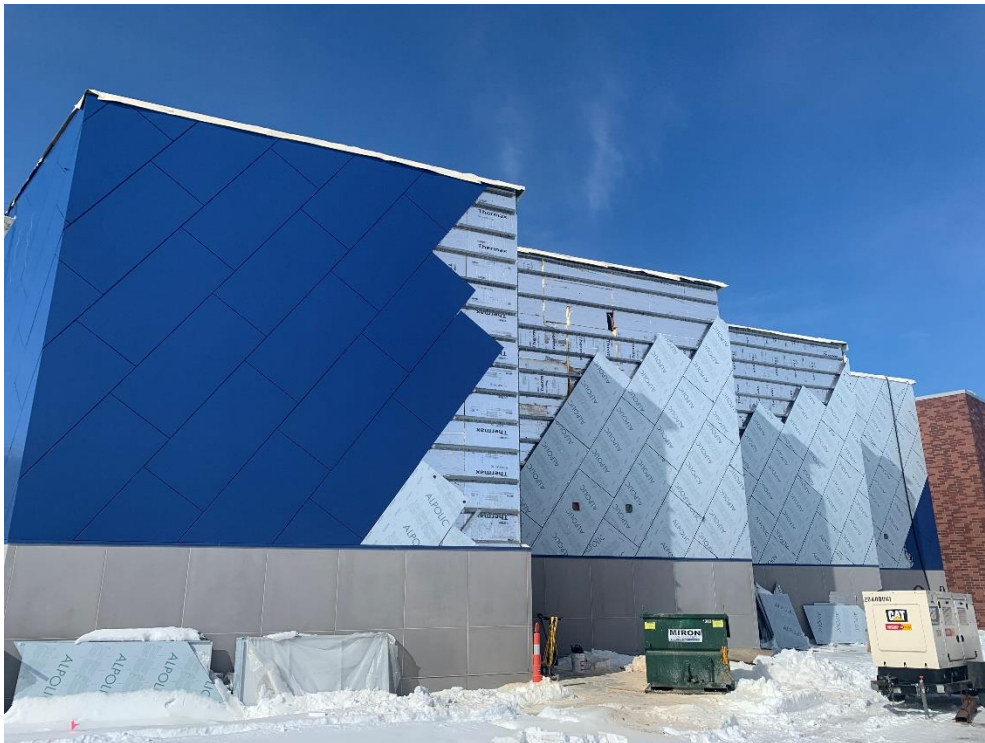
2. Area 6 – Composite wall panel install continues on east sawtooth walls.

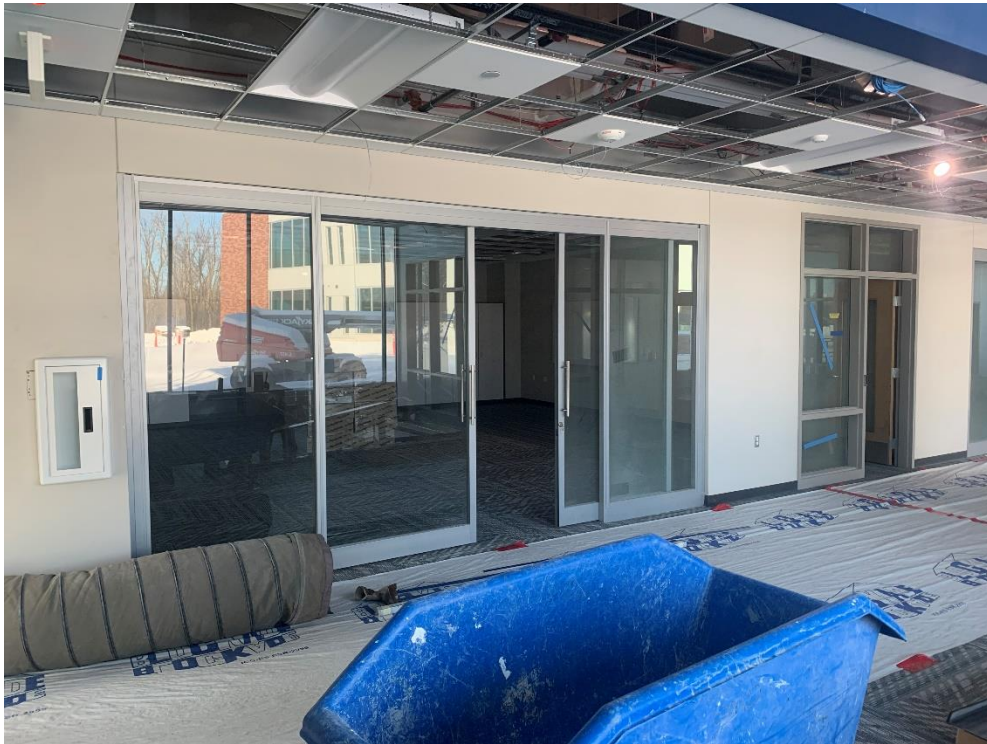
3. Area 6 – Sliding door system appears to be installed in first floor classrooms. Wall base appears to be installed throughout area.

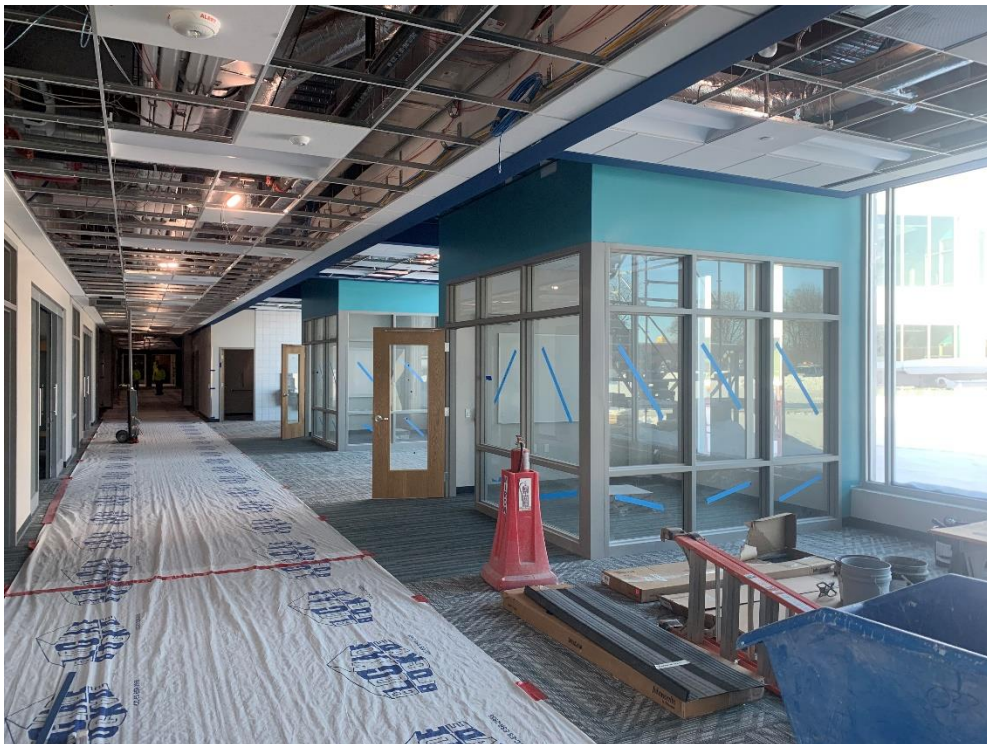
4. Area 6 – Doors, lites, and hardware appear to be installed in first floor collab area. Exterior window sill install in progress.

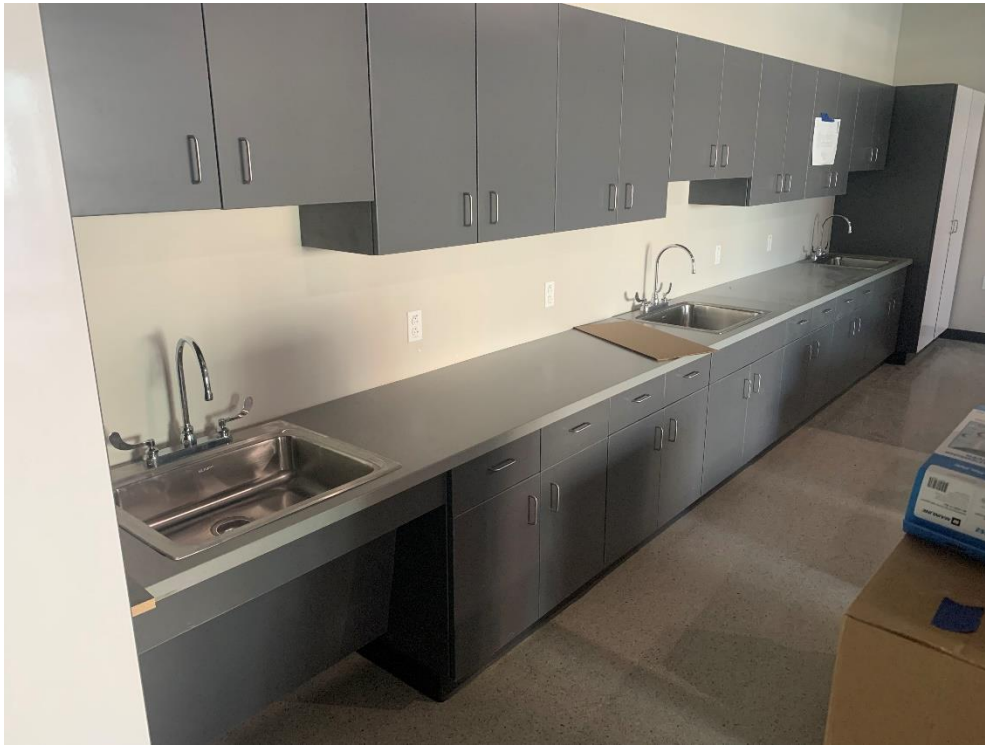
5. Area 6 – Countertop and sinks appears to be installed in science classroom.

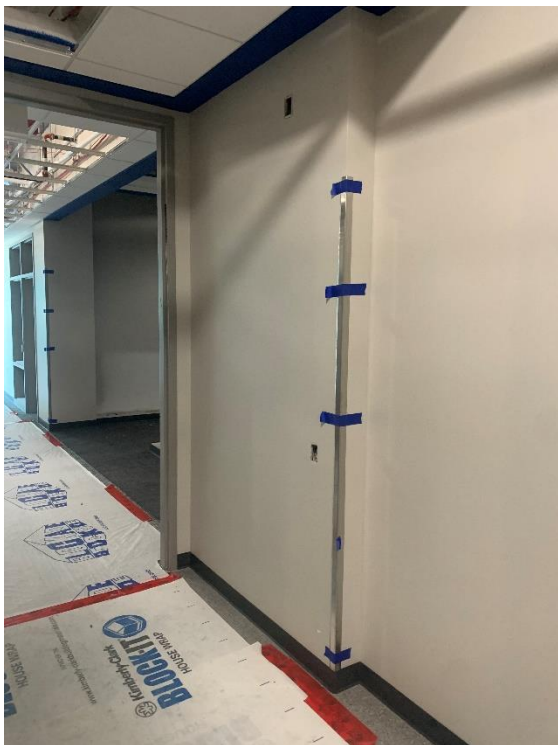
6. Area 6 – Corner guard install in progress throughout first floor area.

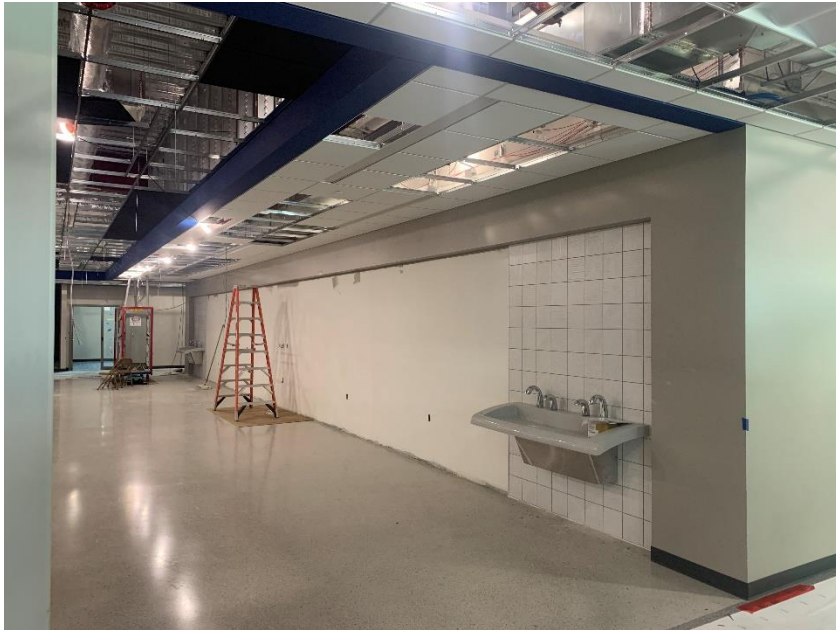
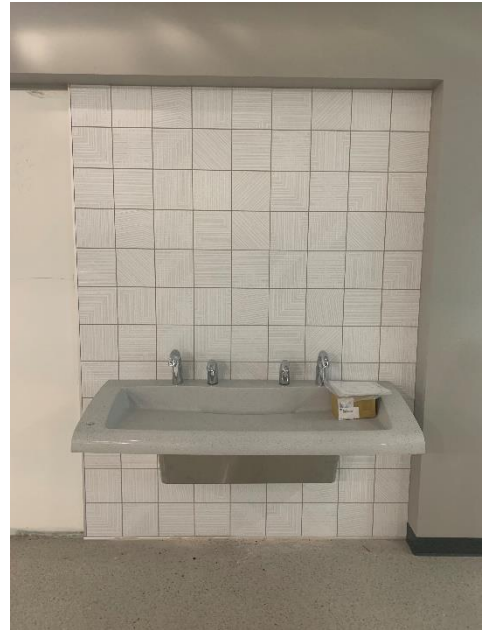
7. Area 5 – Wall tile and sinks at teaching wall in first floor flex café appear to be installed.

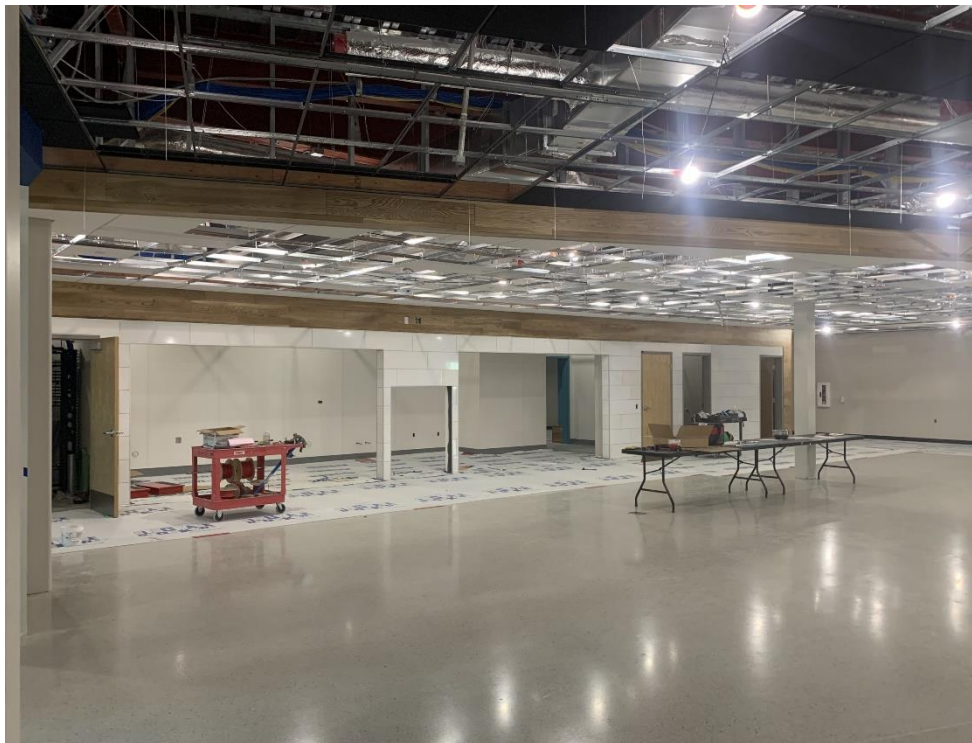
8. Area 5 – Wall tile, FRP wall panels, and doors appear to be installed in first floor servery.

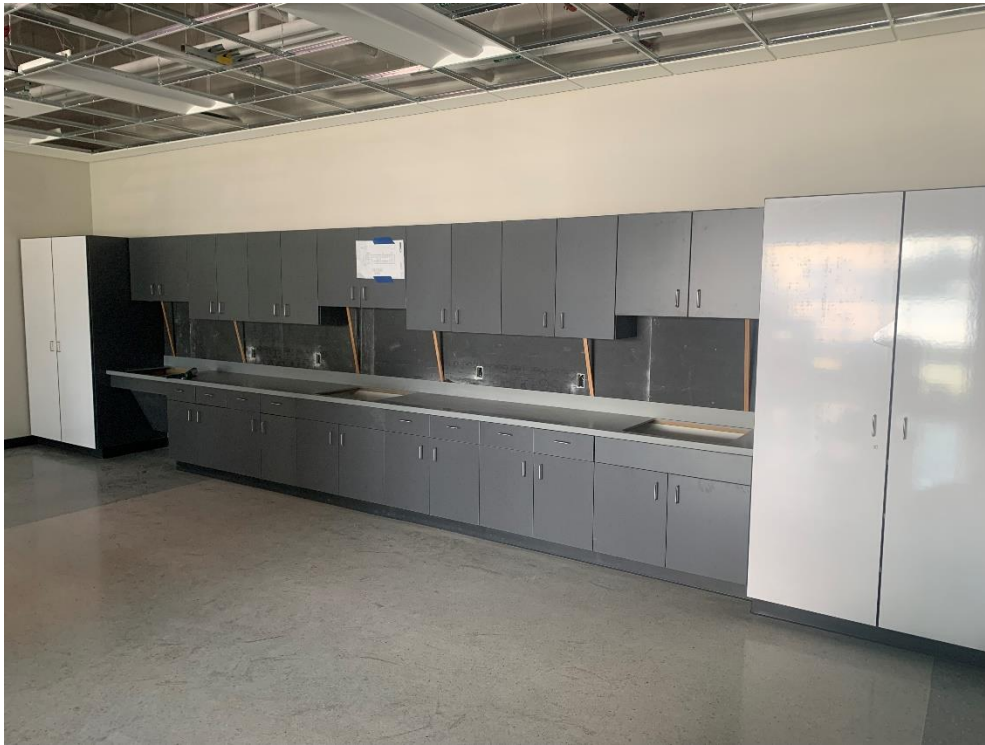
9. Area 5 – Countertop install in progress in first floor science classrooms.

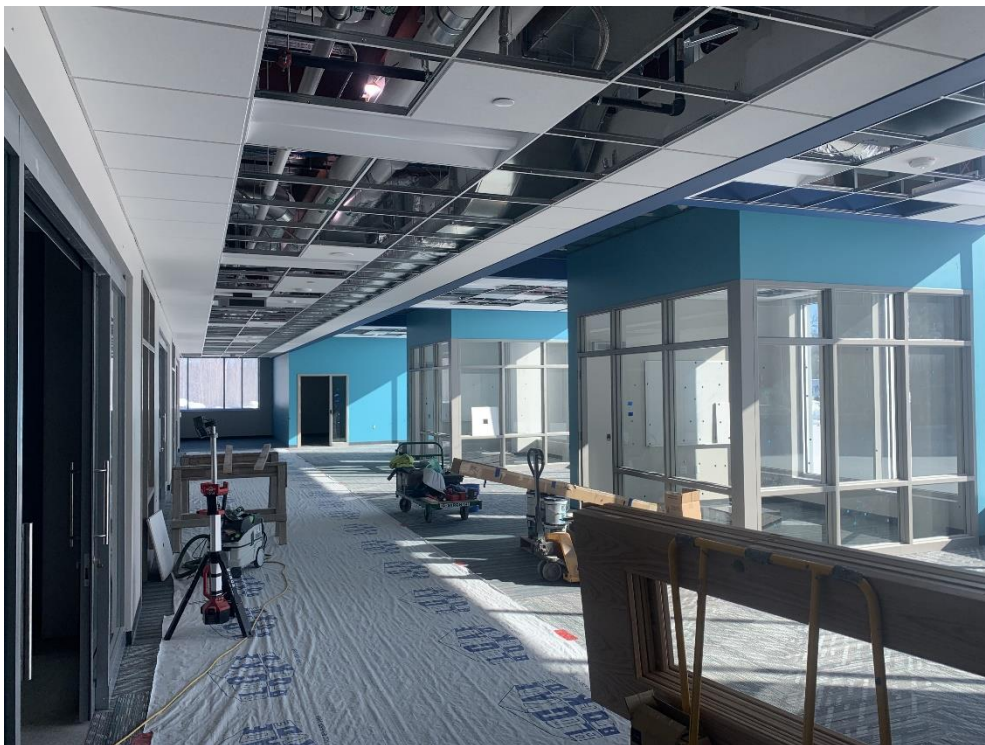
10. Area 5 – Door install in first floor collab area in progress. Wall base appears to be installed throughout area.

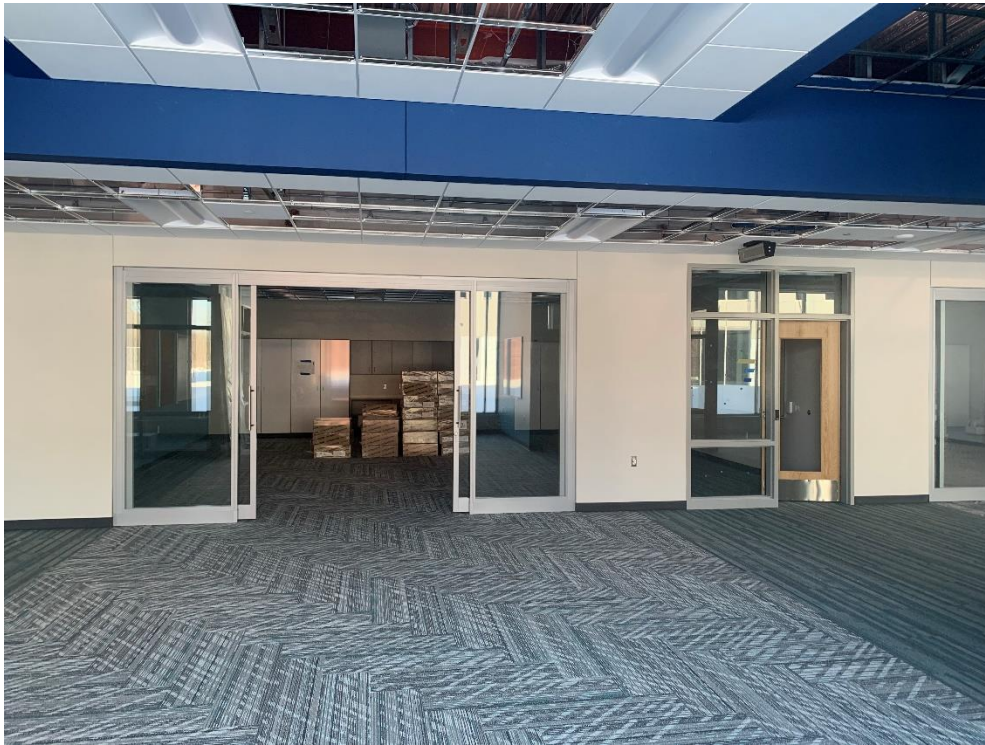
11. Area 5 – Sliding door system appears to be installed in first floor classrooms.

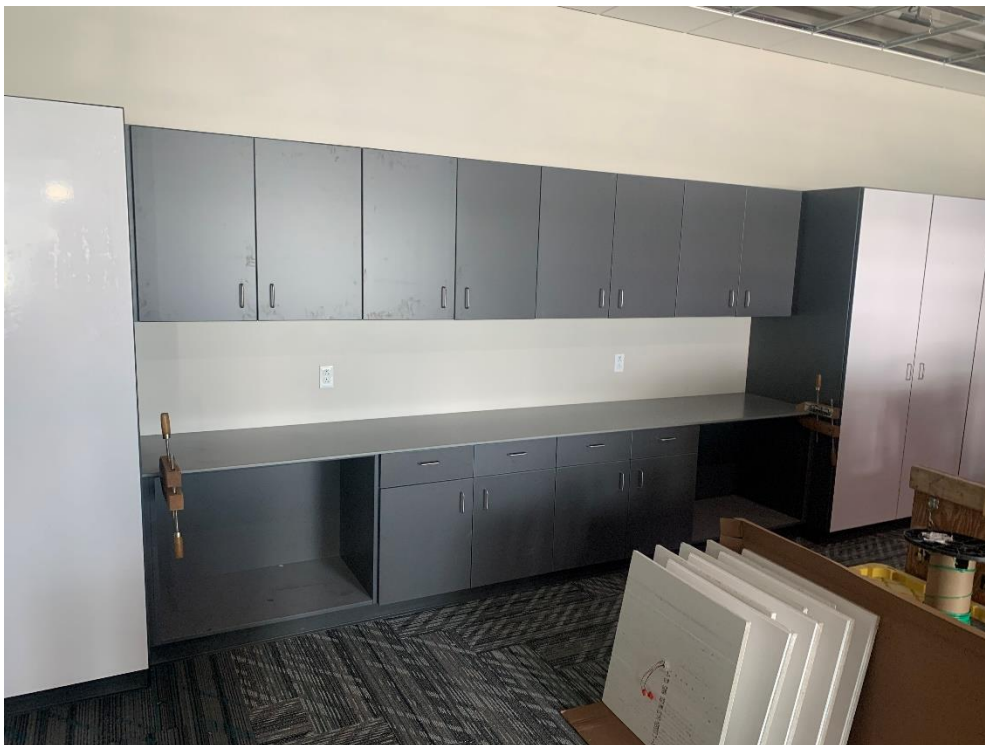
12. Area 5 – Countertop install in progress in first floor classrooms.

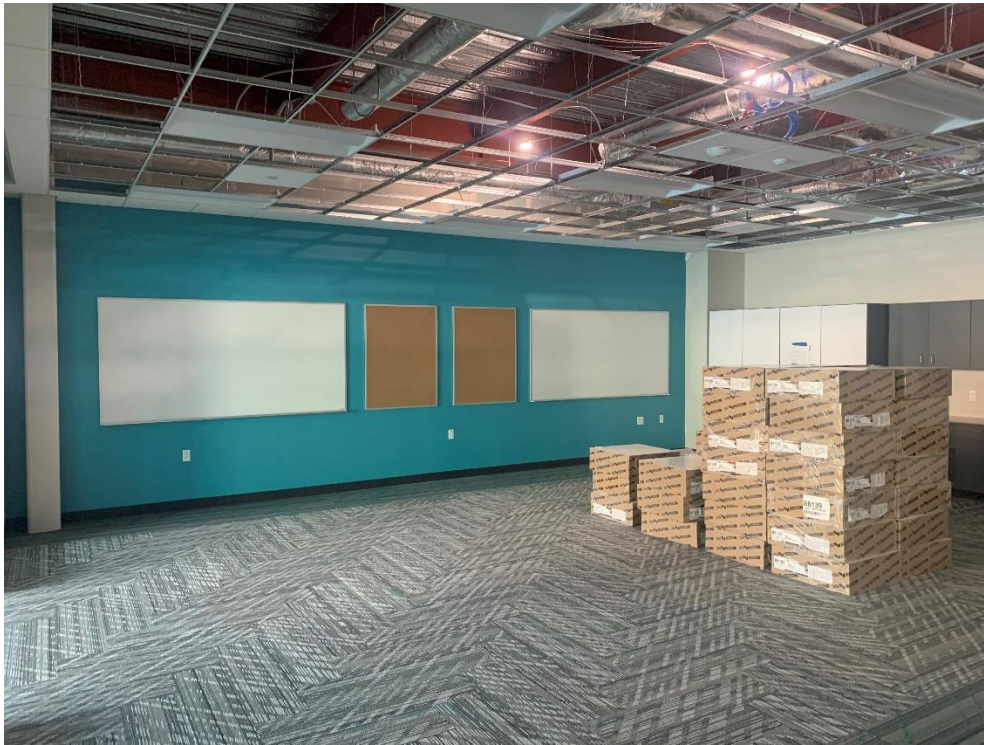
13. Area 5 – Tack and whiteboards appear to be installed in first floor classrooms.

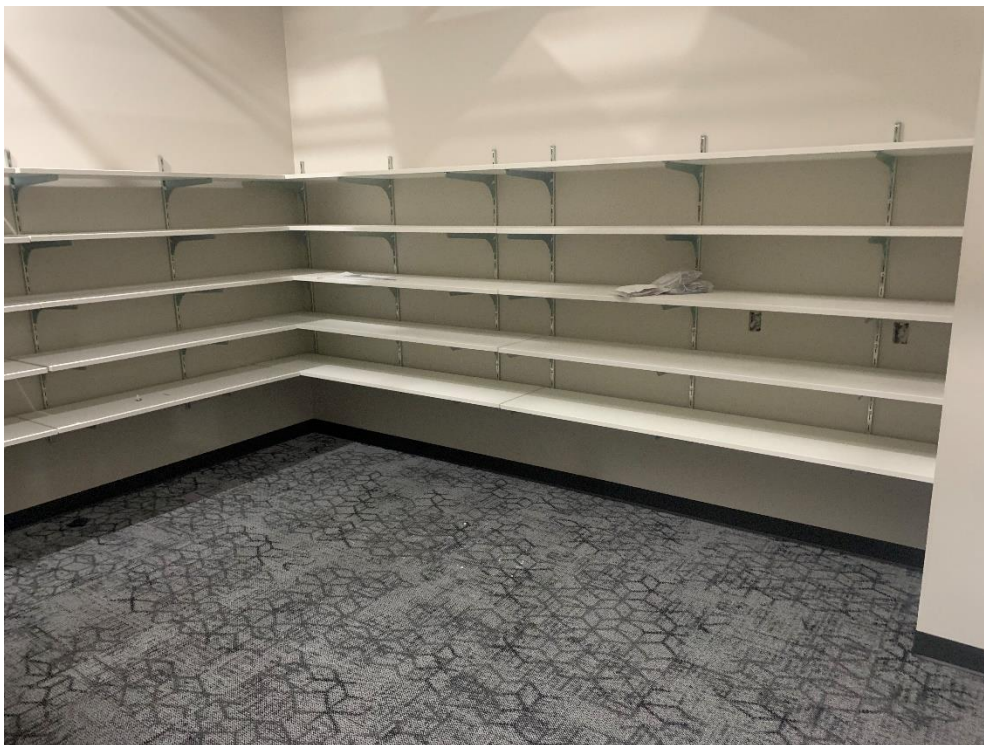
14. Area 6 – Shelving and wall mounted equipment appear to be installed in CLC office.

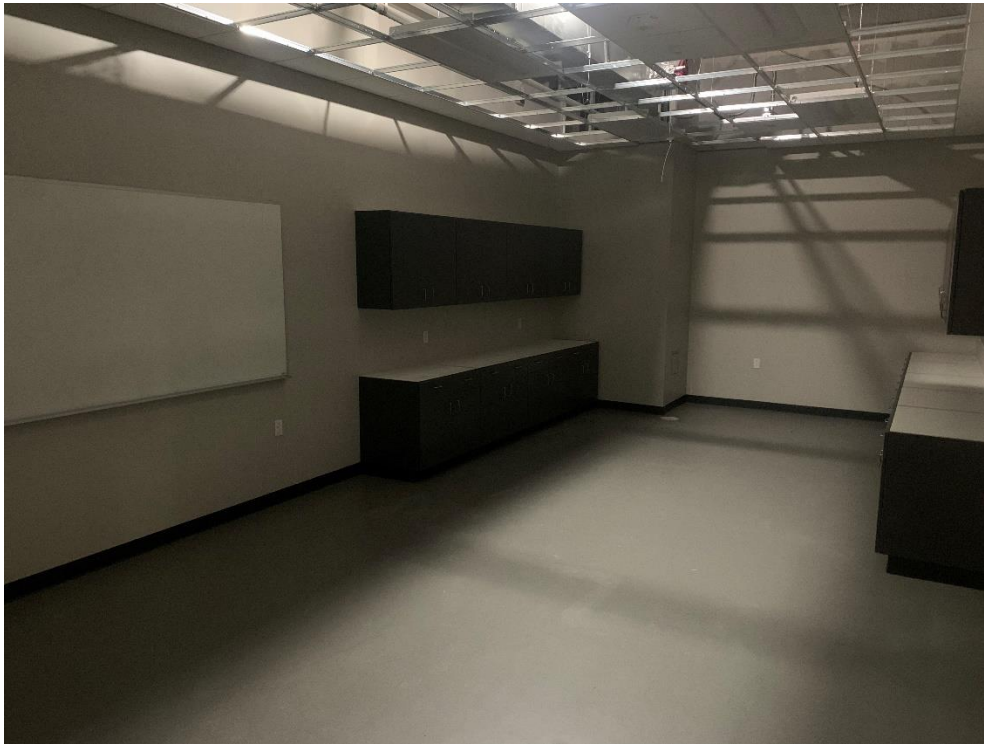
15. Area 6 – Casework and markerboards appear to be installed in first floor work room. Counter top install in progress.

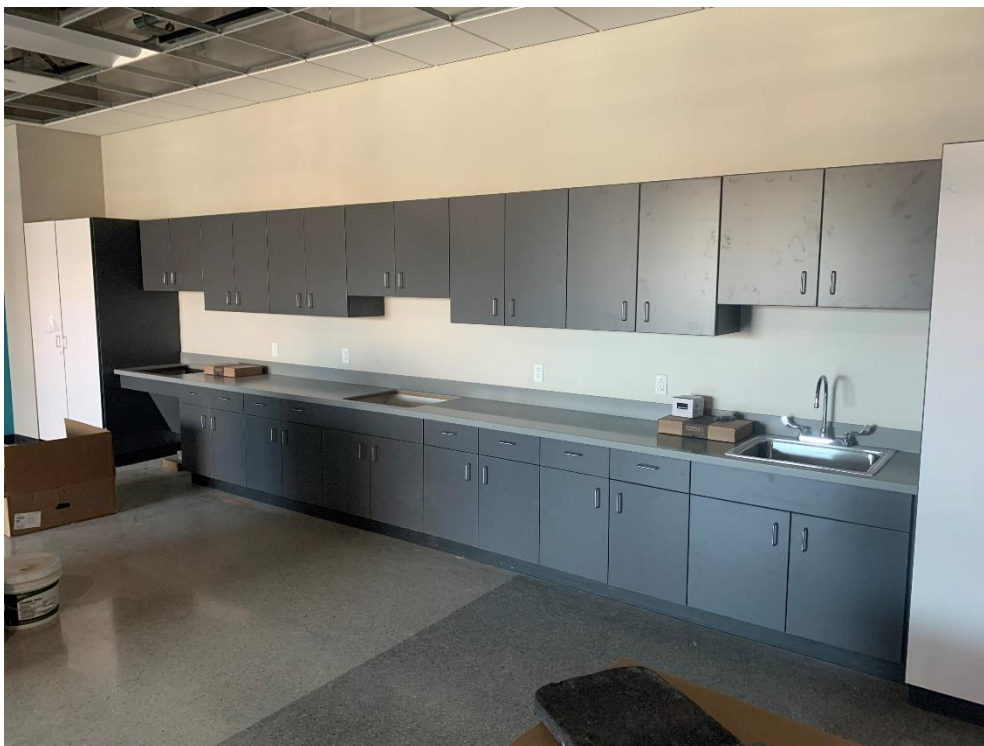
16. Area 6 – Countertop in second floor science classroom appears to be installed. Sink install in progress.

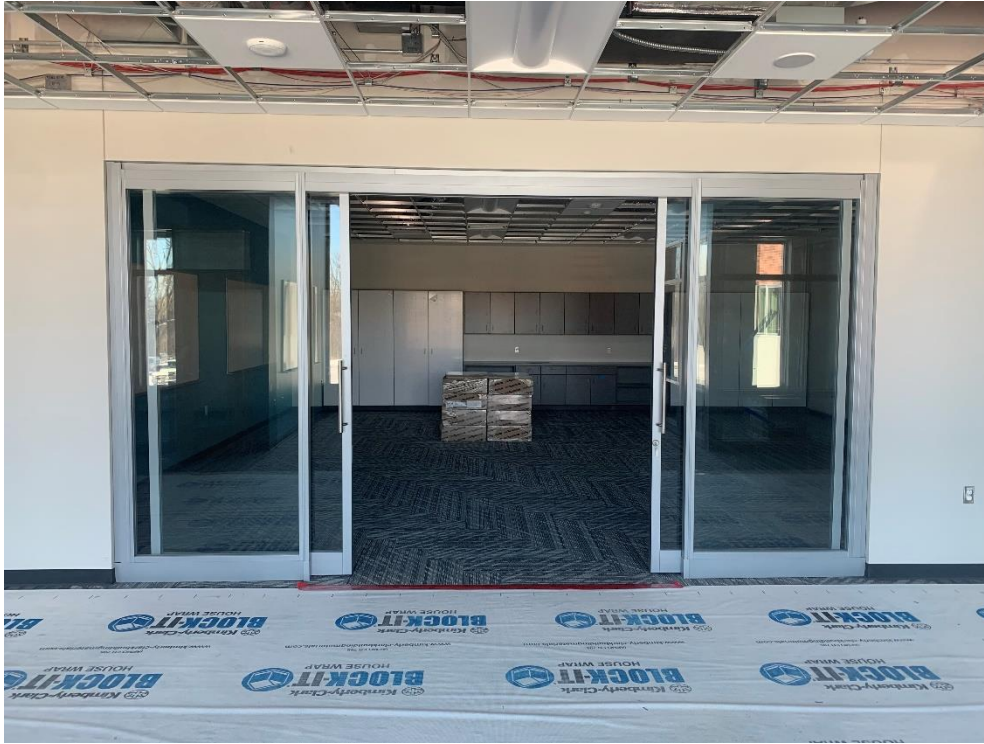
17. Area 6 – Sliding door system appears to be installed in second floor classrooms.

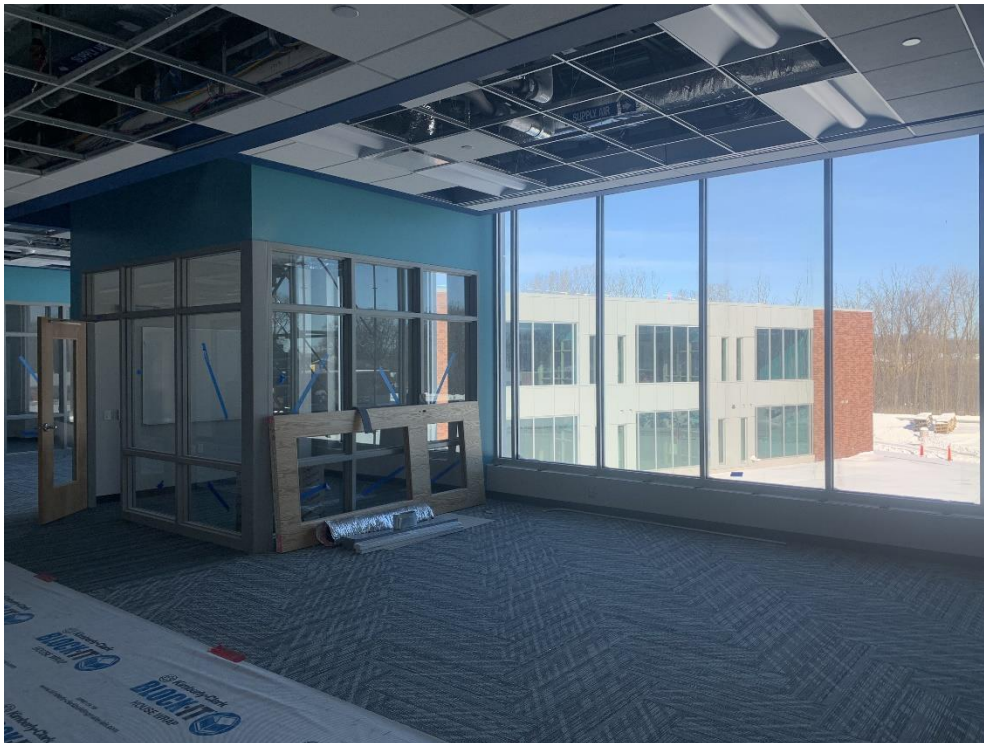
18. Area 6 – Wall base appears to be installed throughout second floor area. Window sill install in progress.

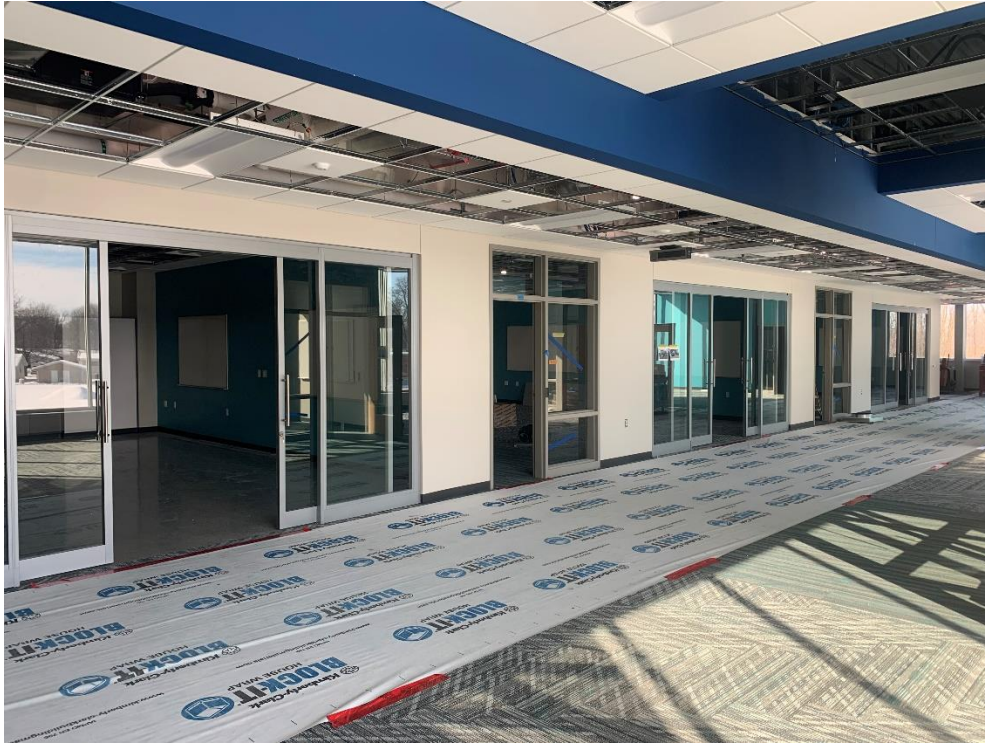
19. Area 5 – Sliding door system appears to be installed in second floor classrooms. Wall base appears to be installed throughout the area.

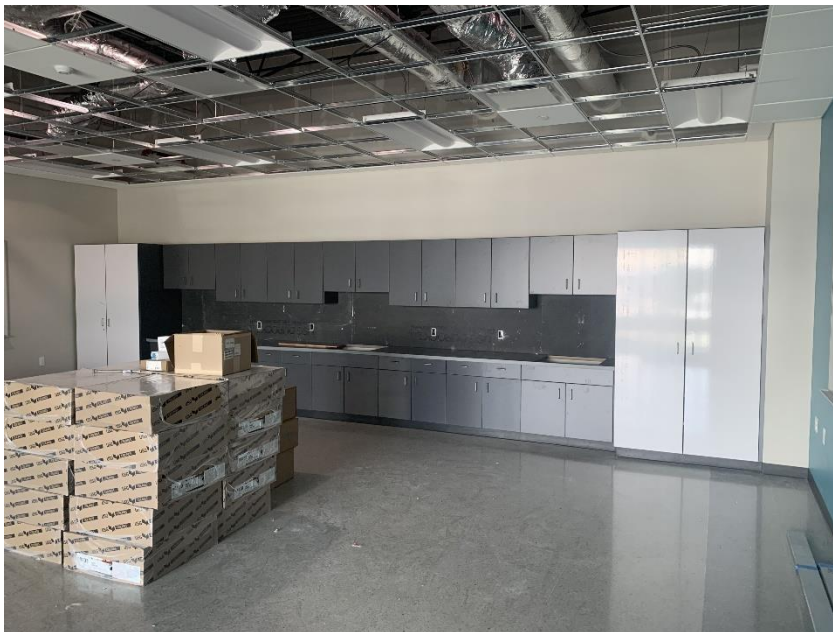
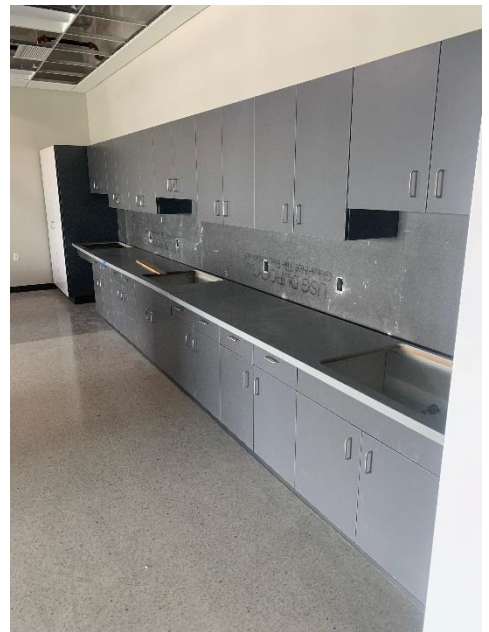
20. Area 5 – Countertop install in second floor science classrooms in progress.

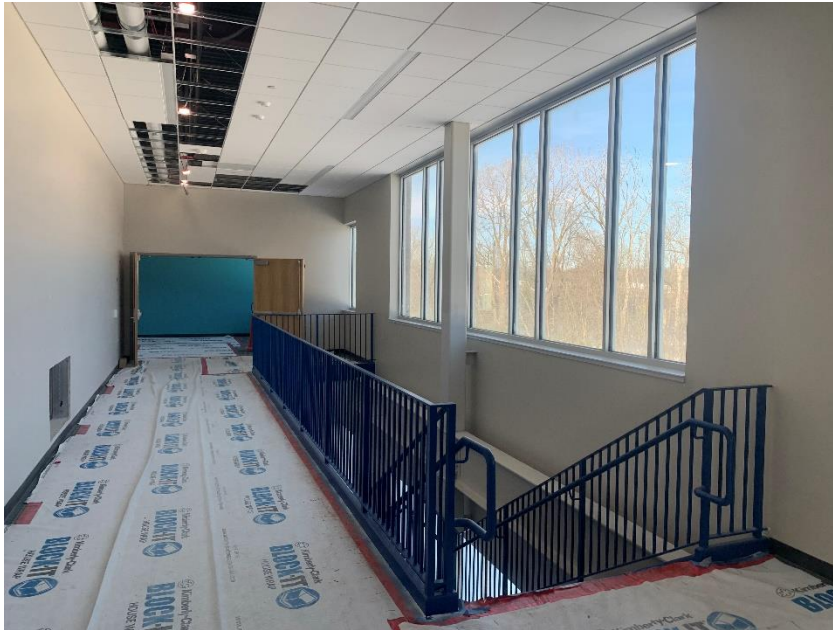
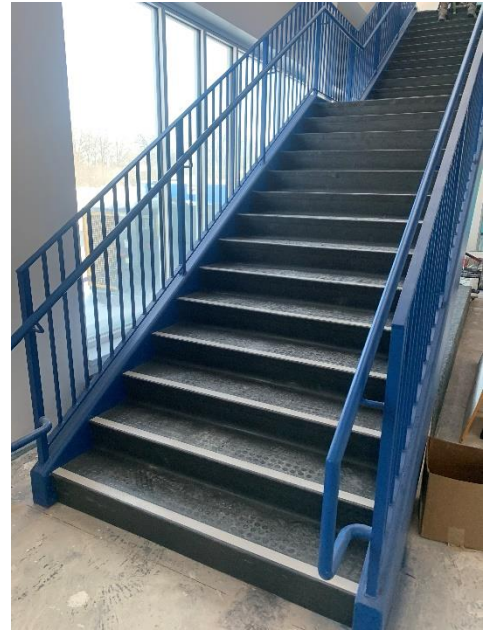
21. Area 5 – Stair railing system in north stair appears to be painted. Stair nosing and threads appear to be installed.

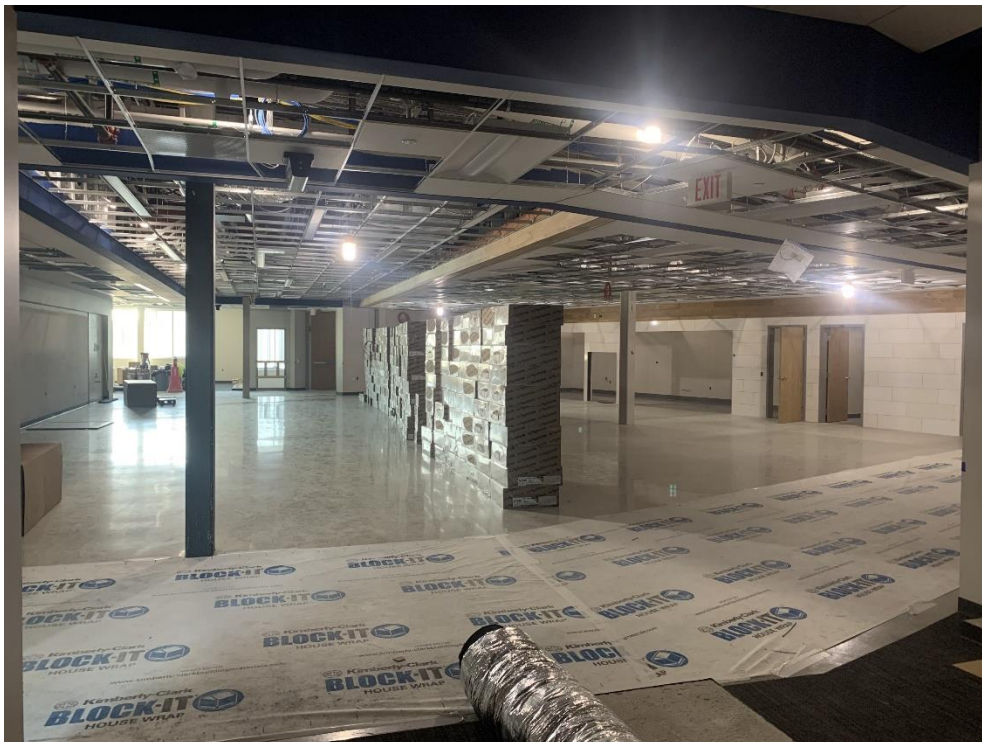
22. Area 5 – Wall tile appears to be installed in second floor flex café.

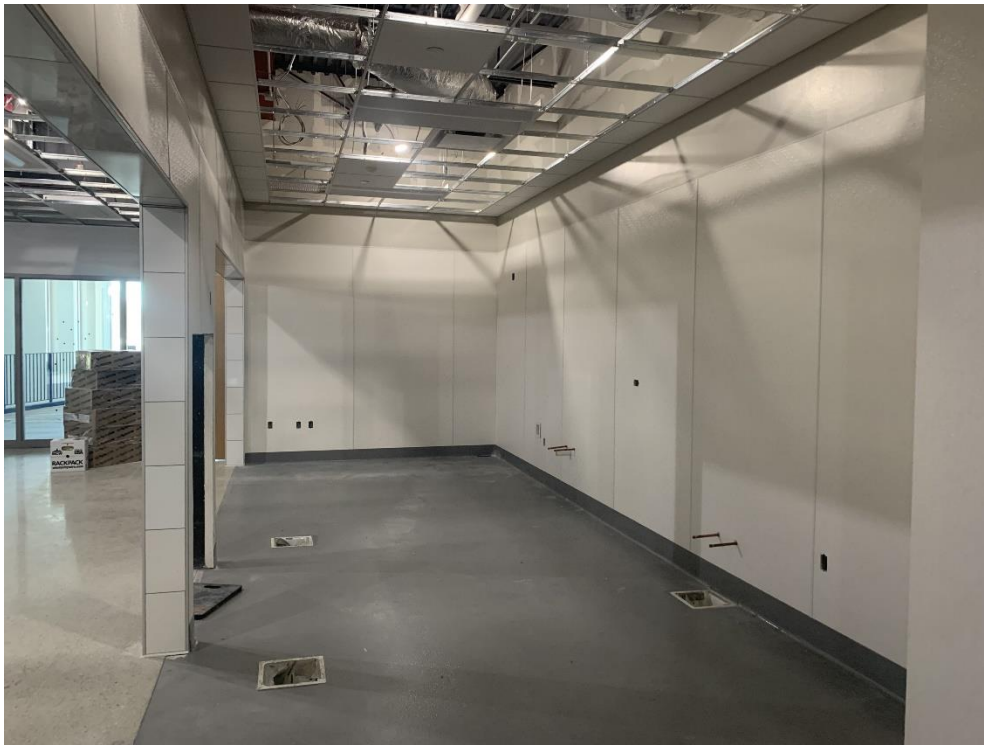
23. Area 5 – FRP wall panels appear to be installed in second floor server.

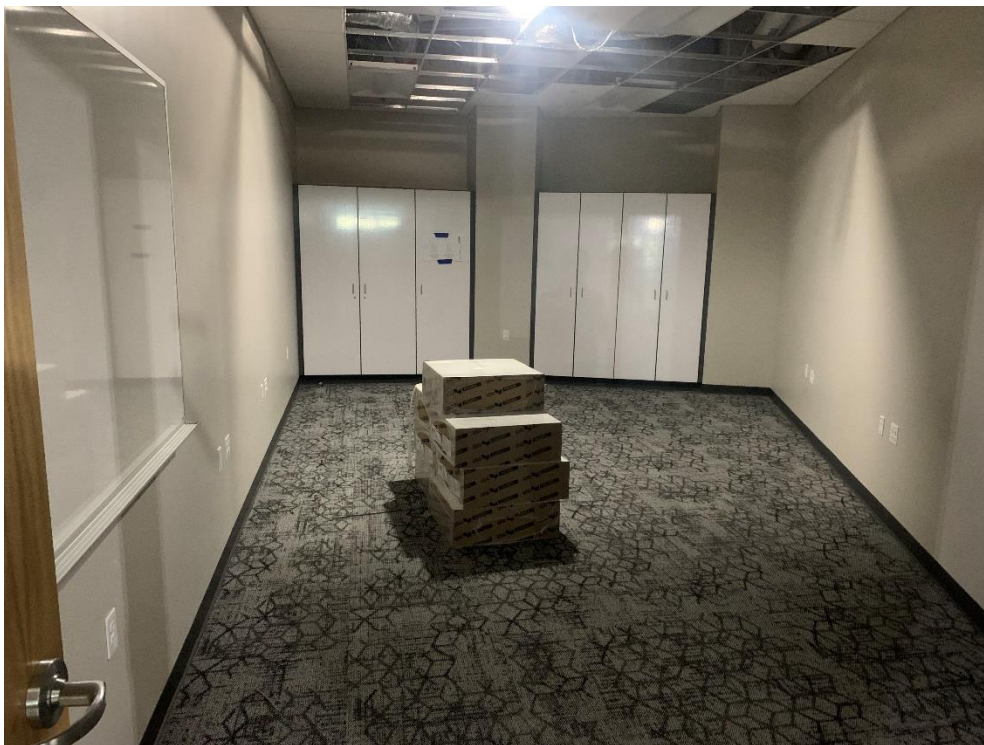
24. Area 5 – Carpet, casework and marker board appears to be installed in second floor ELL Office.

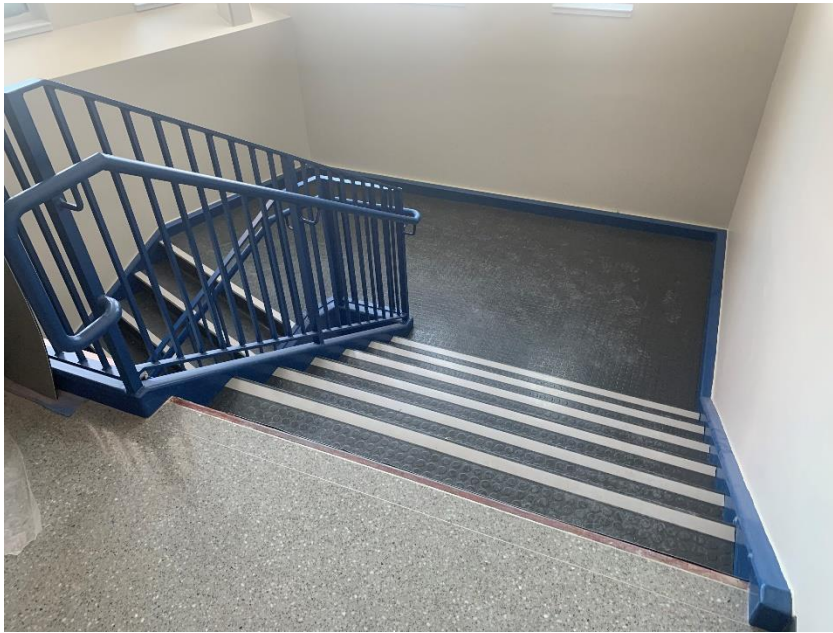
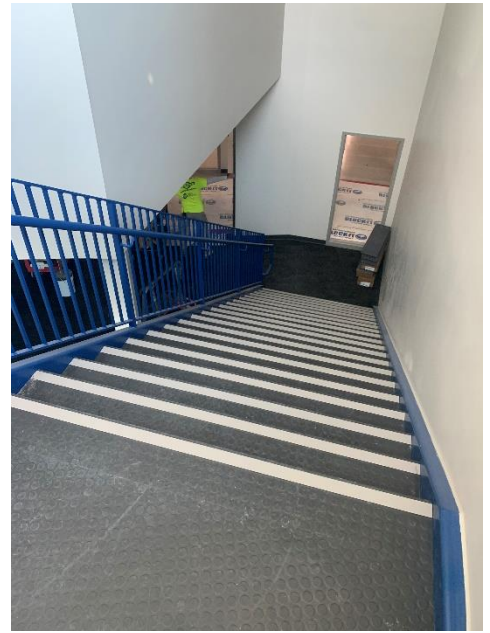
25. Area 5 - Stair railing system in knuckle stair appears to be painted. Stair nosing and threads appear to be installed.

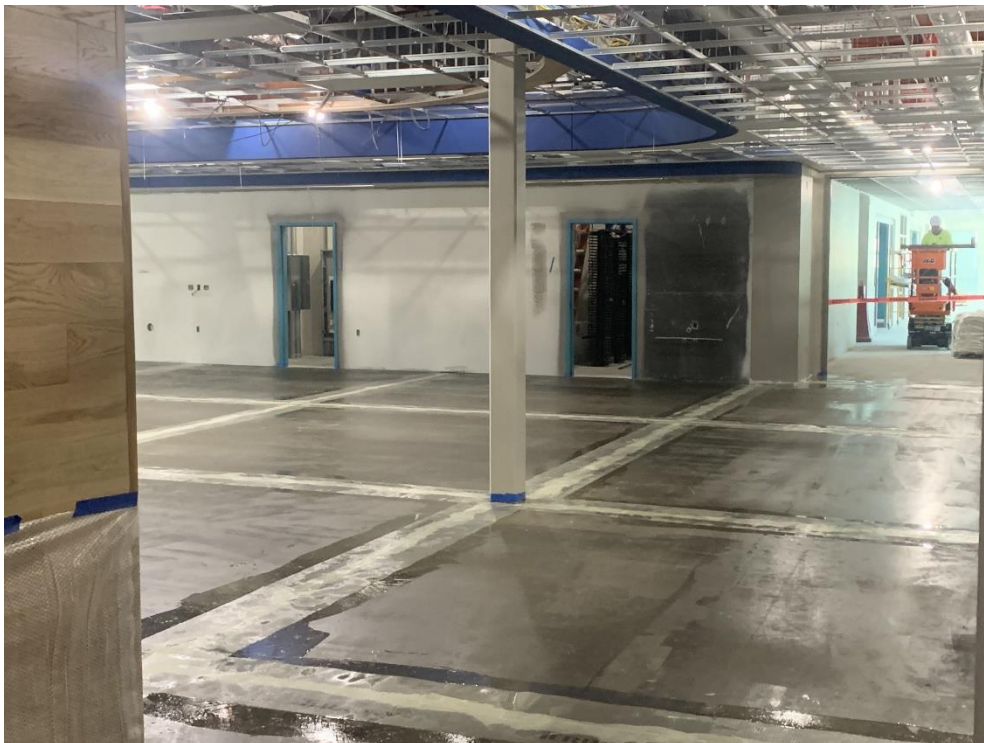
26. Area 3 – Terrazzo flooring install in progress at first floor flex café.

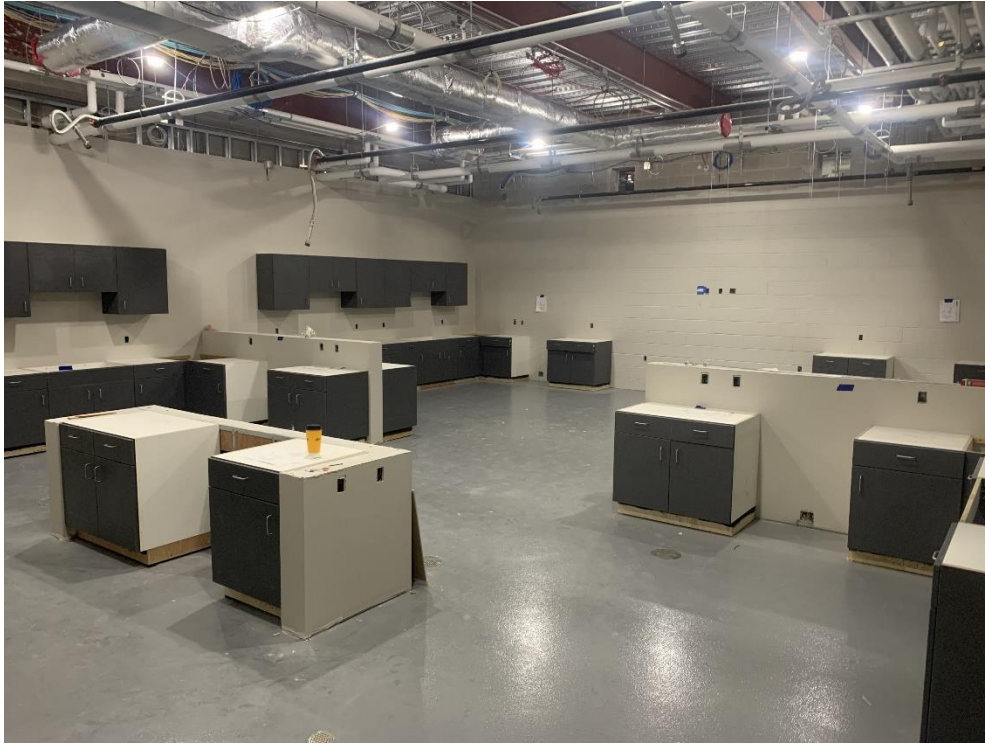
27. Area 3 – Casework install in Culinary Lab in progress.

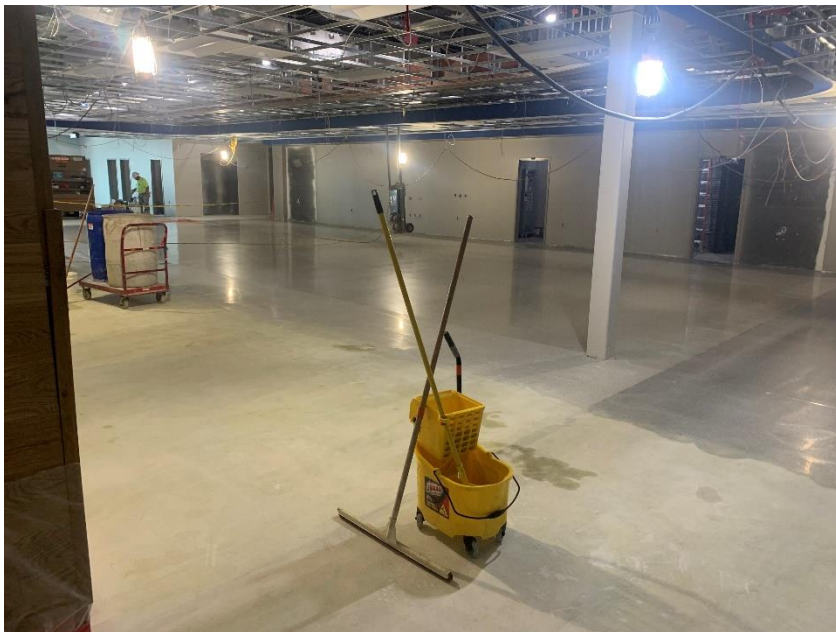
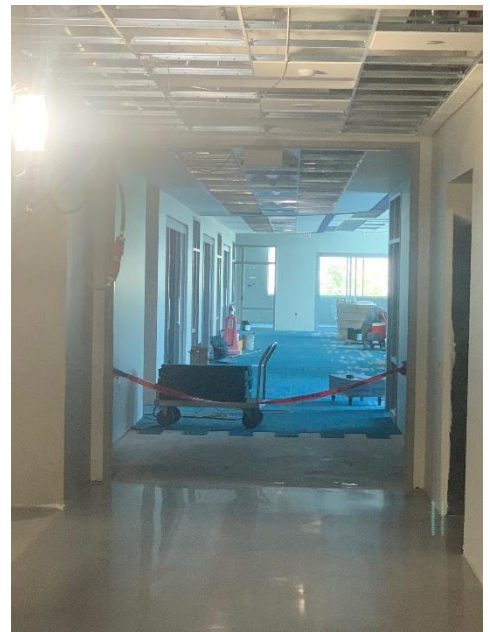
28. Area 3&4 – Terrazzo floor is getting sealed in second floor flex café and carpet install in gradewing area in progress.

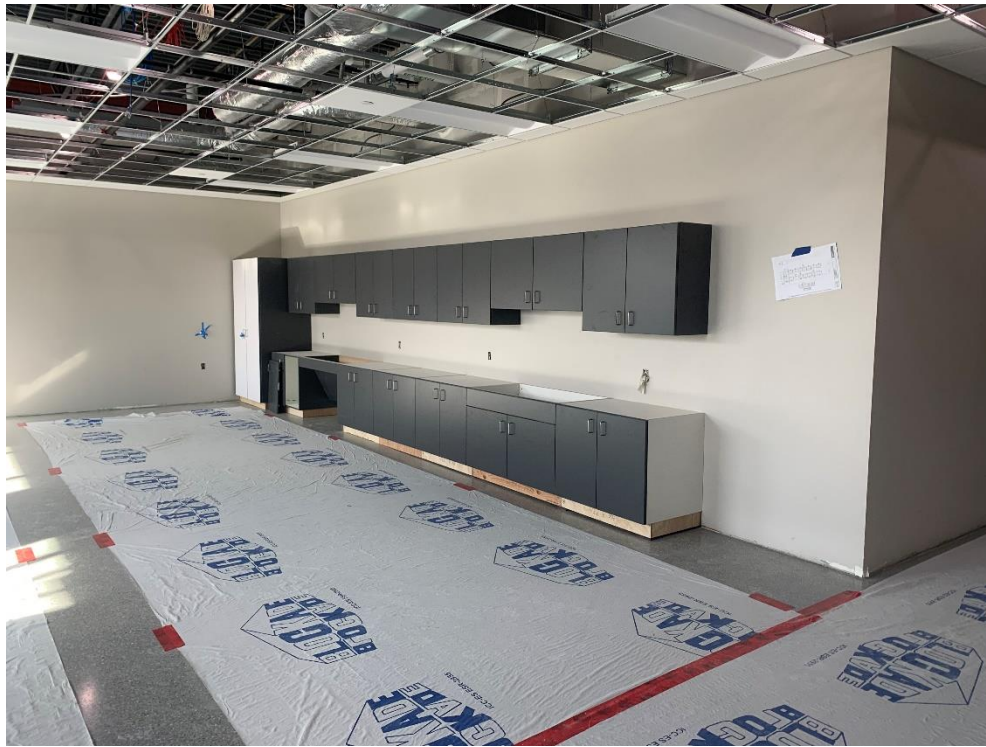
29. Area 3 – Terrazzo flooring appears to be installed in the art rooms. Casework install in progress.

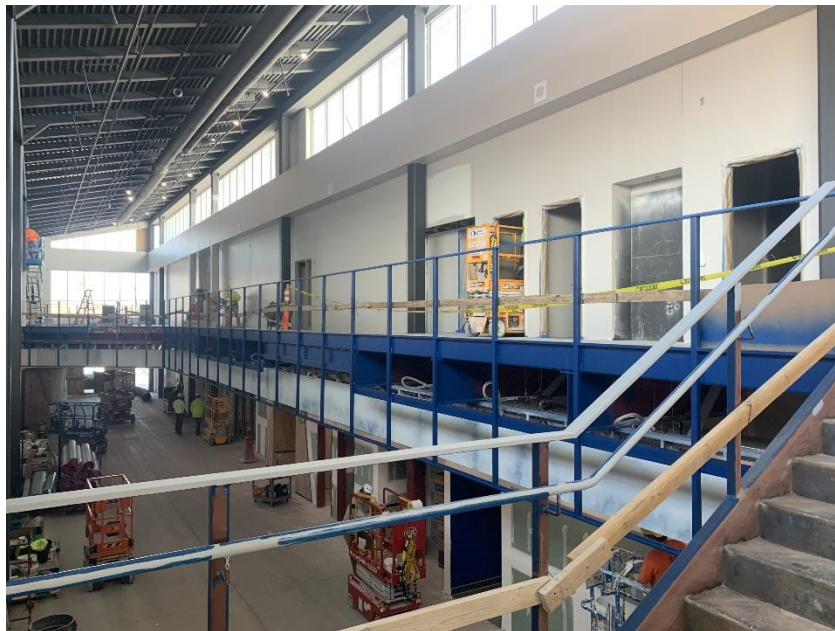
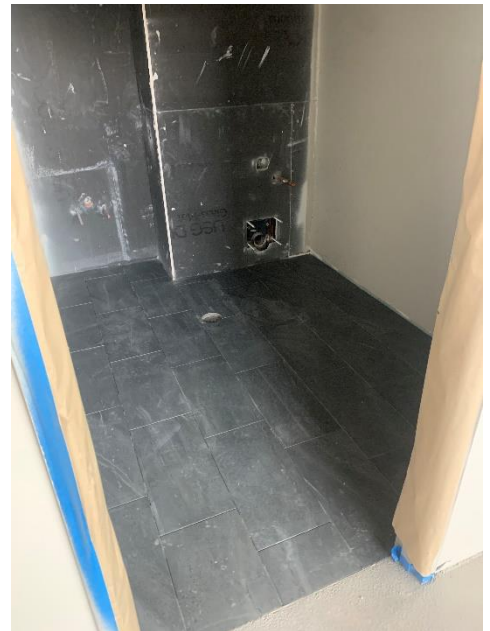
30. Area 1A&B – Painting of second floor center spine and tile install in toilet rooms in progress.
