# Construction Observation Report 024 – February 19<sup>th</sup>, 2025

Maplewood School

PROJECT NUMBER: 321169-01

| SITE OBSERVATION TYPE | ARCHITECTURAL |

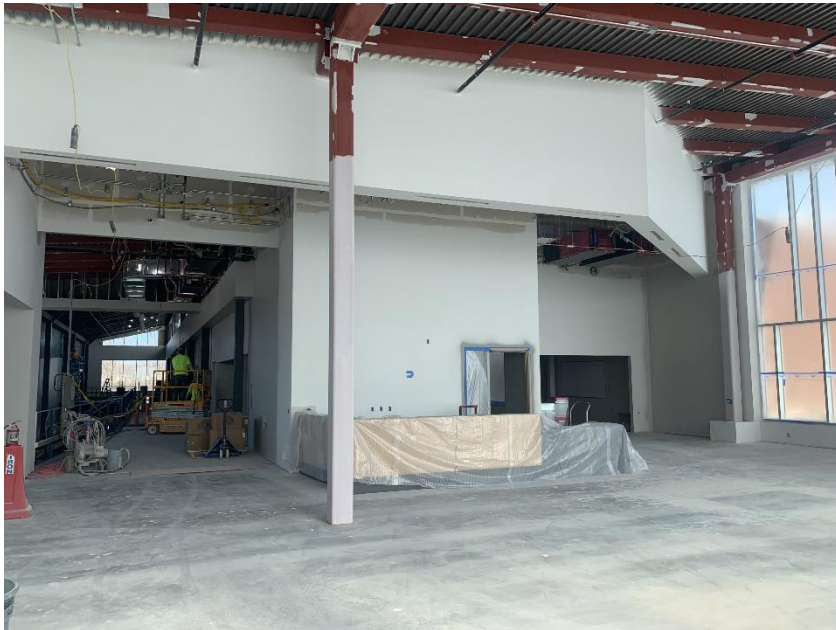
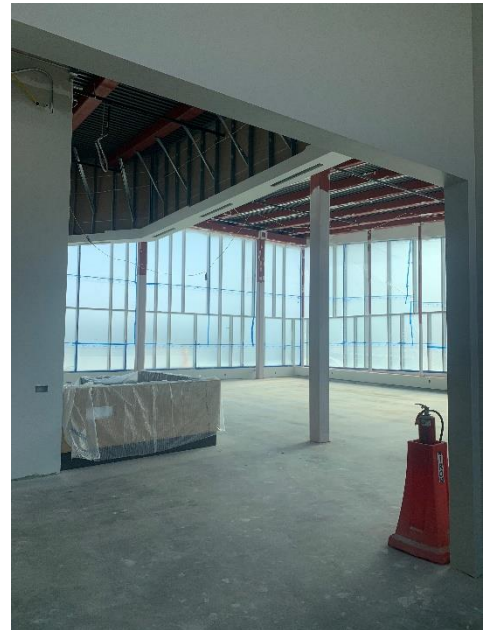
31. Area 1A – Painting and reception desk install in LMC in progress.

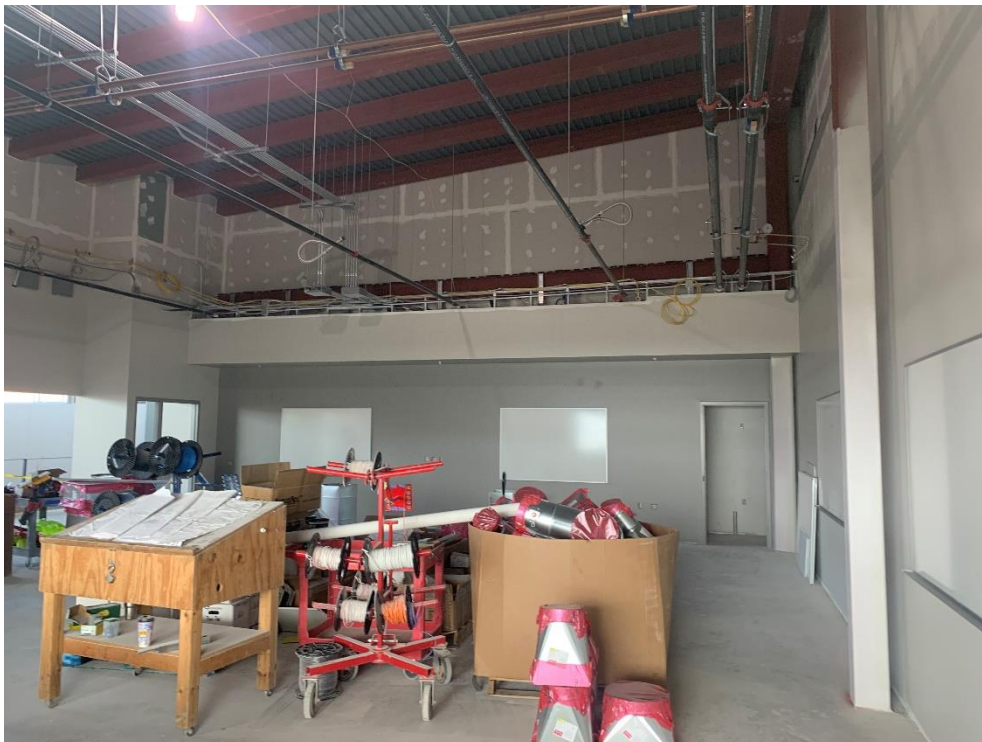
32. Area 1A – Painting appears to be complete in community room. Wall mounted equipment install in progress.

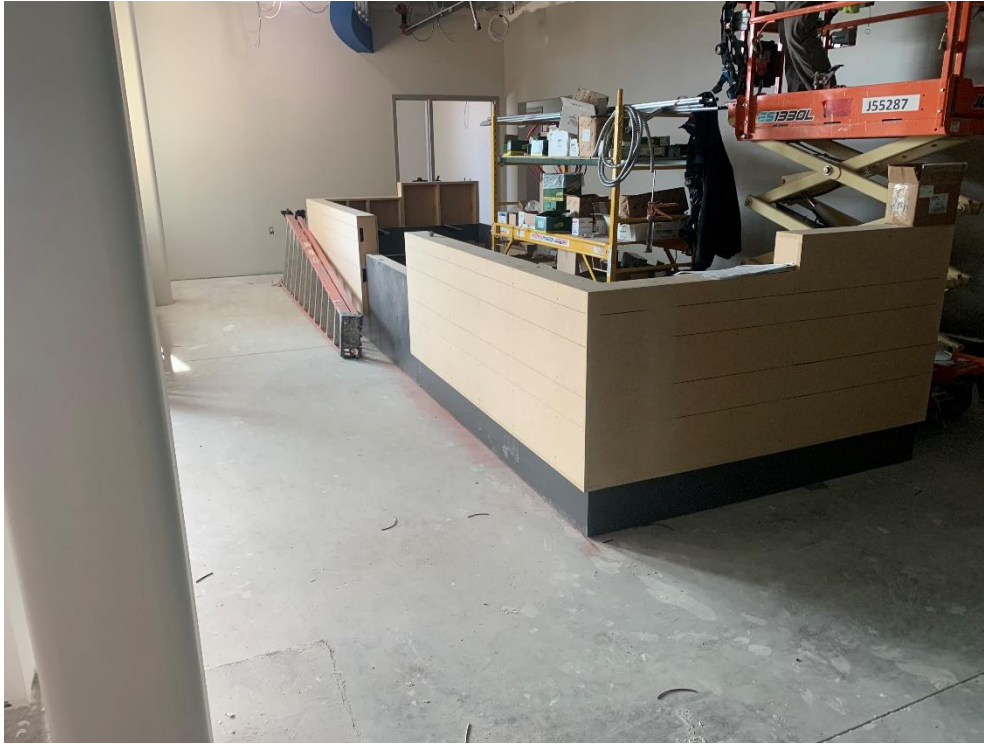
33. Area 1A – Reception desk in 5/6 office install continues.

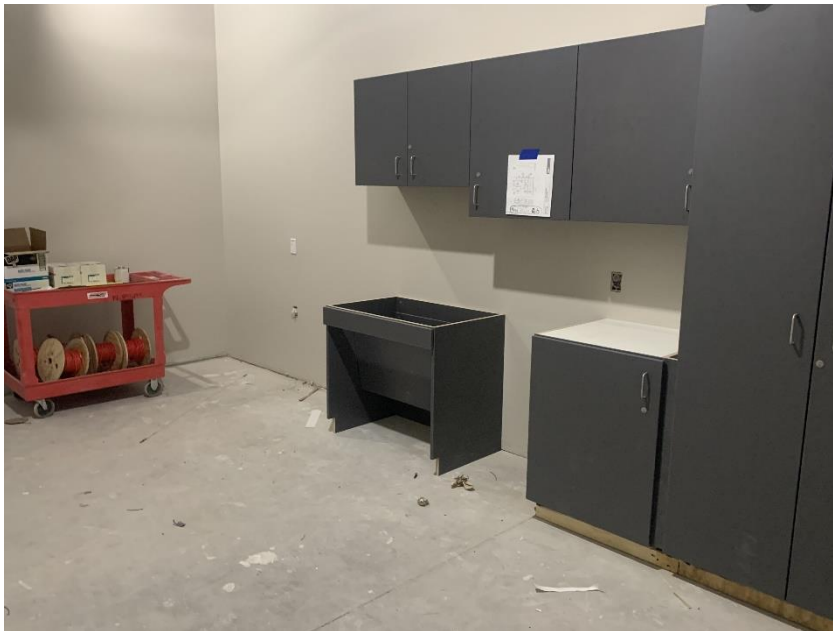
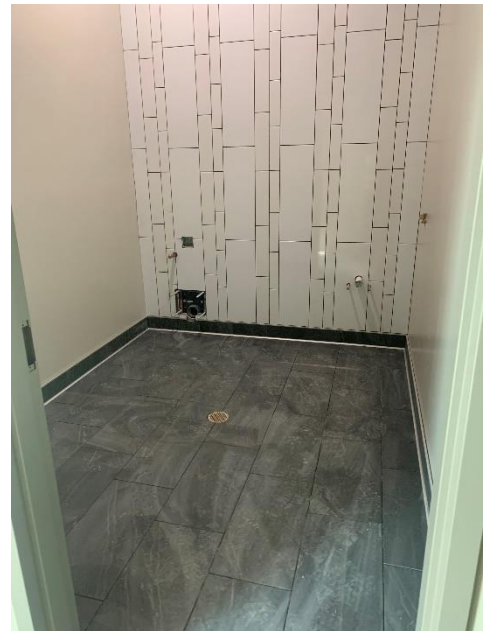
34. Area 1A – Casework install in nurse suite in progress. Wall and floor tile in nurse toilet room appears to be installed.

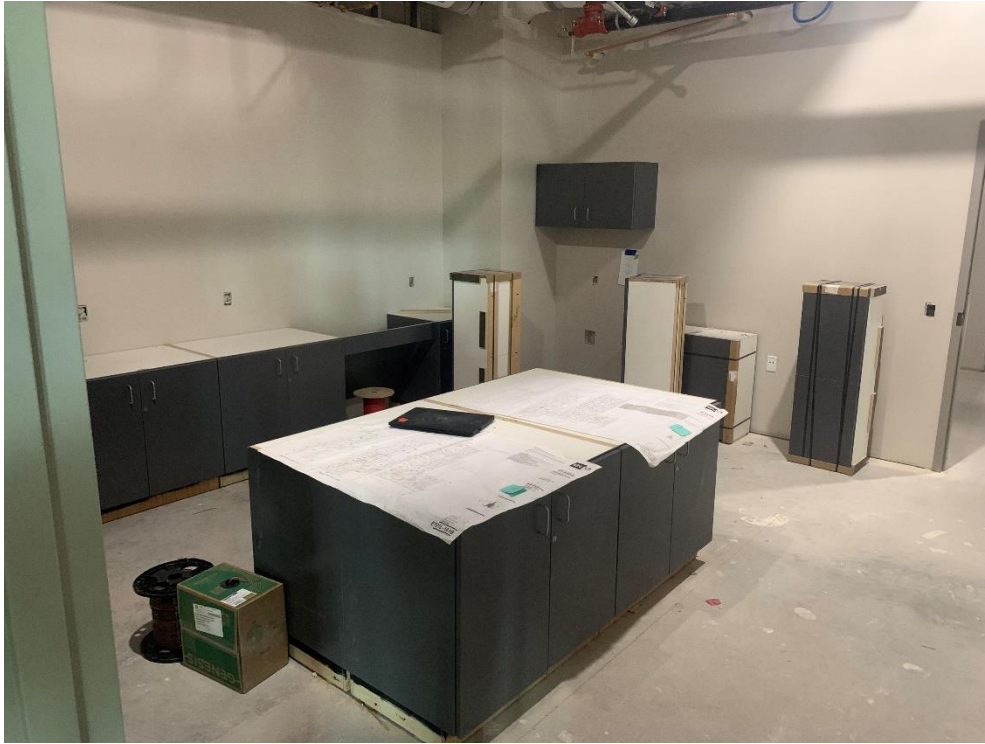
35. Area 1A – Casework install in 5/6 admin work room in progress.

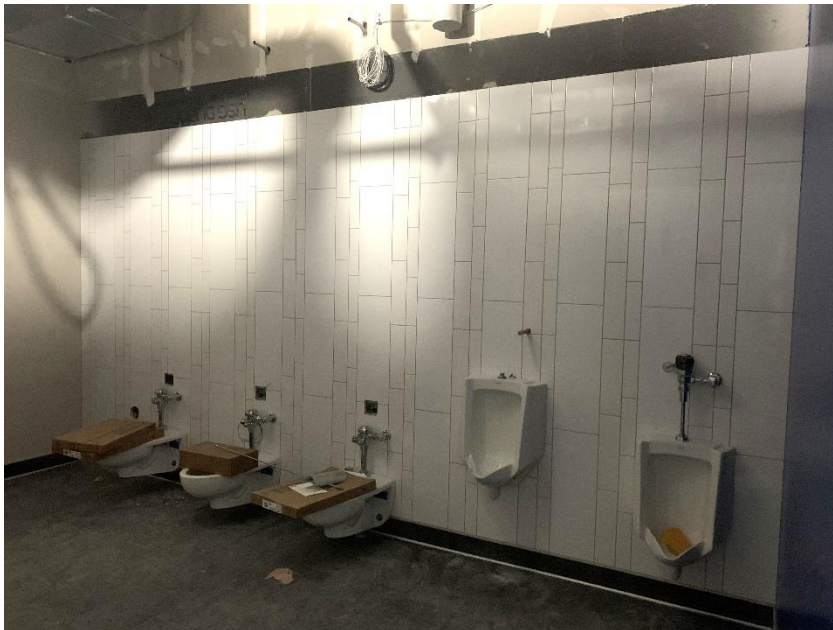
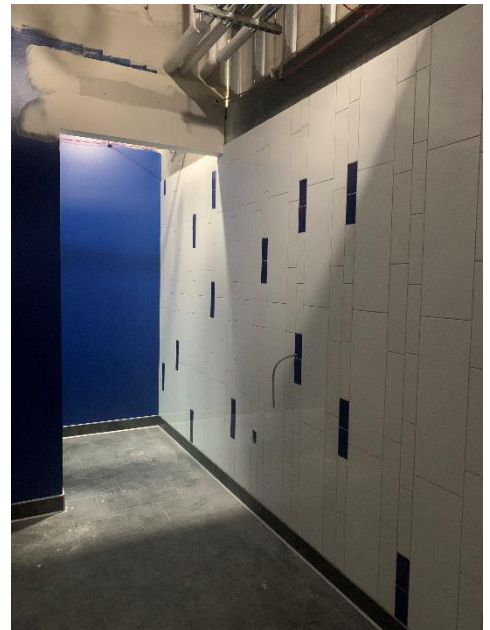
36. Area 1A – Wall and floor tile in center spine group toilets appear to be installed. Plumbing fixtures install in progress.

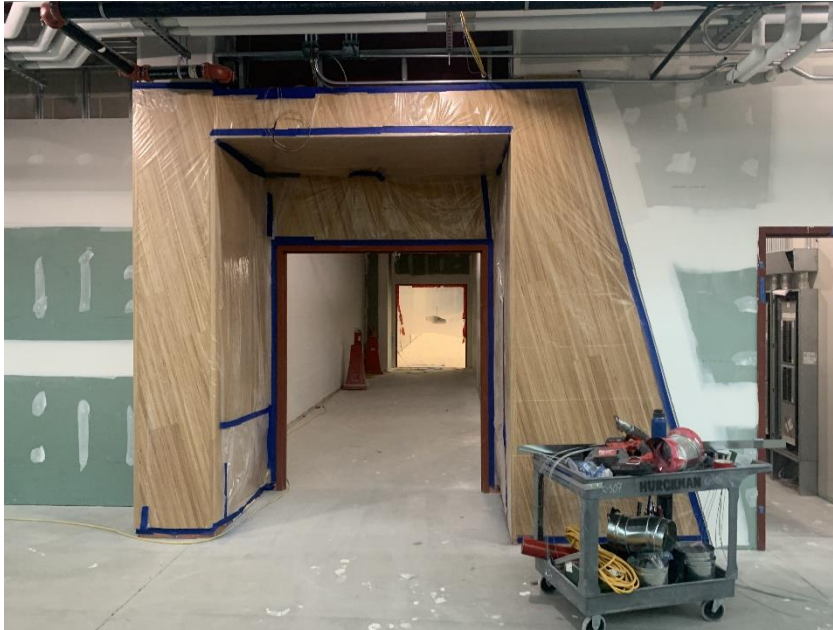
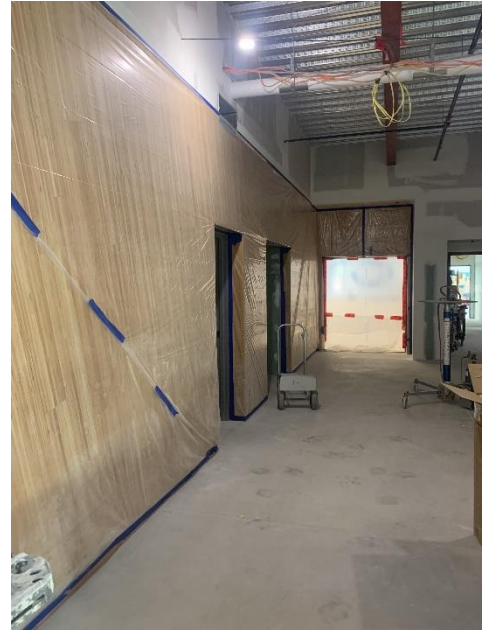
37. Area 1A – Accent wood plank at gym entries appear to be installed.

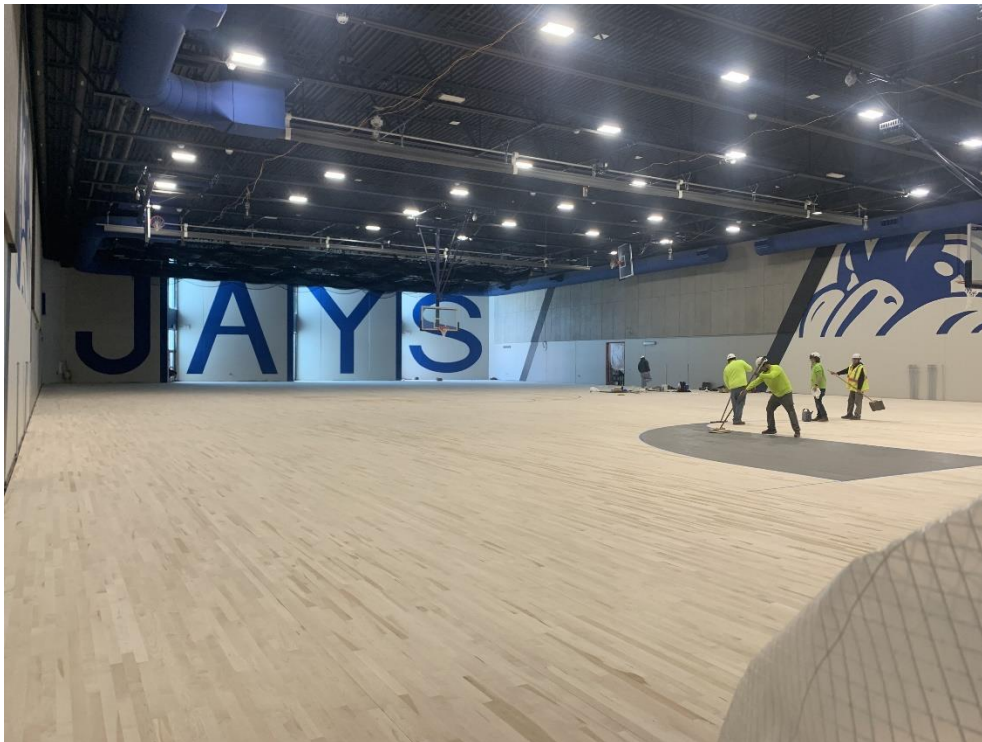
38. Area 6 – Gym floor appears to be installed. Staining and finishing in progress.
